Tarbolton Cemetery, South Ayrshire: Archaeological Mitigation

Data Structure Report

by Louise Turner

issued 5th January 2012

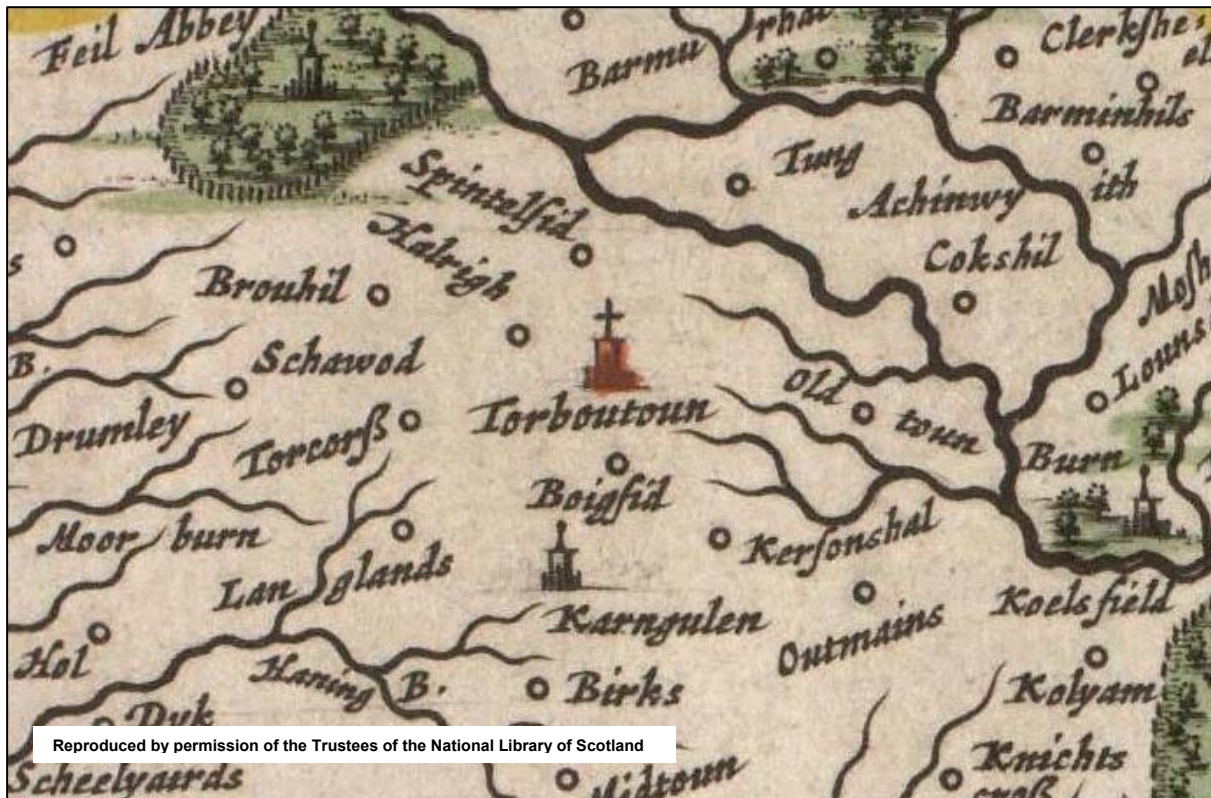
Fig 1a: Excerpt from Blaeu's Map of 1654

9. The earliest mapping available for the area – Blaeu's map of 1654 – is based upon an earlier map surveyed by Timothy Pont in the late 16th century (Figure 1a). This shows a church at 'Torboutoun', but unfortunately, because the drawing itself is stylised, it is impossible to infer anything about this early structure may have looked.

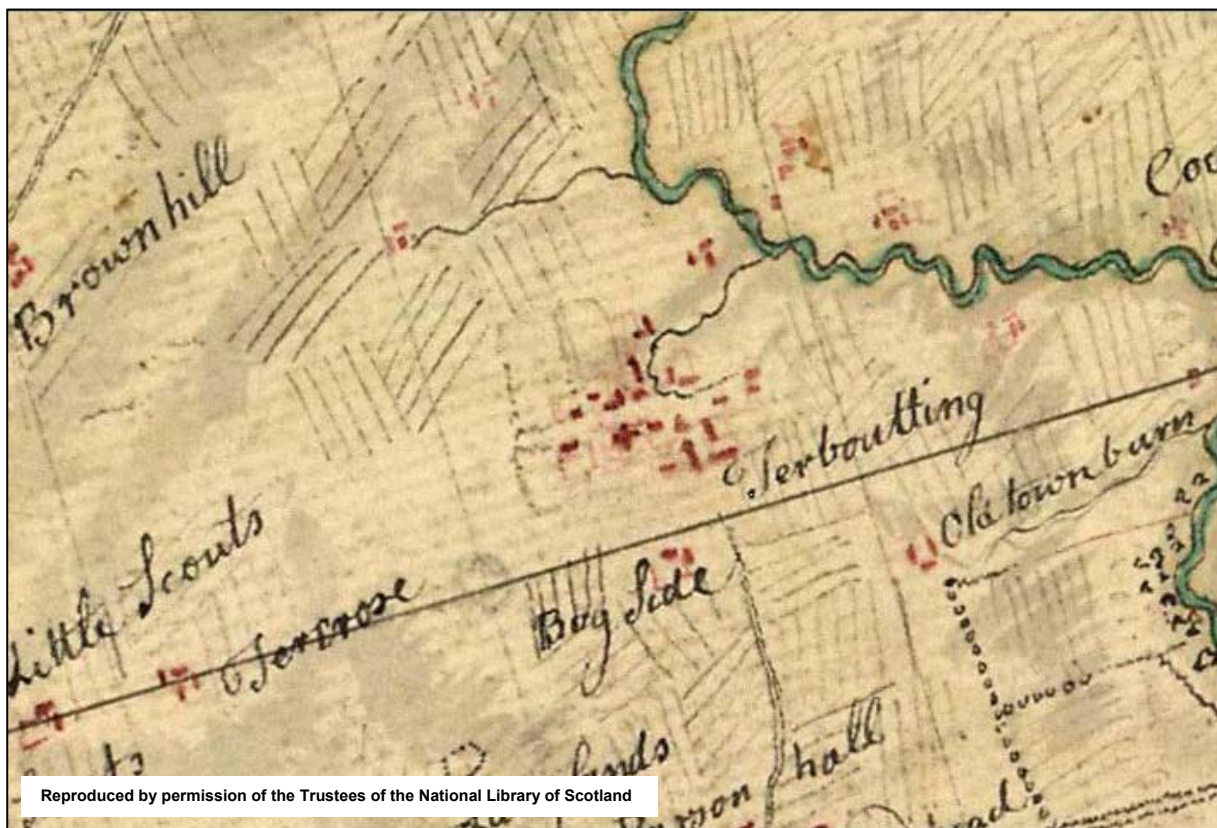
Figure 1b: Excerpt from Roy's Military Survey of 1747-55

10. Roy's Military Survey of 1747-55 is more useful in this respect (Figure 1b). Here, the village of Tarbolton is shown as cruciform on plan, with a main street running roughly east-west. At the east end, the arrangement of houses, running north and south of the main street, suggests that the settlement was expanding outwards in this location, creating a layout very similar to that seen today.

11. Roy's map shows a large structure, cruciform on plan, on the south side of the main street at a roughly central location. Occupying the same location as the modern church building, this appears to be a representation of the earlier church building, and it is sufficiently detailed for us to infer what the earlier church may have looked like. The core of the church, no doubt comprising its original medieval fabric, appears to be aligned east-west, with off-set projecting aisles, presumably later additions, on both the north and the south sides. No traces of this earlier structure now survive.

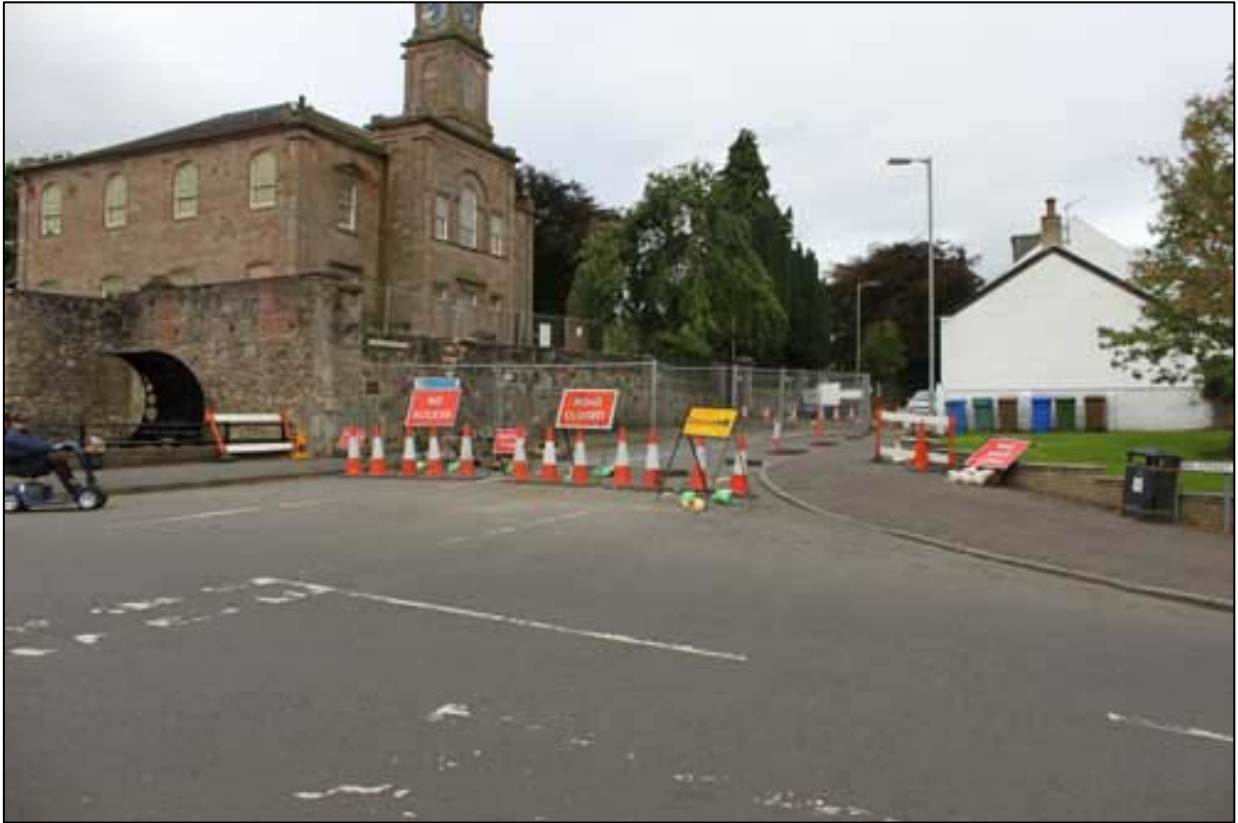
24. The retaining wall 000 (shown in Figure 4a) was built of mortared rubble. It had a maximum height of approximately 2.7m at its east end: from here, the base of the wall rose gently upwards, while the coping remained level for a distance of 14.5 m. Here it dropped to a height of roughly 1.5m, with an iron railing built into the coping. Behind the wall, the ground sloped gently downwards, from a height of approximately 1.5m above pavement level at the east end, to a height of roughly 1m at the west end.

Figure 4a: General View, Showing Modern Church with Retaining Wall to north

20. The 1820s church building occupies an elevated position in the town of Tarbolton, forming a prominent feature within the surrounding landscape. Within the churchyard, the ground slopes gently down from the church in all directions, with a sudden drop of 1-1.5m at the northern boundary, overlooking Cunningham Street (Figure 4a).

25. Wall (000), which acted as a revetment wall for the kirkyard ground to the rear, was in a poor condition, and in imminent danger of failure. The works to replace it required the removal of the wall, plus further excavation to the rear that extended approximately 1m into the kirkyard. This additional work was required to safely accommodate the founds of the replacement structure, and to allow a sufficiently robust structure to be created that would fulfil modern specifications.

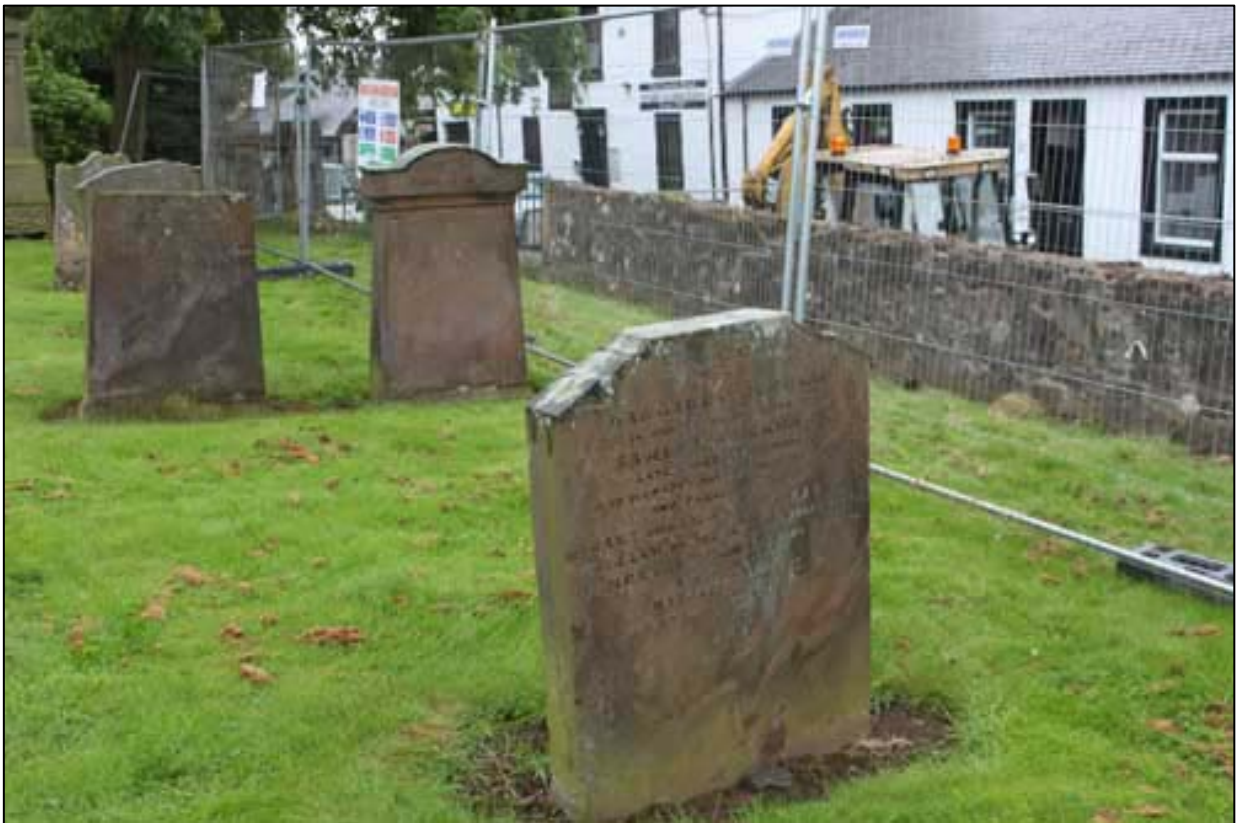
Figure 4b: View along Line of Graves, with Marked Grave of Catherine Andrews in centre

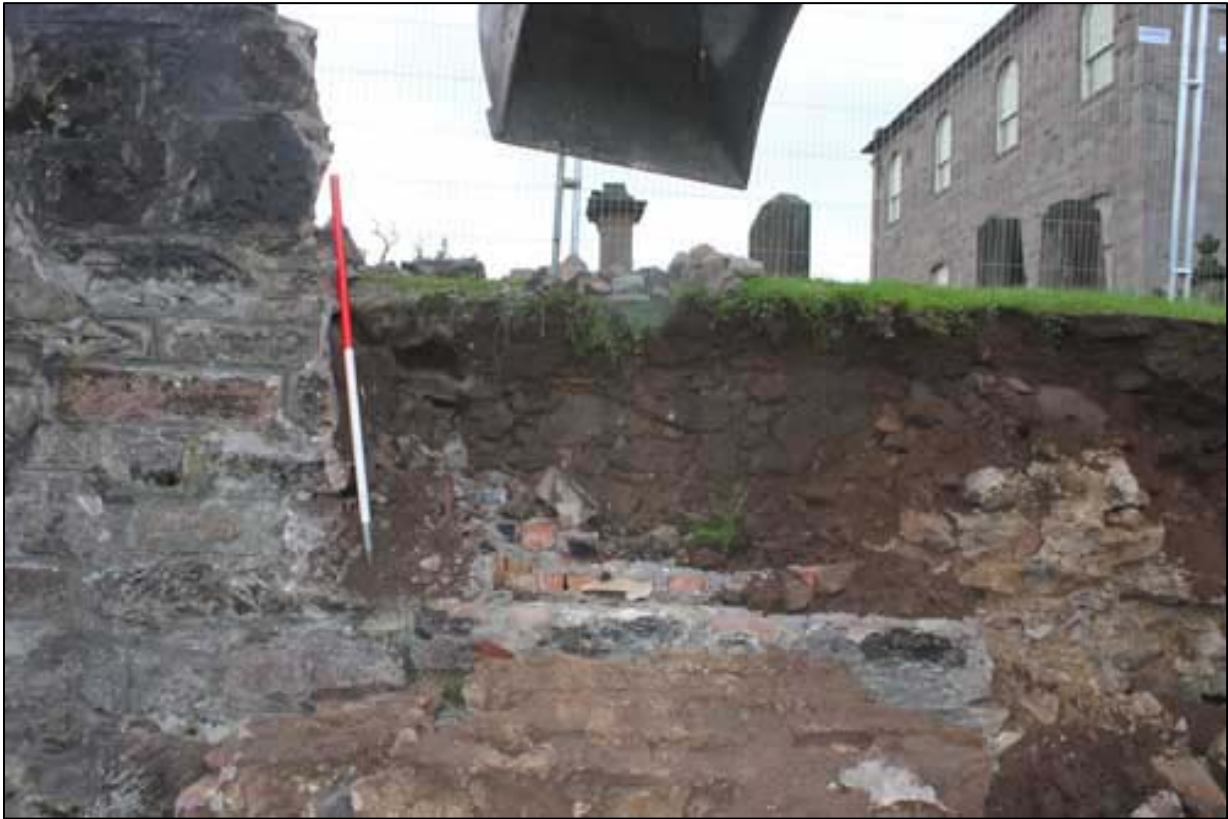
29. Works began with the cutting of a channel through Wall (000), to the west of the Gibson Lair, at a point lying 3.9m west of the eastern limits of the wall. This revealed that repairs to retaining wall 000 had already taken place in the recent past (mid to late 20th century), and that an earlier retaining wall still survived *in situ* to the rear of (000) (Figure 5a). The space between walls (000) and (002), which measured roughly 0.8m in extent, was filled with a dark reddish-brown sandy silty-clay (003), which had occasional lenses of yellow sand.

Figure 5a: Wall 003 and modern brick repairs revealed behind Retaining Wall 000

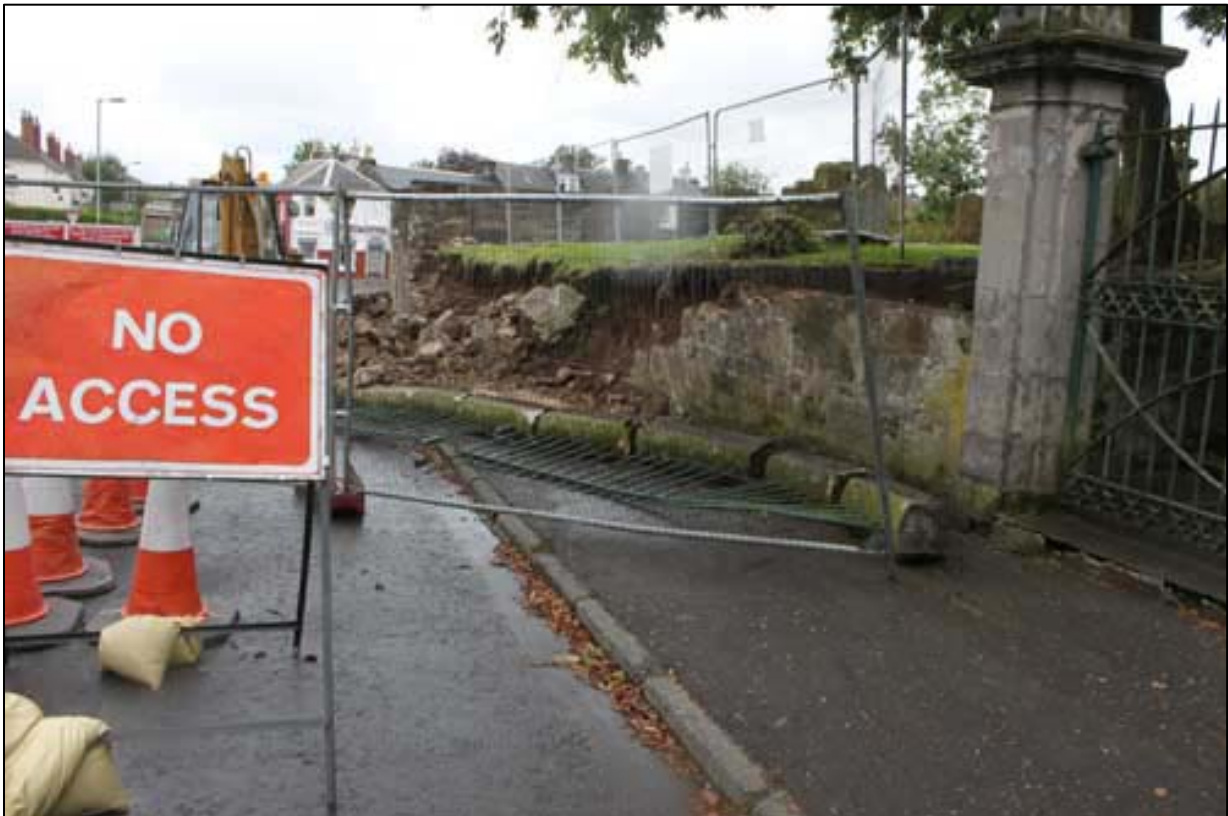
Figure 5b: General View from west, following collapse of Retaining Wall 000

31. These initial explorations revealed the full extent of the weakness of Wall 000, which collapsed soon after (Figure 5b).
32. With the known graves concentrated towards the east end, work at ground reduction began at the west end of the collapsed section of walling, at a point lying roughly 14m west of the eastern limits of the kirkyard. However, at a depth of 1.1m, human skeletal material was uncovered, and further investigation revealed an articulated limb. The fill of Grave [004]/(005) revealed bottle glass and pottery of 19th century date, indicating a modern origin for the deceased (Figure 6a). More importantly, the grave cut through (003), the backfill which lay to the rear of Wall (000). This indicated that it had post-dated the construction of the later retaining wall. No coffin was identified in association with this particular burial.

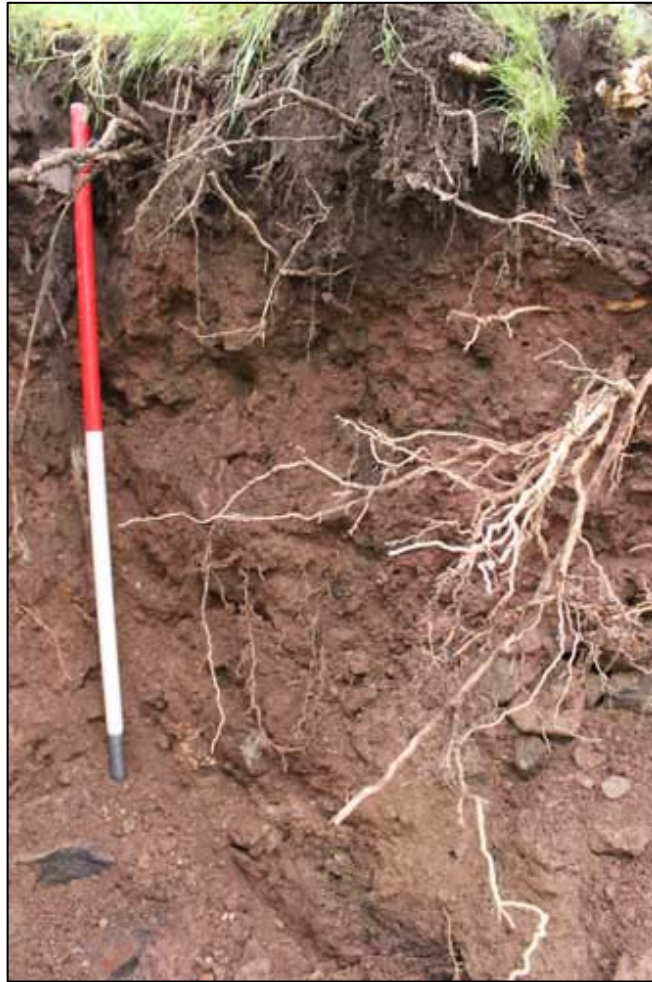
Figure 6a: E-Facing Section of Grave [004]/(005), with *in situ* human remains at base

43. In contrast to these informal deposits of human bone identified throughout the length of (011), Graves [004]/(005) and [012]/(013), though found at a similar level, appeared to represent single burials, aligned east-west, and fully articulated. No evidence of a coffin was found in association with either, though a single coffin nail was recovered from (005). Both graves cut the earlier retaining wall (002), and the backfill (003) of retaining wall (000), thus confirming a late 19th century date for both. The lack of coffins and headstones, and the complete lack of recorded documentary information relating to either, strongly suggests that both features represent paupers' graves, located at the very edge of the burial ground.

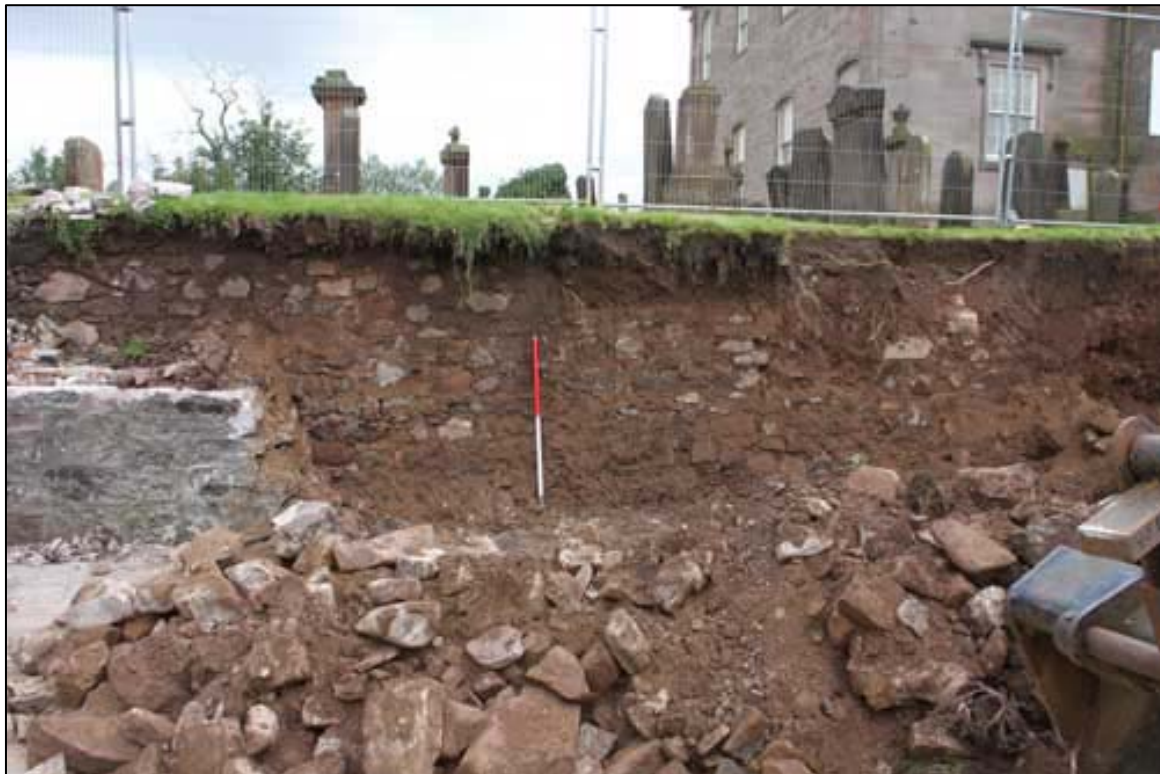
33. With work halted in this location due to the discovery of *in situ* human remains, the investigation of the east end continued. Initial works involved the removal of Deposit 003, revealing the intact face of Wall 002 to the rear (Figure 6b). Beneath (003) was a thin band of black sandy silty-clay (006), which again revealed numerous fragments of modern pottery (included transfer-printed glazed white earthenware). This directly overlay grey stony subsoil (007), which had the character and appearance of degraded bedrock.

Figure 6b: Retaining Wall 002 Revealed following removal of Deposit 003

40. The outstanding features which were encountered during these works were the two retaining walls, (000) and (002). The earlier of the two, (002) had been constructed by cutting back into an existing slope, represented by the relict soil horizons (008) and (009), and backfilling the void to the rear once the wall had been constructed. Finds of ceramics and bottle glass within this backfill, (011), suggested that the wall had been built during a period spanning the late 18th-early 19th century. It does not therefore seem unreasonable to suggest, therefore, that Wall (002) is contemporary with the original build of the modern church building c. 1820.

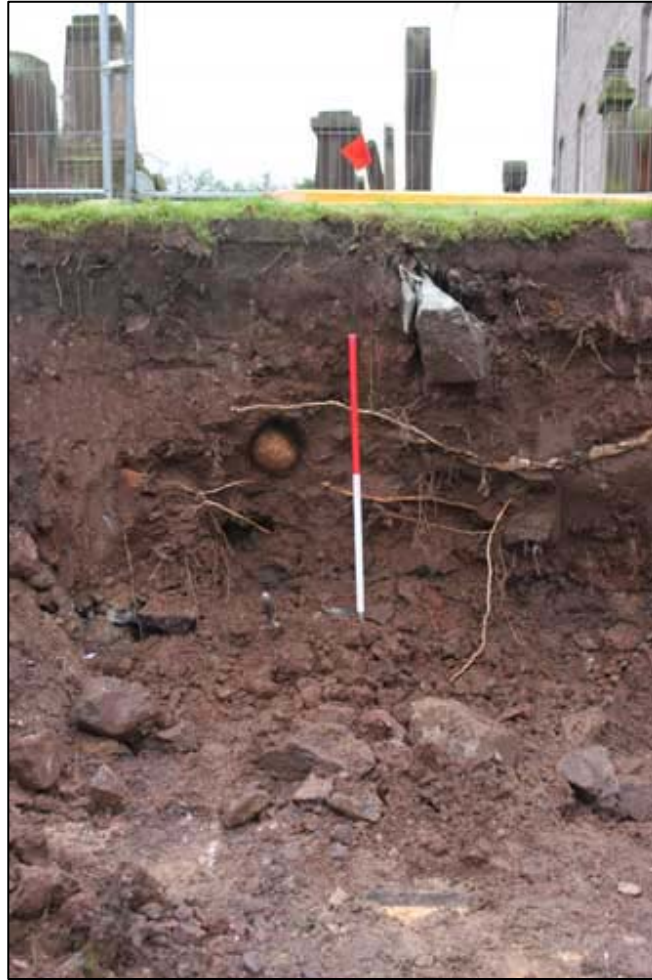
35. Human remains were also frequently encountered within (011). These were found consistently at a level of 1m-1.1m beneath the surface, with all skeletal material taking the form of disarticulated material: femurs were found buried with the ball joint to the west, and in one location, three skulls were found packed together, one of which had been buried upside-down. A fragmentary worked stone slab was also found within (011): the tooling and dimensions were comparable with the bases of the early 19th century headstones that still stood within the kirkyard (Figure 7a).

Figure 7a: Disarticulated skull revealed in Deposit (011), with broken headstone to right

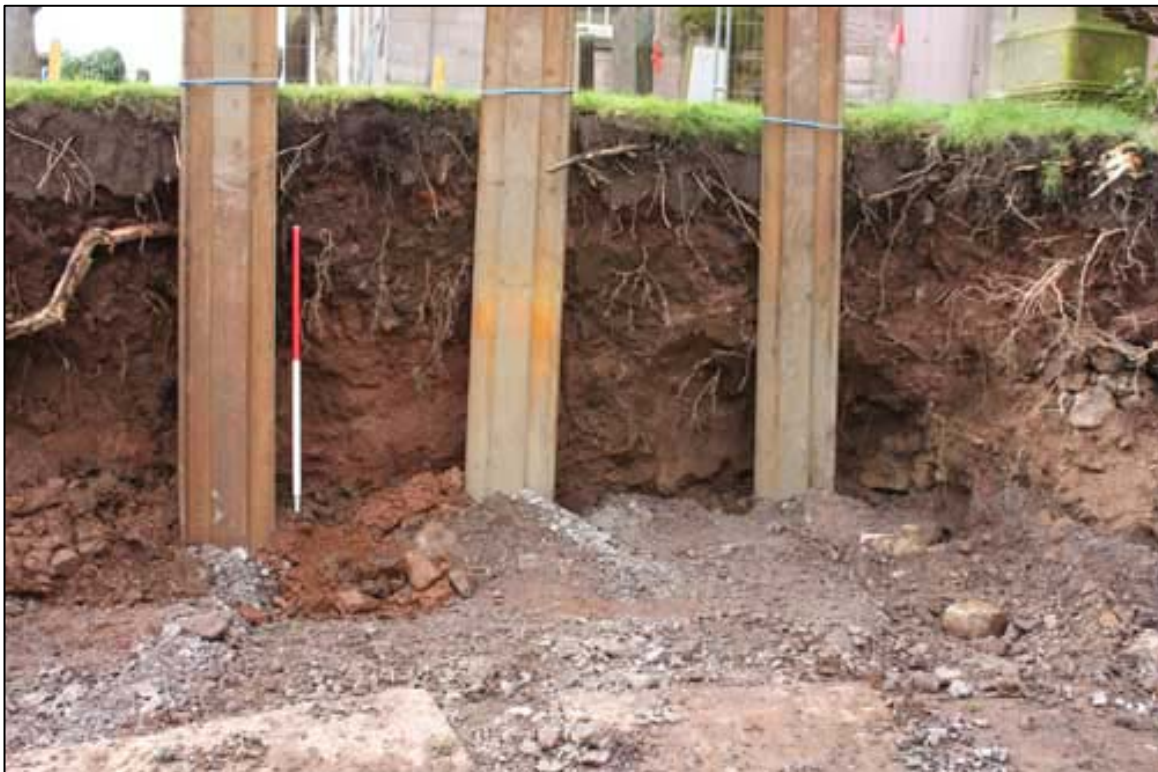
Figure 7b: Cultivation Horizon (008) and Subsoil (009) revealed, Grave [004]/(005) to right

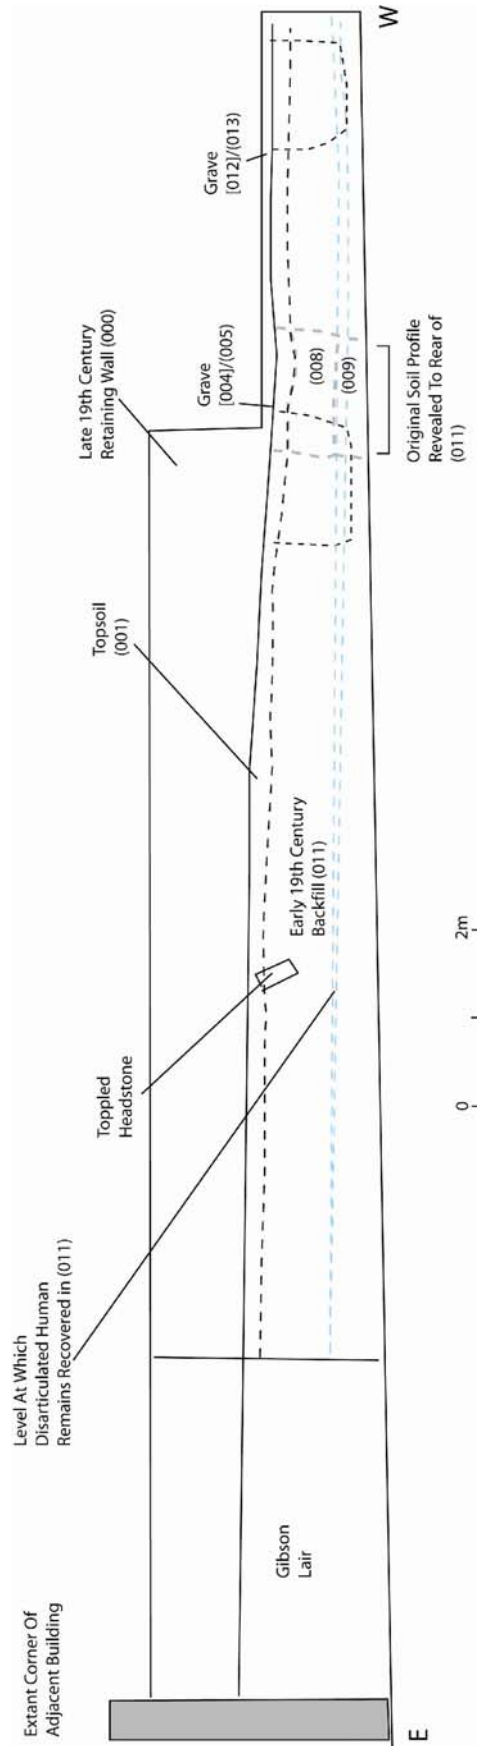
41. Contained within (011) was a layer of human skeletal material, commonly encountered between 1m and 1.1m below the present ground surface (Figure 8). This layer was not consistent throughout the length of the trench: rather it seemed to represent several discrete deposits of human bone. Isolated finds of coffin fittings were recovered, but actual traces of coffins were conspicuous by their absence.

Figure 8: East-West Section, following removal of Retaining Walls (000) and (002)
