**Land South of 6 Gowlands Terrace,
Barrhill, South Ayrshire:
Archaeological Mitigation**

Data Structure Report

by Claire Williamson

issued 19th October 2011

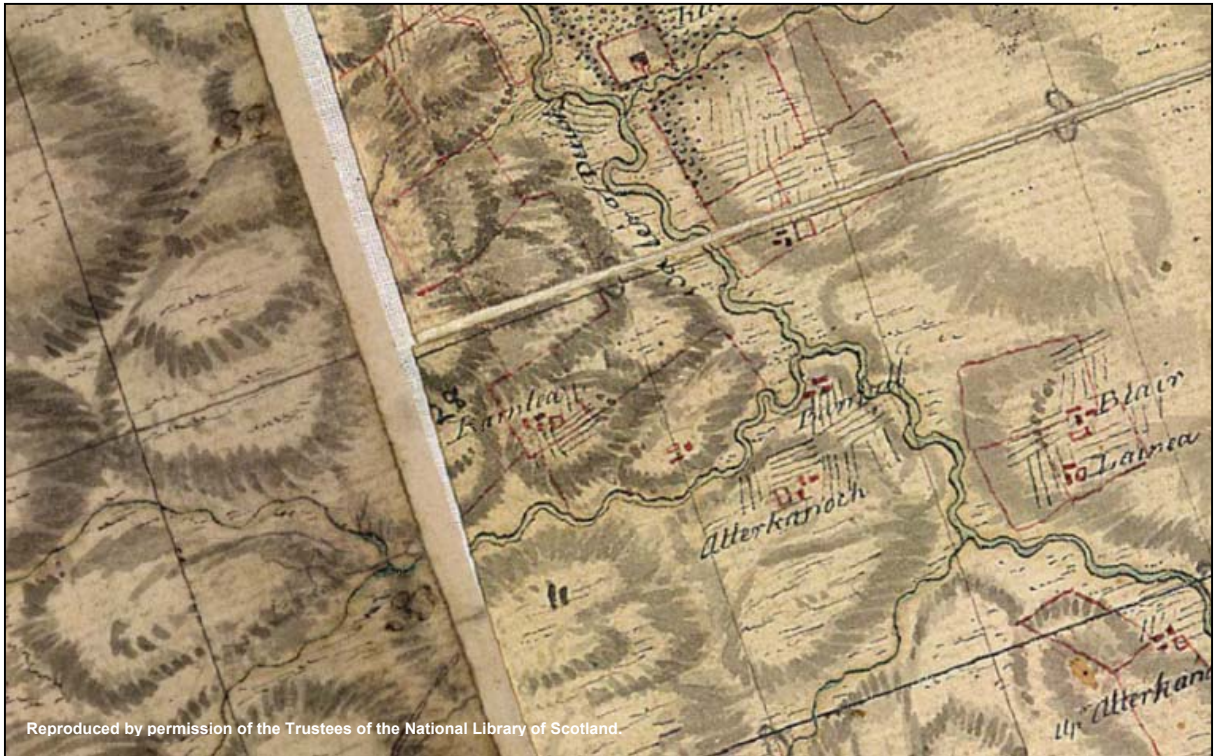
Figure 1a: Roy's Military Map 1747-55

6. A review of the available historical mapping has shown that in the mid 18th century, when recorded by Roy's Military Survey of Scotland (1747-55), the proposed development area is marked as unused hill ground (see Figure 1a) lying to the west of the Cross Water. The first viable 19th century mapping is the First Edition Ordnance Survey (1857, Figure 1b), which shows the ground has been enclosed and two buildings are depicted in the far east of the ground within an area of garden next to the Cross Water. This is the only potential archaeological site identified by the desk-assessment and is probably an early 19th century structure. The building is not present on the subsequent 2nd edition Ordnance Survey (1897).

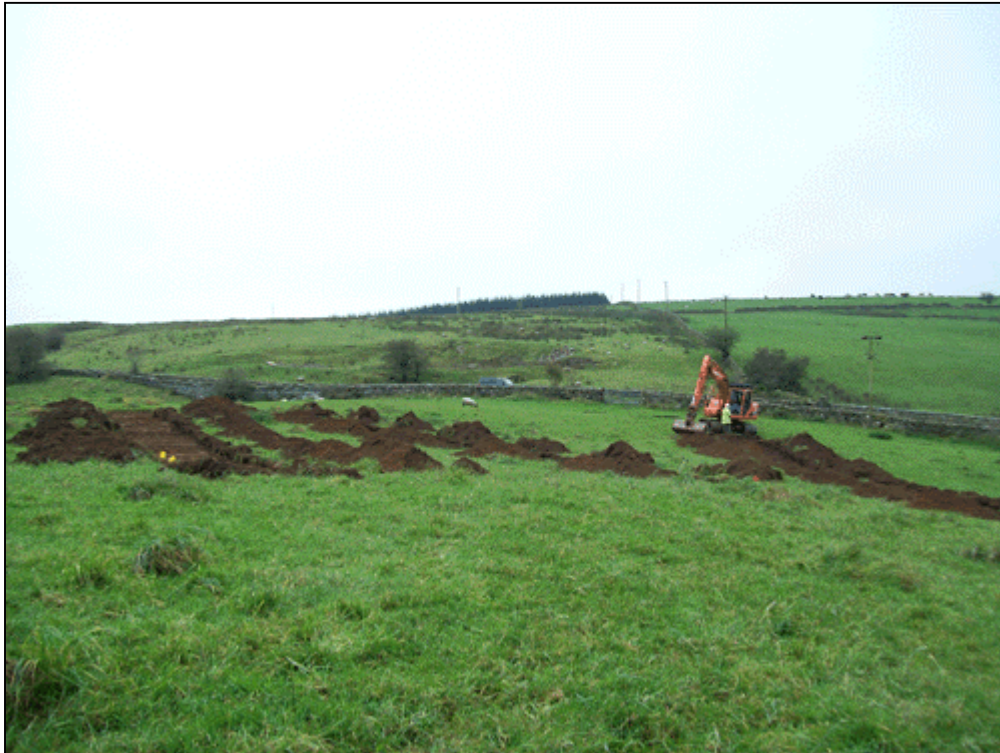
Figure 3a: General shot of site from the northeast with Trenches 3, 4 and 5

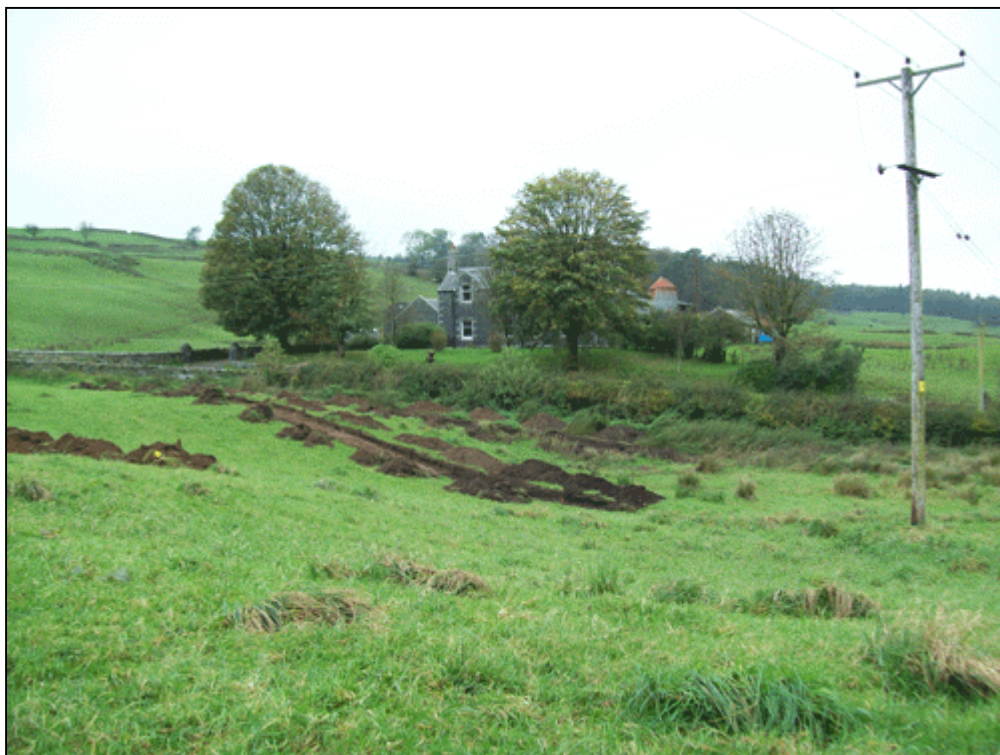
17. The northeast end of Trench 2, which ran into the margins of the northwest peat area, exposed the peat (007) to be approximately 200 to 400mm in depth running approximately 9m into the trench. This end of the trench and the northeast end of Trench 1 were also affected by waterlogging.

Figure 3b: General shot of site from the east-south-east with Trenches 1 and 2

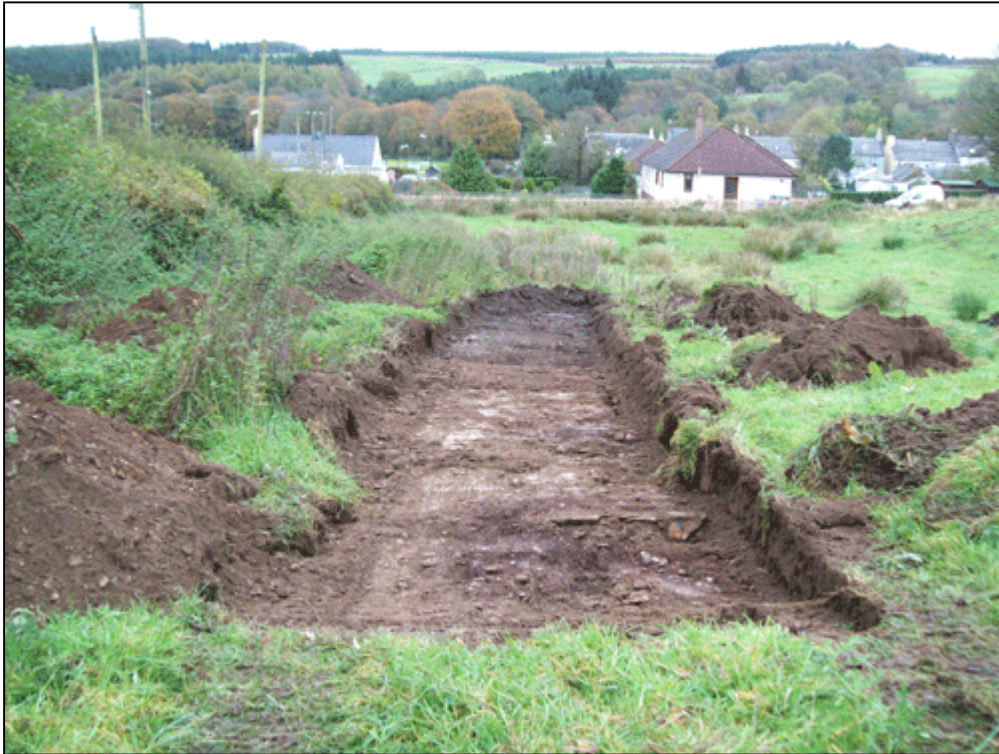
20. Trench 1 exhibited modern disturbance in the form of a field drain. Sitting in its northeast half, a rubble field drain was exposed running SW-NE measuring 400mm in width. No field drains were present within the rest of the trenches.

Figure 4a: Trench 1 from the southwest

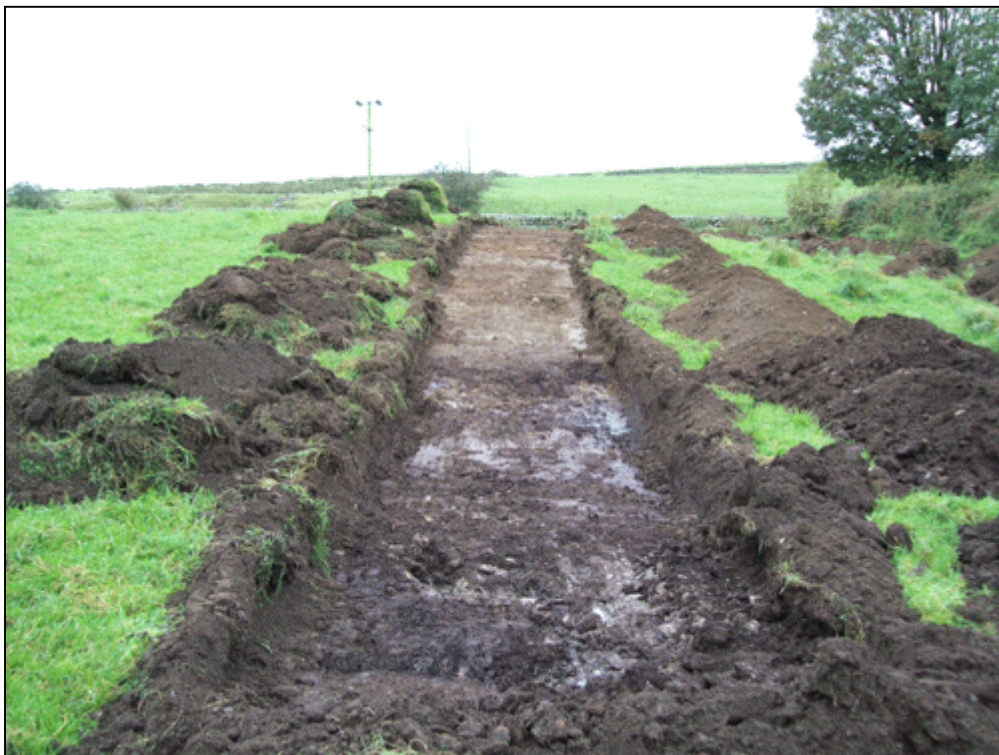
Figure 4b: Trench 2 from the east-north-east

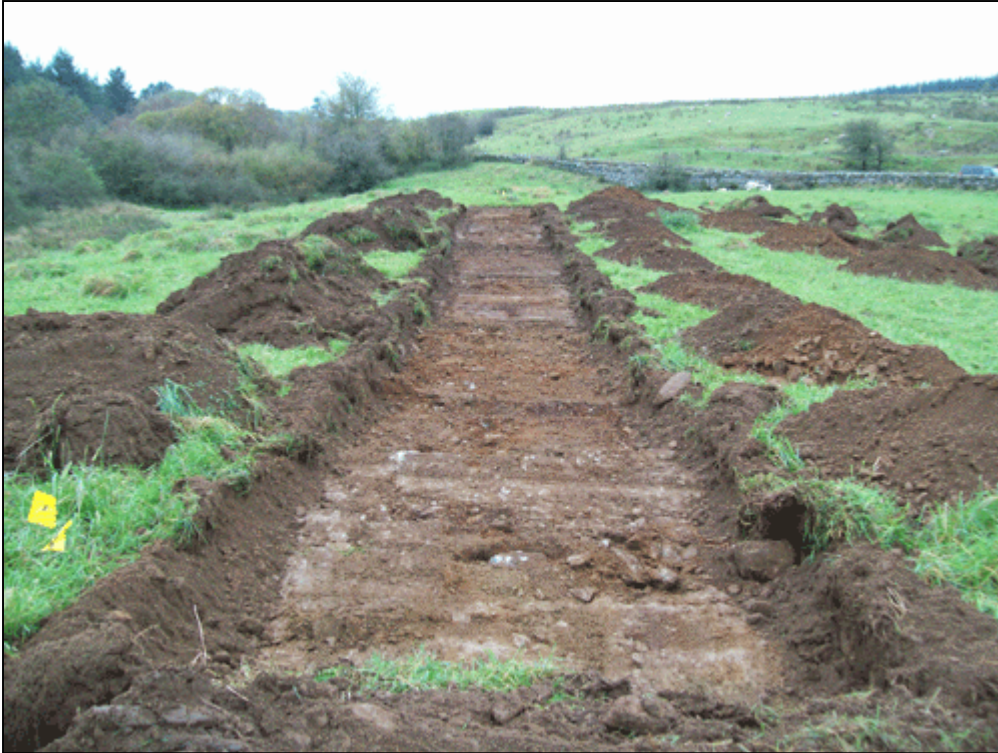
Figure 5a: Trench 5 from the northeast

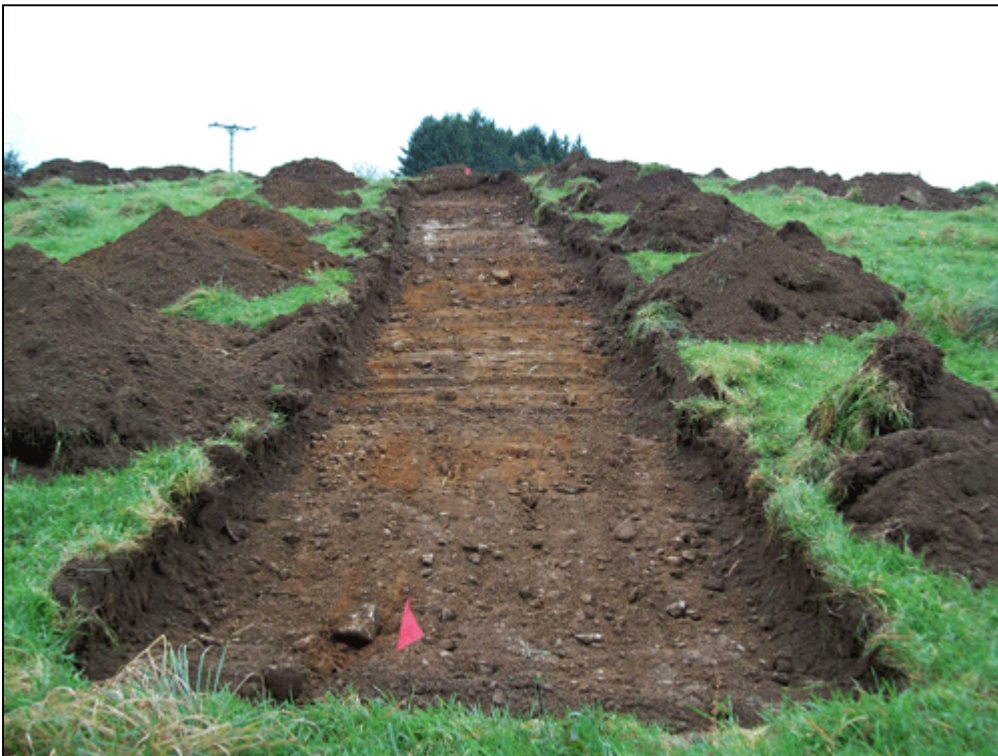
Figure 5b: Trench 7 from the north
