**The Linn, Dunning:
Archaeological Assessment and Survey**

Data Structure Report

by Louise Turner

Rathmell
Archaeology Ltd

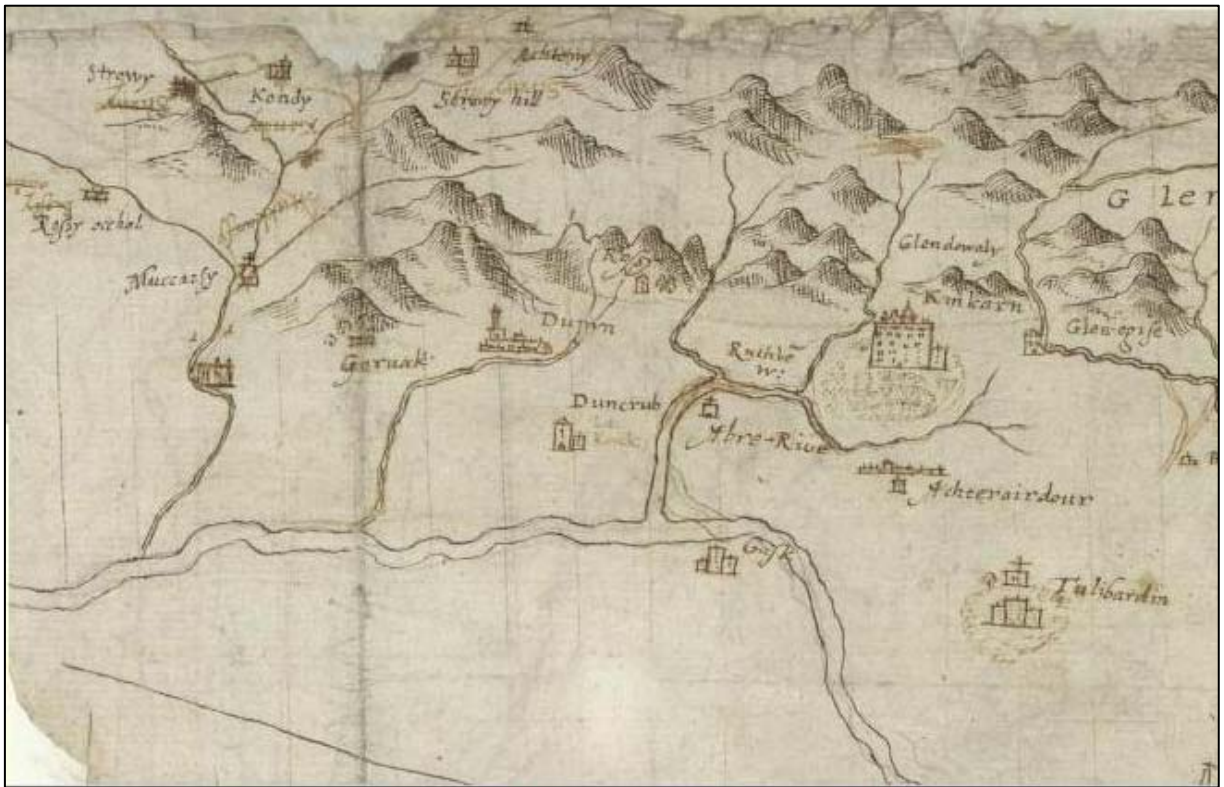
Figure 1: Extract From Pont's map of South Strathearn, Glen Almond (1580s-1590s)

15. The earliest map coverage available for mainland Scotland is provided by Timothy Pont's map, surveyed in the 1580s and 1590s (Figure 1). This map is hard to interpret from a modern perspective, as it has been drawn with the south lying at the top of the sheet. However, it is still possible to identify the village of Dunning (named 'Dunyn'), with its church tower (still extant today) featured prominently. Close inspection also reveals, lying at the top right of the map, two buildings named 'Struwy' and 'Kondy'. These important structures would have been the residences of local gentry, and they will be considered in detail at a later point.

35. Pont's map (Figure 1) shows two substantial structures in the area: Kondy (i.e. Condie) and Struwy (i.e. Struie), and further exploration of these particular place names seems a good starting point for any investigation regarding early land divisions. Prior to the Reformation in 1560, information relating to these landholdings is poor. Evidence suggests, however, that the Spens family were in possession of Condie in 1547. Struie demonstrates a more complex history, however, with various landholdings belonging to various lairds included within it (Meldrum 1926, 183). The portion containing Struie Castle, which is the structure shown on Pont's map, appears however to have been in the hands of the Barclay family. Other notable land owners in the area were the Rollos of Duncrub, the Oliphants of Condie and the Murrays: the Rollos were also granted the title Baron of Dunning, but at which point this honour was awarded is unclear.

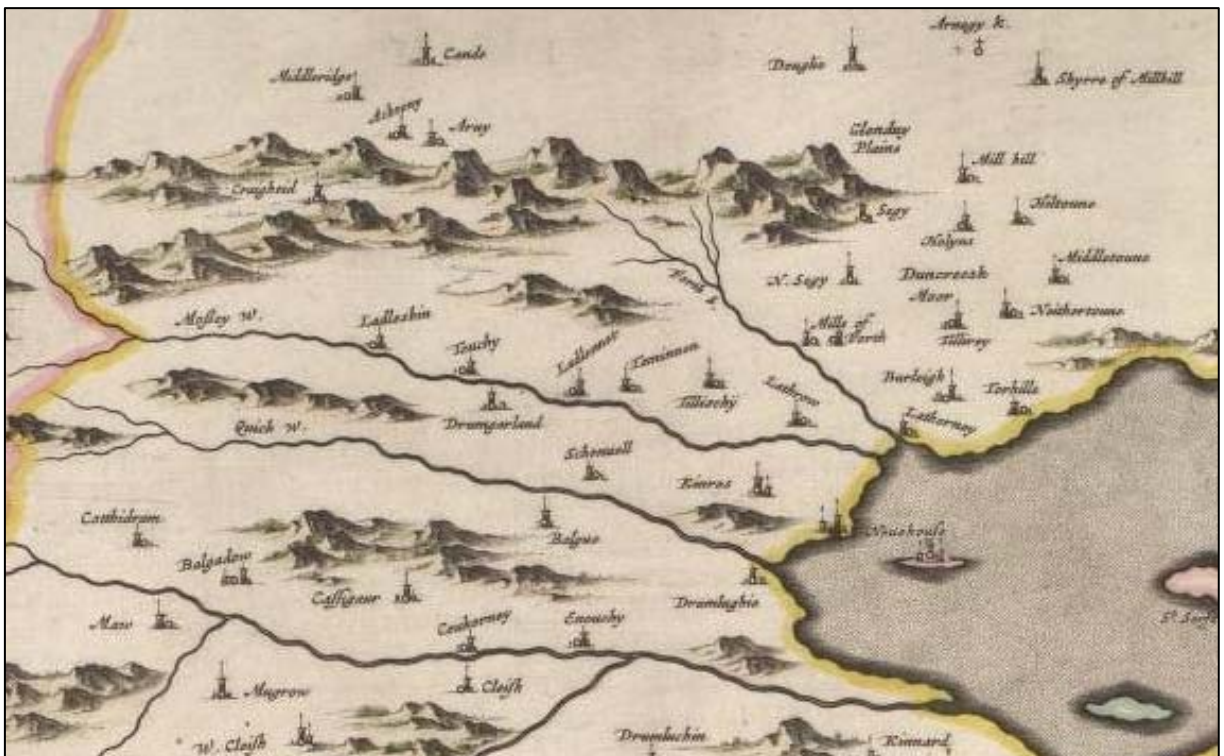
Figure 2: Extract from Blaeu's Map of Fife (The West Part), dated 1654

16. Blaeu's map of 1654 used Pont's earlier version as its basis (Figure 2), but only one or two occasional common points of reference can be found, in particular, the building named 'Kondy' (here called 'Condi'). A building named 'Middleridge' is also present – this may correspond to 'Middlerig', a placename which also features upon later mapping. Blaeu's mapping of this area is poorly detailed in comparison with both Pont's earlier version and Moll's later example of 1745: this probably indicates that the map in question, which features Fife as its subject, was never intended to represent the area around Dunning in any great detail. It should be noted, however, that Moll's 1745 map is the first to name the minor watercourse – the May Water – in close proximity to which Lategreen and Linnhill were situated.

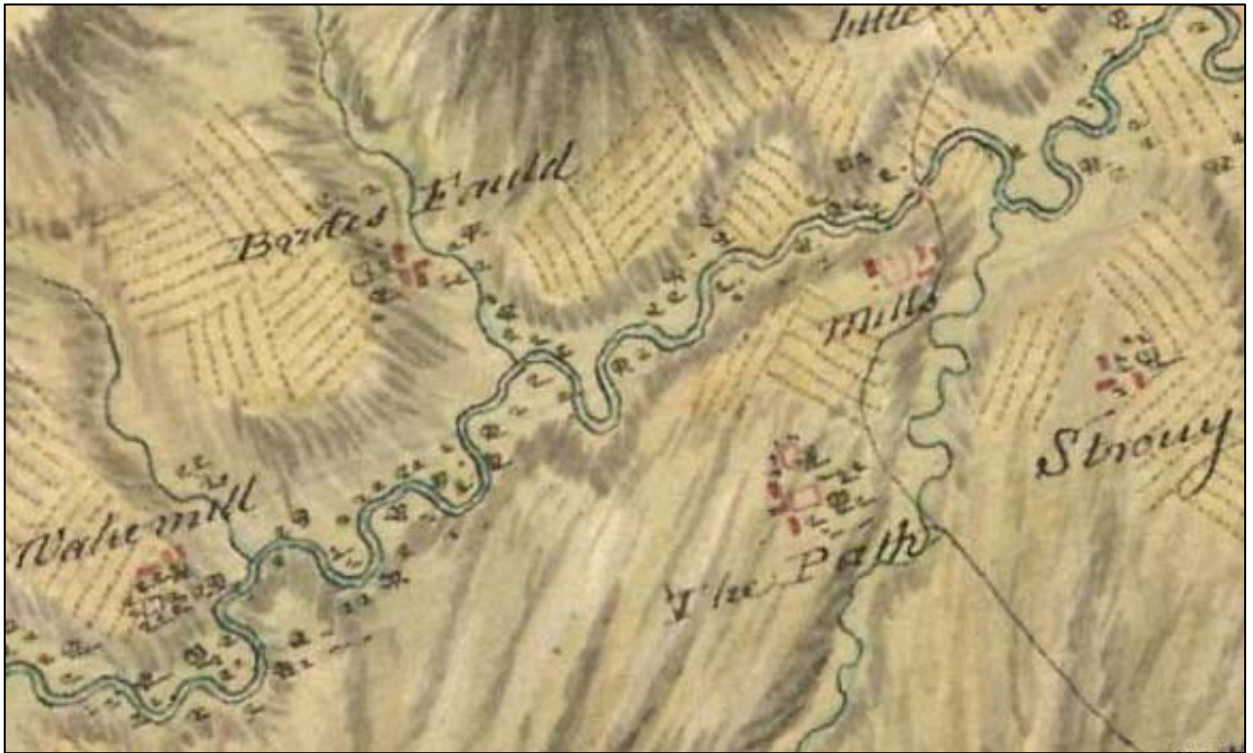
Figure 3: Extract from Roy's Military Survey of Scotland (1745 -55)

18. Roy's Military Survey of Scotland from 1747-55 marks a radical departure from these early maps (Figure 3). He illustrates individual farm buildings in great detail, along with the extent of cultivated land (shown by the lines of diagonal hatching, which represents rig and furrow). This detailed depiction of the land allows much closer comparison to made with modern maps of the area. Of note are the large number of placenames around the Water of May which make reference to mills – two are shown on this small stretch of burn alone. While the place name of the westernmost mill is difficult to decipher on Roy, it is likely it corresponds to Maidsmill (or Midmill).

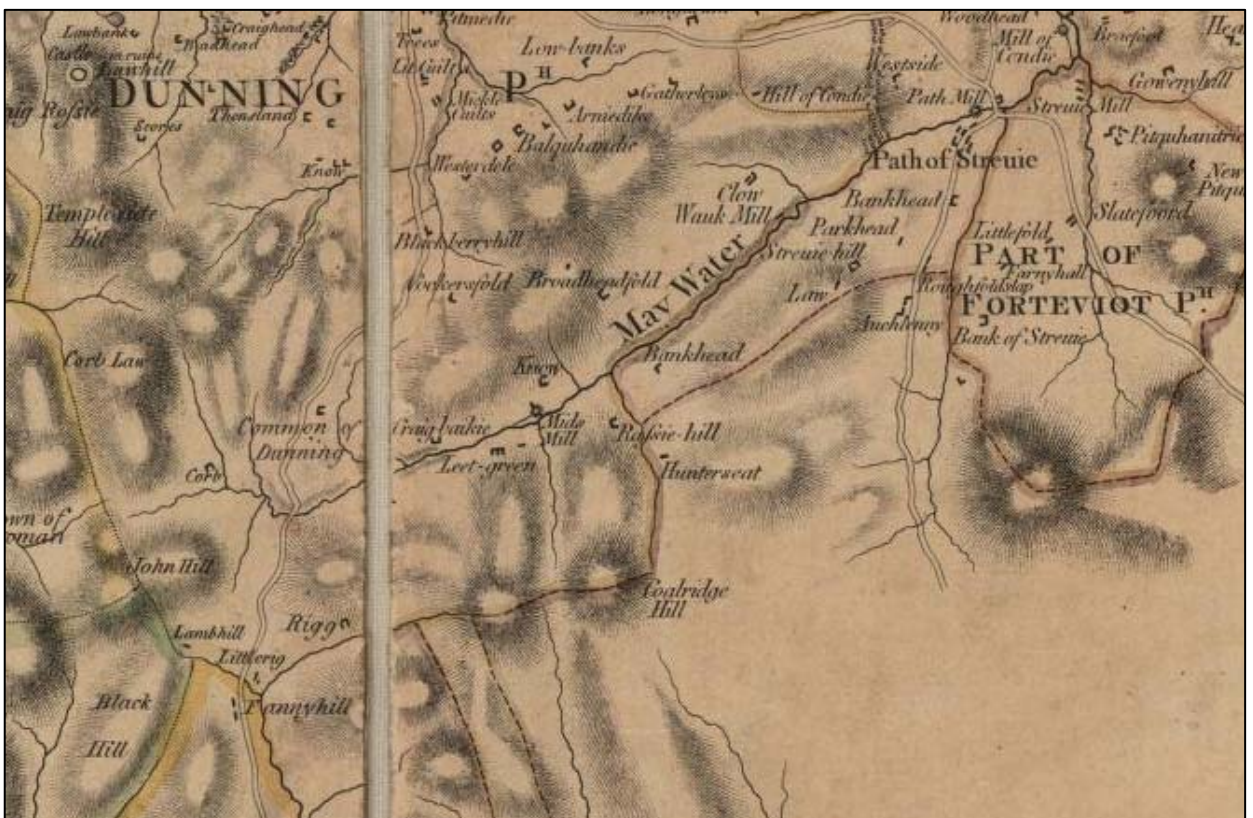
Figure 4: Extract from Stobie's Map of 1783

20. It is Stobie's map of 1783 (Figure 4) which first features the place name 'Leet-green'. This early version of the name which uses the prefix 'Leet' suggest a milling connection, though the lack of any nearby watercourses would strongly argue against this possibility. The farmsteading is shown as 'E'-shaped on plan, comprising a long range to the rear with additional buildings forming wings at either side. An additional building – unnamed – lies to the east: this corresponds well with the location of Linnhill – although again this would correlate well with the farmstead named 'The Path' on Roy.

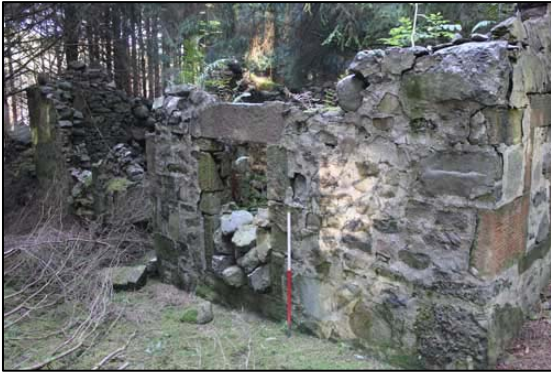
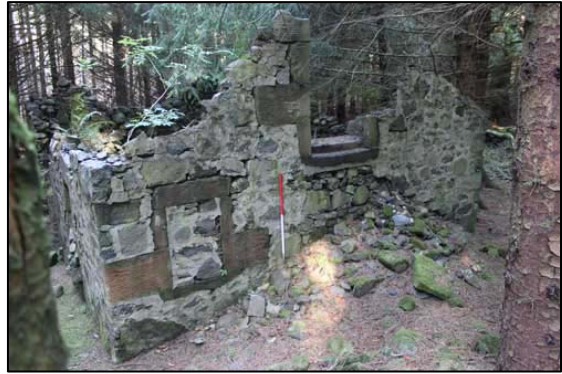
60. The eastern building (1001) was a one-storey cottage composed of mortared rubble (whinstone) masonry 0.7m thick with droved sandstone quoins (Figures 10 to 12). The exterior had originally been rendered. The pitched roof would have been slated: loose slates survived as surface finds in the vicinity, the course of the original roofline evident as a thin deposit of mortar on the eastern side of the south wall. There was an outshot (1013) projecting from the south wall, surviving only as basal courses partially obscured by rubble.

a: Exterior View From S, (1001)

b: Exterior View from S, (1001)(1013)

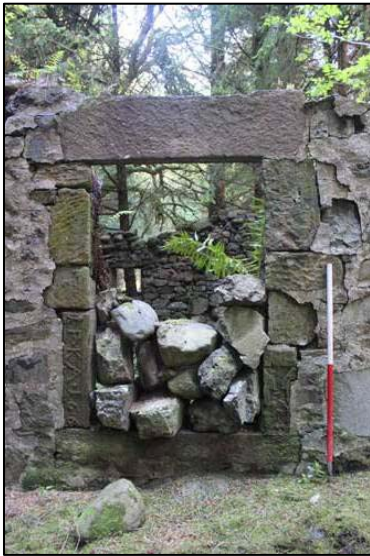
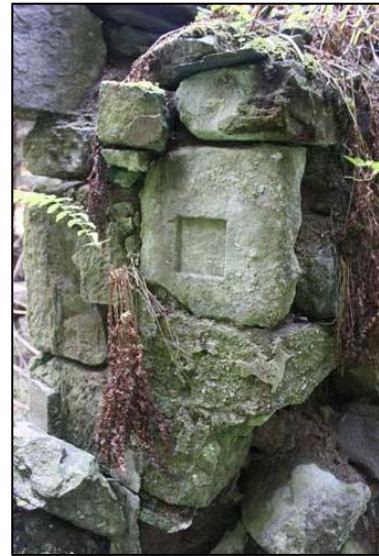
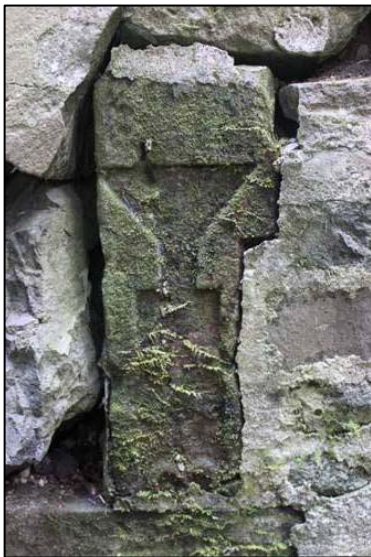
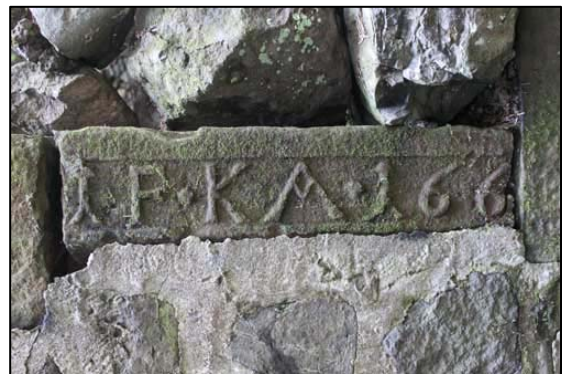
63. One particular window – located at the south end of the west wall – was of particular interest as it had three fragments of carved stone built into its fabric. These were all located within the south window on the west elevation, and they were distributed at various points around the margins (Figure 11c). These carved stones included a small sandstone block decorated with a recessed square (Figure 11d) built into north side of the splayed embrasure which defined the window recess. A similar recessed geometric shape is to be found on the external margin of the south window (south side), comprising a square, with adjoining triangle (Figure 11e). The remainder of the feature has been lost through spalling of the surface.

c: S Window, W Wall with Carved Stones

d: Carved stone, Interior S Window, W Wall

e: Carved Stone, W Side, S Window, W Wall

f: Carved Stone (?Marriage Stone), E Side, S Window, W Wall

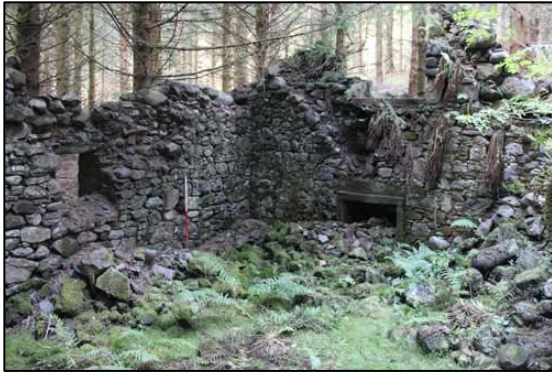
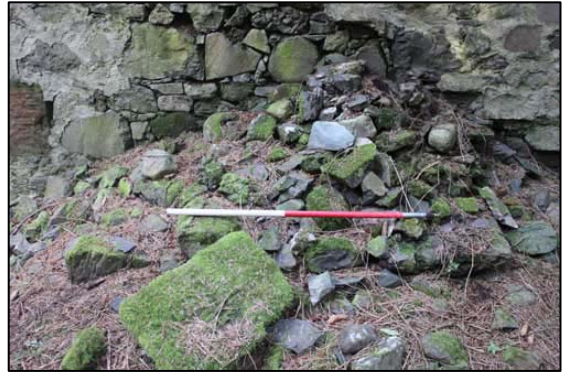
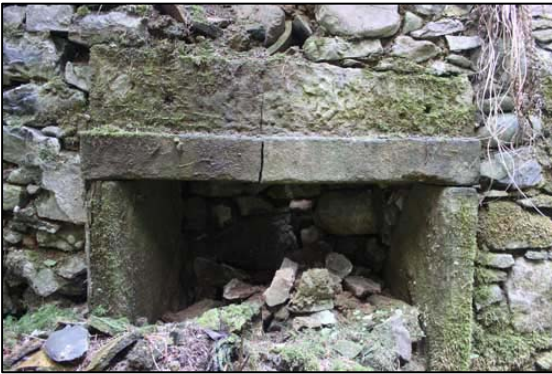
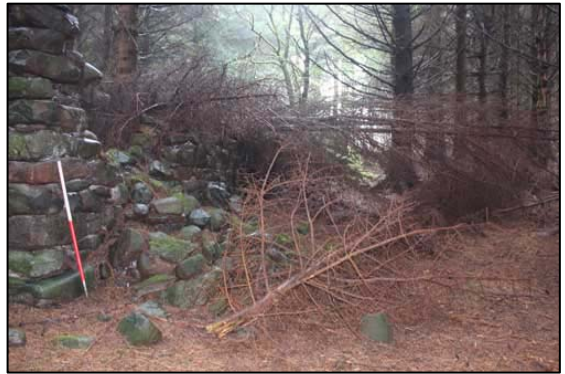
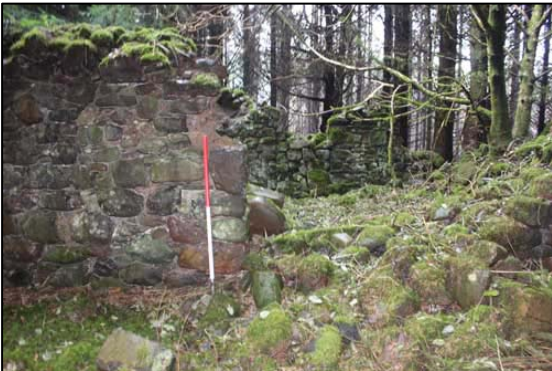
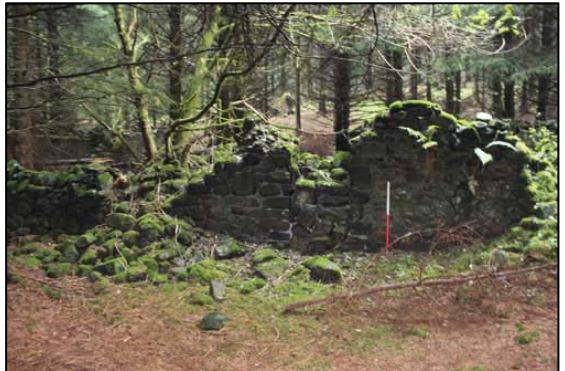
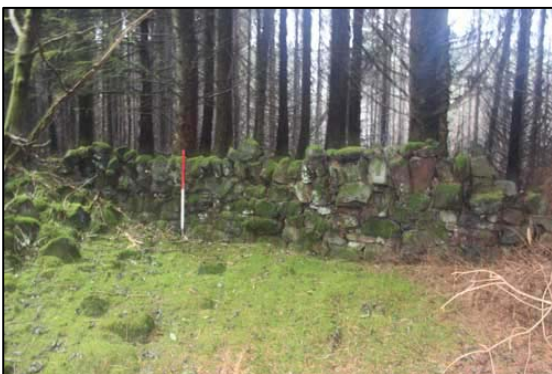
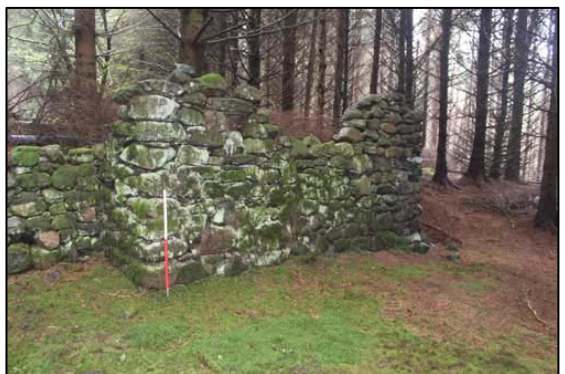
Figure 12: Images of Lategreen

a: Interior S Gable, 1001

b: Pos. External stair, 1013

c: Fireplace, S Wall, 1001

d: View along N Elevation, 1002

e: N Range 1002, Room B

f: External (N) Elevation, 1002

g: Rear (N) Wall of Room C, 1002

h: E Elevation (Gable, Room D), 1002

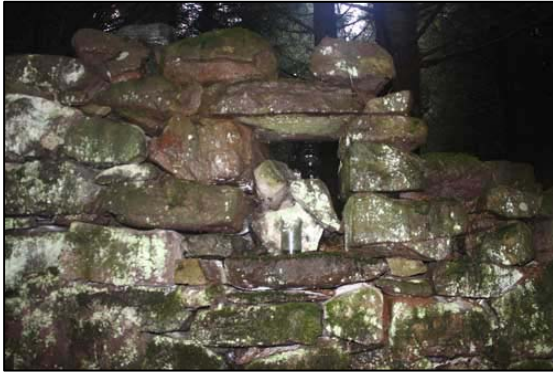
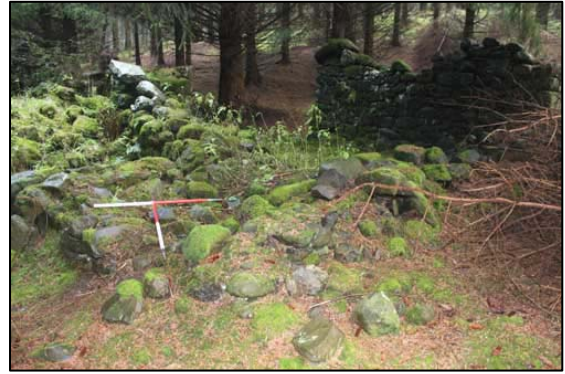
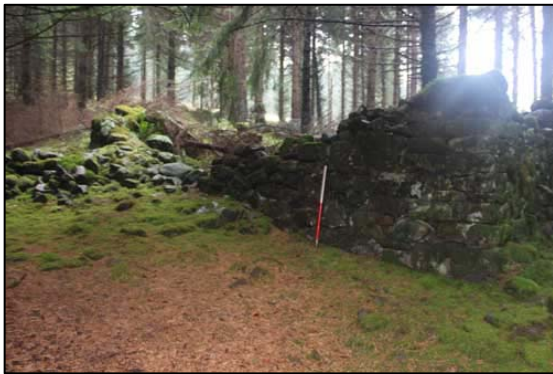
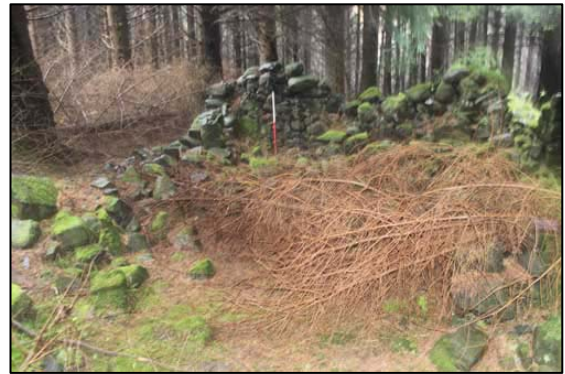
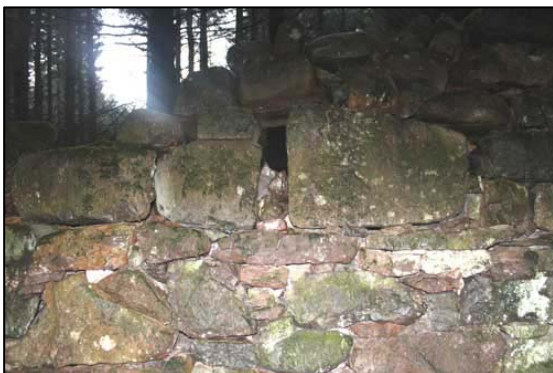
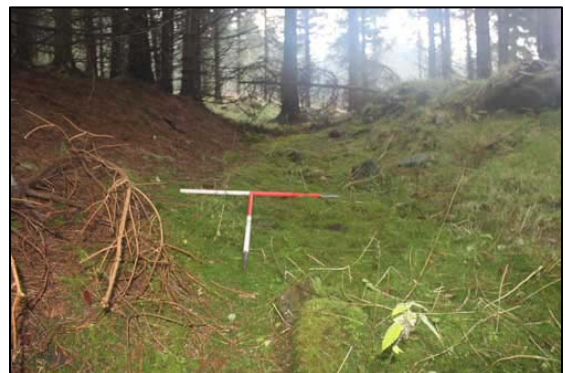
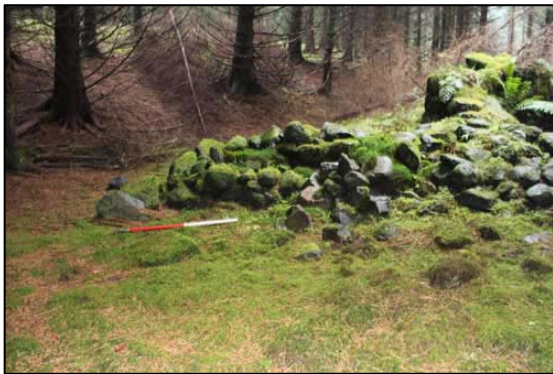
a: Window, E Wall, Room D, 1002

b: Outshot & Later Wall, 1003

c: Structure 1004 from NE

d: Interior Structure 1004 from S

e: Detail of Window, Structure 1004

f: Track 1006, Looking SW

g: Walling 1008, from NE

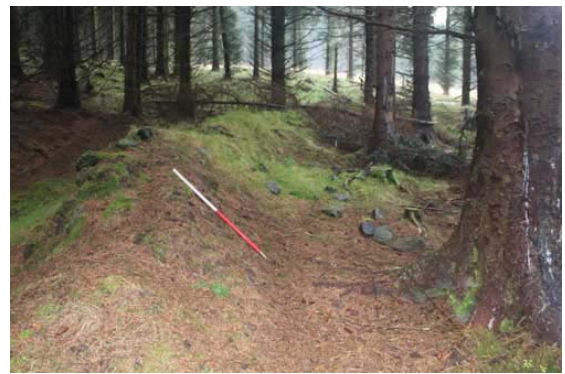
80. The western enclosure, (1005), was 'D'-shaped in plan, with the enclosure bank (Figure 13h) appearing to abut the walls of (1004) and (1002). It survived in poor condition on the north side, surviving only as stony revetment, and it is possible that this revetment continued along the break of slope that lay to the rear (i.e. north) of the steading and merged with the north side of (1011). No traces of this feature had survived in this location, however, making this suggestion entirely conjectural.

82. These ancillary features were partially overplanted with mature coniferous trees, unlike the steading buildings, which had been excluded from planting. Some damage by heavy machinery was also evident (most notably at the gap in the south side of (1005)) on the upstanding features.

h: Enclosure 1005, Bank at S Side

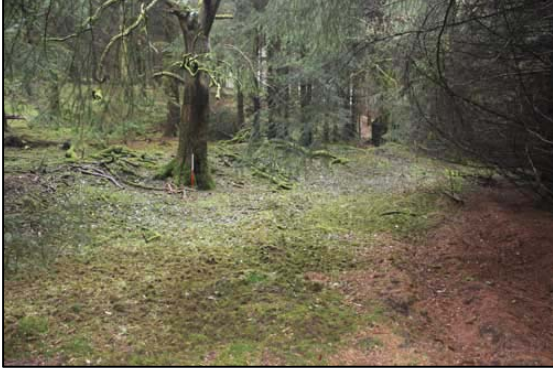
81. The eastern enclosure, (1011) (Figure 15a), was similar, in that it was 'D'-shaped on plan and defined on the west, south and east sides by an earthen bank that probably represented a tumbled, grass-covered wall. Two mature deciduous trees – one apparently dead – still stood within its extent, on the south side of the interior. These were apparently relict specimens that still survived within the coniferous plantation. One had a steel salt-lick holder tacked onto its trunk (Figure 15b), probably added during the late twentieth century. The presence of this item may suggest that the modification of the farmsteading into a series of pens for livestock may be a comparatively late re-use, dating to around this time.

a: View Across Interior of Enclosure (1011)

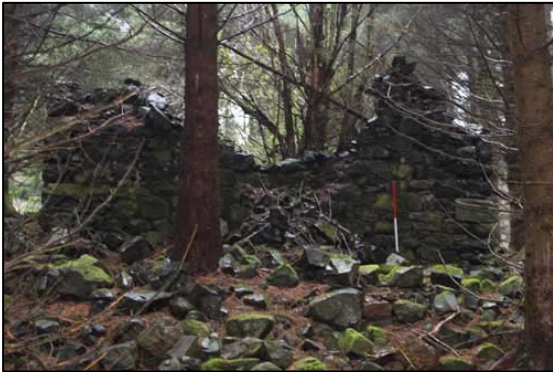
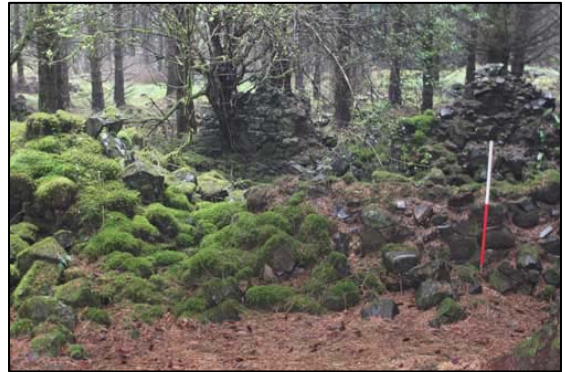
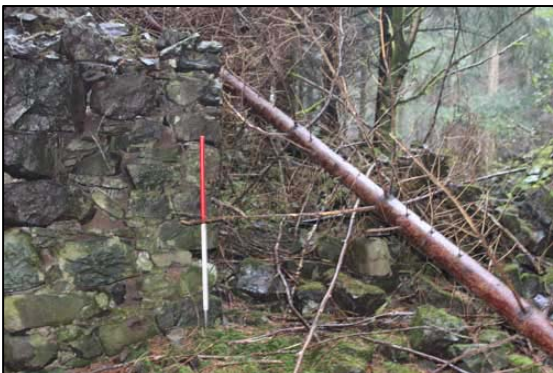
c: Structure (2001), SW Gable Wall

d: Structure (2001), Room a from NW

e: Doorway, SE Wall, Room A (2001)

f: Possible Mason's Mark, Room A (2001)

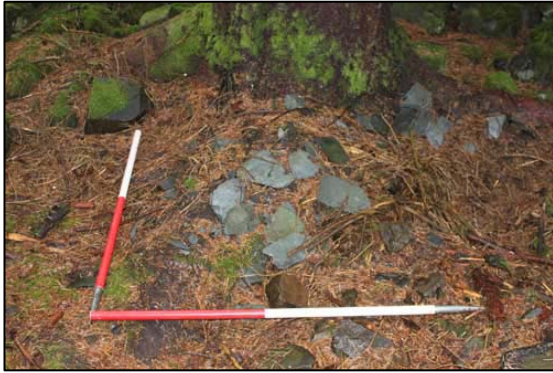
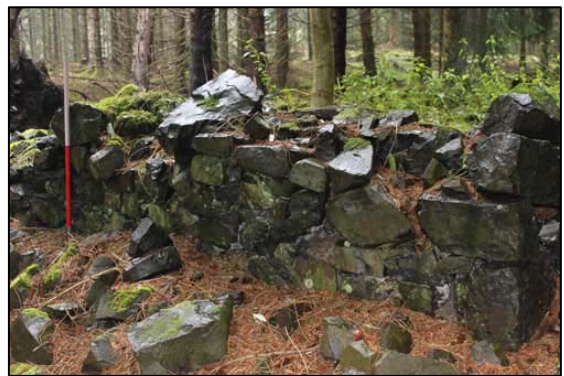
89. The north-west end of Structure (2002), which would originally have been a gable wall, was the best preserved, upstanding to a maximum height of 4 courses (roughly 1m in height). The interior of this structure, though obscured by fallen branches, was free of saplings and other intrusive vegetation. The north-east wall had, however, been damaged by a recent tree-throw.

a: Deposit of Roofing Slates

d: NW wall, Structure (2002)

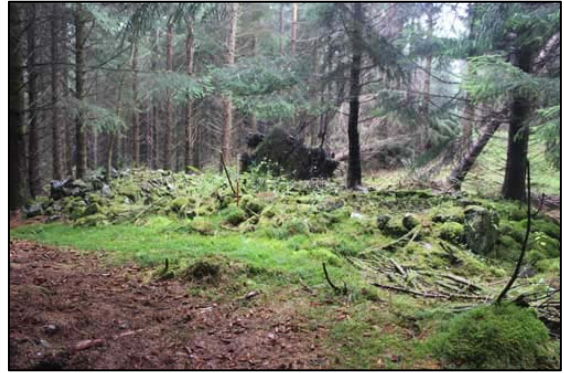
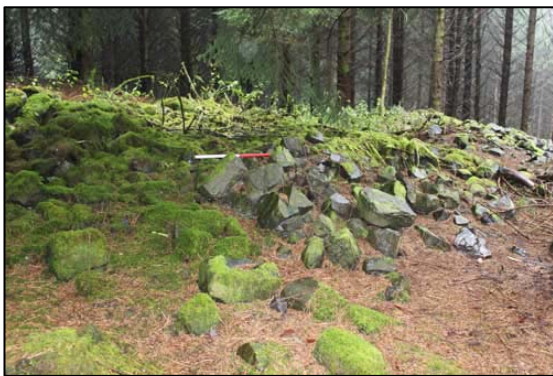
88. Structure (2002) survived in very poor condition (Figures 16 b and c), though it seems likely that beneath the mass of rubble that had built over its entire extent, details regarding the original floor plan will survive in good condition. During the field survey, however, the interior was so badly obscured by rubble and a build up of brash and deadwood that it was impossible to be certain of its original layout. It is possible, however, that the structure was originally subdivided into three roughly equal compartments (as per the plan illustrated in Figure 14).

b: General View of (2002) from S

c: General View of (2002) from W

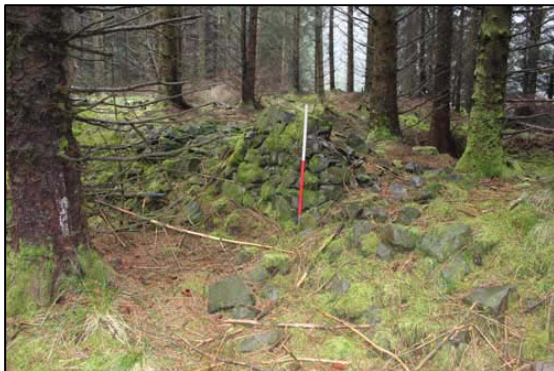
90. Like Lategreen, Linnhill survived in association with a complex of field boundaries. These could be traced as upstanding tumbled walls (now grass-covered) over much of their extent, but in some places, the wall face survived intact to a maximum height of 0.9m (e.g. Figure 15e).

e: Upstanding Field Boundary (2003)

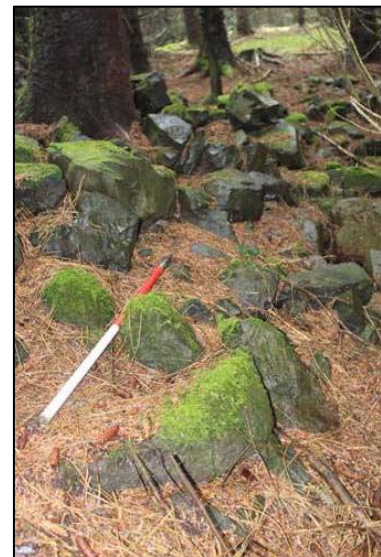
91. Traces of a stone revetment (2005) also survived (Figure 15f), cut into the slope which lay immediately to the south-west of (2001). This had been created in order to stabilise the ground surface in the vicinity of the farmhouse: it is possible that the ground level was built up slightly in this portion of the site in order to create a level building platform, but this could not be confirmed without further investigation.

f: Stone Revetment (2005) to SW of (2001)
