**56a Ardrossan Road, Seamill,
North Ayrshire:
Archaeological Mitigation**

Data Structure Report

by Louise Turner

issued 8th June 2010

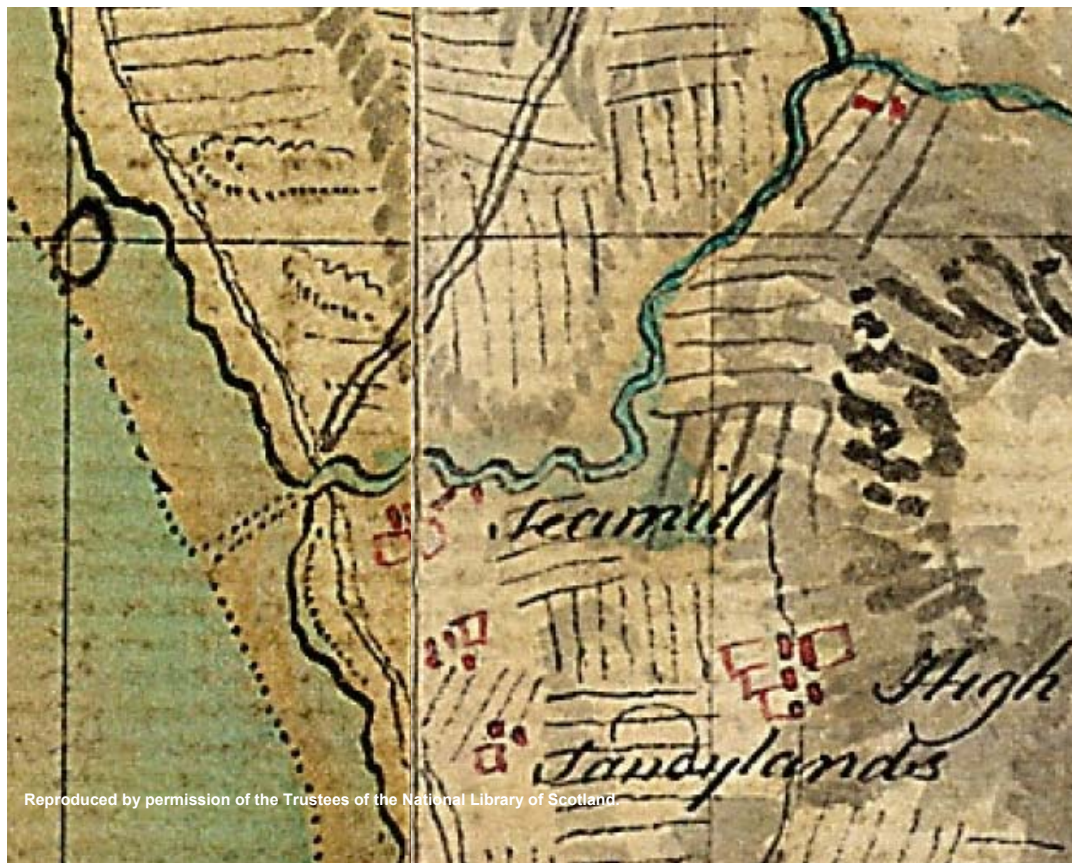
Figure 1a: Roy's Military Map (1747-55) Showing Seamill And Nearby Enclosures

9. The earliest map evidence that shows the area in basic detail is Roy's Military Map (1747-1755) (Figure 1a). It shows a settlement at Seamill comprising four structures and two enclosures. The structures are adjacent to the Kilbride Burn, below the site, while the enclosures may be on the higher ground now occupied by the 19th century houses. The northeastern enclosure appears to be oval in plan and may be the fort.

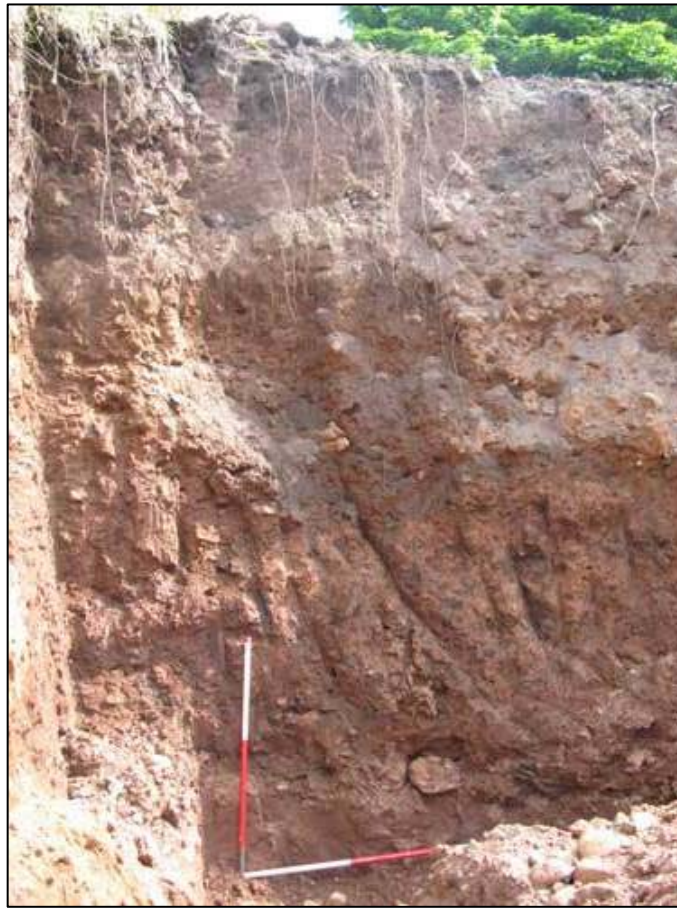
Figure 3a: SW-facing Section of Garage Footprint, N side

14. No features of definite anthropic origin were identified in either section. The SW-facing section (Figures 3a-b) revealed a dark band of topsoil (001) which was markedly thicker (as thick as 0.45m in places) towards the base of the hill. This overlay a horizon of paler red-brown sand (002), flecked with occasional fragments of charcoal, which represents an earlier buried soil horizon.

15. A lens of shells 0.1m thick (003) lay directly beneath (002) on the summit of the mound. Unfortunately, this could not be investigated further as it was a localised deposit, the extent of which could not be fully established but which had previously been disturbed by activities on the top of the mound, as frequent fragments of limpet and periwinkle were found dispersed within the topsoil during the later monitoring work. Particular care was taken to recover any lithics which may have been present in association, but none were identified.

16. Below this thin layer of shell (003), the underlying deposits were clearly geological in origin. A thick band of gritty sand (004), filled with frequent inclusions of angular stones measuring up to 0.2 by 0.15m in extent, overlay another layer of sand which was much less stony in character (005). This in turn overlay very stiff, compact clay (006). The SE-facing section (Figure 4 a & b) was similar, with a further stony layer (007) revealed at the base. These observations confirmed that the knoll was glacial in origin.

25. The band of shells (003) noted in the SW-Facing section of the garage footprint was of potential interest. Munro mentions the finding of similar concentrations of shell and bone during the 1880s excavations at the site, and it is possible that this localised concentration of material had an anthropic origin. Unfortunately, the work carried out on the summit of the mound could not clarify this further. Frequent finds of shell were encountered in the topsoil, suggesting that this layer had previously been more extensive, but that it had been truncated by earlier activities on the summit of the mound. Occasional finds of bone, though possibly associated, could not be confirmed as such for they were, once again, dispersed throughout the topsoil. No artefacts were recovered.

26. Looking at this shell lens in its wider context, it clearly predated the early post-glacial horizon (002) and lay immediately above a stony layer (004) that appeared to be of glacial origin. Any association with the fort's occupation therefore seems doubtful and it may in fact be of natural origin.

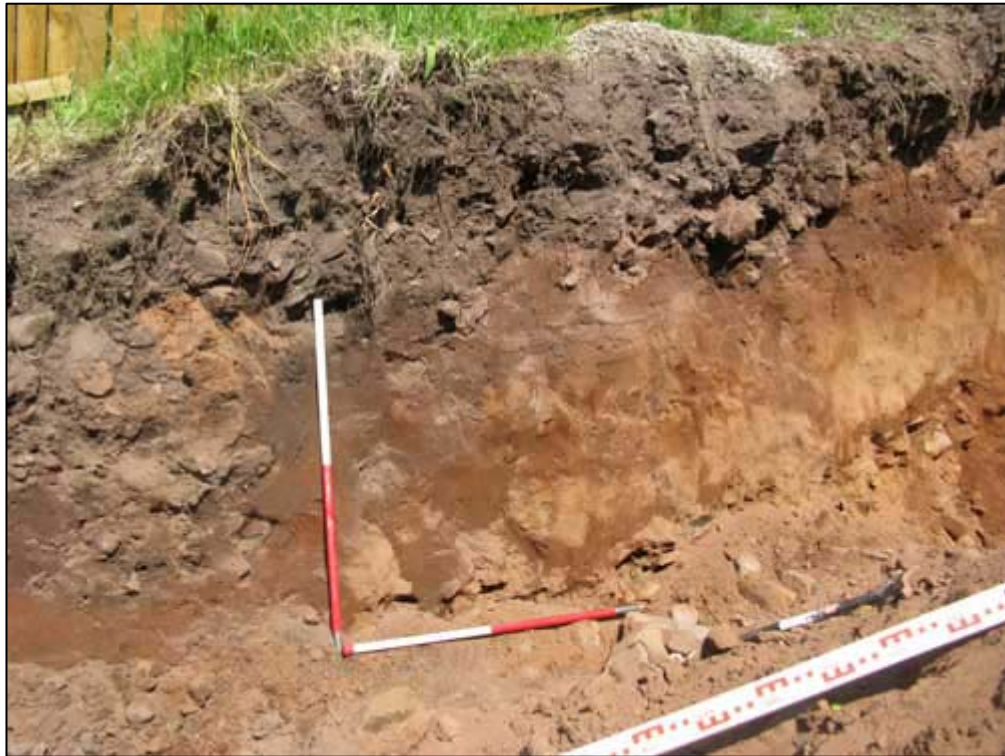
Figure 4a: SE-Facing section of Garage Footprint, W side

13. Excavation works carried out prior to the arrival of the archaeologist had been undertaken using a mini-digger. They comprised a rectangular area measuring approximately 6m by 6m in extent, which had been levelled into the side of the mound to a relative depth of 4m in places. The resulting sections were cleaned and recorded by photograph and drawing as appropriate, with all exposed strata characterised and evaluated.

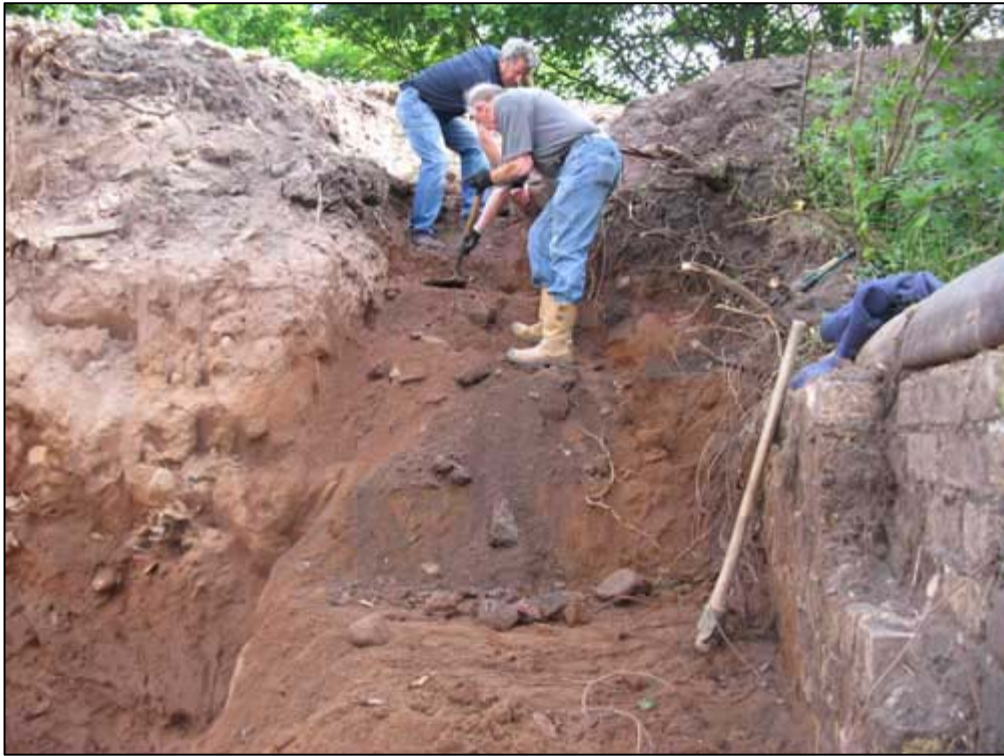
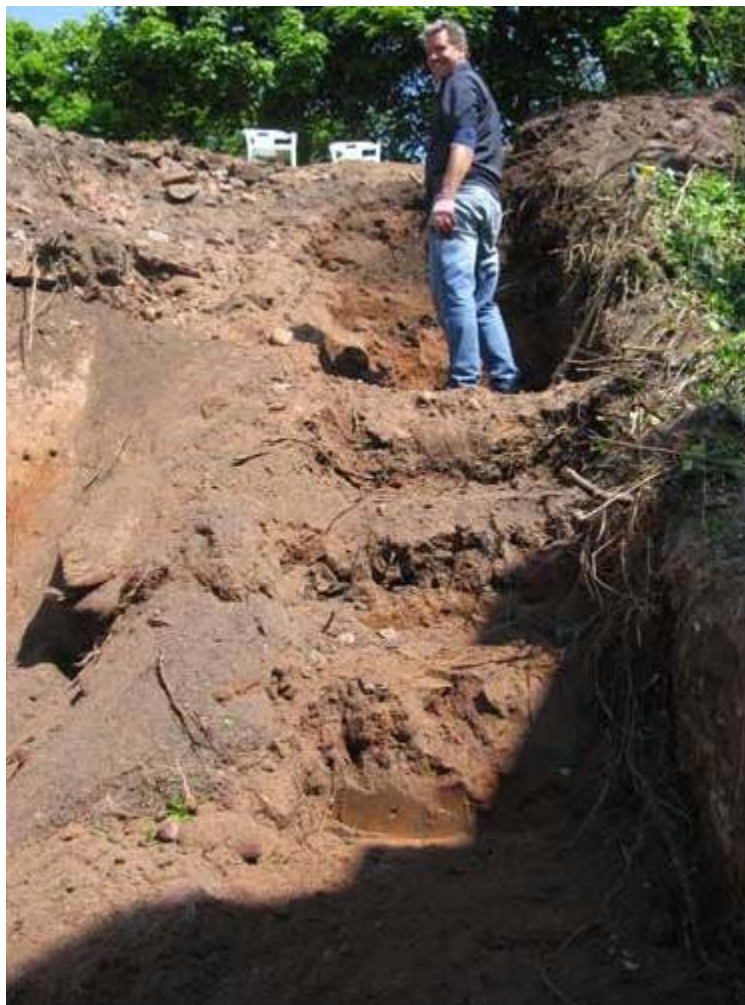
Figure 5a: Excavation of Stair: Lower Levels

17. The monitoring of the stairway revealed no change to the previous observations (Fig. 5 a & b). In the lower half, works immediately reached subsoil with nothing of interest noted. It was in the upper levels, which carried the proposed stair up onto the summit of the mound itself, which proved likely to be of greater archaeological interest.

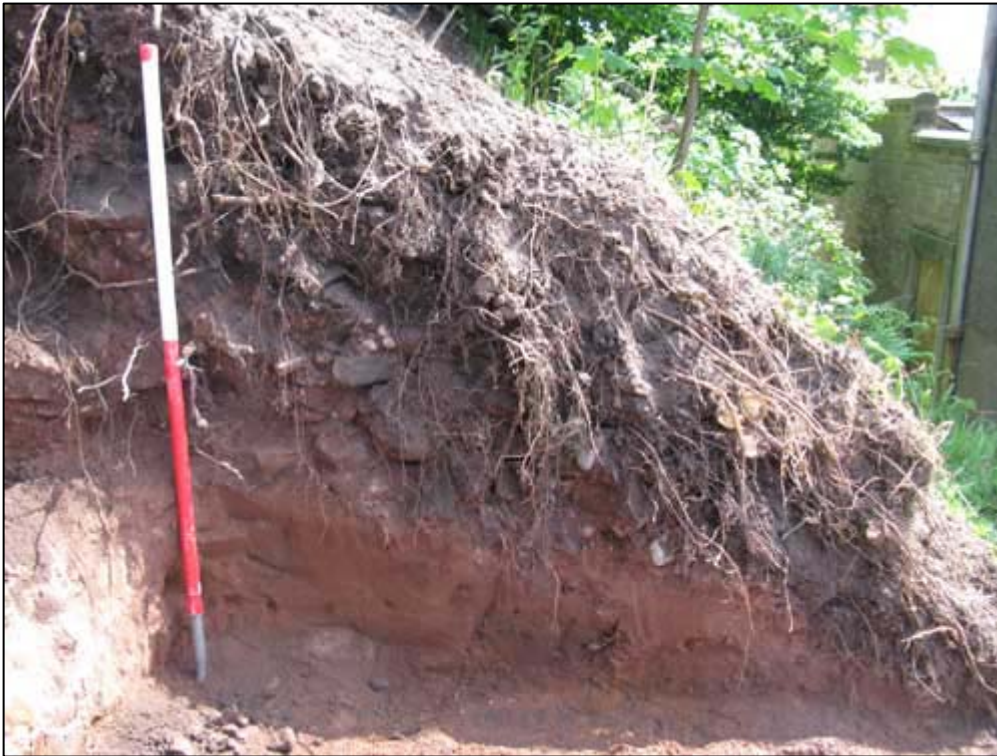
Figure 6a: N-Facing section at Summit of Mound, featuring Stone Spread

19. Following a detailed inspection of the SW-facing section, it seemed likely that this stony material represented the eroded remains of stony layer (004) which had been exposed at the surface following the construction of an earlier pathway contemporary with the original house. Further work revealed a concentration of similar stones (009) in the N-Facing section at the upper stage of the stair, which appeared to have resulted from artificial accumulation (Fig. 6a and b).

20. This material was contained entirely within the topsoil, with a modern glass milk bottle from United Dairies and a fragmentary roofing-slate found in association. It was therefore interpreted as modern, probably representing stone clearance from the summit of the mound or perhaps a simple revetment intended to reduce soil erosion. There was no trace of any structural remains, representing either a stone rampart or an earth-and-stone bank, within the earlier soil horizon (002).

27. There were no traces of any structural features which might be associated with the occupation of the fort. Though an unusually dense concentration of stones was noted during works carried during the digging of the stair in the area located towards the summit of the mound, this had no clear structural integrity and was very ephemeral in nature, contrasting strongly with Munro's descriptions of a double rampart.

28. As work progressed, it was possible to establish that this stony material was derived from two sources. It included material eroding out from the upper surface of the band of stony glacial material (004), which was probably exposed during the cutting of an earlier stair, created as a landscape feature in association with the pre-existing house structure. This had perhaps been accumulated and dumped in a heap or bank at the time of its removal, as a small pile of angular stones (009) was revealed in the section of the stair at the upper staging. This was contained within the topsoil, indicating a recent origin, and it incorporated within it a fragment of modern glass and a roofing slate (not retained).
