The Castle of St. John, Stranraer: Archaeological Mitigation

Data Structure Report v.2

by Louise Turner

Rathmell
Archaeology Ltd

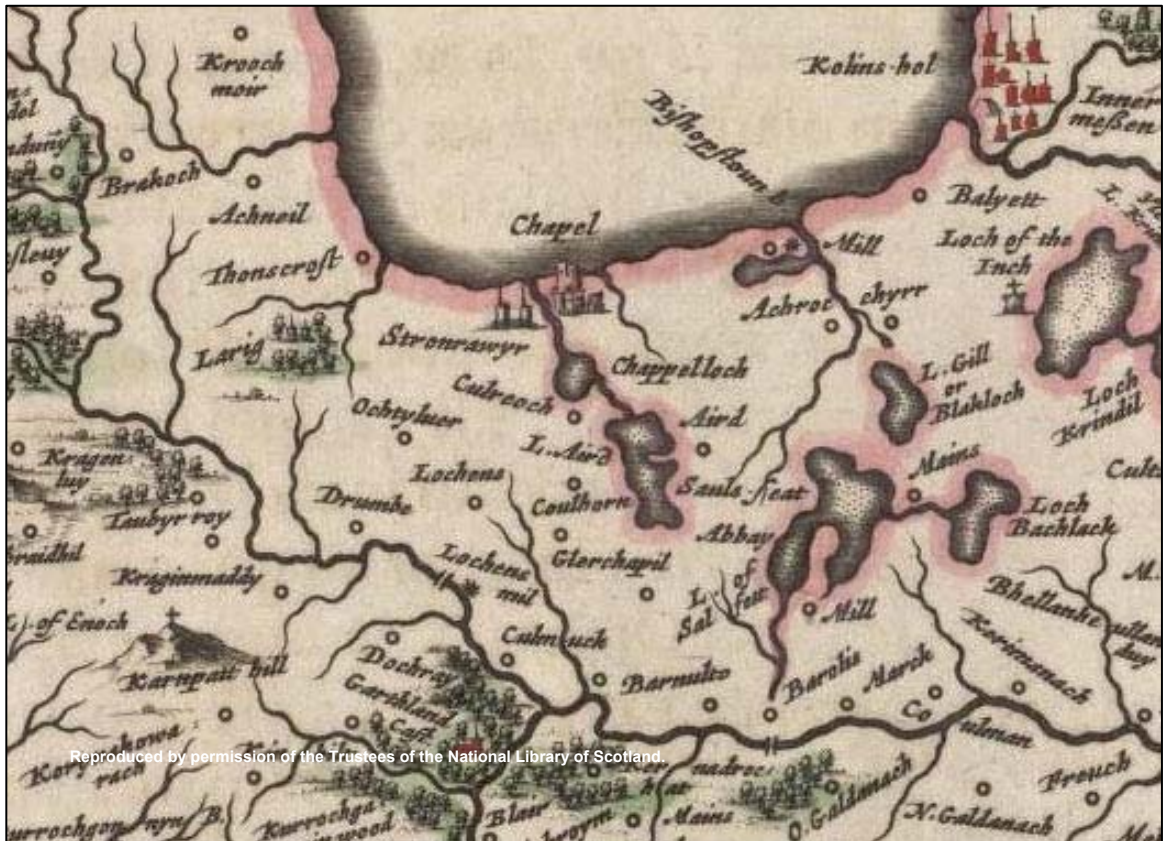
Figure 1a: Blaeu's Map of 1654

11. Blaeu's map of 1654 (Figure 1a), derived from an earlier survey by Pont in the late sixteenth century, shows a settlement at Stranraer ('Stronrowyr'), located to the left of a stream or river. The stream is a watercourse which originally ran through Stranraer, before being diverted via a culvert in the mid-19th century. To the right of this feature is a large structure, possibly defensive, to the right of a stream or river at 'Chapel'. This probably represents the castle, which would have been upstanding by this time, and which may have been located in close proximity to the earlier chapel of St. John. This association is still reflected in the castle's name – the Castle of St John.

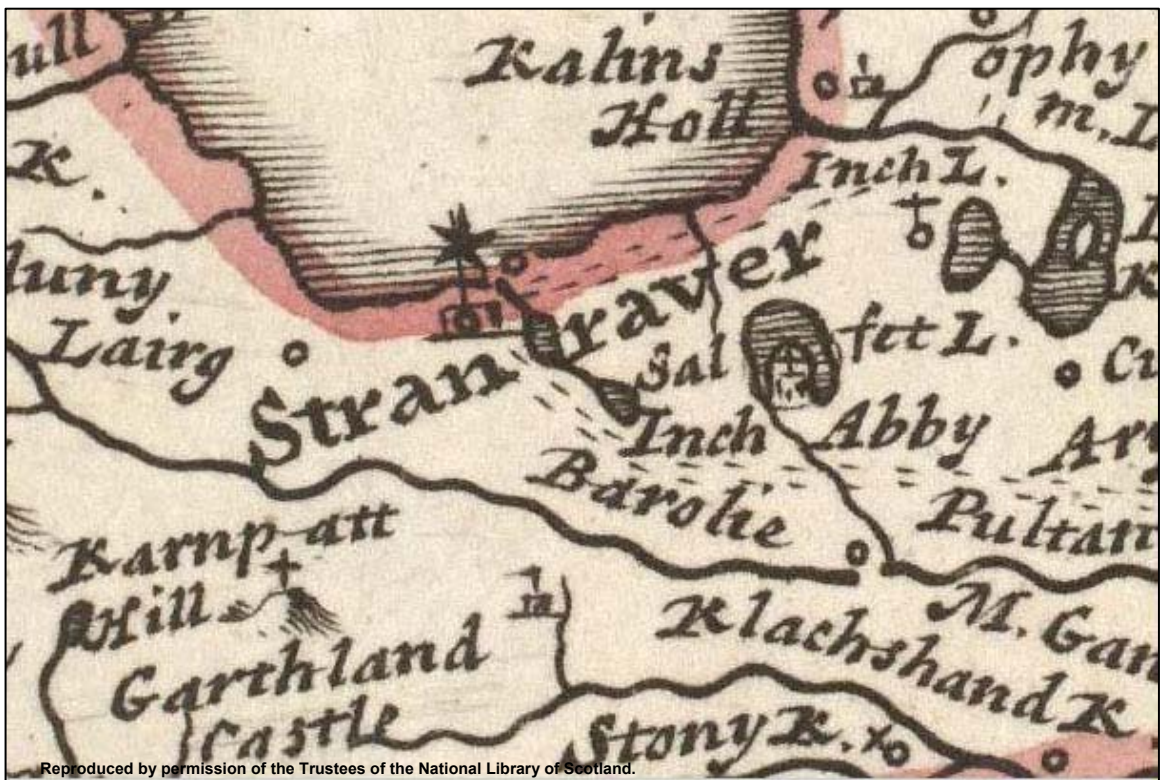
Figure 1b: Extract from Moll's Map of 1745

12. Two maps of mid-eighteenth century date show the area in varying degrees of detail. The earlier of these, Moll's map of 1745 (Figure 1b), harkens back to Blaeu. It is the earliest map to record the area following the town's elevation to burgh status, and it shows only an isolated structure at 'Stranraer', located to the left of the stream.

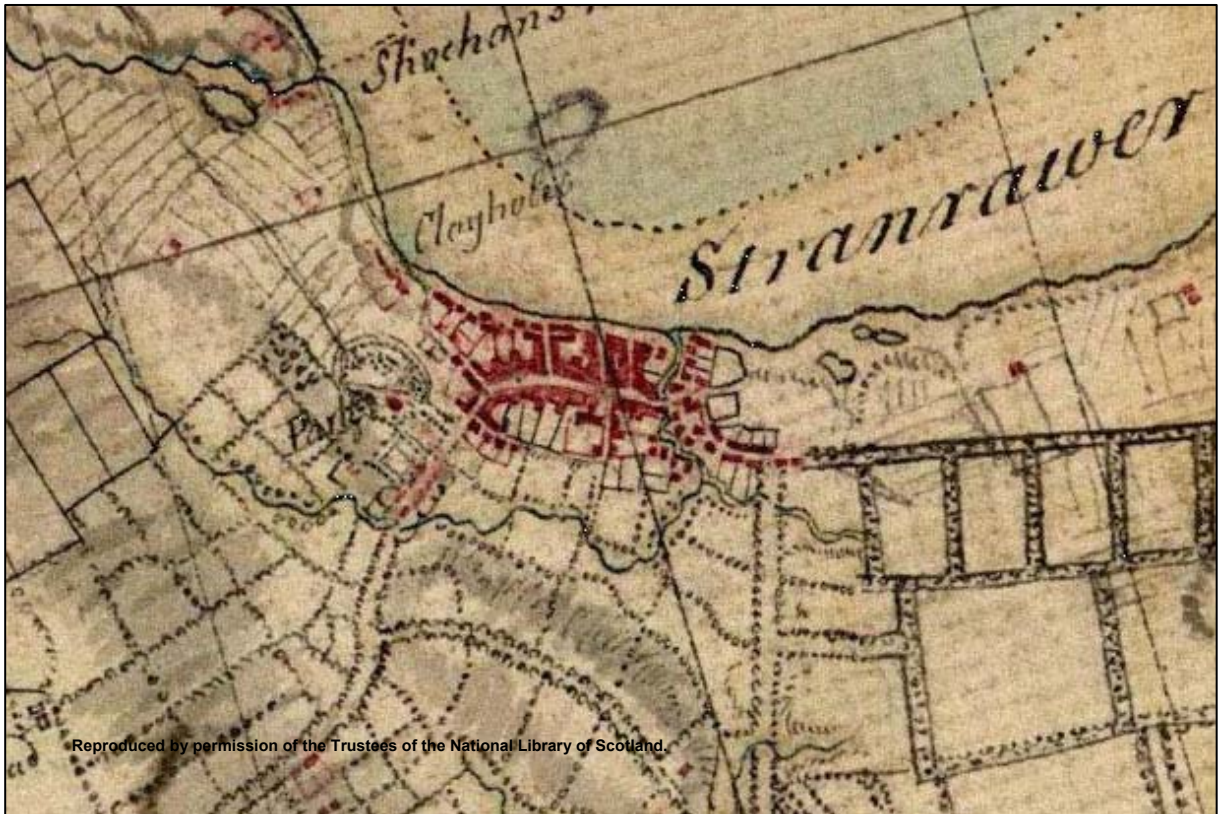
Fig. 2a: Extract From Roy's Military Map of 1747-55

13. Roy's Military Survey of 1747-55 (Figure 2a), carried out only a few years later, shows the town plan of 'Stranraer' in intricate detail. The streets are laid out in typical fashion, with buildings fronting a main east-west thoroughfare, and long strips of 'backland' stretching out to the rear. Some additional streets are also present, running roughly north-south. It is not clear whether the town was laid out in this fashion from the onset, or the streets later imposed. What is apparent, however, is that the Castle of St John had already been incorporated as an integral part of the townscape at this early date.

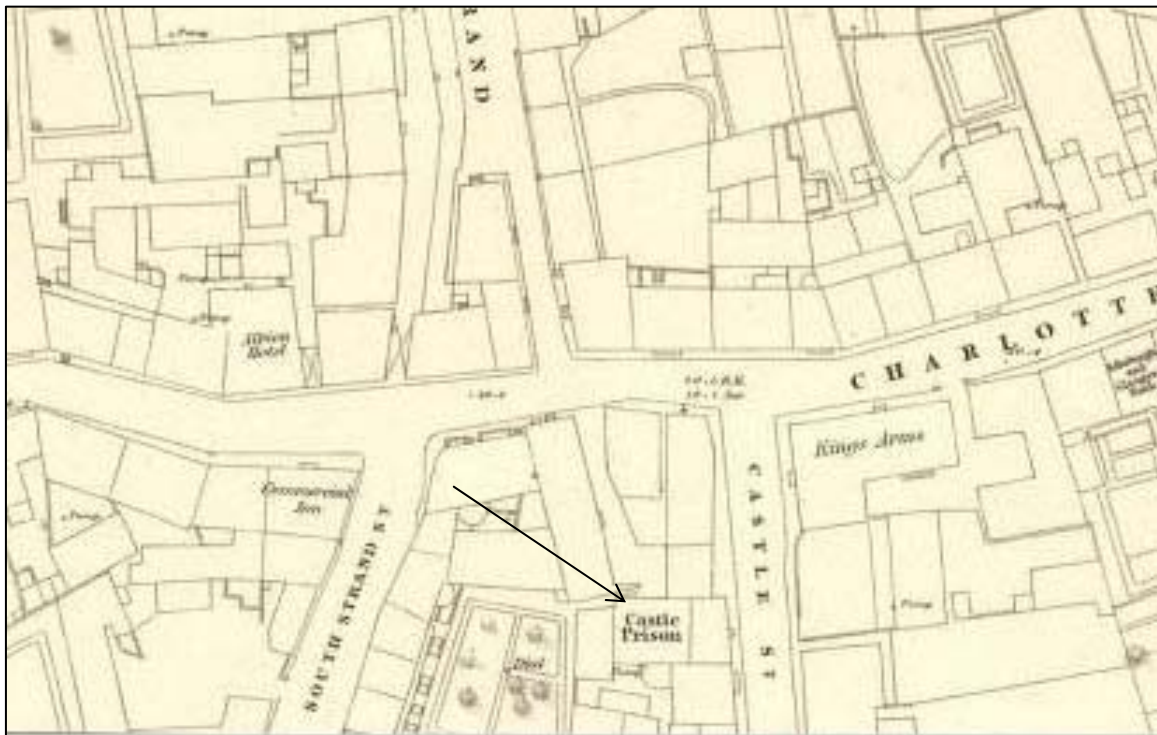
Fig. 2a: Extract From Ordnance Survey Town Plan of 1847

16. The Ordnance Survey Town Plan of 1843 shows the castle in use as a prison (Figure 2b), with the structure clearly labelled 'Castle Prison'. It is accessed by a lane approaching from the north-northwest, and is hemmed in by later buildings on all sides. The circular stair-tower which abuts the south-facing elevation is clearly visible, and a narrow path running west-southwest from the castle accesses a formal garden, complete with sundial.

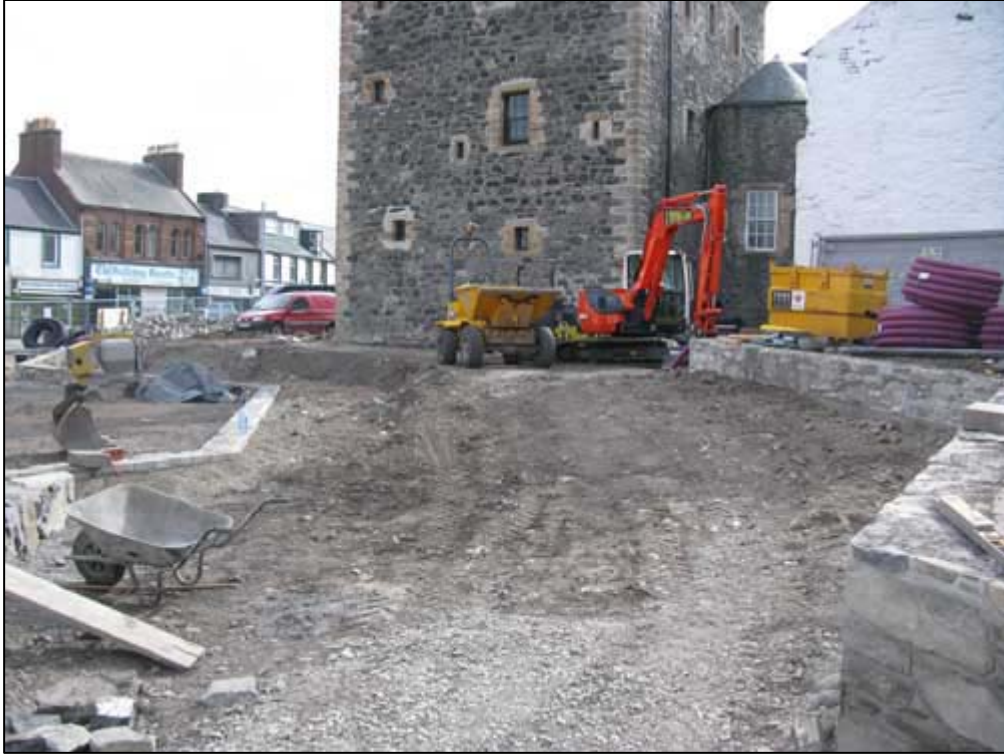
22. Excavation works were undertaken using a 14-ton tracked excavator. The works had already been started by the time an archaeologist arrived on site (Figure 5a); an area of level terraced ground extending 3m west of the west wall of the castle had already been stripped, along the length of the castle wall and extending 1m northwards beyond the north-west corner.

Figure 5a: General View of Site, Showing Works in Vicinity of Tower-House

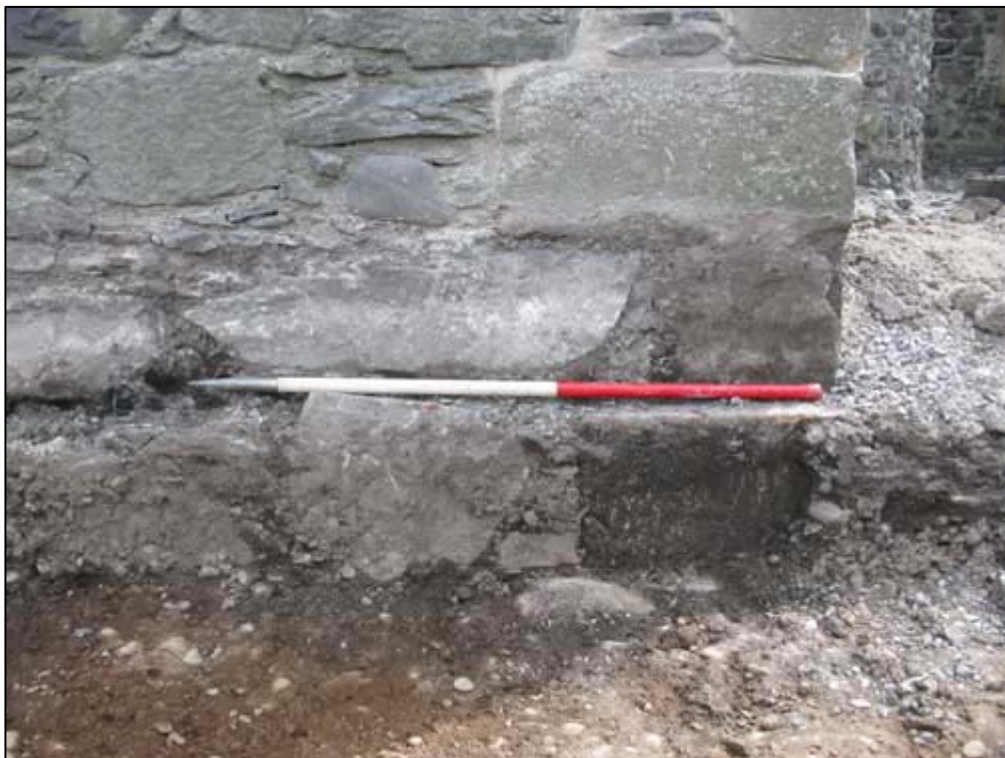
23. This exposed area, described here as the 'West Terrace', was hand cleaned and recorded in detail prior to the commencement of groundbreaking works elsewhere on the site (Figure 6). The ground level had been reduced by approximately 0.2m, revealing some architectural features relating to the castle. The first of these was a basal course of masonry (009), which formed the uppermost course of the foundations (Figure 5b), exposed to a greater depth in October 2009 (Pickin, 2009).

Figure 5b: Basal Course of Masonry (009) revealed at foot of Tower-House

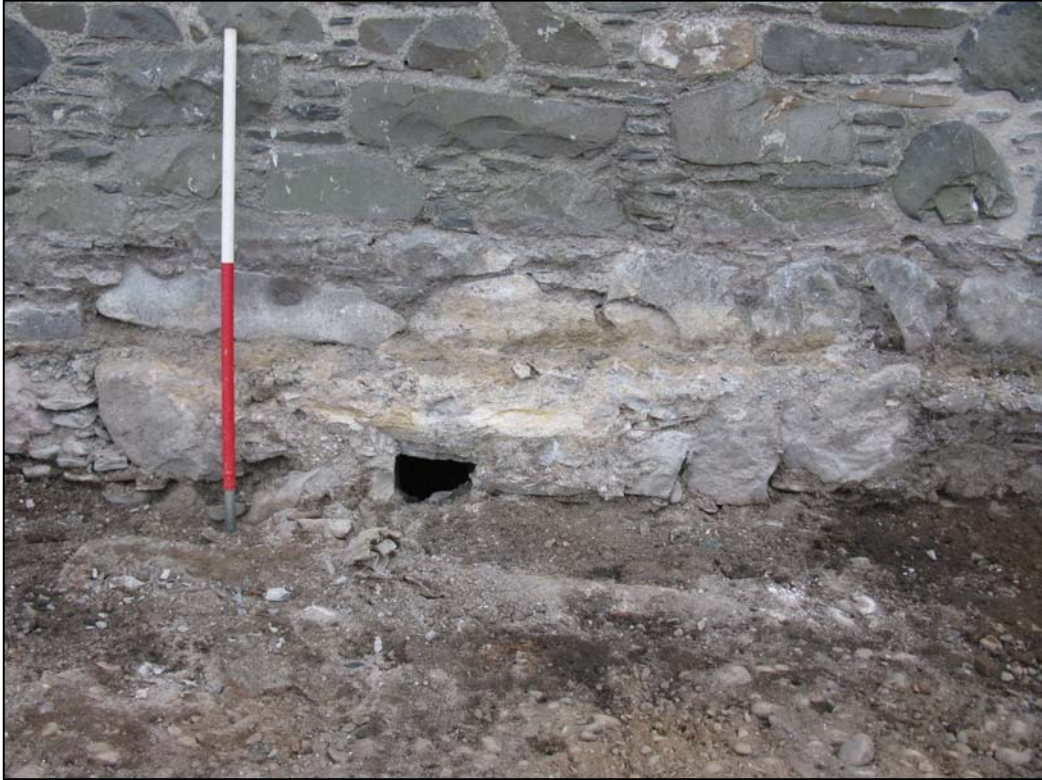
24. A further feature revealed in the castle's fabric was a square opening (011), located just above (009). This appeared to be an original feature (Figure 7a), probably marking the line of a drain.

Figure 7a: *In Situ* ? Drain (011) in W-Facing Elevation of Castle

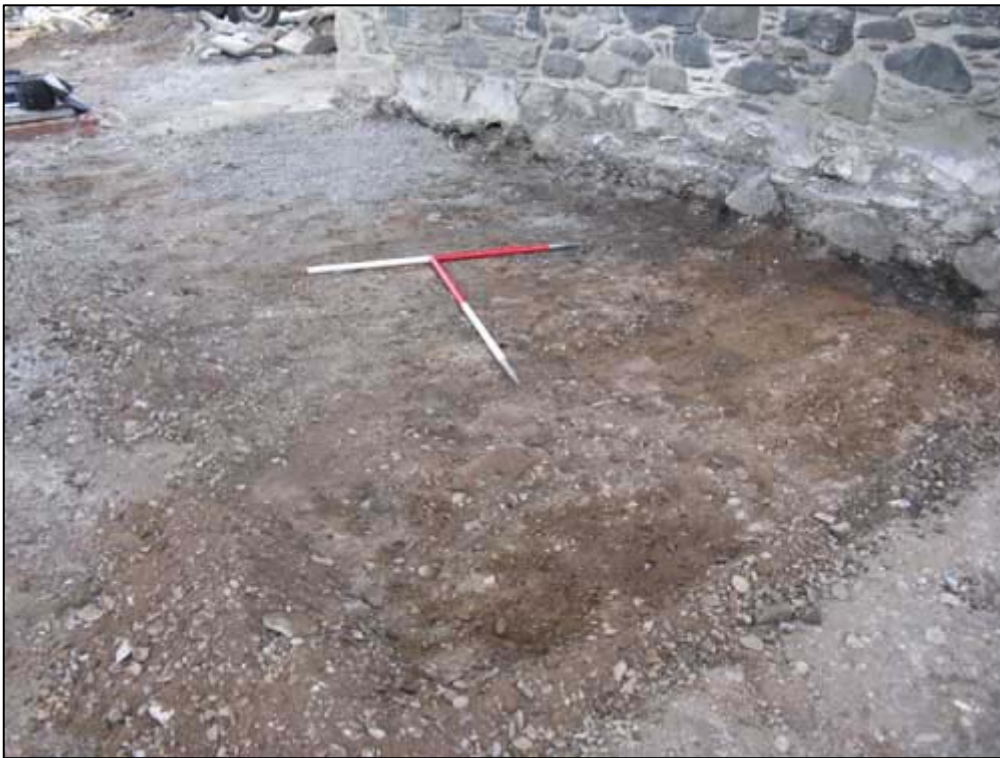
25. A narrow foundation cut (014) could be identified in places (Figure 7b), surviving immediately adjacent to the basal course (009). It was characterised by a dark-brown silty-clay fill (015) and it appeared to be contemporary with the castle, thus representing its foundation trench.

Figure 7b: Surface cleaned, N Side (W Facing Elevation), with Foundation Trench [014]/(015) visible

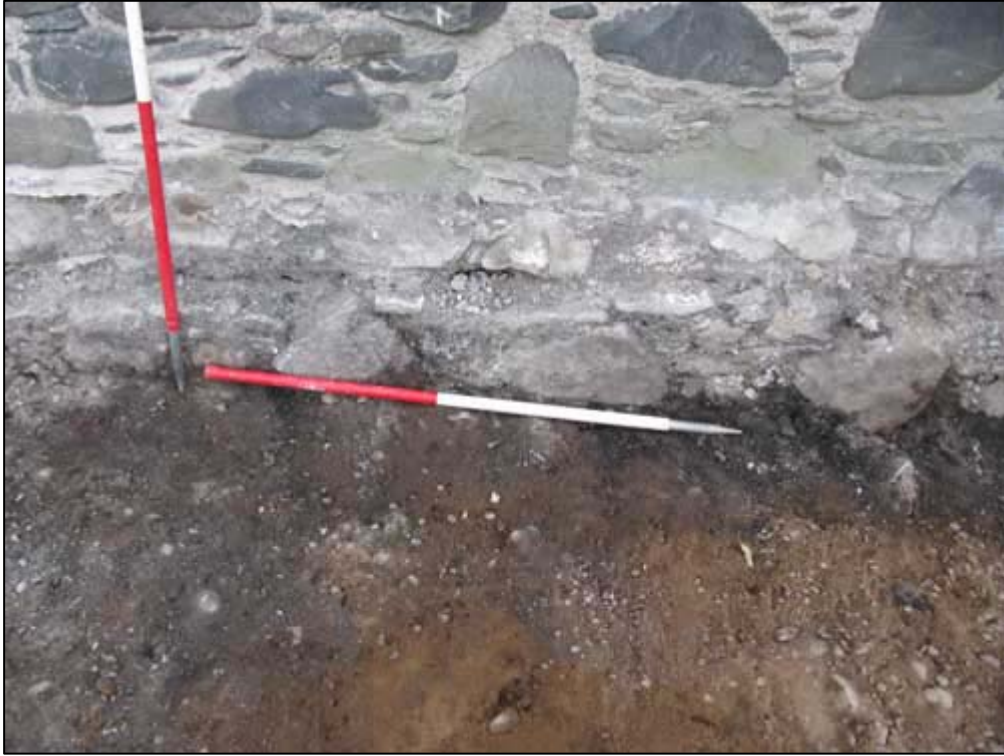
27. Another instance of disturbance were clearly associated with the insertion of a Victorian water pipe in the case of [018]/(019), and recent disturbances of twentieth century date were also evident. Both comprised rather substantial trenches, with one in particular [016]/(017) causing major disturbance in the vicinity of the tower-house's northwest corner.

Fig. 8a: Foundation Trench [014]/(015), with later cuts evident: [018]/(019) to left, [022]/(023) to right

35. Only one feature of potentially early date was identified. This was the line of the foundation trench for the castle, [014]/(015) which had itself been compromised over much of its extent by the cuts of modern service trenches such as ([018]/(019) and, possibly, earlier investigative works of an archaeological nature [022]/(023). Stretches of the original foundation trench still survived, however, at the south-west corner and at the mid-point of the west wall.

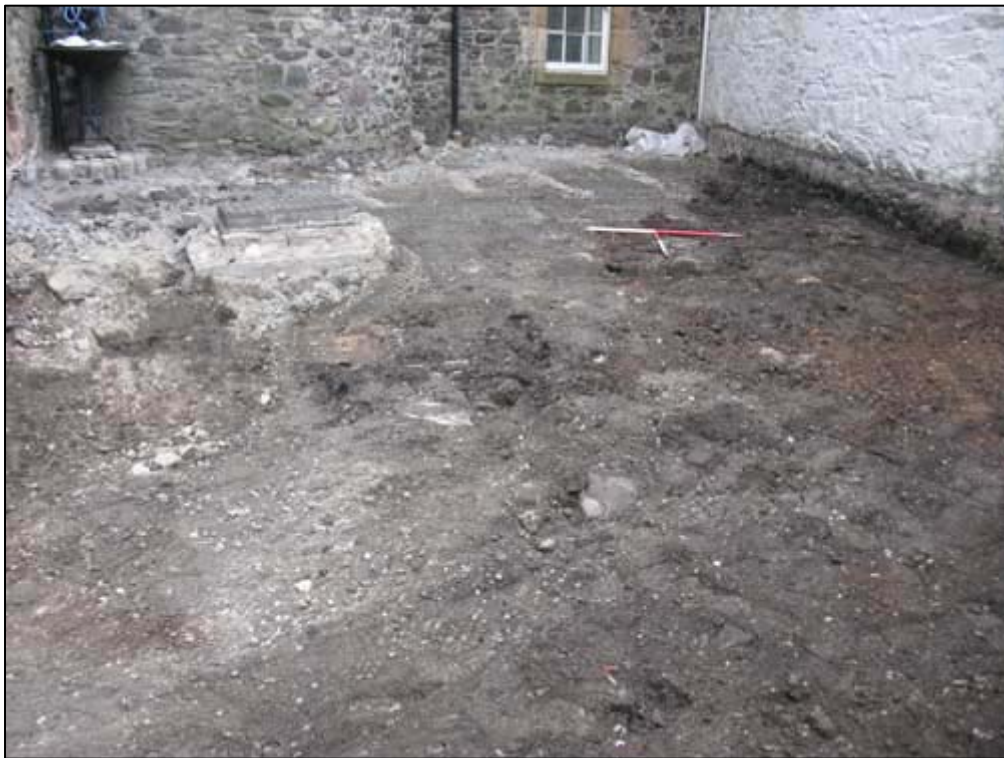
28. Following the recording of the West Terrace, ground reduction was undertaken to the south of the castle (the 'South Extension'). Here the pre-existing ground level was reduced by a depth of approximately 300mm (Figure 8b). This was, however, insufficient either to penetrate the subsoil or reveal any features of archaeological significance. Context Nos. (028), (030) and (033), which were revealed by the ground-breaking works, were clearly modern in origin, with two spreads of modern material (031) and (032) further demonstrating the disturbed nature of the soils at this particular location.

Fig. 5b: South Extension – Fully Excavated

33. In the South Extension, the required ground reduction did not expose enough of the underlying sediments to allow any evaluation of subsurface remains to be identified. It revealed instead an area of disturbed sediments (028), (030), (033) which appeared to represent disturbed topsoil or overburden laid down in the nineteenth or twentieth centuries.
