**Duke Street, Glasgow:
Archaeological Watching Brief**

Data Structure Report

issued 29th August 2012

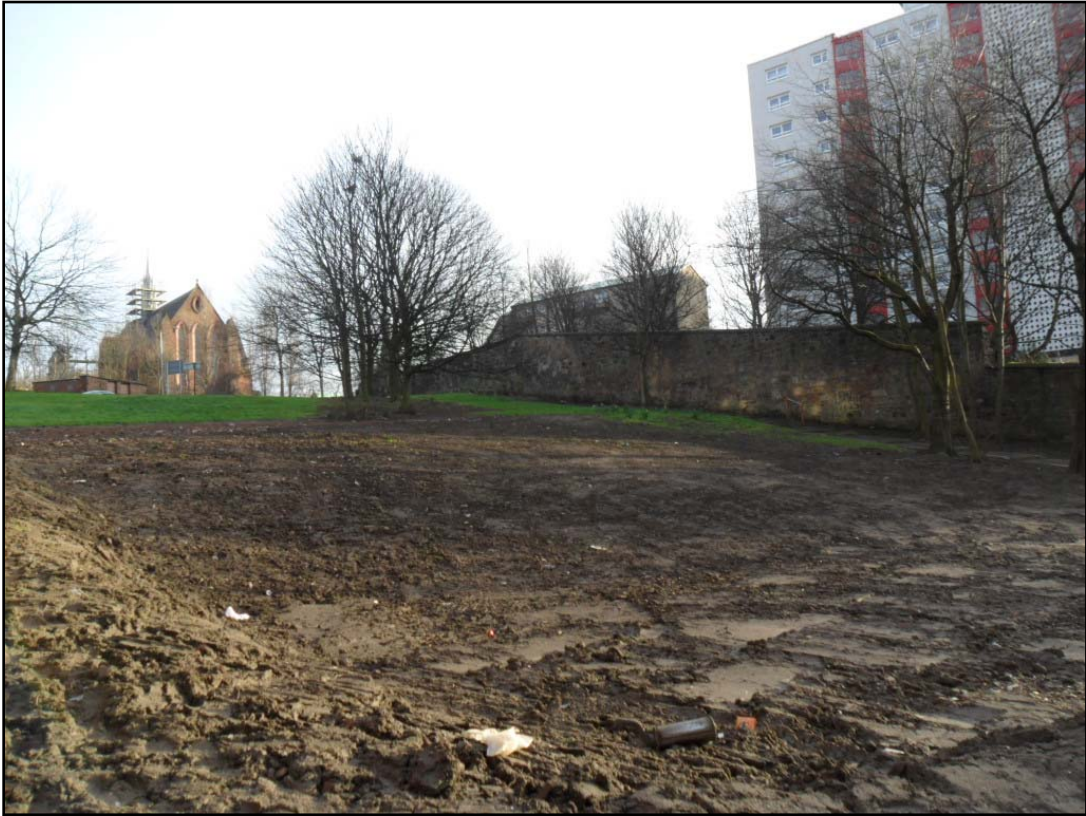
Figure 1a: Duke St Prison western boundary wall

6. The boundary wall on the east side of the site (figure 1a & 4b) is most likely the Duke Street Prison (also known as Bridewell or the Northern Prison) and was originally established in 1798. Various extensions were added, the last of which were in 1872 when the northern end of the boundary wall was remodelled to accommodate the expansion of the prison. Duke Street prison remained open until 1955. After the transfer of responsibility to the state from local authorities, HM Prison Barlinnie was built in the Eastern suburbs of the city in 1882 in order to take over from Duke Street which eventually remained open as a women's prison until 1955.

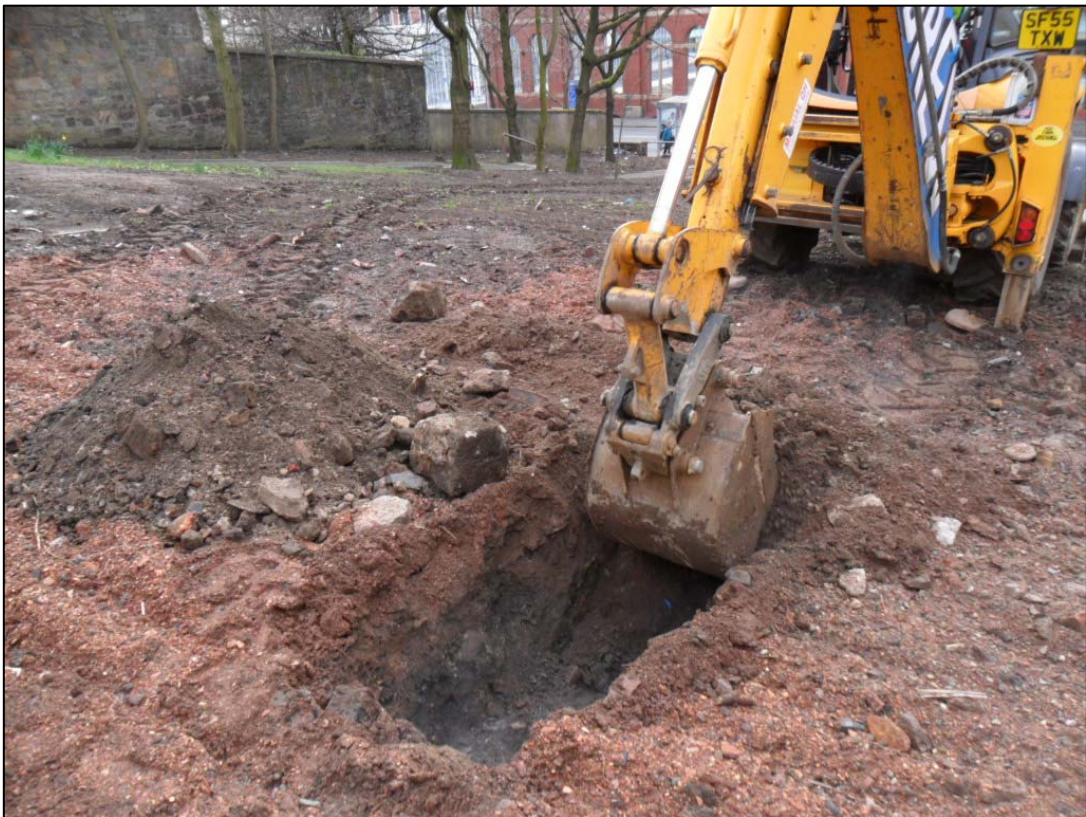
Figure 1b: Excavation of test pits prior to development

9. The first phase of works was carried out on the 6th March 2012 and comprised the monitoring for the excavation of test pits related to environmental and engineering work to evaluate the depth and physical characteristics of the underlying sub-soil. In total six test pits were excavated using a JCB 3CX with a 500mm flat edged bucket. The test pits measured 600mm in width and 2m in length and ranged in depth from 2.5m-3.6m (figure 1b). Across the six test pits the natural (019) which was characterised by a dark yellow to grey clay was reached at 1.5-1.6m. The topsoil (001) was a loosely compacted black silty loam mixed with demolition material formed of red brick, worked sandstone and ceramic drainage from the previous tenements. No significant deposits or features were recorded.

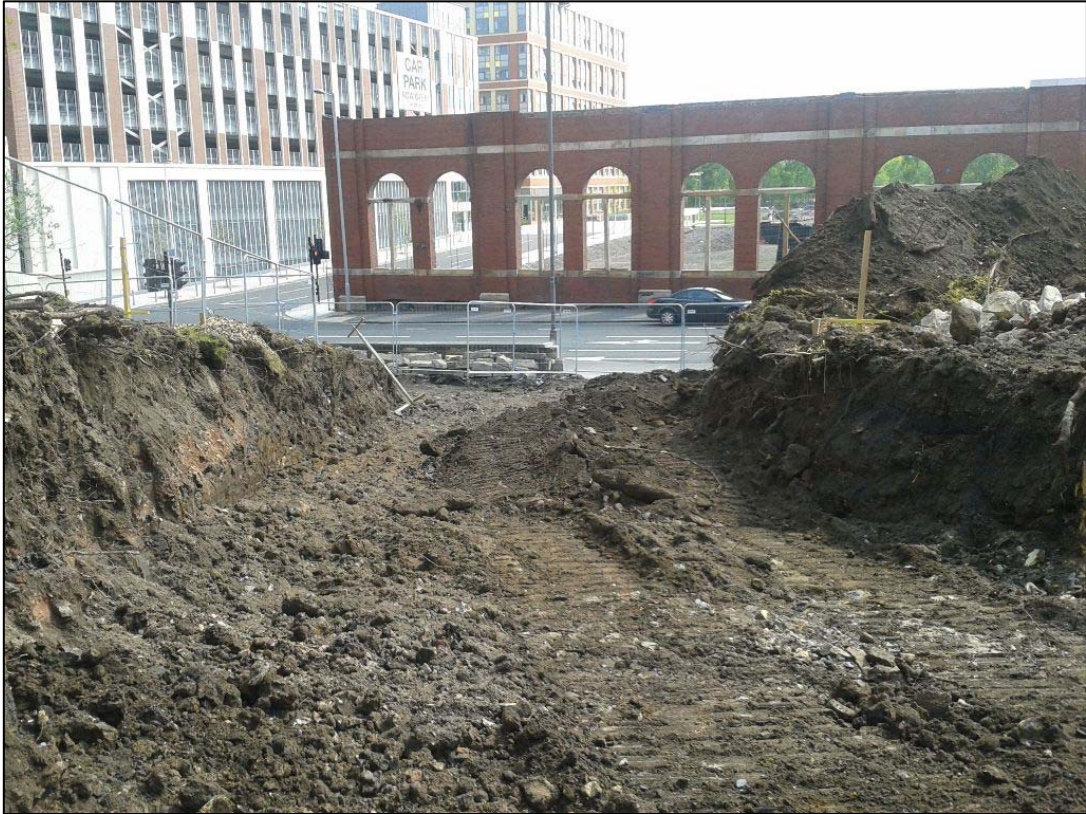
Figure 3a: Demonstrating deposits (001) & (002) within access road

10. The second phase of monitoring was carried out from the 23rd May 2012 to the 24th May 2012. This phase of works was focused on the excavation of material for a temporary access road leading from Duke Street and curving around to the west and ending at Burrell's Lane. The area excavated had been heavily disturbed and is formed of a mixed context containing a silty loam with sandstone, loose made ground and glass (001). There is not a clear separation between (001) and (002) which is also formed of a mixed demolition material containing larger sandstone blocks, ceramic drainage and lead piping (figure 3a).

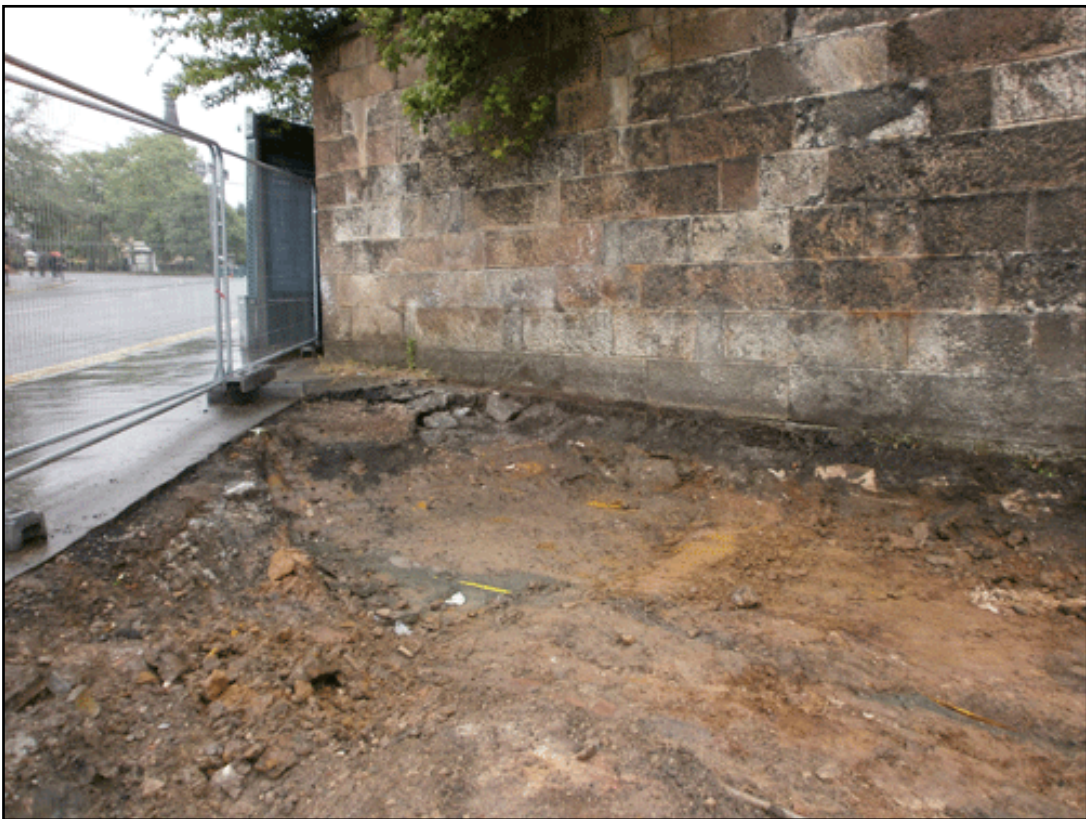
Figure 3b: Subsoil (012) at west side of Prison Wall [022]

17. Further subsoil had been exposed (prior to the excavation of the PHs) in the very north-east corner of site (figure 3b) (north of PH 1, between the High Street pavement and west of the prison wall). This was subsoil (012), found at 0.1-0.3m depth below the top of the High Street pavement, and covering an area measuring 2.5m by 2m. This deposit was soft, mid-dark brown/grey, sandy clay and contained frequent small to medium orange/blonde sandstone fragments. A possible foundation cut [030] for the foundations/footings of the wall seems to cut through subsoil (012). The section of the upstanding prison wall [022] adjacent to this area of subsoil is the remodelled newer section and can be dated to the late 19th century.

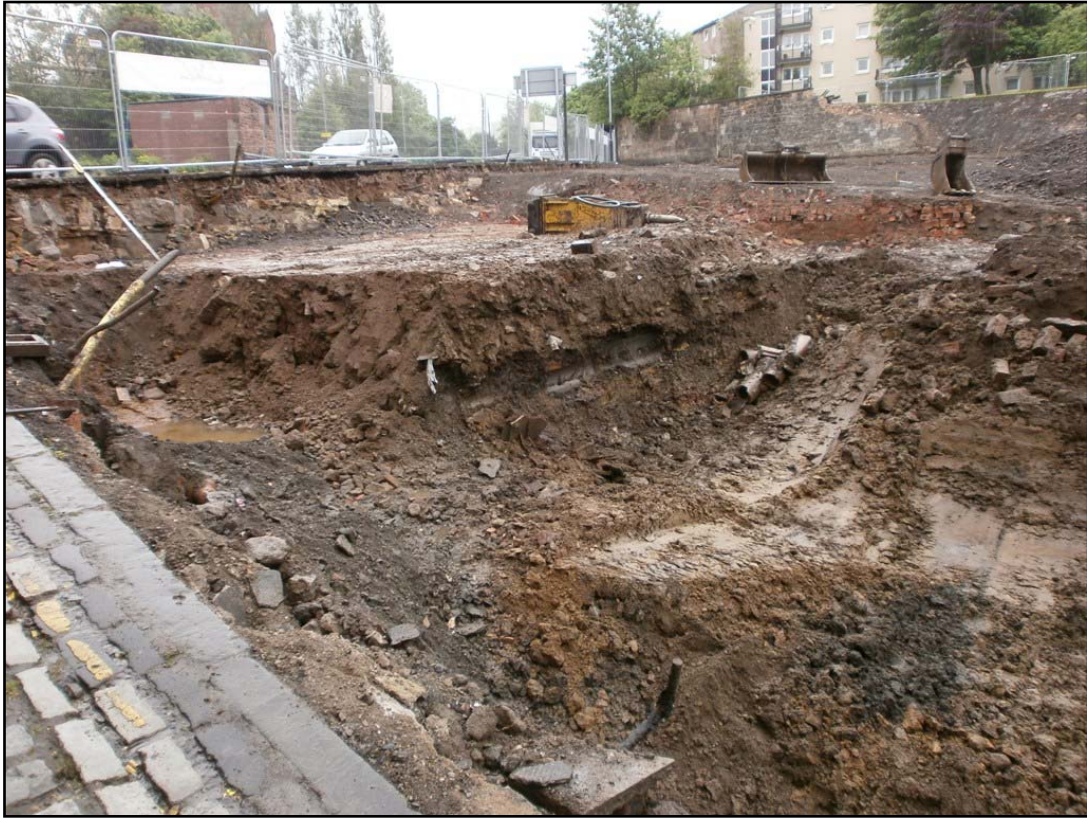
Figure 4a: Excavations at north end of site

20. Reduction of all the whole northern area of site took place, rather than targeted excavations as originally intended. Excavation began immediately east of Burrell's Lane and continued for approximately 50m eastwards. Excavations in this area exposed deposits of modern disturbance to a maximum depth of 4m from the top of the High St pavement (figure 4a).

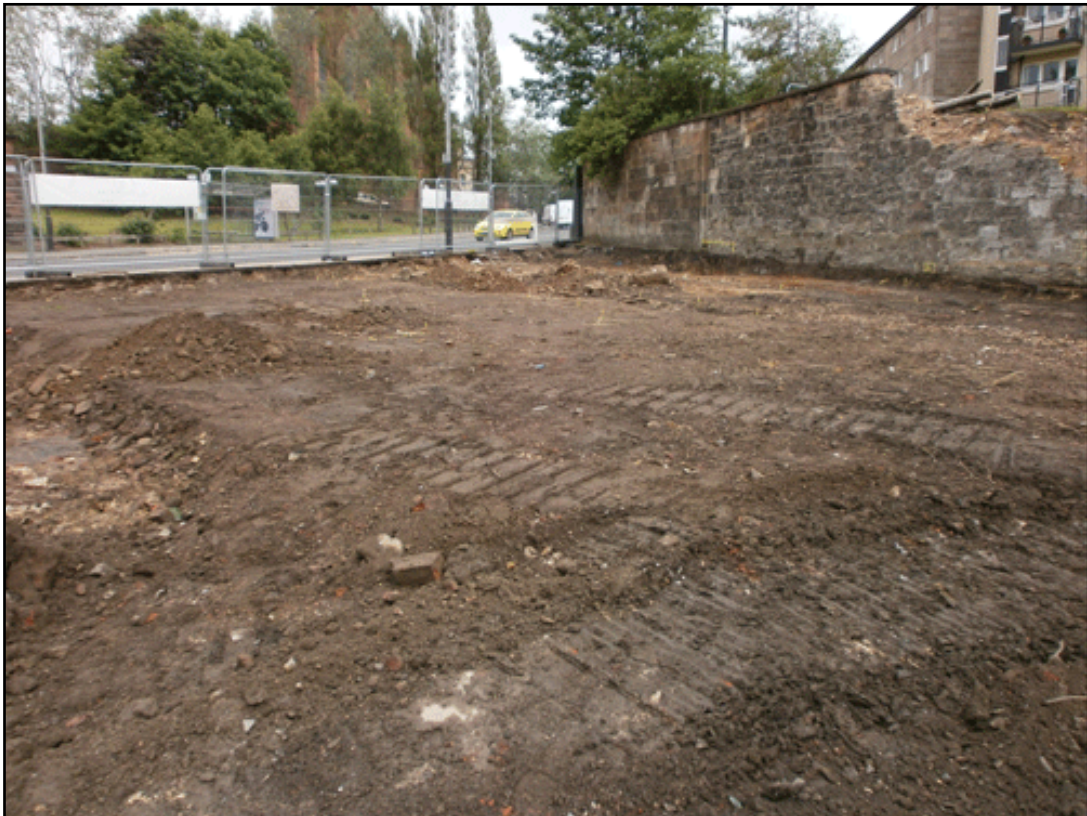
Figure 4b: North end of site, original wall and remodelled upstanding wall [022]

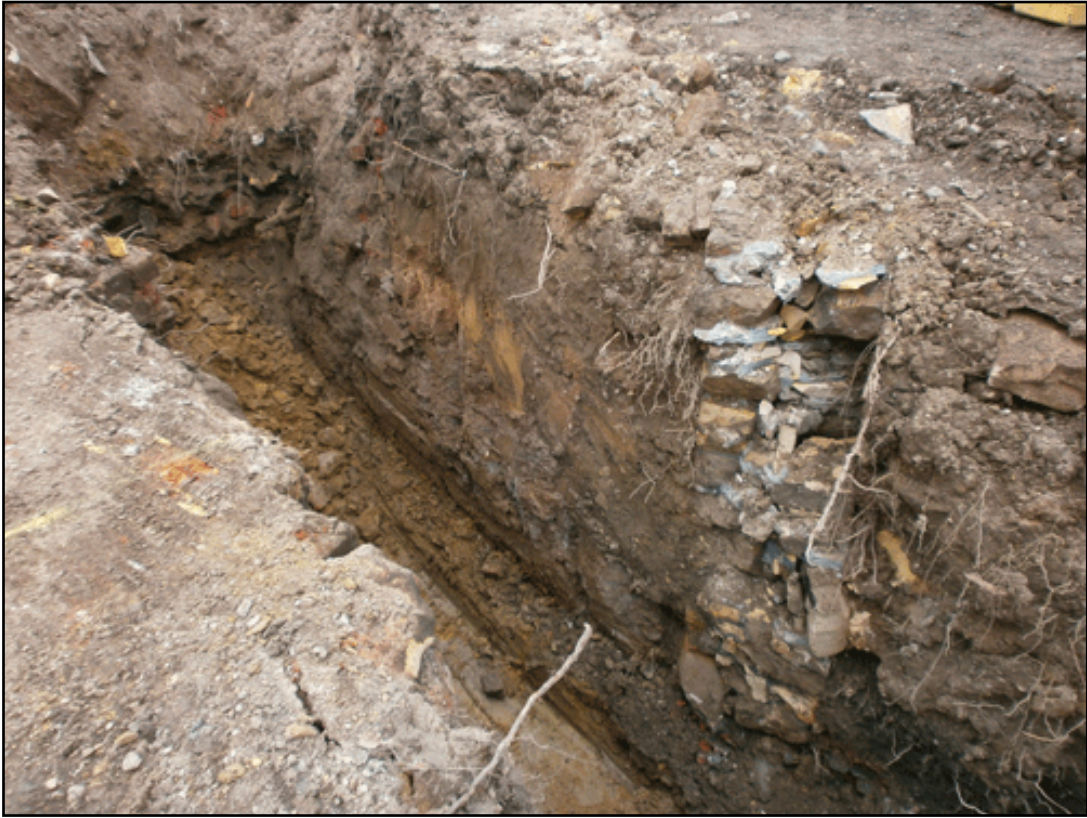
Figure 5a: Foundations of wall [022] (pipe trench)

24. Excavations for a drainage pipe trench to facilitate services for the site compound continued from the south-east corner of the site. The trench maintained a depth of 3m from the top of the current site ground level, and was 1m wide. Approximately 15m of the excavation of this trench was monitored altogether. The trench ran north-west from the compound area towards the centre of the site and then turned north-east. The western wall of the Duke Street prison [022] (figure 5a & 5b) was exposed within the pipe trench continuing along the same orientation (as was visible with the upstanding remains). This is the southern, original section of the wall [022] which can be dated to 1798.

25. The top of the wall [022] was found at 0.1m depth from the top of the current site ground level; 1.3m thickness of the wall was visible below ground. The lower 0.8m-0.9m of the wall were cut into (019) and (020), which are both likely natural subsoil. Deposit (019) was mid-orange clay (with sporadic light grey clay) and contained no visible inclusions. This deposit was 0.5m maximum thickness and was found only on the north side of wall [022]. The deposit visible for 3m maximum in section, after which it gives way to demolition materials (011) and (009) (figure 5a). Deposit (020) was mid-brown clay (with sporadic light grey clay) and also showed no visible inclusions; this was excavated to 0.3-0.4m maximum depth. This deposit seems to continue further north, but the full extent is unknown.

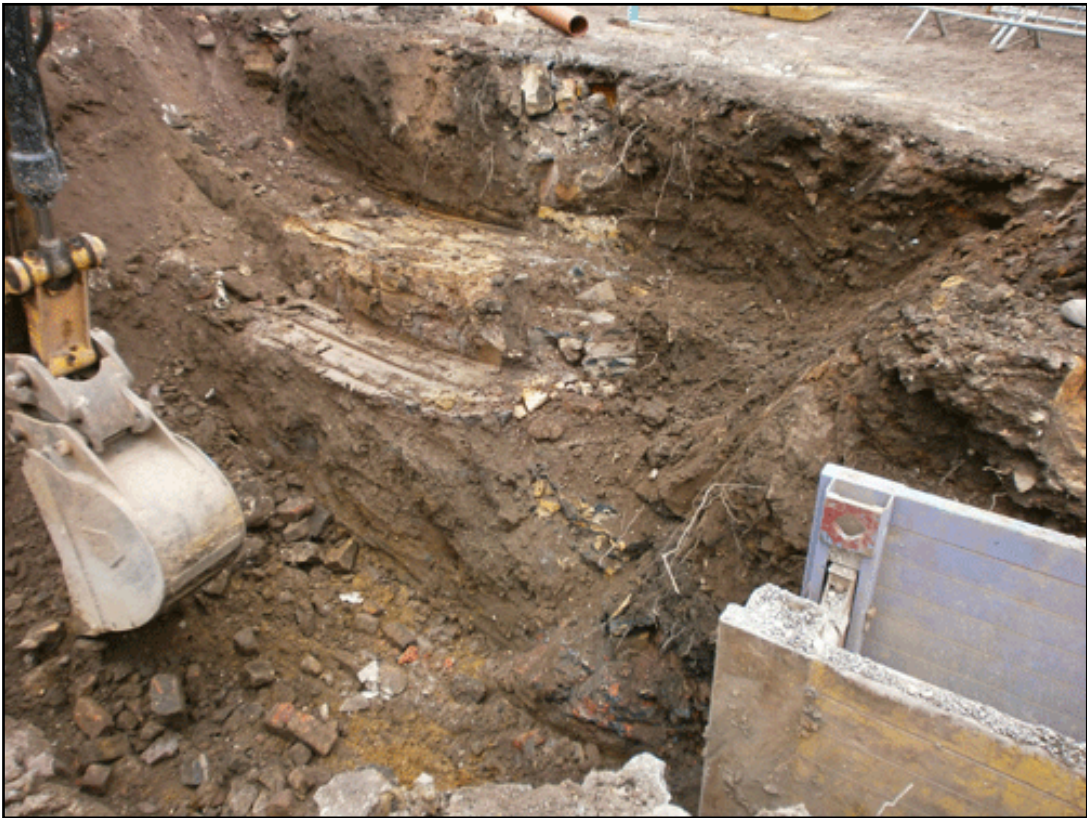
Figure 5b: Foundation of wall [022] (pipe trench)

26. Cut [021] truncated (019) and (020), but was only visible on the north side of the wall, within the south-west facing section (figure 5b); it was not visible elsewhere due to later disturbance. The base of this cut was filled with dark grey, ashy material (018) to 0.4m thickness. Below (020) natural subsoil (016) was exposed, a light brown/yellow sand (this was the lowest deposit encountered within the pipe trench). This deposit was excavated to 0.4m depth and forms a continuous band below the wall [022].
