**Bishopton Royal Ordnance Factory, Renfrewshire:
Archaeological Evaluation, Northern Access Road**

Data Structure Report

by Douglas Gordon

issued 24th April 2012

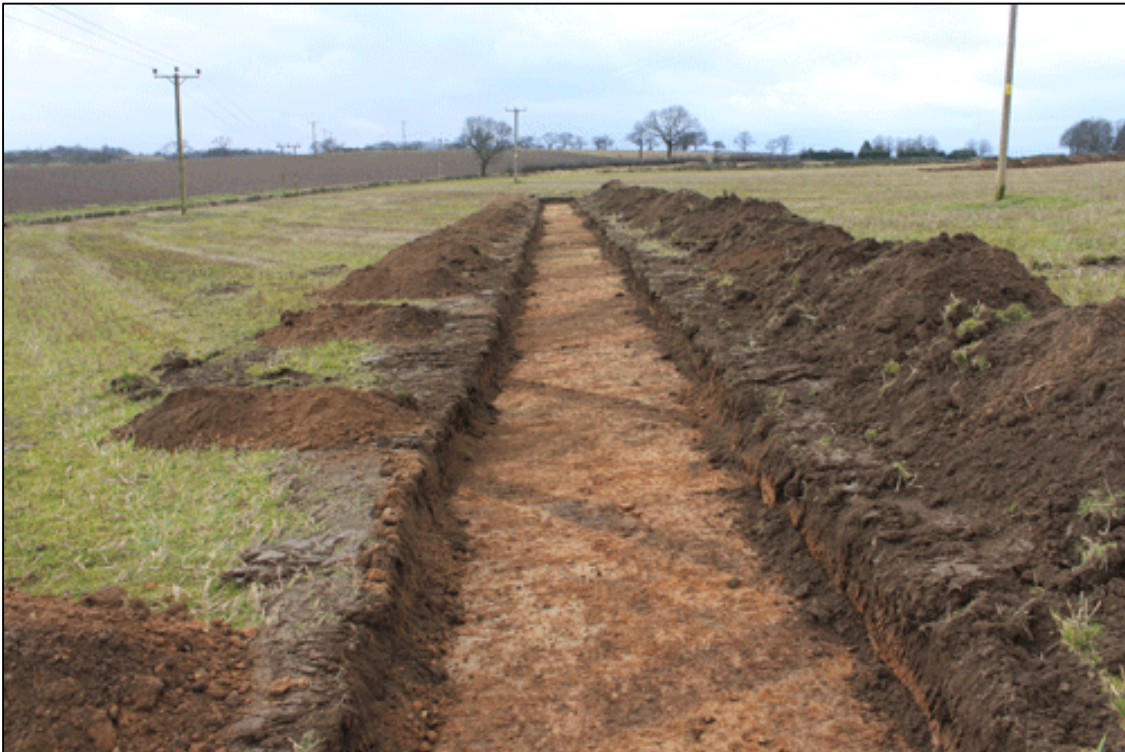
Figure 2b: Trench 10 from the East with field drain evident in the trench bed

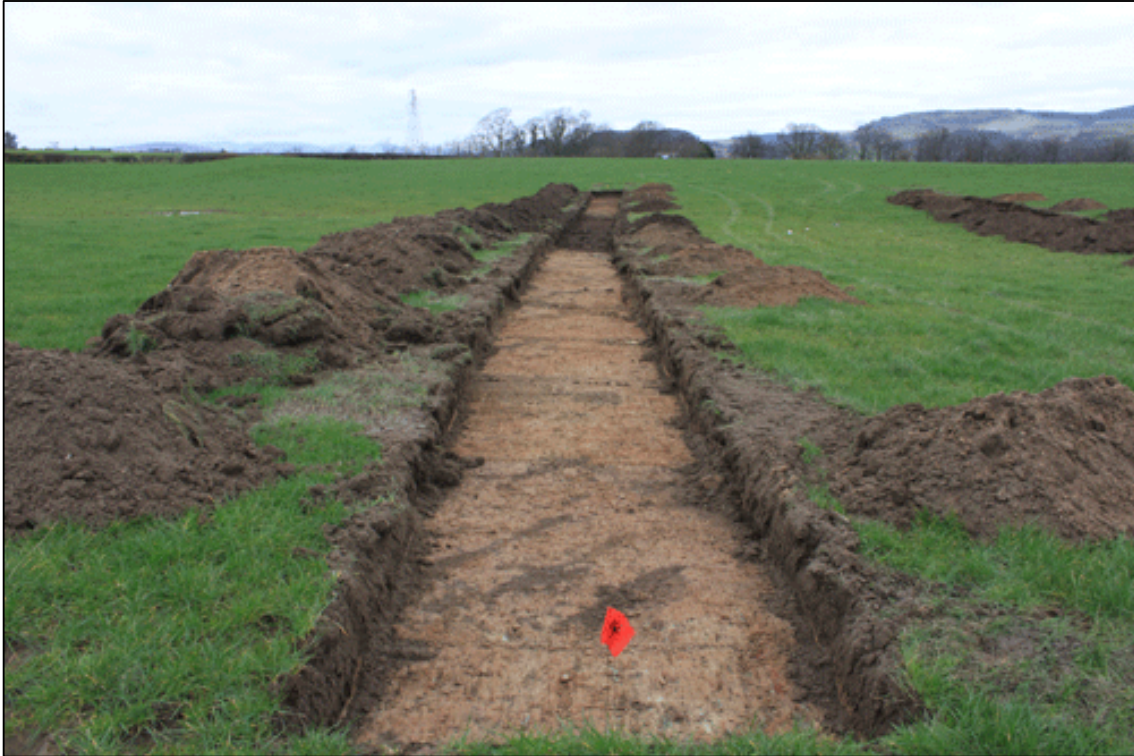
Figure 3a: Trench 37 from the South with plough scars evident in the foreground

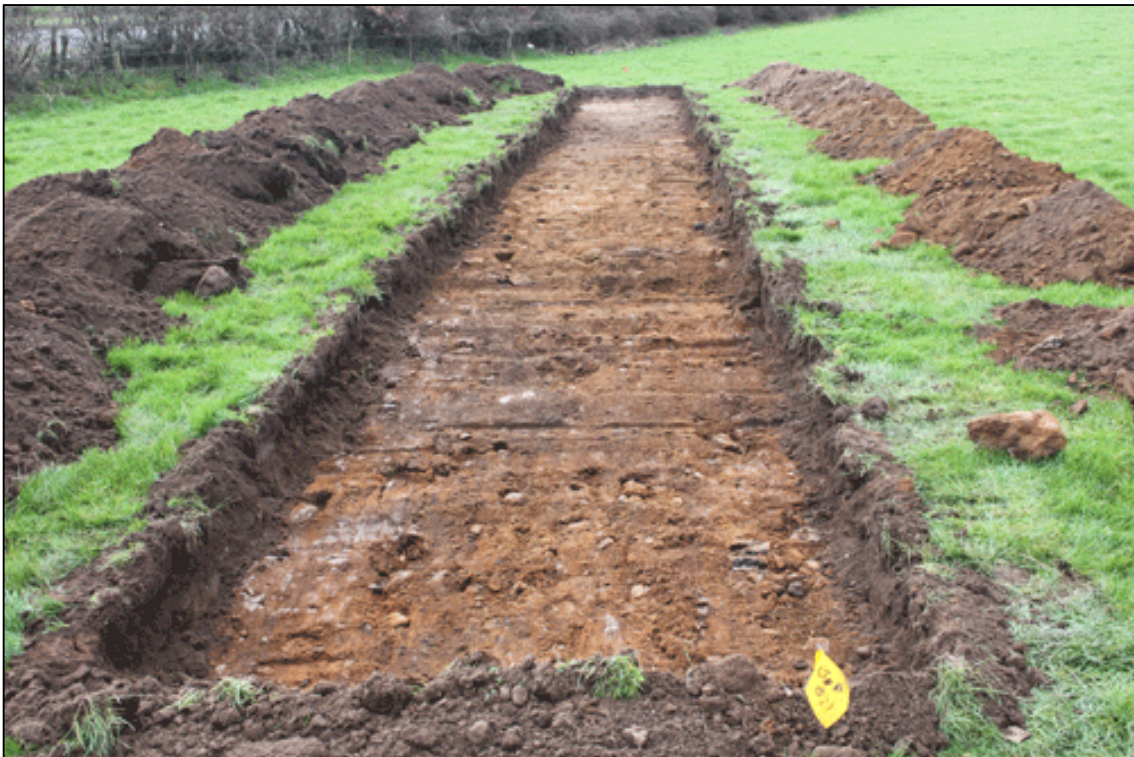
Figure 3b: Trench 50 from the South

12. All trenches were excavated to archaeologically sterile subsoil (e.g. Figure 3b). With very few exceptions subsoil was exposed along the entire length of each evaluation trench. The subsoil was generally a sand and/or gravel that varied slightly across the trenches in colour but was a variant of orange and/or brown.

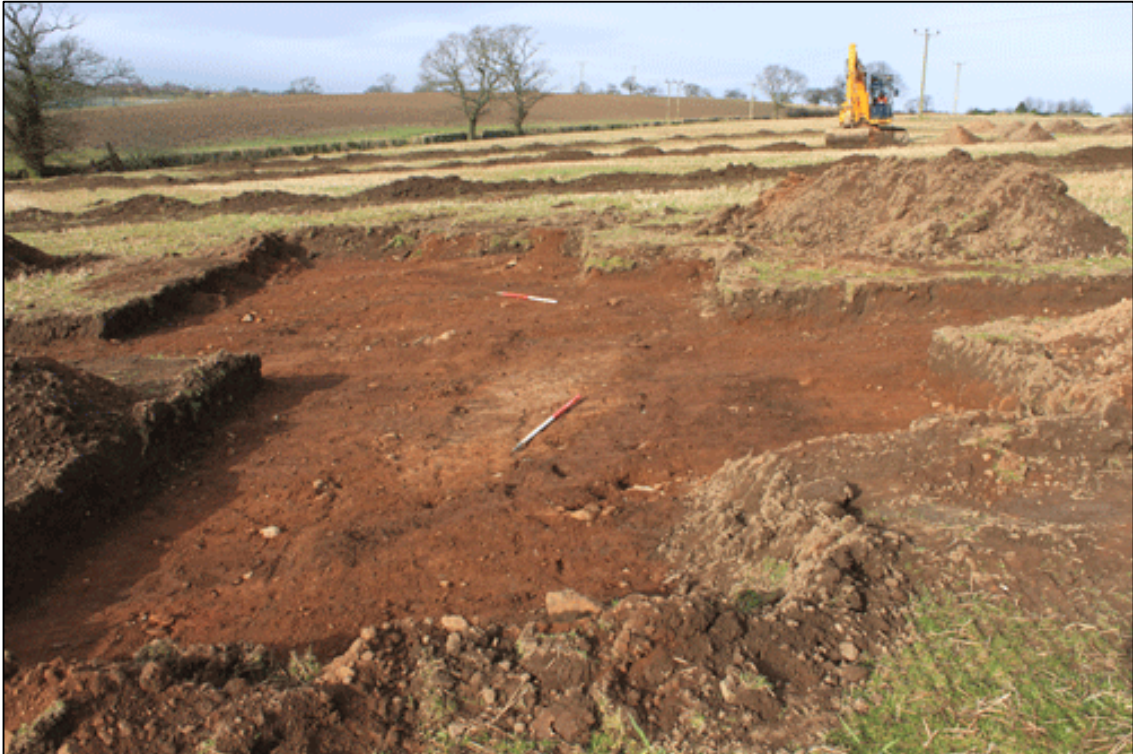
Figure 4a: Curvilinear [009] from the East, as originally exposed within the enlarged Trench 5

15. Only one feature of note was uncovered in Trench 5 at +17.8m (Figures 4a-b, 5a); [009] was a curvilinear feature placed mid slope that curved east to west and bowing to the north with the ends of the feature appearing to straighten out. It measured 12m in length, 400 to 600mm wide and 100 to 190mm in depth. With a V-shaped section the feature was filled by a firm brown orange clay silt with occasional rounded stone inclusions. Following a preliminary investigation of [009], an area 40m by 40m was topsoil stripped centred (NGR NS 4261 7123) on the curvilinear to establish the presence in any of associated archaeological features.

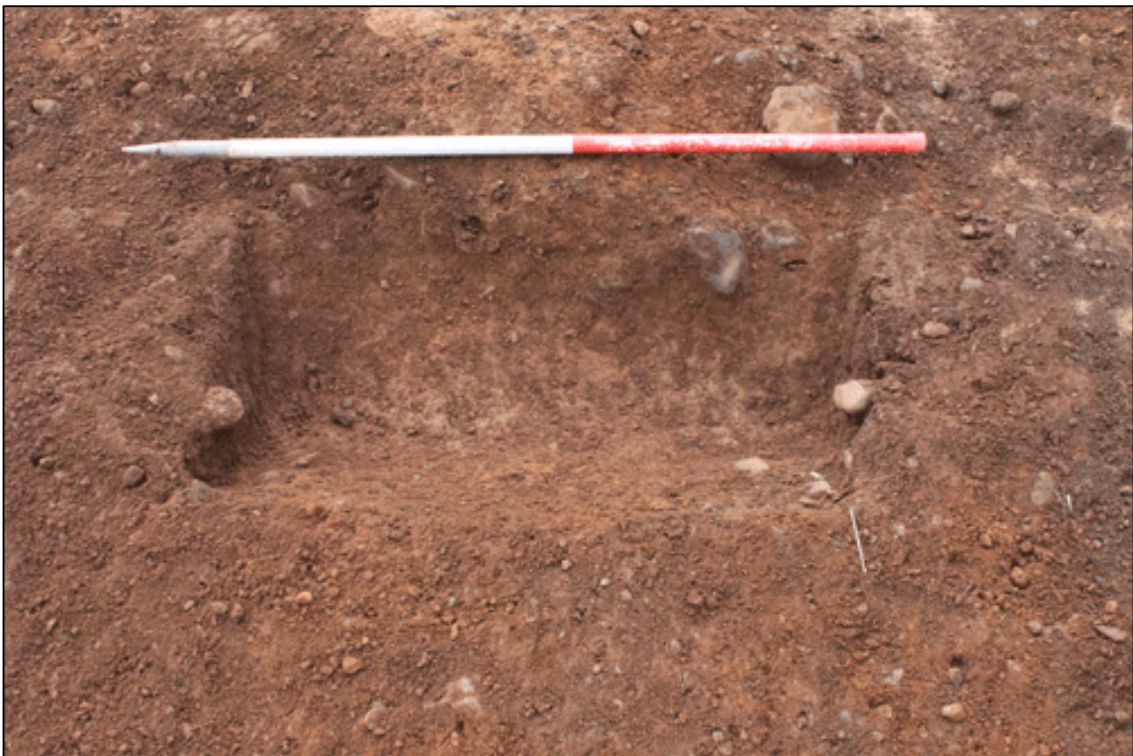
Figure 4b: Slot A through [009] from the North

- ❖ Slot A revealed [009] to be from 400-600mm wide and from 150-260mm deep with a orange brown clay silt fill with occasional medium sized sub rounded stone inclusions;

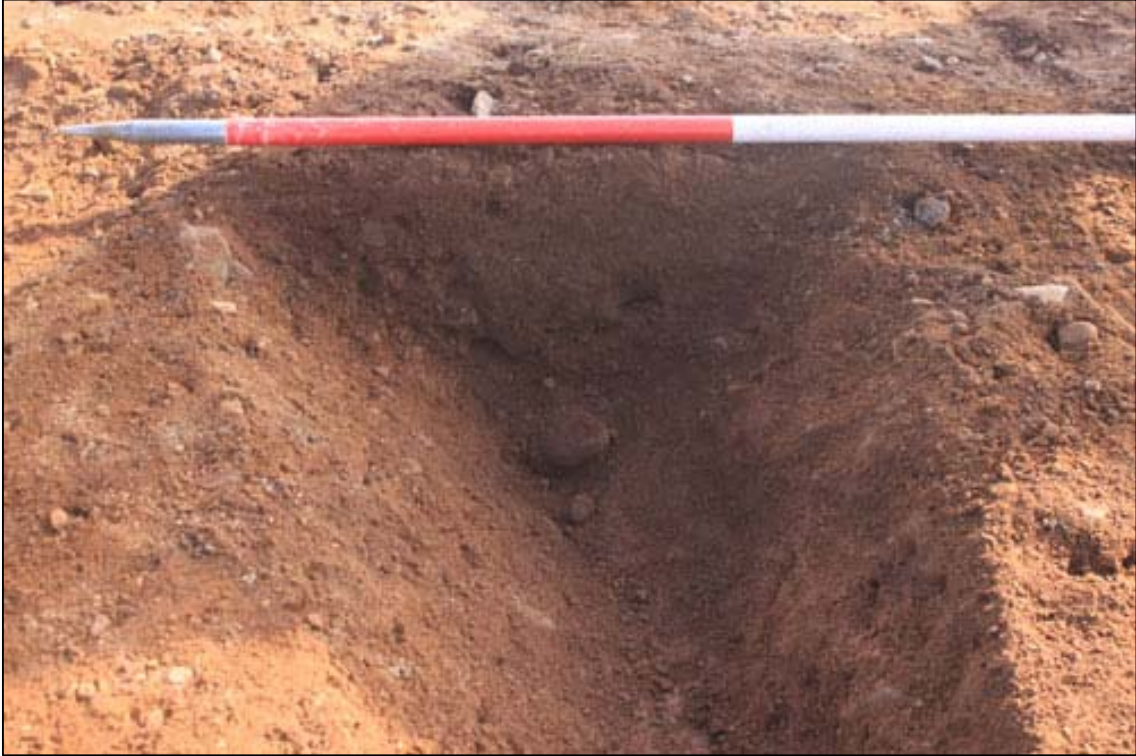
Figure 5a: West facing section of Slot C [009]

- ❖ Slot B [009] was 450mm wide and 190mm deep with a comparable fill; and
 - ❖ Slot C [009] was 490mm wide and 180mm deep with a comparable fill to Slots A and B.

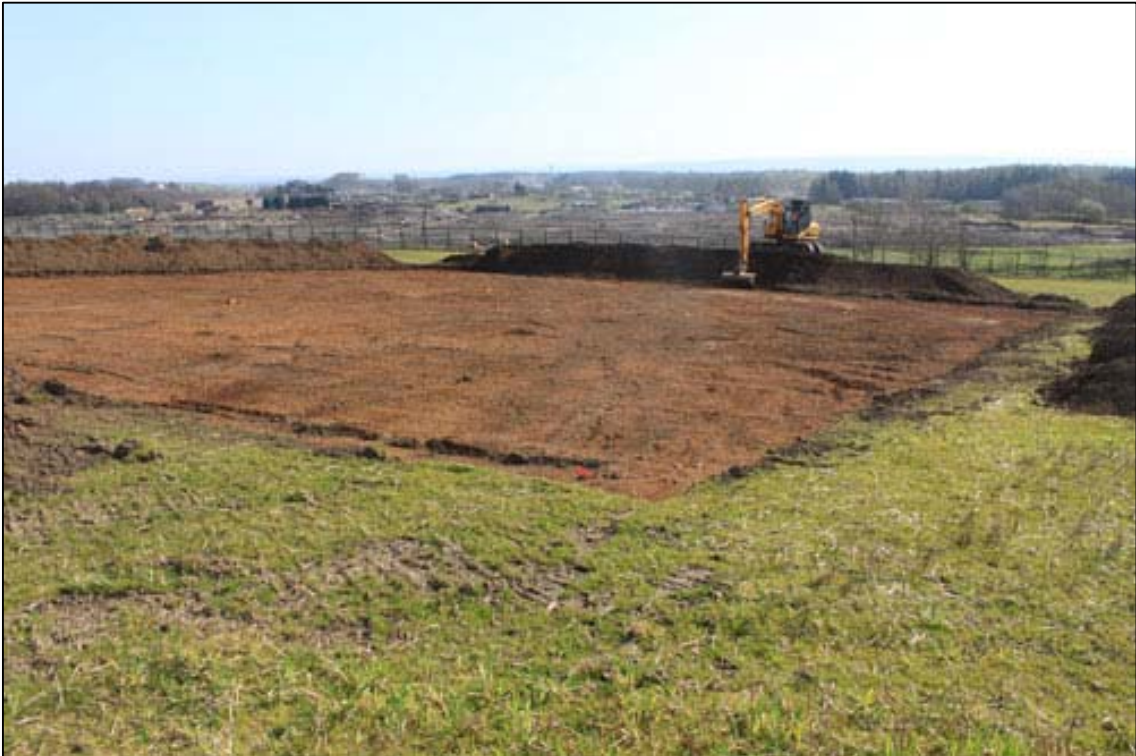
Figure 5b: Open Area strip around [009] from West

16. This open area revealed the entirety of [009] but didn't reveal any further significant archaeological features. Three slots 1m long were excavated along the length of the feature to characterise and sample it:
