**Bishopton Royal Ordnance Factory, Renfrewshire:
Archaeological Evaluation, Southern Access Road**

Data Structure Report

Issued 30th April 2012

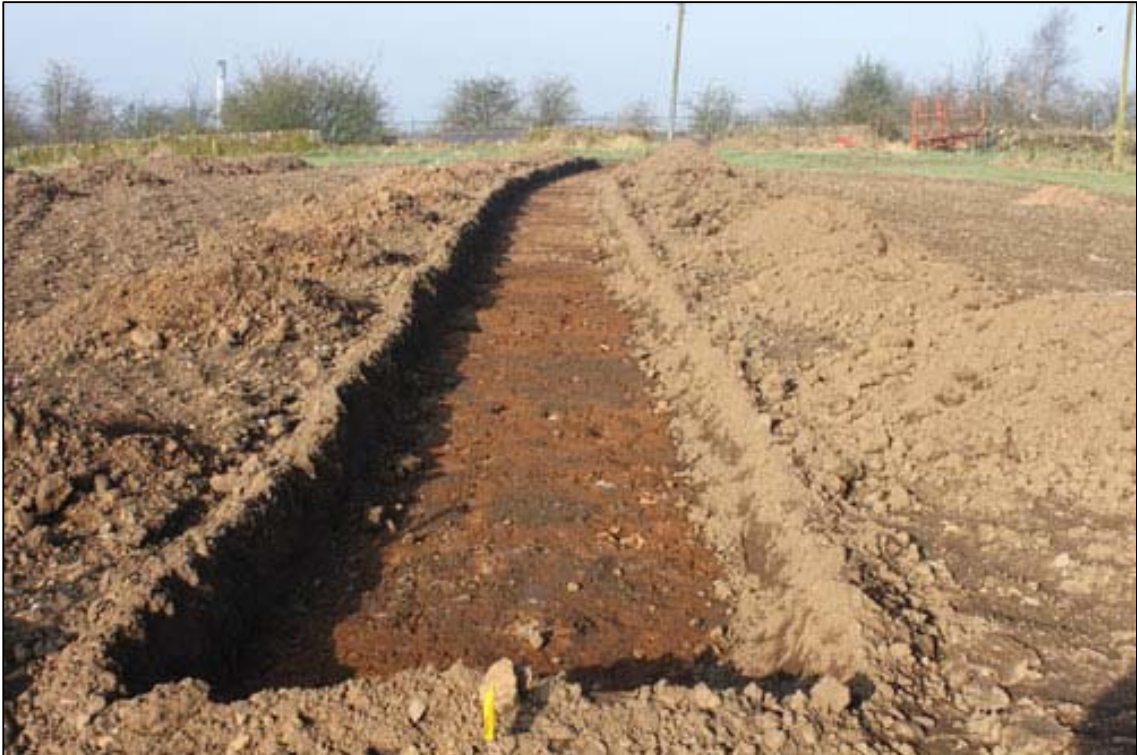
Figure 2a: Trench 5 from the East

05	East-south-east to west-south- west	2m by 50.5m	310mm – 410mm	Orange-brown sandy clay subsoil (002) is the subsoil for the entirety of the trench.	A small circular depression with a fill of (001) containing modern glass and ceramics was observed at 25m, this is interpreted as a modern stone heave. 4 ceramic field drains (003) were present; 3 on a north-south alignment at 29m, 38.5m, 45m; and 1 on an east-west alignment at 31.5m. A linear vertical sided cut feature (004) interpreted as a modern service related feature was present	None.	None.

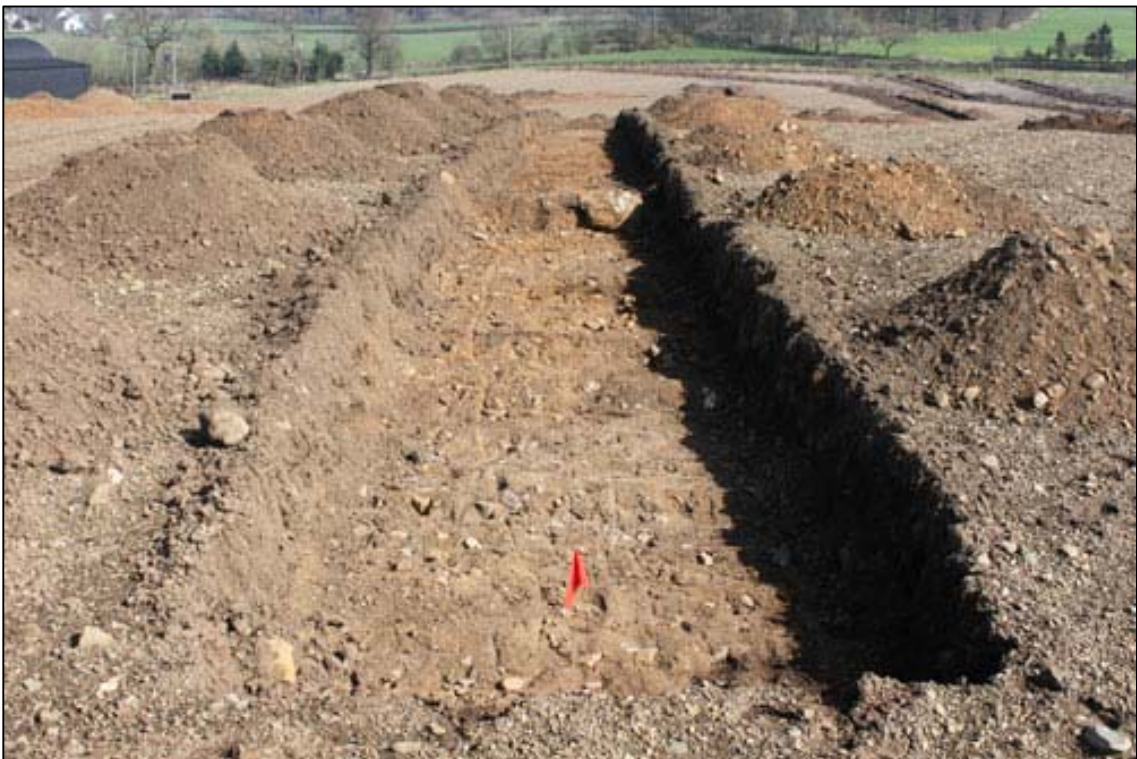
Figure 2b: Trench 9 from the West

09	West to east	2m by 51.5	280mm – 360mm	Orange-brown sandy clay with sub-angular stone inclusions (002) present throughout trench.	Modern ceramic field drain (003) present at 4.0m to 5m. Orientated north-north-west to south-south-east. Modern ceramic field drain (003) present at 30m to 35m with both ends of the drain quite ephemeral in nature likely caused by ploughing. Orientated north-east to south-west. A section of modern ceramic field drain (003) present at 40m to 47.5m	None.	None.
010	East to west	2m by 51m	360mm - 370mm	Orange-brown sandy clay with sub-angular stone inclusions (002)	Small spread area of dark patchy soil, likely manganese present at	None.	None.
