Benlister, Lamlash, Arran: Archaeological Evaluation

Data Structure Report

by Douglas Gordon and Peter Klemen

Rathmell
Archaeology Ltd

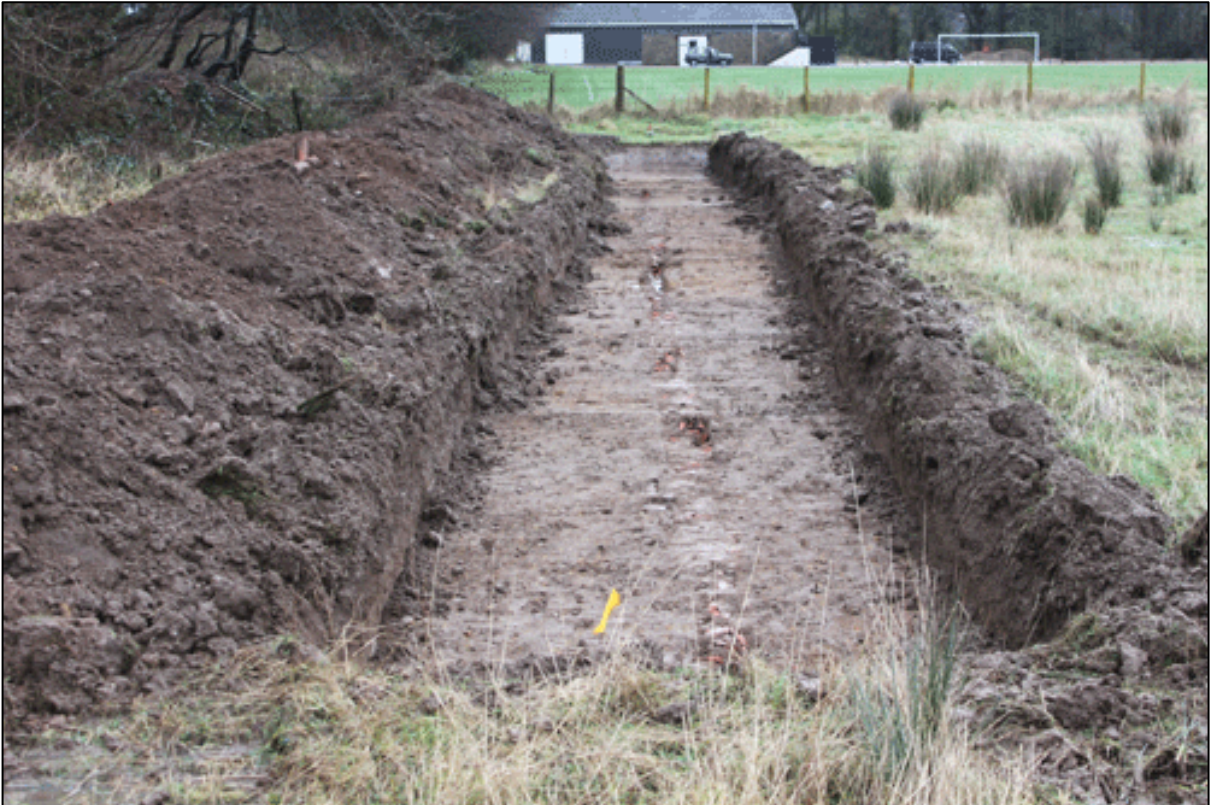
Figure 3a: Trench 1 from W with modern tile field drain (004) running W-E through the centre

14. Within Trenches 1, 2, 10 and 12 modern tile field drainage pipes were recorded with 20th century pipes recorded in Trenches 2 and 3. Plough scars in Trenches 5, 7, and 8 are evidence that the development area has been previously ploughed.

18. No significant archaeological remains were uncovered in the course of the archaeological works. The features that were revealed and investigated are the result of modern activities; the modern tile field pipes used for drainage (004) are possible the result of late 19th century to earlier 20th century activity to prevent standing large bodies of standing water, as were noticed on arrival.

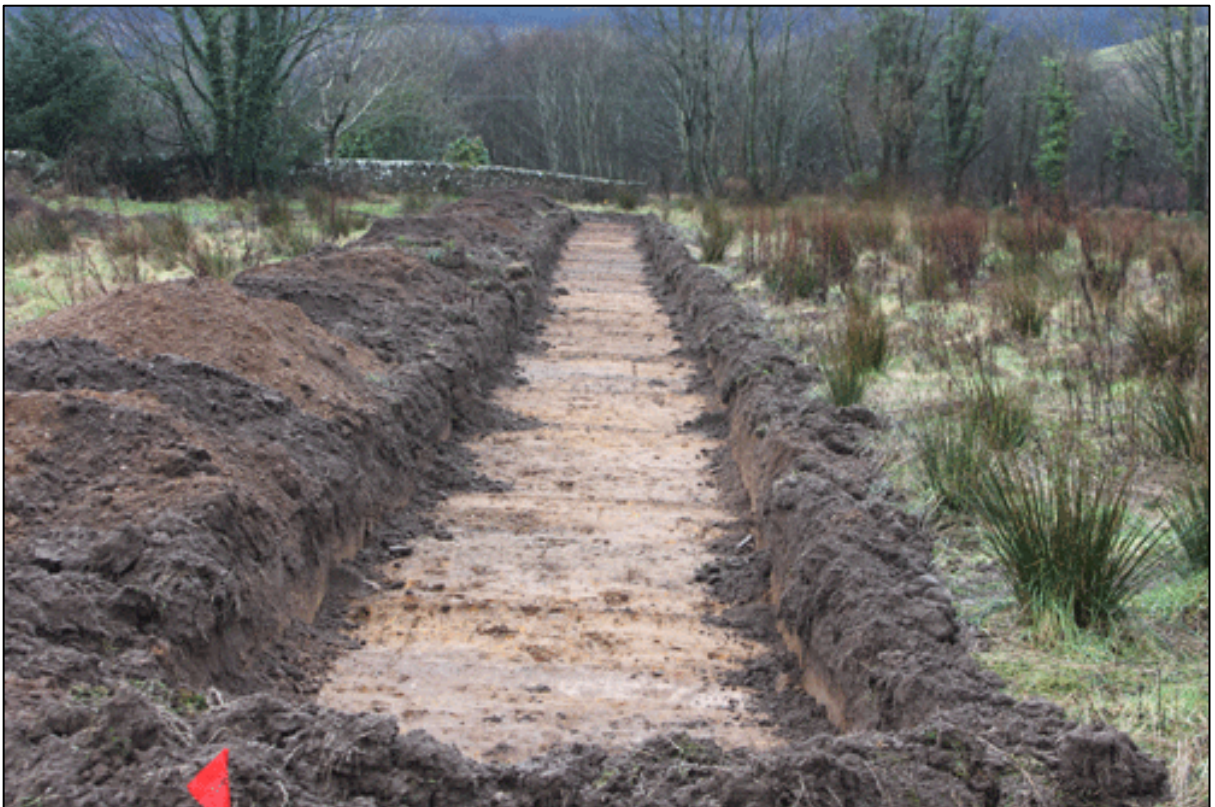
Figure 3b: Trench 7 from NE showing the predominant subsoil (003) recorded across the site

12. Natural subsoil was encountered at depths of between 280mm-440mm below the top of the current ground surface and consisted predominantly of a moderately compacted, dark yellow orange, sand and gravel (003). The colours of the exposed subsoil were very similar in nature, and varied only slightly. Trenches 4 and 5 contained narrow areas of loosely compacted gravel bands with rounded stones ranging in size from 10-50mm (006). The stone inclusions found within the subsoil and the predominantly sand composition of the subsoil ((002) (003) (010)) are probably a result of marine deposition.

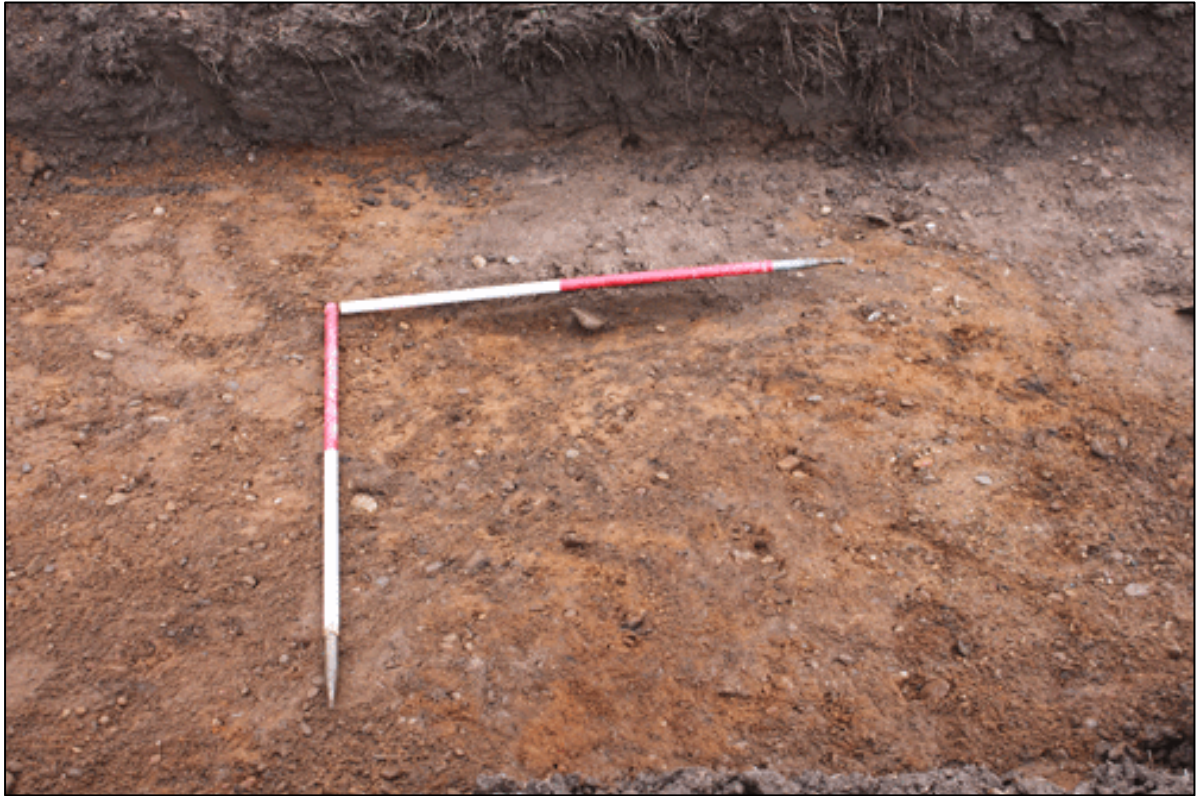
Figure 4a: Section through [009] from south

16. Within Trench 8 one of the linear features once sectioned and cleaned was concluded to have been the result of bioturbation, most likely caused by animal activity. The second linear feature after being sectioned and cleaned was still inconclusive and as a result it was felt that it was necessary to draw the section at 1:10. Both the cut and fill were given the same context number [(009)]. Aligned N-S, its dimensions are 93mm wide and 130mm in depth with a moderately compacted light grey brown, silty sand small to medium angular and rounded stones (see Figure 4a).

21. The two linear features [009] and [011] were both ephemeral though clearly of anthropic origin. Their common alignment and character of fills suggest that they are infilled ditches rather than structural slots. There were no artefacts associated with these ditches (either modern or ancient) and no other associated features. Their linear form would suggest they should have appeared in other trenches, but they were not observed at these points. It is reasonable to suggest that these were once longer feature, truncated by agricultural ploughing. Indeed on balance, we would propose these to be the fragmentary remains of a rig and furrow field system – being the truncated remnant of two furrows.

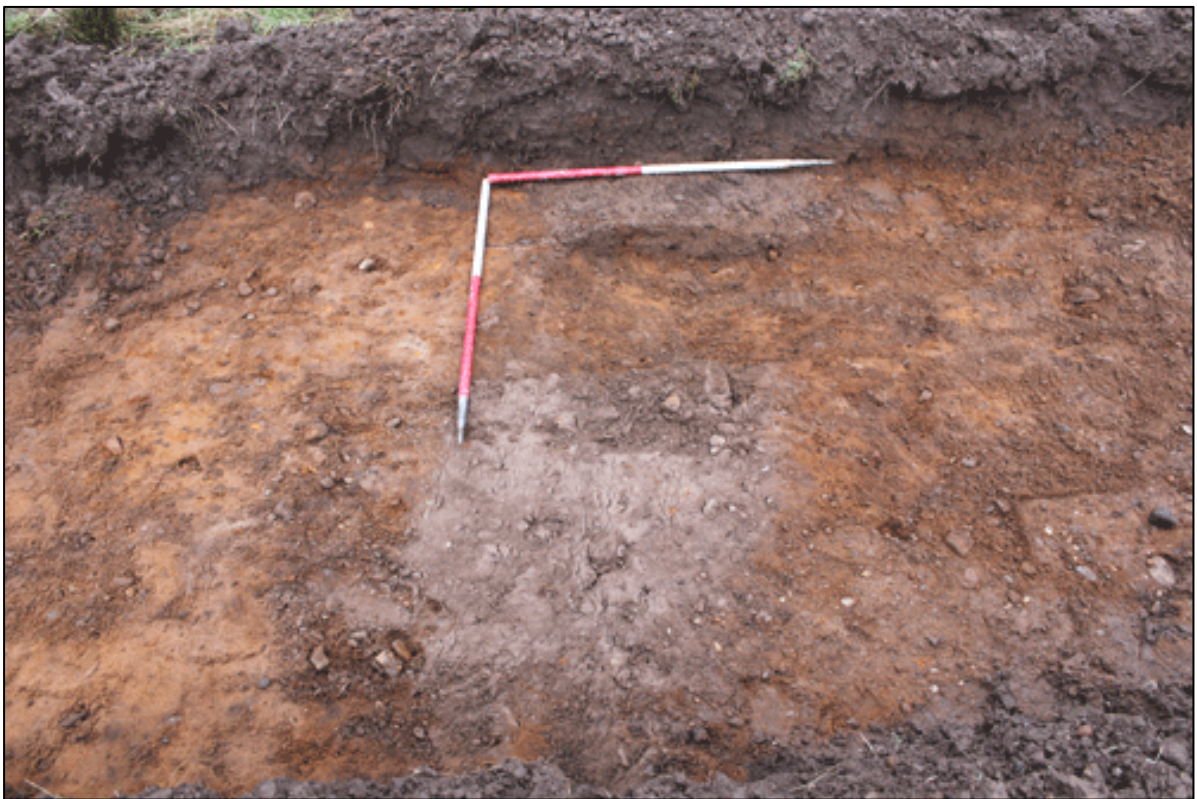
Figure 4b: Section through [011] from south

17. In Trench 7 the cut and fill [(011)] were again given the same context number. Aligned N-S, 700mm wide and 90mm in depth with a moderately compacted light grey brown, silty sand with occasional small to medium angular and rounded stones (see Figure 4b). A bulk sample of 10 litres was extracted from (009) as charcoal was visible within the fill. No artefacts were recovered from either (009) or (011).
