# **Alloway Kirk, South Ayrshire: Archaeological Mitigation**

Data Structure Report

issued 14<sup>th</sup> August 2012

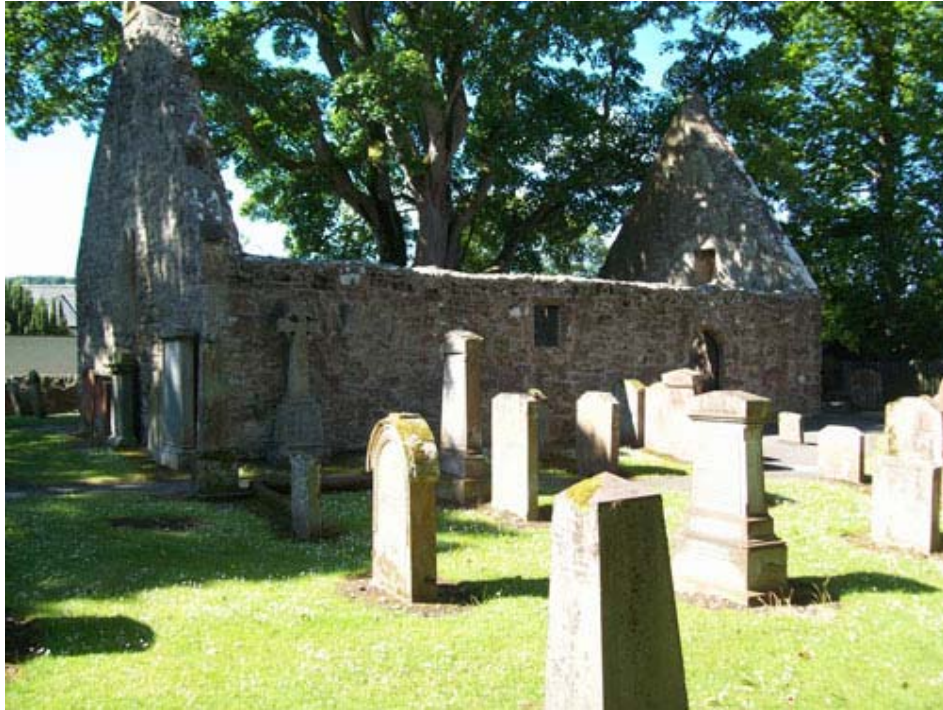
Figure 3a: Auld Kirk Alloway from the Northeast

11. The roofless ruin of Alloway's medieval parish church, Alloway Kirk, stands on the south side of its walled burial-ground (Figure 3a). It is gable-ended and rectangular on plan (measuring 14m by 7.7m within walls 0.9m thick); the structure has been modified on a number of occasions and a small aisle appears to have formerly projected from the east end of the north wall.

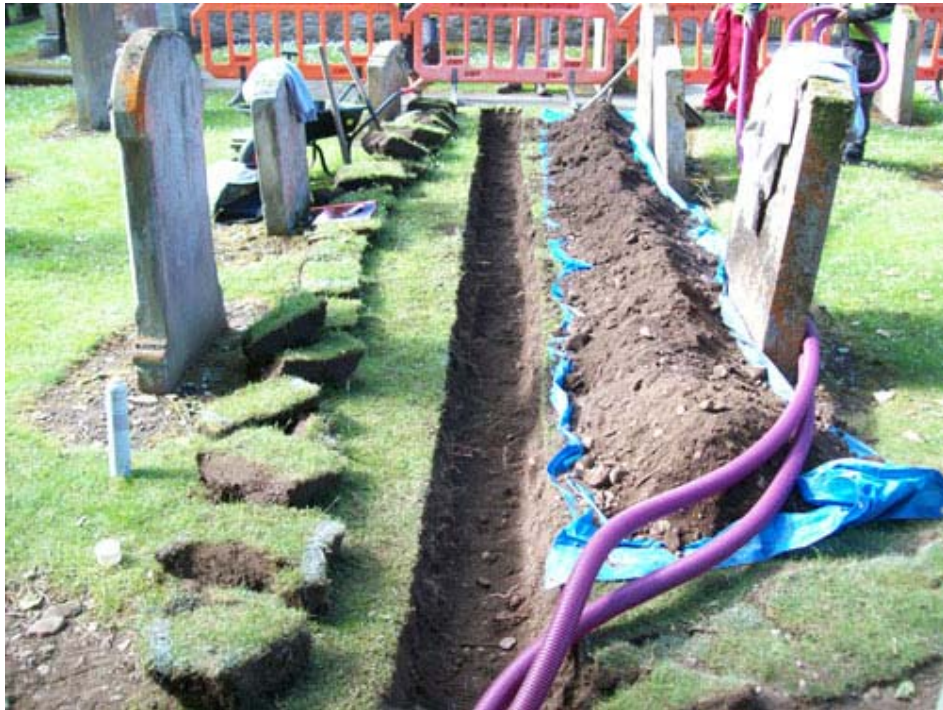
Figure 3b: Trench within the graveyard from the North

22. All trenches were hand-dug and excavated no deeper than 300mm and therefore did not extend any deeper than the topsoil (001) (Figure 3b). The topsoil (001) covered the whole graveyard and was characterised by a dark brown humic sandy/silt layer with frequent small to large tree roots, and frequent sub-rounded and sub-angular medium to small stones. In addition, there were occasional inclusions of disarticulated human bone. Between the covering layer of turf and (001) there was a light yellow and moderately compacted layer of mortar (004) present to approximately 50mm in depth (004), which was frequently found to the north and east of the Kirk building.

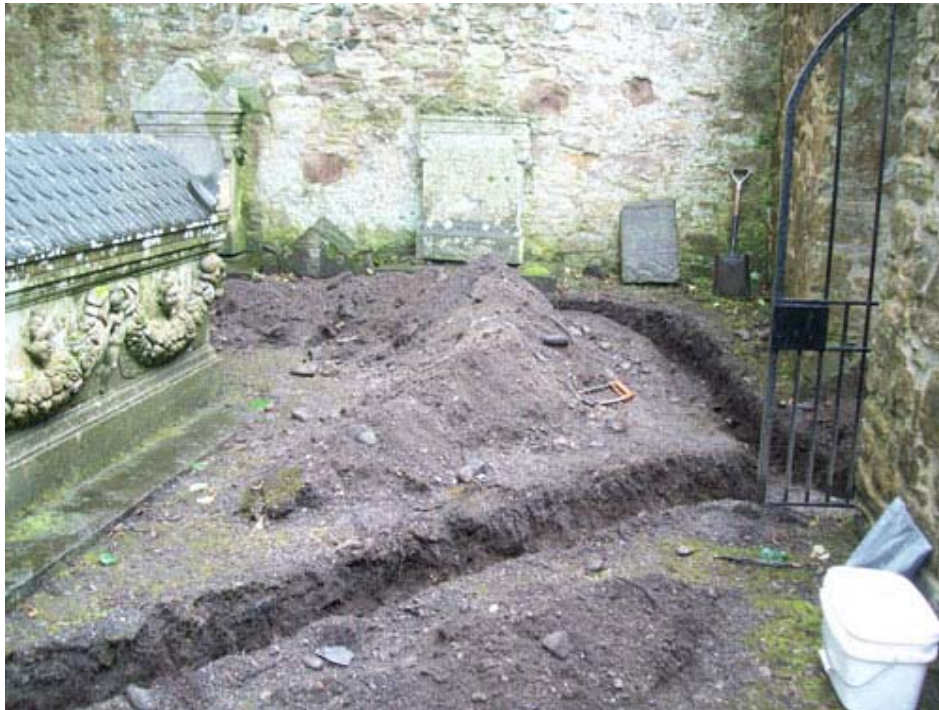
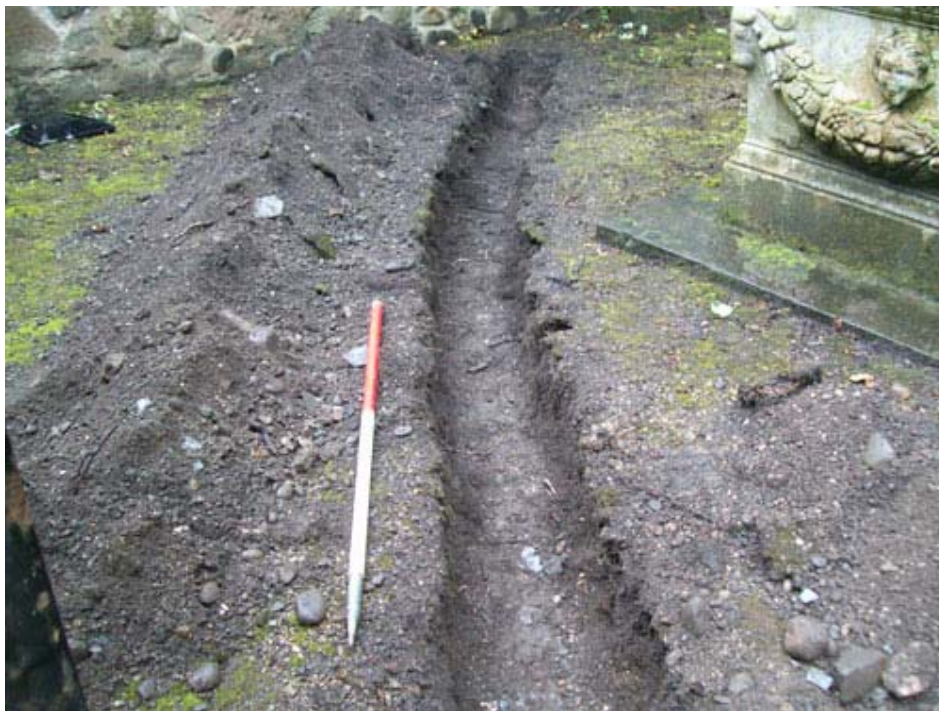
24. Within the Kirk, the trenches revealed an upper surface (006) composed of small red gravel 70mm in depth which was starting to become obscured by grass and moss. This in turn was overlying (007), which comprised medium-sized gravel set within a dark brown silt matrix with inclusions of moderate-sized tree roots, roofing slate, sandstone fragments and occasional disarticulated human bone (Figures 4a and 4b).

Figure 4a: Trenches within Kirk from the West

Figure 4b: Trenches within Kirk from the Northwest
