**Towns House, Irvine, North Ayrshire:
Historic Building Recording**
Data Structure Report

by Louise Turner

issued 31st July 2012

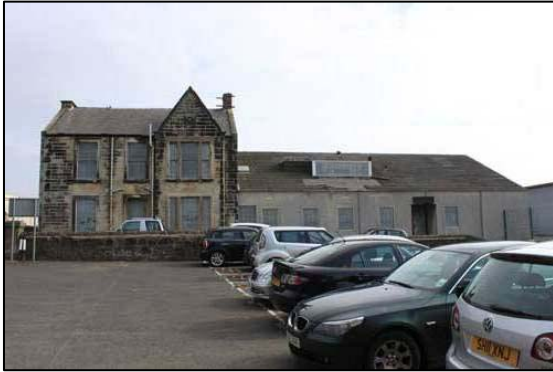
Fig. 3a: Police Station, S Elevation

23. The police station is a large 'L'-shaped structure in plan, comprising a 19th century core with a large extension of 1960s or 70s date, to the east (Fig. 3a). It is the early core of this much bigger structure which formed the focus of these works and which will be discussed in detail below.

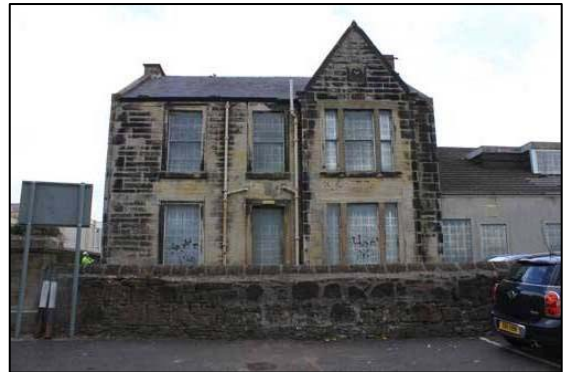
Fig. 3b: Police Station, S Elevation, 19th century core of Structure

24. The west and south elevations of the 19th century structure are still exposed in their entirety and are both clearly meant to function as street frontages. The masonry is coursed blond sandstone rubble: the blocks are squared and of consistent size, and stugged throughout. The margins, also of blond sandstone, are ashlar. The south elevation (Fig. 3b) is three bays in extent, with the eastern bay advanced and equipped with tripartite windows in ground and first floors and a pedimented gablet above. Sitting above the window at first floor level is an armorial panel depicting the saltire (Fig. 3c).

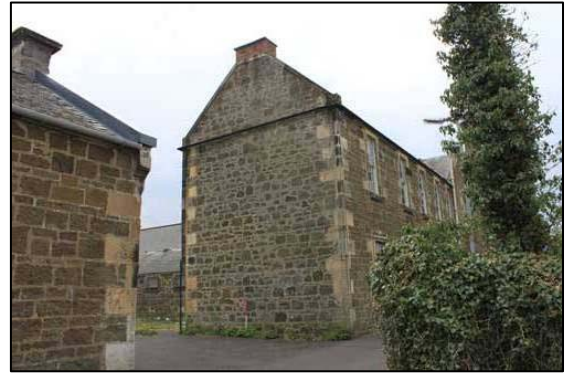
Fig. 3d: Police Station, N & W Elevations

25. The masonry employed in the construction of the west-facing elevation does not appear to be as finely finished: again, squared coursed rubble is employed, but here the blocks are not of equal size and there is abundant use of cherry-cocking. This may suggest that this elevation was originally intended as secondary to the adjacent south elevation, though attention to detail is still evident in the margins of windows and doors and the style of masonry used here once again contrasts with the much more modest form of coursed rubble used in the adjacent north, gable end wall (Fig. 3d).

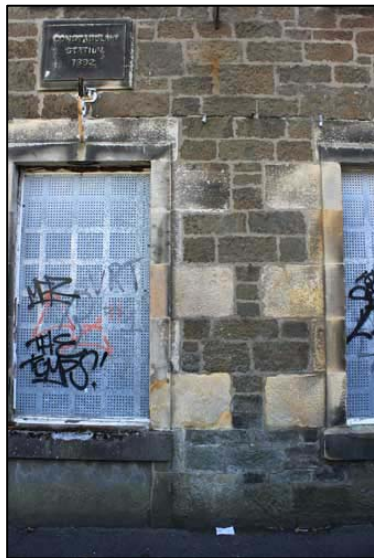
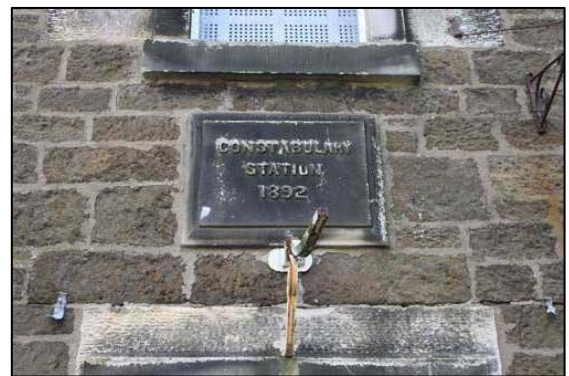
26. An interesting feature of note is the datestone which sits above a now-disused doorway in the west elevation (Figs. 3e, f). This features the inscription 'Constabulary Station 1892' and its presence suggests that the building was remodelled in the 1890s. This datestone, combined with the presence of two wrought iron lamp brackets over the doorway (Fig. 4a), suggests that the core of the structure changed, with the west elevation now emphasised as the public entrance.

Fig. 3e: Police Station, W Elevation with blocked doorway

Fig. 3f: Police Station, W Elevation, detail of 1892 Datestone

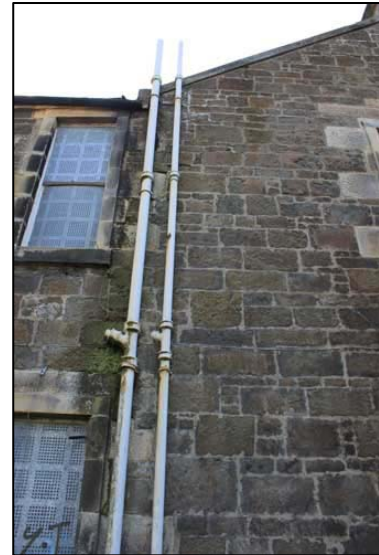
Fig. 4b: Police Station, S Elevation possible Running Joint

27. While the style of construction remains similar throughout, it is possible to identify a potential running joint in the stonework between the gable at the south end of the west-facing elevation and the adjacent two storey block (Fig. 4b). This suggests that the building originally comprised a rectangular 3 x 2 bay two storey structure, which was later extended to the north through the addition of a rectangular 4 x 2 bay annexe.

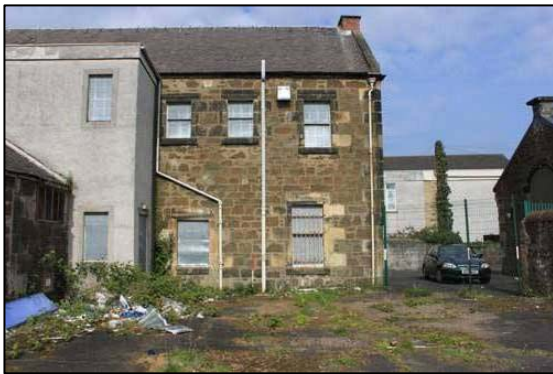
Fig. 4c: Police Station, E Elevation

28. The E elevation, now partly concealed beyond a 1960s/70s stairwell, uses masonry which is similar in character to the north, gable end wall, i.e. coursed rubble, with squared blocks restricted for use in quoins and margins, and no evidence of cherry-cocking (Fig. 4c). This is consistent with the area's location to the rear of the building. A former doorway – now partly infilled for use as a window – once opened out into the yard from this elevation.

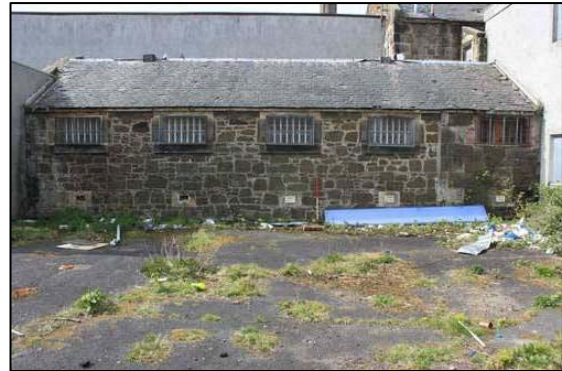
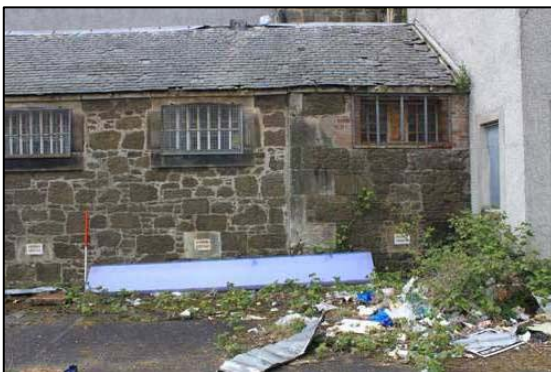
Fig. 4d: Police Station, N Elevation, Cell Block

Fig. 4e: Police Station, N Elevation, visible Phasing in Cell Block

29. Also visible to the rear of the building is the cell block. Forming a low, one-storey outshot to the rear of the main structure (Fig. 4d), this part of the structure is now partially concealed beneath a modern 1960s/70s stair tower. However, it is evident that this feature has also been extended: a running joint is visible on the external wall between the westernmost cell, and those lying to the east (Fig. 4e). This suggests that this portion of the structure was also extended, with an initial single cell proving inadequate for the facility's needs.

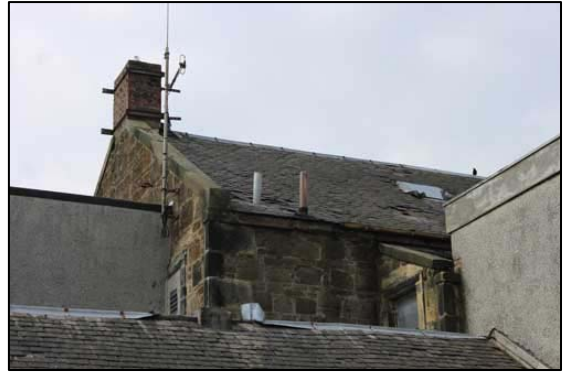
Fig. 6b: Exposed Upper Storey, with Projecting Stair

32. It is possible that the structure originally comprised a square two-storey three by two bay building with an attached stair tower. This latter feature is now completely concealed by the cell block and the modern stair, which makes it impossible to establish the original configuration. The outline of the cornice suggests that the original ground floor plan would have comprised four rectangular rooms arranged around a central access corridor that ran from north to south and linked with the rectangular stair tower allowing access to the first floor in the rear. Traces of this stair tower can still be seen projecting at attic level (Fig. 6b).

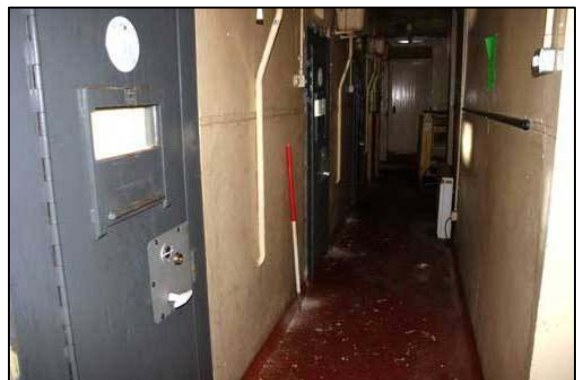
Fig. 6f: General View of Cell Bay

37. Externally, the cell bay (Fig. 6f) showed evidence of two discrete building phases, but this was not reflected with any great clarity internally. Some variation in cell design was apparent. The most striking example of this was the contrast between the cell door set within a recessed embrasure at the east end of the cell bay (Fig. 7a), and the remaining four cells which had the doors set virtually flush against the surrounding wall (Fig. 7b).

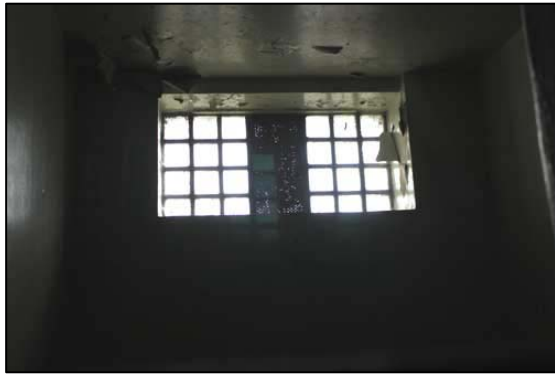
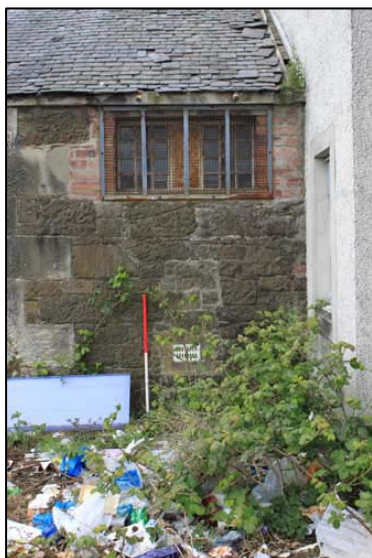
38. Some variation was, however, evident in the design of the windows, with the westernmost cell (Cell v) having a rectangular window equipped, presumably, with a flat lintel (Fig. 7c). By contrast, the windows of the four cells to the east which make up the later build are shaped in the form of a segmental arch (Figure 7d), with the external lintel shaped to accommodate the convex upper surface of the window frame. It should however be borne in mind that the differing shape of the window of the westernmost cell (cell v) may reflect a later remodelling, as externally this feature incorporates modern brick, suggesting that perhaps the lintel failed and repairs were required as a consequence.

Fig. 7c: Rectangular Window, Cell v

Fig. 7e: Alterations to Window,
exterior of Cell v

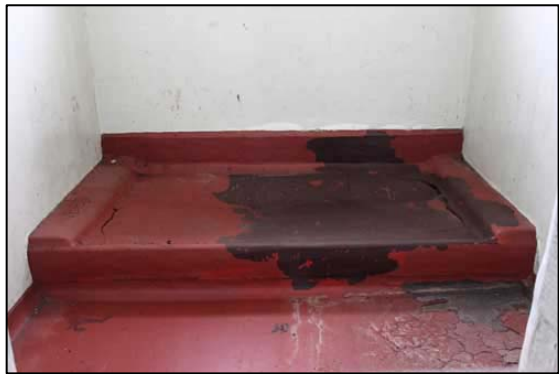
Fig. 8c: Bed, raised rims and sunken interior

40. Accommodation within the cell appeared spartan, with integral beds cast from concrete taking up the entire width of the rear portion of the cell. Since the cells could not be accessed, their size can only be estimated, but each appeared to be roughly the same size as a modern double bed. Their design varied between a raised flat slab (Fig. 8b), and a more contoured feature with a sunken interior and a raised broad lip at both sides (Fig. 8c).

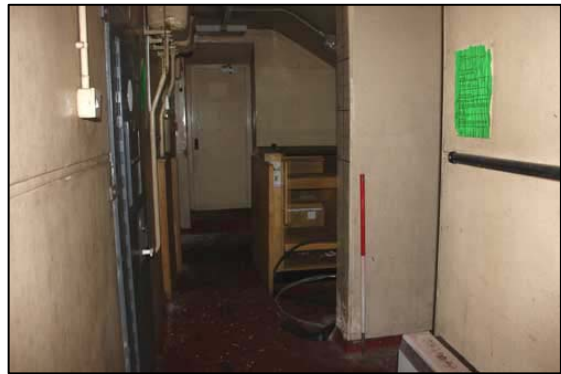
Fig. 8d: Cable Moulding & Bar Area

42. Moving beyond the cells themselves, the layout of the cell bay remains largely unchanged from its original plan. The presence of a cable moulding at dado height (Fig. 8d) on both north and south walls of the corridor is consistent with a 19th century date for construction, with the slope of the pitched roof surviving in relict form on the south side (Fig. 8e). The late use of the structure is denoted by the presence of an alarm strip on the south wall of the corridor, overlying the cable moulding over much of its length, a security feature which would have been added in the late 90s or early 2000s.

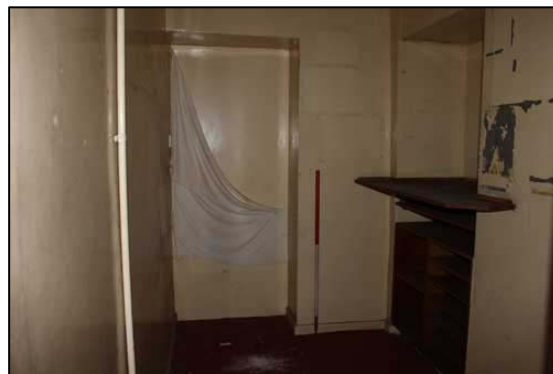
Fig. 8g: Possible Prisoner Processing Area

44. Again on the south side, there is a further recess which may have been used as a prisoner processing area (Fig. 8g). A white cloth curtain hung over a blocked doorway may have been used as a backdrop for photographs, and a set of wooden shelves could have been used for fingerprinting (though the lack of a brass plate for inking, or screw holes for the attachment of such a plate was notable).

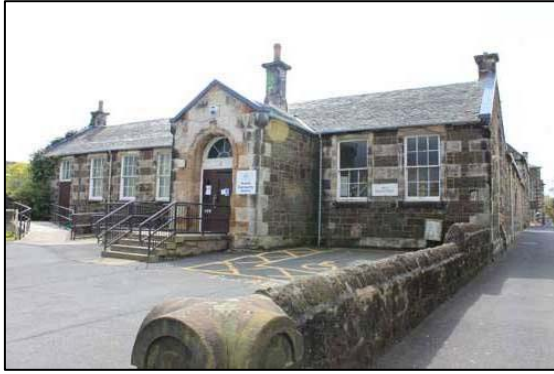
Fig. 8a: Industrial School, N Elevation

47. The Industrial School is an 'L'-shaped structure of one storey height (Fig. 8a), which is built throughout of squared coursed blond sandstone rubble, roughly stugged and with widespread use of cherry-cocking evident. The quoins and margins are stugged blond sandstone, with contrasting red sandstone used to dramatic effect in the main doorways (Fig. 8b). Additional embellishment is evident around the skewputts and the chimneys (Fig. 8c)

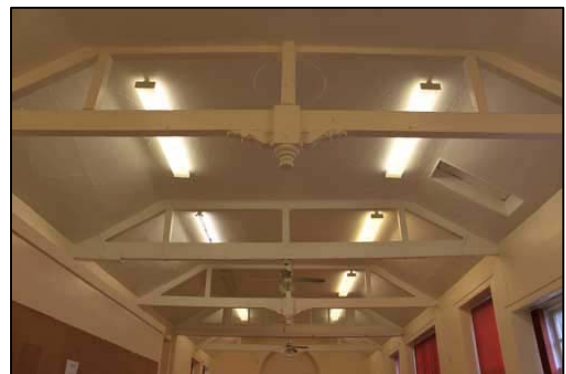
Fig 10f: Room g, Detail of Roof Trusses

56. The spacious nature of this environment is further emphasised by the use of the roof-space. Instead of being enclosed behind a ceiling, the king-post roof is left exposed and has in fact been turned into a decorative feature, with carved details evident (Fig. 10f).

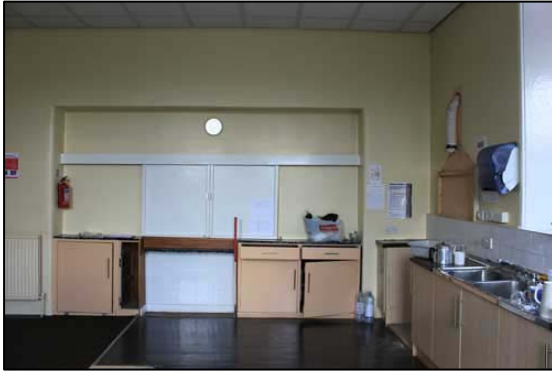
Fig. 11a: E Wall, Room c

57. It is the relationship of Room c to these two larger spaces which remains uncertain. The south and east walls appear to represent later infill (Fig. 11a), but it is evident that this area was separated from the two classrooms to some degree, perhaps by an opening as opposed to a solid partition wall. Perhaps this area housed the schoolmaster, who could monitor both groups of pupils from this location and instruct them as required.

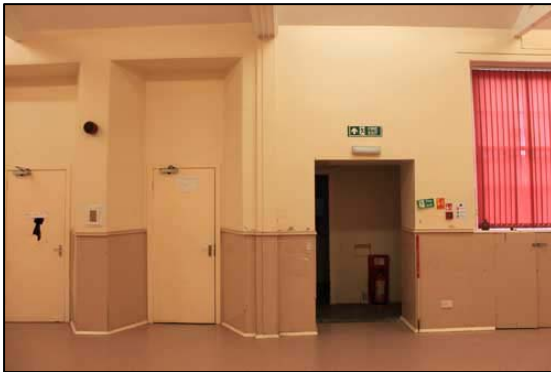
Fig. 11c: Room g, Pilaster in E Wall

61. Besides the insertion of access corridors, the floor plan has changed in recent times through the creation of new toilet blocks (Rooms e, k, j). In some instances, this appears to have involved the creation of new doorways into what was previously a solid wall. In others, however, existing window embrasures have been reutilised. These can be identified by their splayed embrasures (see doorways to left of pilaster, Fig. 11c).

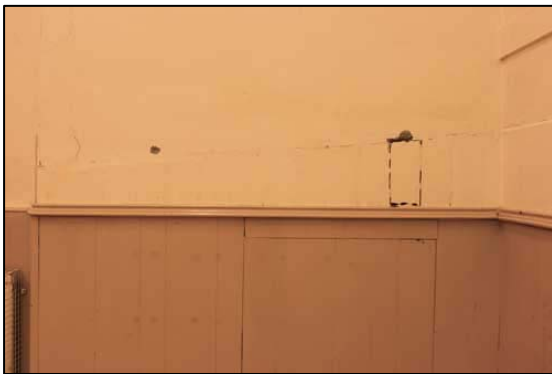
Fig. 11e: Room g, Panelling at S end

59. Though nothing survived which could establish a purpose for this apparent subdivision, small details in the decoration further served to set this space apart and mark it out as different in some way. Here, the timber panelling extended above dado height, forming a simple decorative feature which ran level along the east and west walls (Fig. 11d), then tapered down slightly to the central arched recess which, as discussed previously, may once have held a window (Fig. 11e).

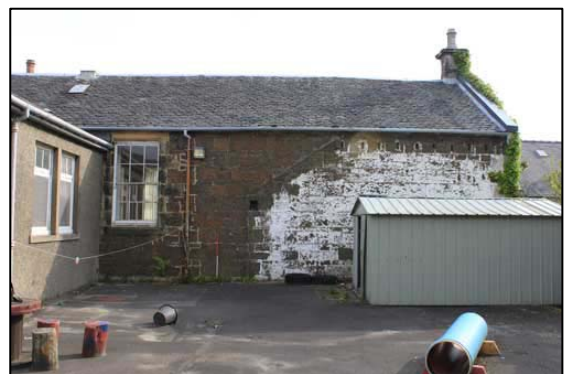
Fig. 11h: Site of Outbuilding, S Elevation

63. One further feature which is worthy of note is the site of a former outbuilding, still visible on the east end of the south elevation as a series of joistholes, a raggle marking the extent of a sloping roofline, and an area of paint or whitewash (Fig. 11h). Now largely obscured by the construction of a free-standing lock-up shed of modern date, this feature makes its first appearance on the Ordnance Survey 3rd edition map of 1911. That it may have been an integral part of the school building from its construction must, however be borne in mind. The lack of fenestration in the south wall of Room d, compared, say, with the large number of windows in both the east and west walls of Room g may indicate that the addition of an outbuilding in this location was always intended to be part of the original build, even if it was not executed immediately.

65. Of the two structures, it is the industrial school which shows the least change through the years. The basic layout of the structure remained virtually consistent throughout the nineteenth century. The only change evidenced throughout the whole of this period is the addition of an outbuilding projecting from the east end of the south elevation, shown first on the Ordnance Survey 3rd edition map of 1911, and this supposedly 'new' addition may reflect a lack of detail in the available mapping rather than a change to the structure itself. The Ordnance Survey 2nd edition map, on which this structure first appears, also fails to show either of the projecting entrance vestibules located on the north and east elevations, and with no evidence of any blocked windows present in the south fenestration, it seems likely that the presence of this outbuilding (now lost) formed an
