**Neilston Community Wind Farm:  
Archaeological Watching Brief**

Data Structure Report

by Diane Gorman

issued 11<sup>th</sup> July 2012

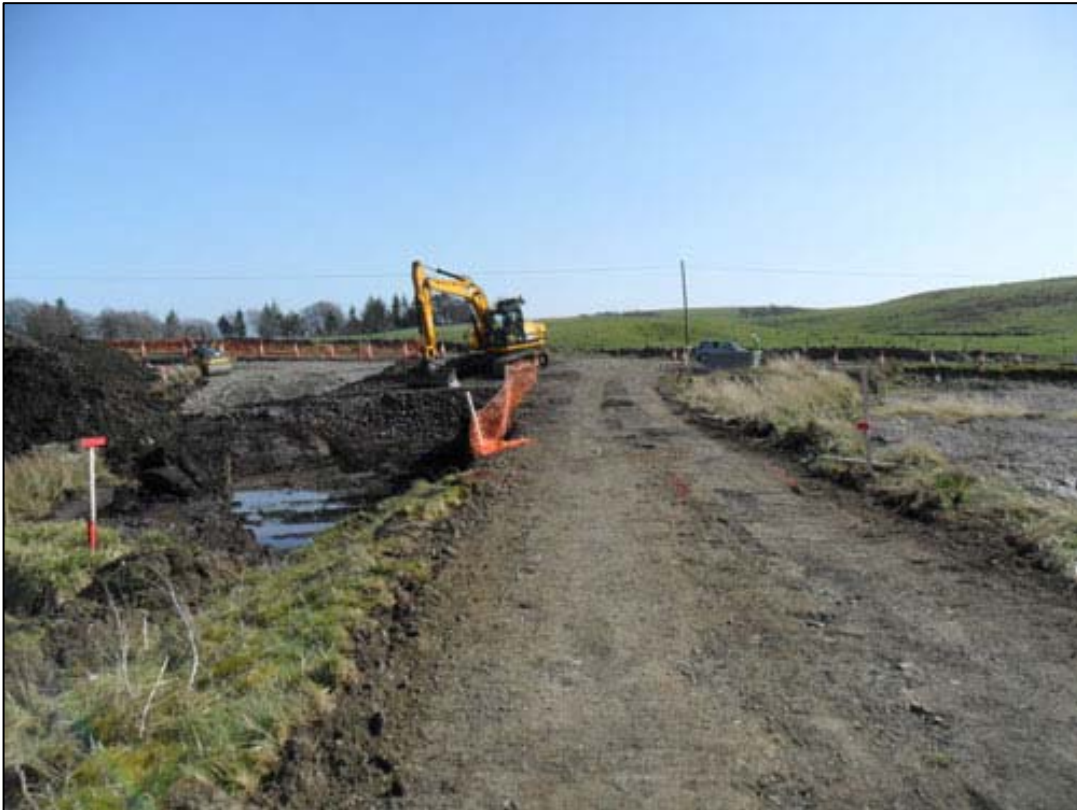
Figure 3a: Area 1 main entrance and bell-mouth

22. The area immediately adjacent to the main road was widened to the north and north-east to create a bell-mouth (see Figure 3a); deep excavations were required in this area. The pre-existing tarmac covered a portion of this area, presumably relating to access for the landfill at some point. The area was cleared to reveal upper layers of both tarmac and turf (003).

23. Excavations within the bell-mouth area revealed a variety of deposits; within the tarmac area closest to Kingston Road, 0.25m thickness of tarmac and hardcore material (002) was removed to reveal 0.4m thickness of orange gravel (007) below (this looked to be a levelling deposit). A layer of peat (008) was found below (007); this was 0.2m to 0.3m thickness, and looked to be undisturbed with no modern inclusions. A thin interface (011) (0.02m to 0.06m thickness) was located below this, with natural subsoil (009), light-brown/orange silty clay, found below the interface. No evidence of interference was revealed within the subsoil.

24. The northern end of the bell-mouth was excavated through the uppermost layer of 0.1m thickness of turf (003) to reveal a layer of peat (010) 0.2m to 0.5m thick, which had been subject to much interference. This contained an abundance of modern debris including red bricks, concrete, plastic and linoleum tile fragments amongst other things. Removal of this deposit revealed the interface (011) below which maintains roughly the same thickness throughout. Generally subsoil (009) was found below this, although subsoil was not reached throughout the whole area of the extension. In the areas where it was reached the subsoil within the bell-mouth extension was excavated to a maximum depth of 0.4m thickness.

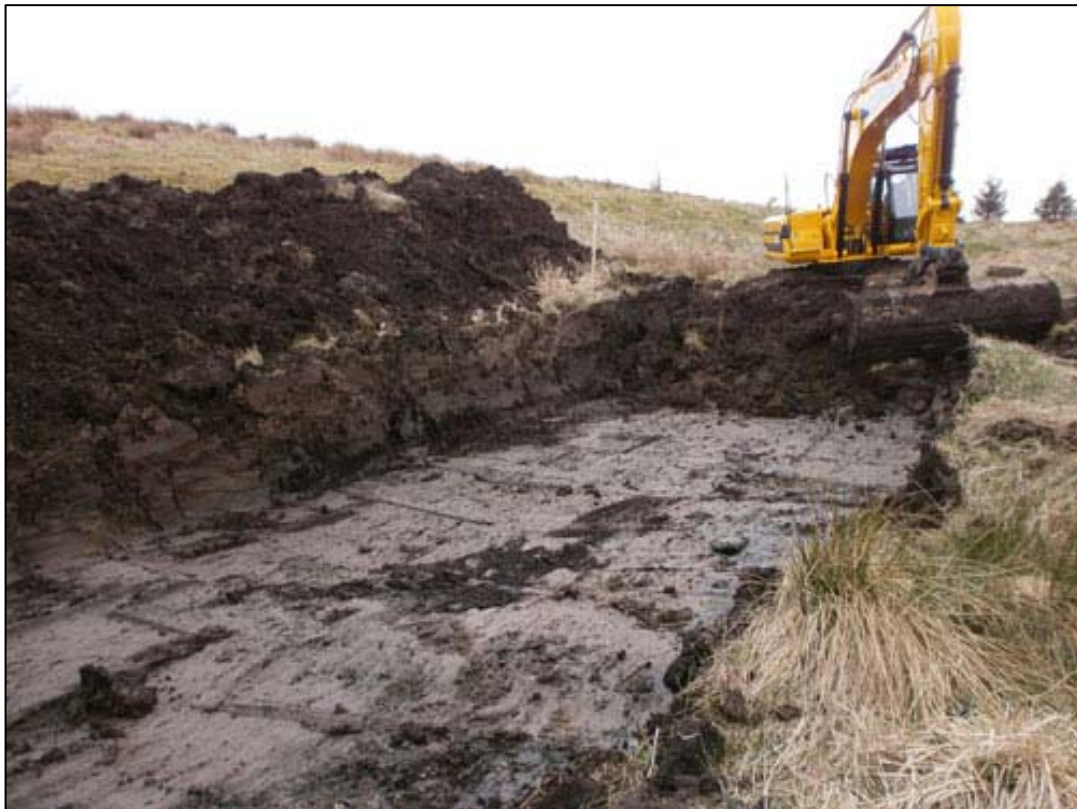
Figure 3b: Area 3 excavation of main access road

32. The stratigraphy within the excavated access road within Area 3 (Figure 3b) showed the upper strata to be undisturbed peat (008) which varied in thickness from 0.1m to 0.45m. Below this, the strata varied according to location, although generally below the peat the underlying stratigraphy came down onto natural clay subsoil. The depth of excavation within Area 3 varies from 0.5m to 1.7m.

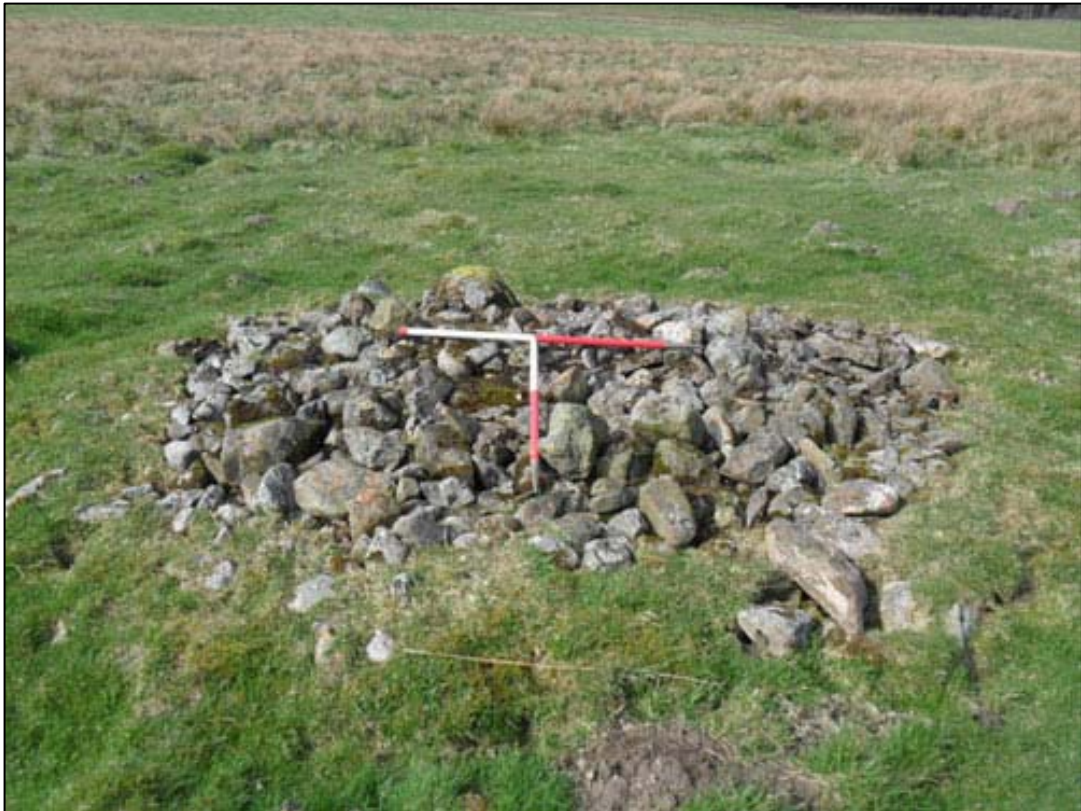
Figure 4a: Clearance cairn [016] Area 4

38. A clearance cairn [016] (0.82m above the turf with a diameter of 4.37m) was located north-west of the access road within Area 4 (Figure 4a). A slot excavated through the structure revealed plastic at 0.67m depth below the top of the cairn. The fill of this structure was small to medium field stones mixed with topsoil (017): dark brown/black silty clay.

54. The clearance cairn [016] which was investigated within Area 4 also looks to be the result of recent activity in the area, and seems likely to have post-date landfill activity. The clearance cairn seems likely to be the result of clearing of stones within the area, usually associated with farming activities. The plastic found within the fill of this feature indicates it is the result of very recent activities.

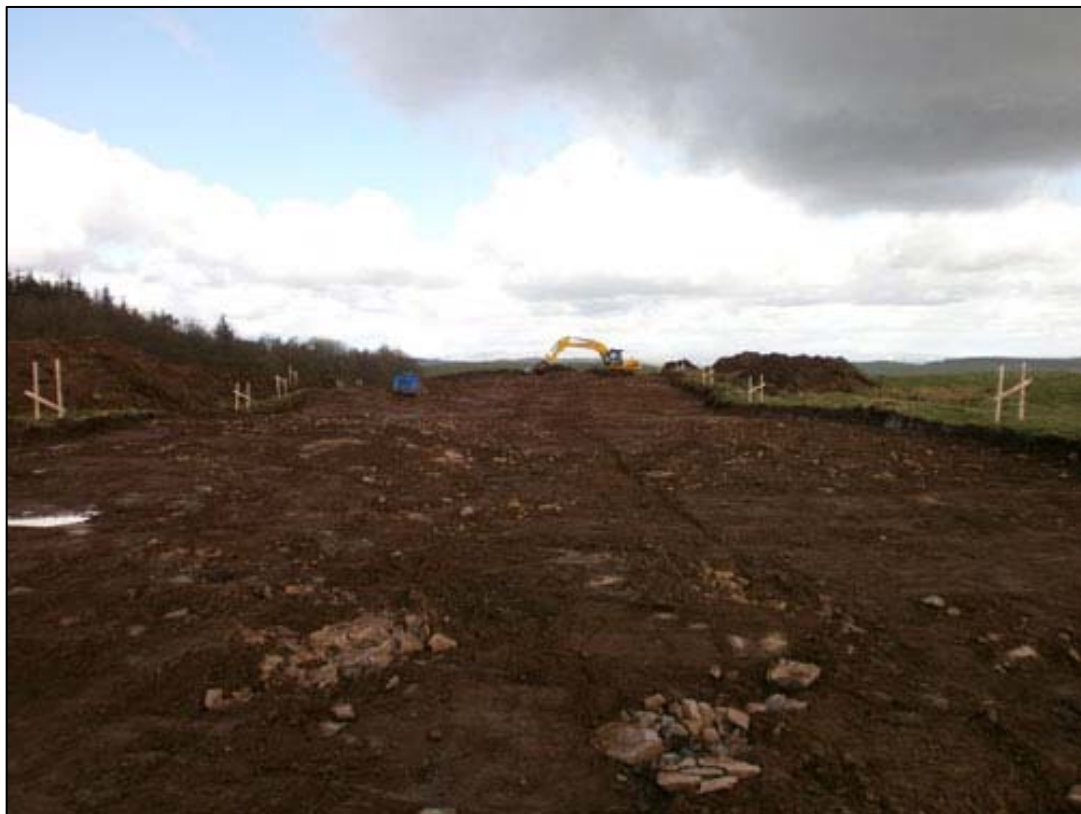
Figure 4b: Excavation of Area 4 main access road

39. The initial archaeological monitoring of works in this area included the main access road (which included a turning point at the northern end) as well as the area for Turbine 4 and the adjacent Crane Pad. Only the main access road and turning point were monitored during the course of these works (Chainage 0 to Chainage 300). The access road varies in width from 9m to 14m wide (see Figure 4b). Subsoil was reached throughout the excavation of the access road within Area 4. The depths of excavation within this area generally did not go below 0.5m. Bedrock was generally found at depths of not greater than 0.5m (measured from the top of the turf), and in many places was found much higher (0.1m depth below the top of the turf).

40. Excavation at Chainage 0 exposed 0.09m thickness of turf (003) above 0.17m thickness of topsoil (012); this was above 0.1m to 0.2m thickness of subsoil (009), which sat immediately above bedrock (013). These deposits were consistent across the entire area although patches of subsoil (018) were also revealed within some areas in place of (009); this was mid-brown/grey clay with occasional sandstone inclusions and small to medium rounded and angular stones, found at 0.25m to 0.3m below the top of the turf.

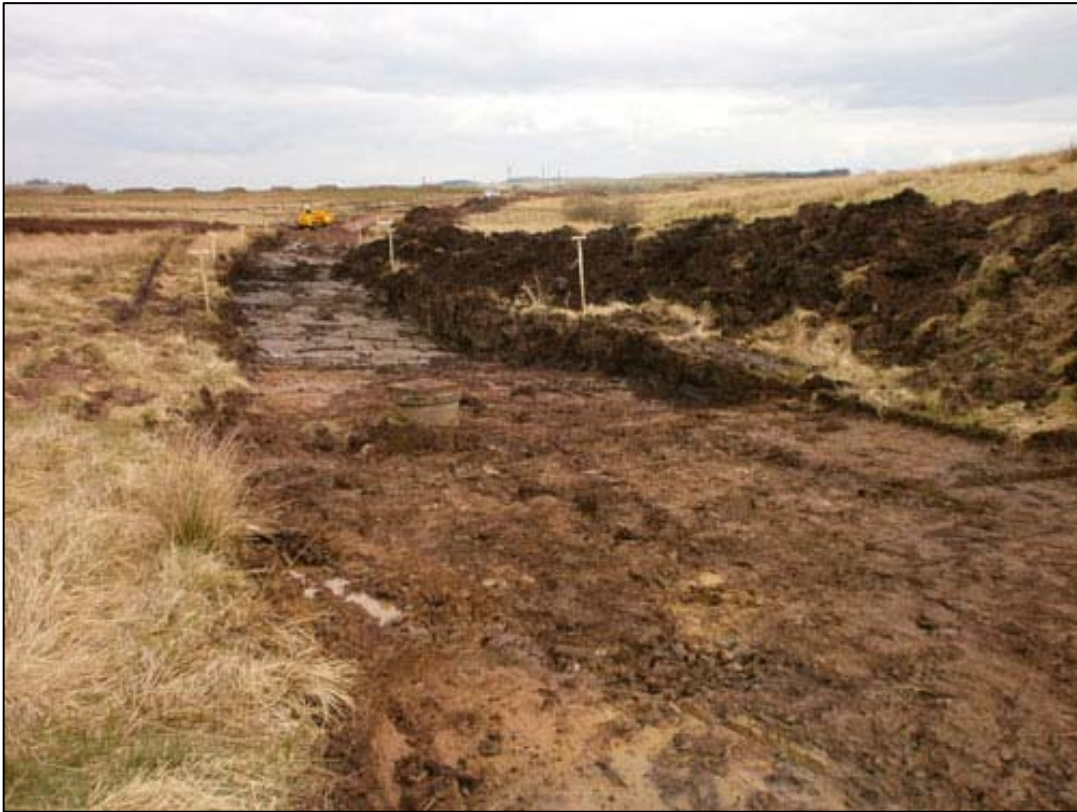
Figure 5a: Area of landfill cut by main access track within Area 3

37. From Chainage 720 to Chainage 740 it became apparent that the layout of the access road encroached on the area of the landfill (Figure 5a). The base of the trench at Chainage 700 revealed subsoil (029); at Chainage 720 this changes to the fill of a dump of modern rubbish (full bin bags, plastic bags, plastic containers, cast iron pipes etc). It was unclear at what point the base of the trench reverts back to undisturbed natural subsoil. At Chainage 750 (the beginning of Area 5) the excavation of the main access road was temporarily suspended due to the presence of otters or badgers in the vicinity. No significant archaeological features were found during monitoring of works in Area 3.

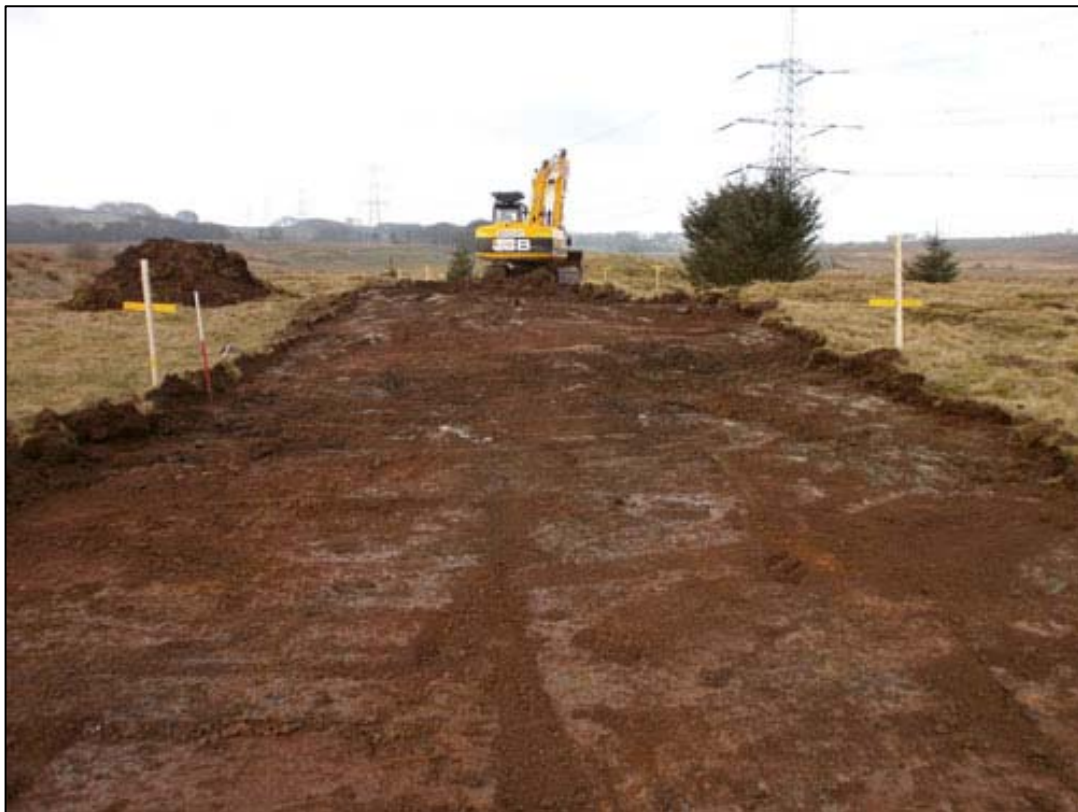
Figure 5b: Excavation of Area 5 main access track

44. Initially this encompassed the area from Chainage 750 to Chainage 1400, the areas for Turbines 1 and 2, the adjacent Crane Pad for Turbine 1, the Borrow Pit and the access road leading to the borrow pit. Excavation of the area from Chainage 740 to Chainage 920 was temporarily suspended, due to the possible presence of badgers or otters in the vicinity. This includes the access path to the borrow pit, and the borrow pit itself. The area of Turbine 2 was also within this area, and was also temporarily suspended. Due to these circumstances, archaeological monitoring works within Area 5 were restricted to the area from Chainage 920 to 1400. However, once Chainage 1160 was reached, it was realised that the works already monitored had failed to reveal any significant archaeological features and indeed the majority of the site had been exposed to be archaeologically sterile subsoil or shallow bedrock. As such, archaeological monitoring did not continue beyond this point. The access road was around 5m wide (see Figure 5b).

45. Monitoring of the access road within this area revealed shallow bedrock. The topsoil in the area was (031), light-mid brown clayey silt with frequent rootlets, frequent angular and rounded pieces of bedrock and stones. The thickness of the topsoil varied from 0.05m to 0.15m thickness. A layer of turf or moss (003) 0.02m to 0.1m thickness sat above this.
