**Kirkoswald Mains Rehabilitation, South Ayrshire:  
Archaeological Watching Brief**

Data Structure Report

issued 29<sup>th</sup> August 2012

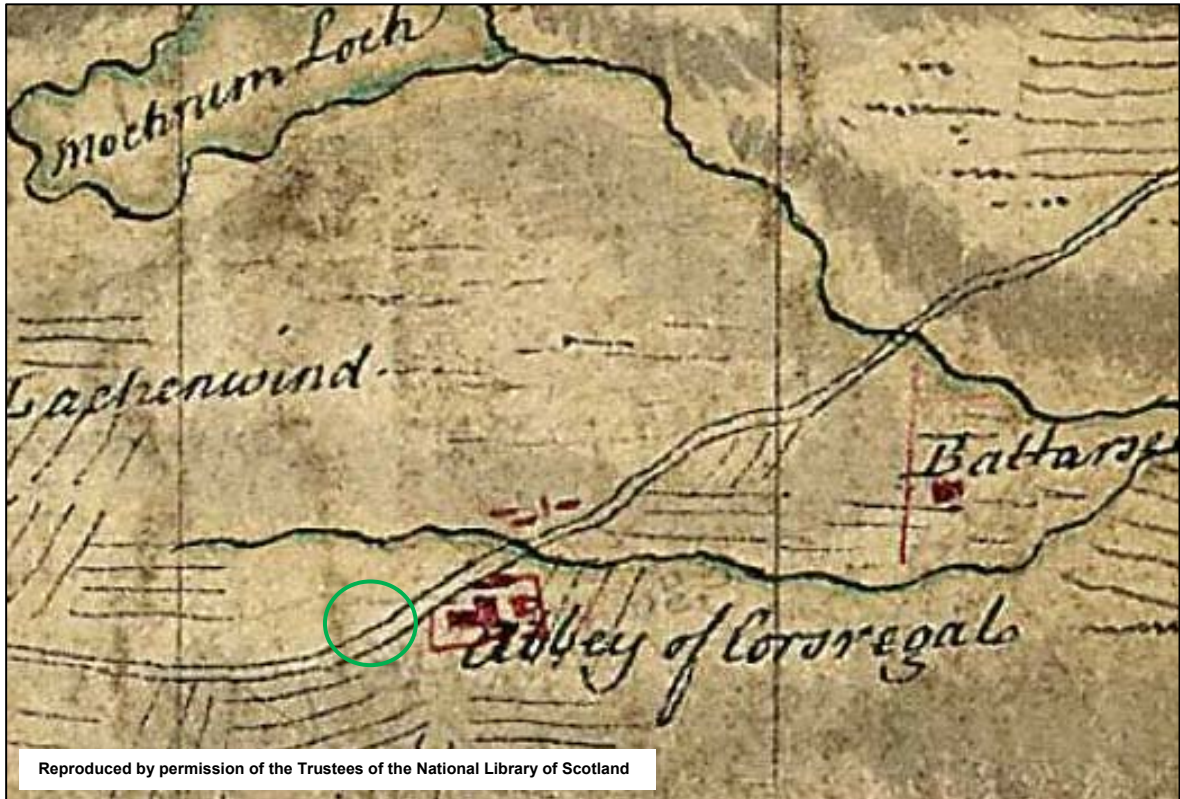
Figure 1a: Roy's Military Survey of Scotland 1752-55. Green circle represents area of monitoring.

4. The A77 itself, running to the north of the main cloistral buildings of Crossraguel Abbey, is mapped in the mid 18<sup>th</sup> century on this alignment (see Figure 1a) and subsequently, under the 1774 Ayr Road Act, became a turnpike road. The 18<sup>th</sup> century turnpike road remained an important route as demonstrated by its inclusion in the Ordnance Survey (see Figure 1b) and its continued use to this day. There is the potential for historic road surfaces to survive at this location, although earlier monitoring work on the resurfacing of the A77 (WoSAS Event 995) in 1995 failed to find any significant archaeological material.

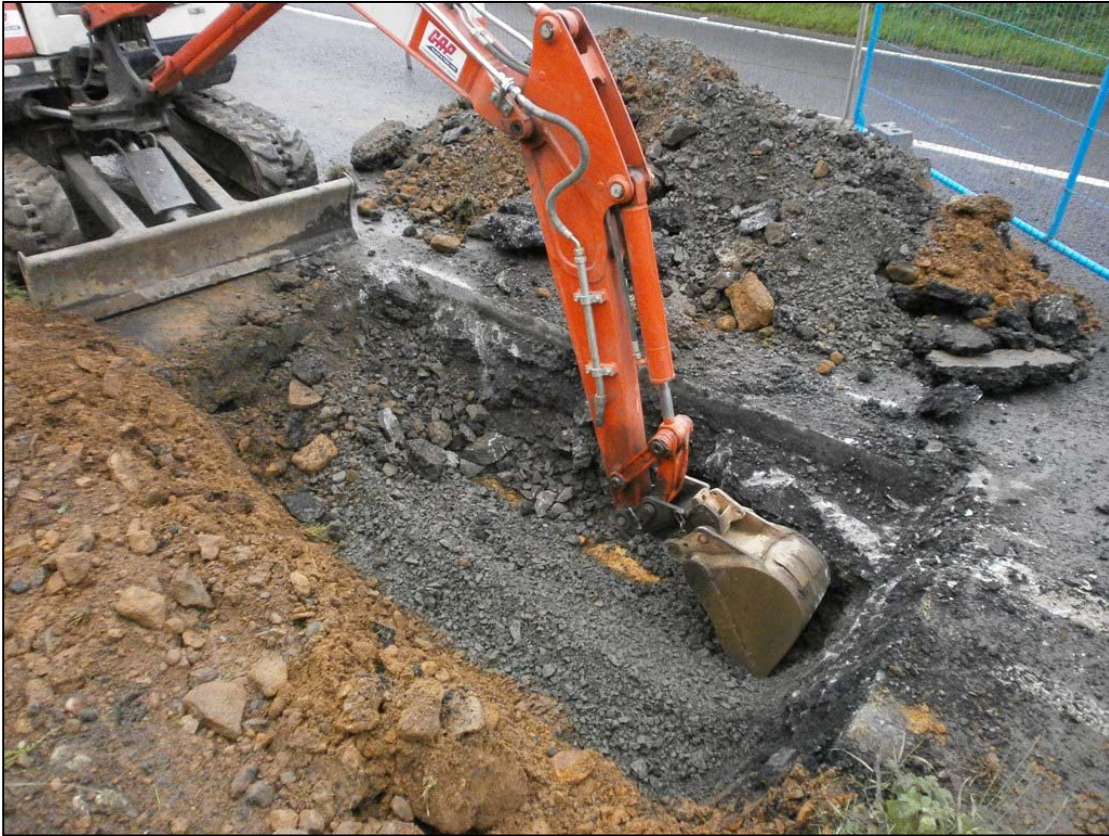
Figure 3a: Opening trench 047.

11. Trenches 046 and 047 were excavated using a Kubota KX 080.3 with a 300mm wide flat edged bucket and had dimensions of 2m by 4m and 2m by 3m respectively (see Figure 3a). Trench 046 was excavated to a depth of approximately 2m to the depth of the mains pipe while 047 was approximately 1.5m in depth. A third trench (south field trench) was excavated for the installation of a new bend located in a waterlogged field to the south of the A77 which runs parallel with the road (see Figure 4a). This trench was excavated using a Kubota KX 61-3, with dimensions of 2m by 1.5m and to a depth of 1m.

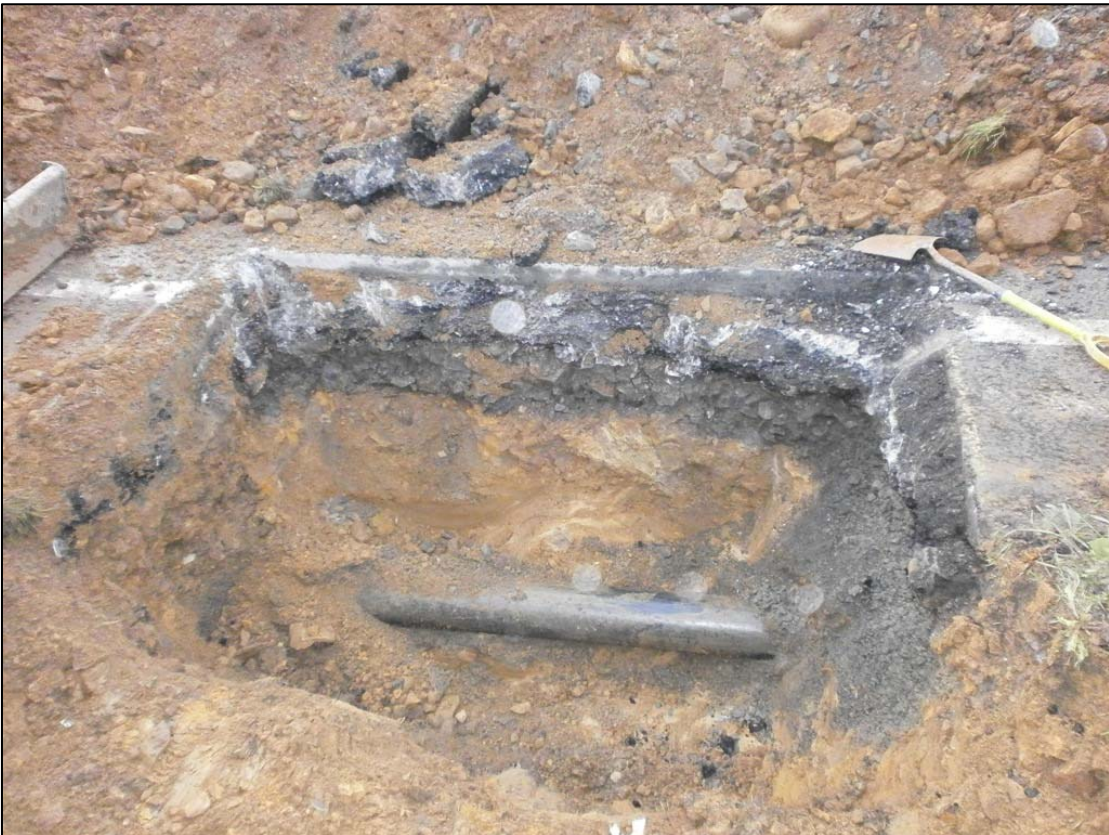
Figure 3b: Trench 047 demonstrating contexts and road surfaces.

12. Both 046 and 047 were located on the road and southern edge of the A77 with 047 extending into the grass verge. Sited approximately 10m apart and excavated down through the road surfaces, both had the same underlying contexts. The surface course (001) was formed of tarmac with a depth of 100mm which overlay (002), a black and compacted layer with sub-rounded and sub-angular stones and tarmac mix measuring approximately 200mm deep. Below (002), (003) was a grey loosely compacted stone fill of Type 1 material (crushed stone used as a construction aggregate) with a thickness of approximately 200mm. The natural subsoil (004) was formed of a yellow/orange clay and sand with frequent angular medium sized stones (see Figure 3b).

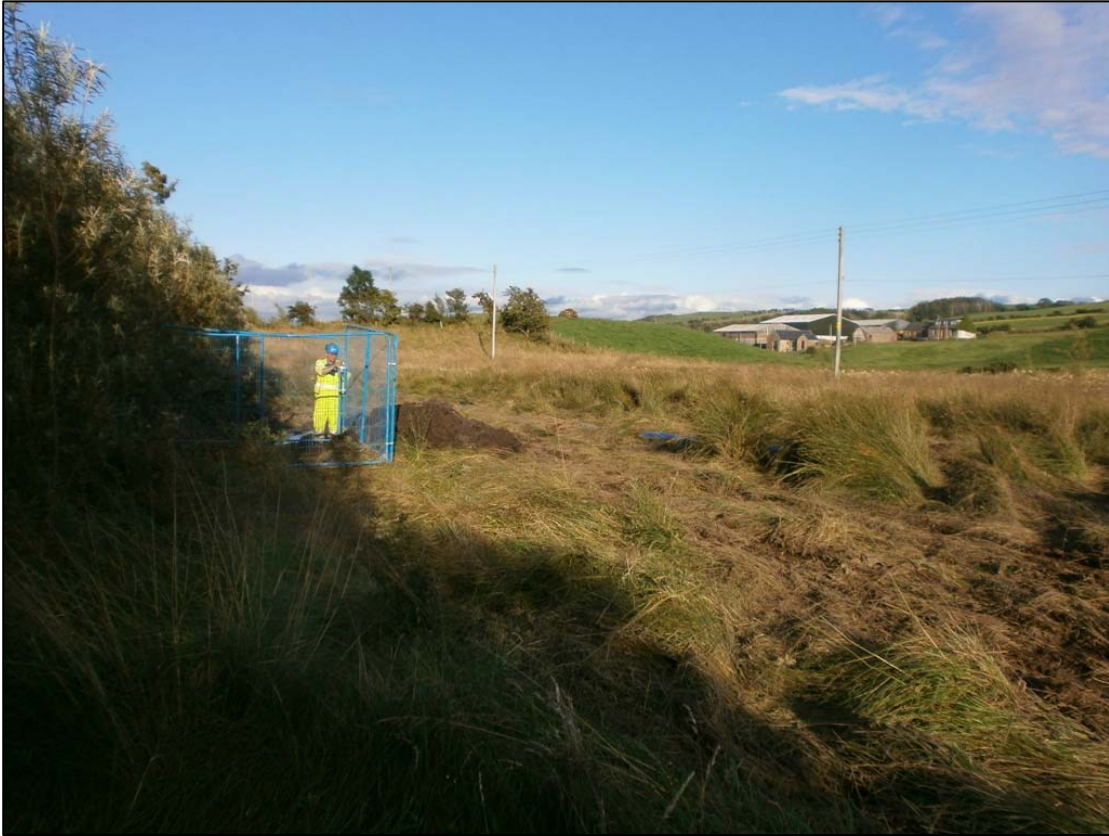
Figure 4a: Location photo of the south field trench and the surrounding topography

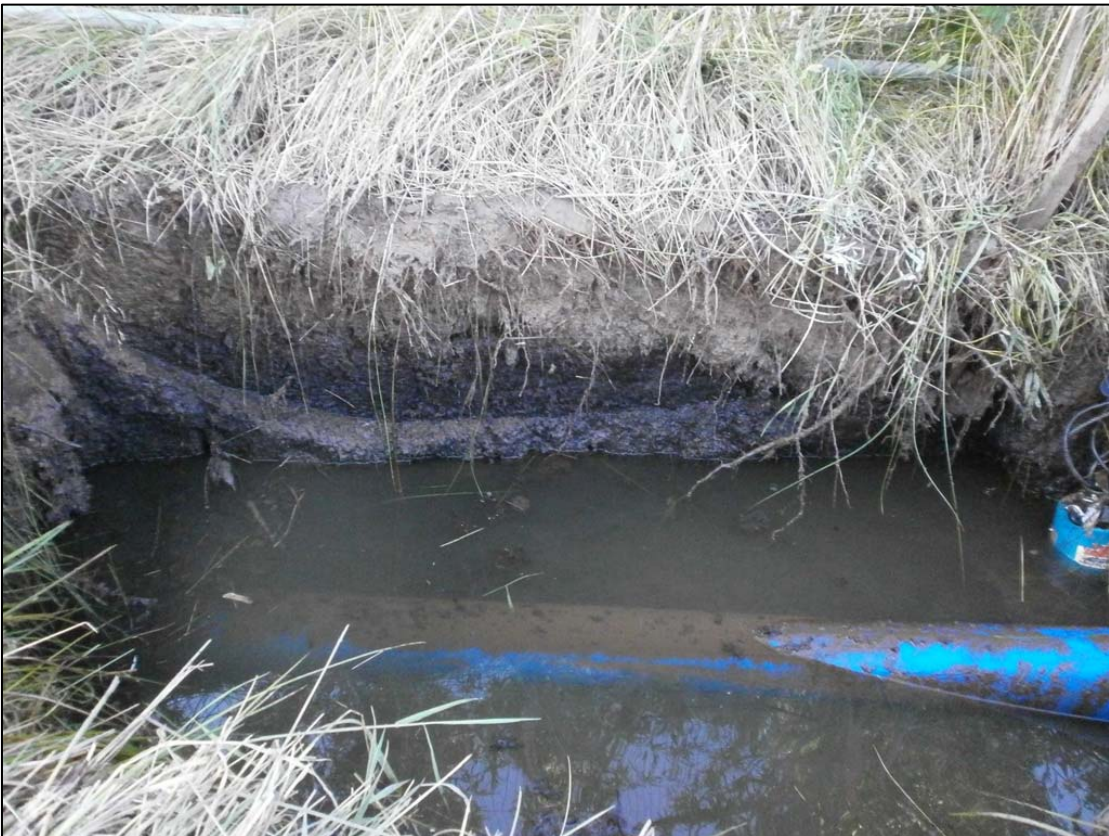
Figure 4b: Showing contexts (005) and (006), also the high water table

13. The south field trench was located at the base of the southern verge of the A77 within the field boundary. The topsoil (005) was formed of moderately compacted and waterlogged light grey clay to a depth a 300mm with frequent roots. This directly overlay subsoil (006) which was formed of a waterlogged humic peat and comprised the lower 700mm of the trench (see Figure 4b). Due to the waterlogged nature of the field the trench quickly became filled with water.
