Skares Water Main Rehabilitation, East Ayrshire: Archaeological Monitoring

Data Structure Report

by Diane Gorman
issued 23rd November 2012

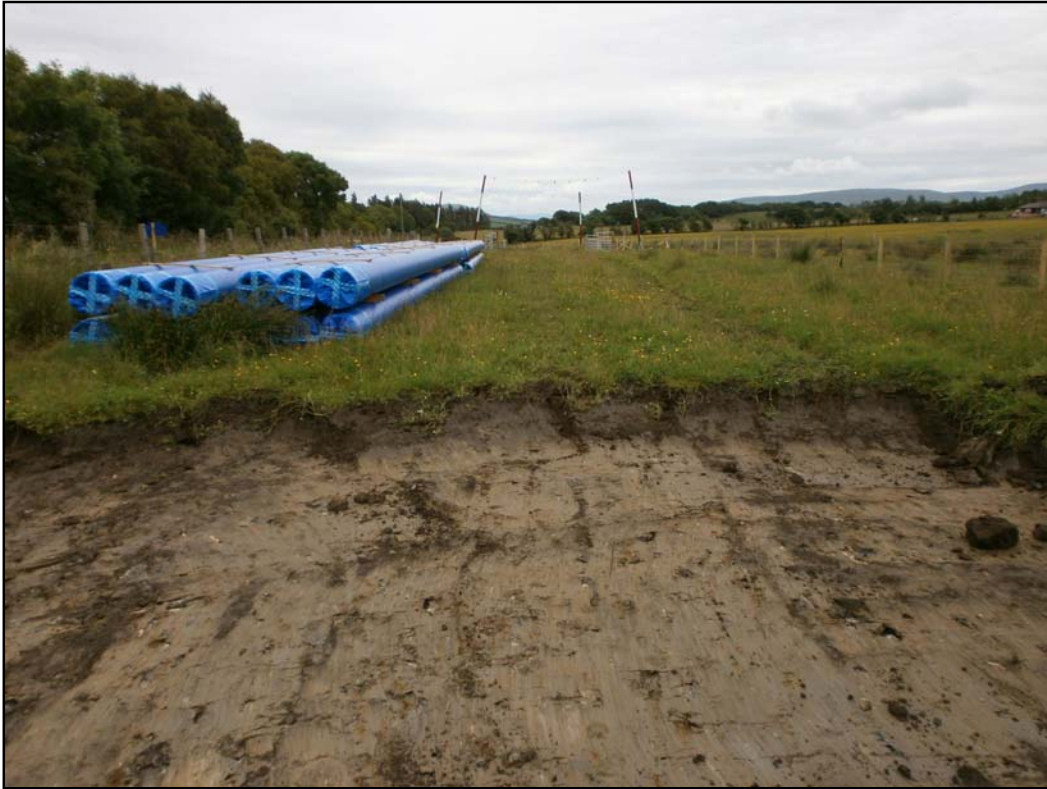
Figure 4a: Ground reduction through turf and topsoil

15. The ground reduction works involved the stripping of topsoil and turf to reveal the subsoil below (Figure 4a). The depth of the ground reduction varied according to the nature of the topsoil, and the location. The width of the stripped area also varied slightly according to location, but generally was 5m-6m wide. This area was stripped to accommodate the construction and installation of the new pipeline, which took place after the main linear area had been stripped. The monitoring works encountered no significant archaeological deposits or features during ground reduction.

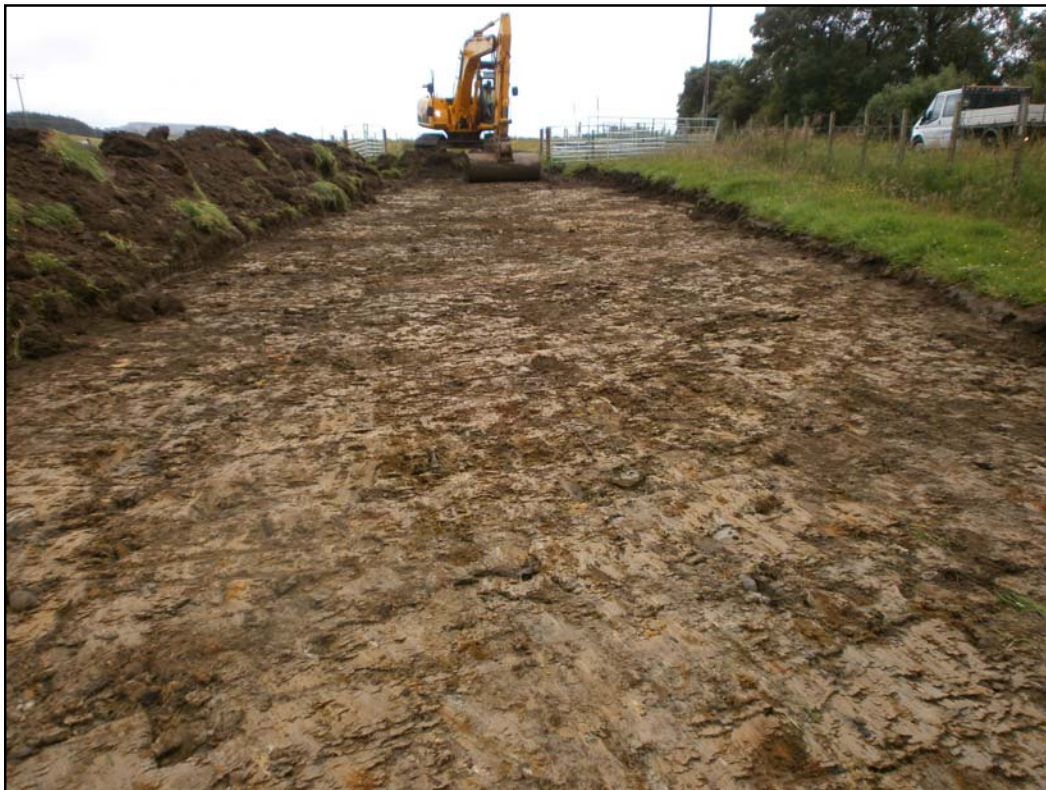
Figure 4b: Shot of deposit (002)

18. Subsoil (002) was encountered within Areas 4 and 5 (Figure 4b) and was firm, light orange to light brown clayey silt (mottled grey). Within this deposit were abundant small stones and frequent coal inclusions. Also found within this subsoil were chunks of cracked bedrock (003); in nature the exposed bedrock was sedimentary and likely to be interstratified with beds of coal and shale (this is further indicated by the abundant quantity of coal deposits found locally in the area). Bedrock was exposed only within a small area of Area 4.

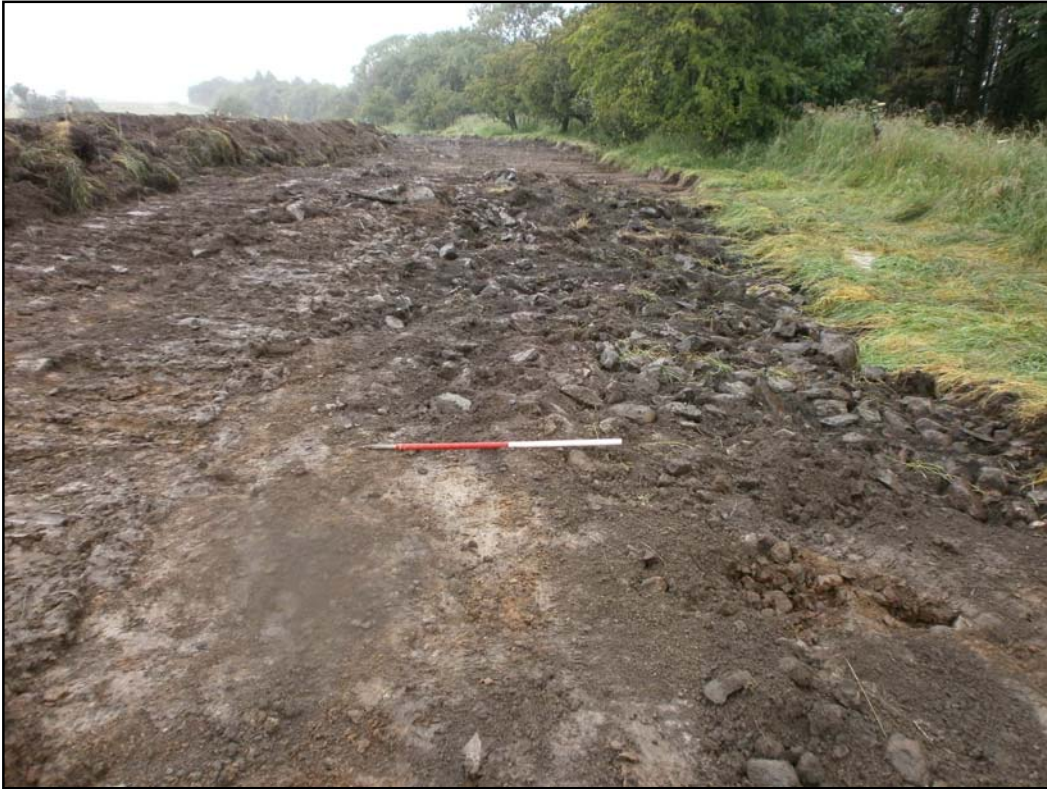
Figure 5a: Deposit (004)

19. Also found within Area 4, located in the same place as (003), was deposit (004) (Figure 5a). The visible extent of this deposit covered a small area measuring 12m by 5.5m; the southern limits were obscured by the limits of excavation, so it is possible it extended further. Deposit (004) consisted of a variety of small to medium sub-angular and sub-rounded stones, in addition to rounded natural field stones. It was mixed in (003), but consisted of a different type of stone. Also within (004) were red ceramic field drain fragments in addition to various small to medium and mixed stones.

31. The presence of features [005] and [010] along the pipeline are indicative of modern human interference in the landscape, carried out to better drain and prepare the land for farming activities. It is likely that deposit (004) found within Area 4 is the result of clearing stones from the surrounding area in preparation for use of the land for farming or arable use.

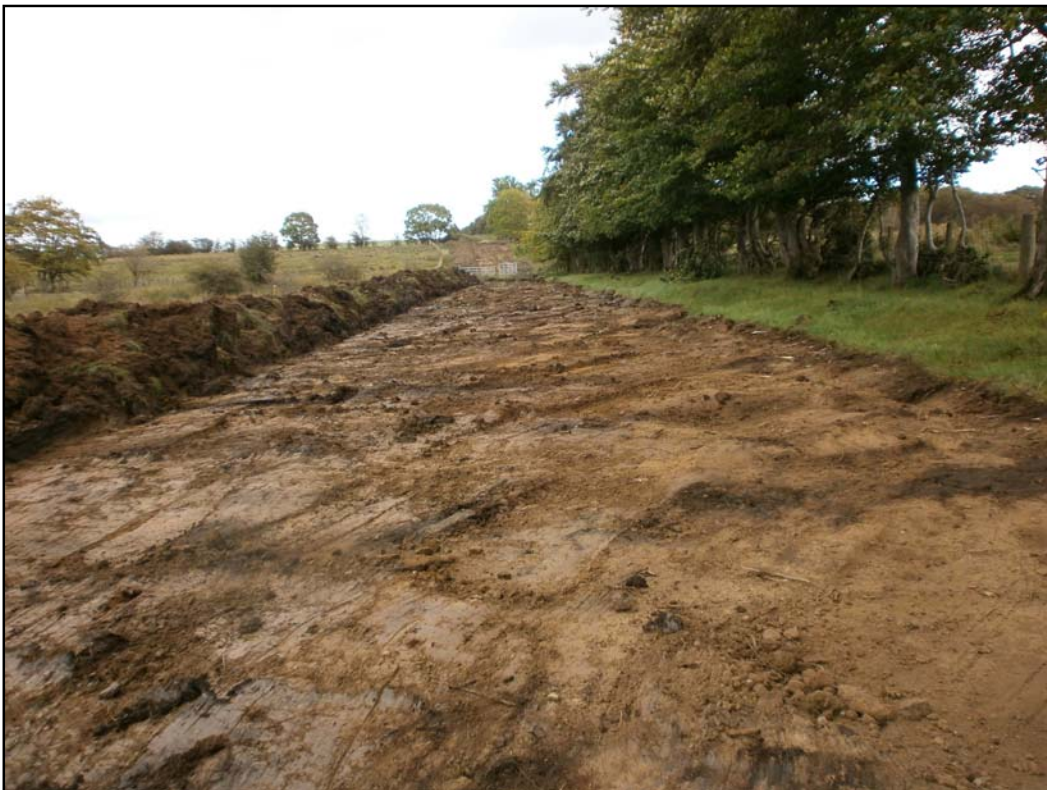
Figure 5b: Subsoil (008)

22. The majority of the area stripped for the pipeline was dominated by subsoil (008), which was exposed along the pipeline to varying degrees (Figure 5b). This deposit was found within Areas 4 and 5, along with subsoil (002) and within Area 8, along with subsoil (009) (see below). In addition, this subsoil dominated Areas 9, 12, 13, 14 and 20; it was also found within Area 21, but was interspersed with other subsoil. Deposit (008) consisted of friable, orange and grey clay and included frequent naturally occurring coal veins and chunks and rare inclusions of naturally occurring red and blonde sandstone. Also found within this deposit were occasional small to medium sub-angular and sub-rounded stones, as well as rare inclusions of natural boulders and field stones. This deposit was located in the areas of the pipeline which spanned higher ground, rather than the lower waterlogged areas.

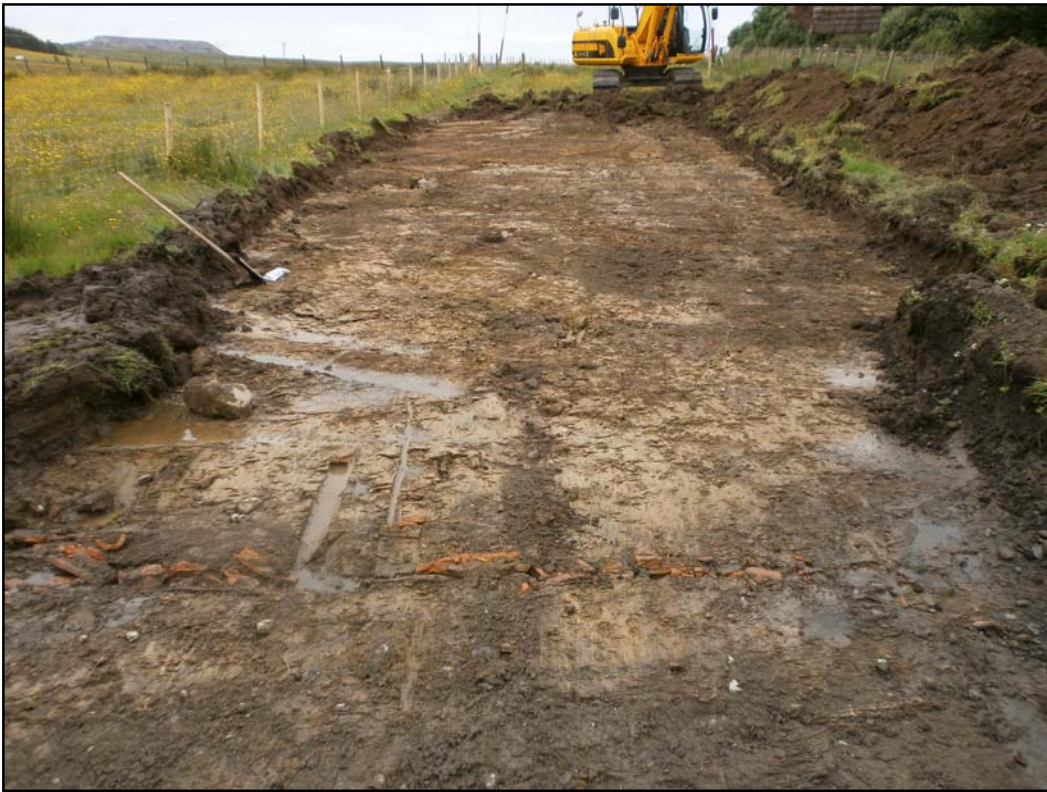
Figure 6a: Field drain [005]

26. Modern ceramic field drains [005] were exposed at various locations along the route of the new pipeline, generally exposed immediately below the topsoil once removed (Figure 6a). The depth at which they were found varied according to location. The density of the field drains also varied, becoming more frequent in waterlogged areas of the site. The field drains were unglazed red terracotta, and consisted of two parts with the upper U-shaped part sitting on top of a flat tile at the base. The width of the cuts for these varied, but on average were 0.2m wide; the orientation of the field drains varied.

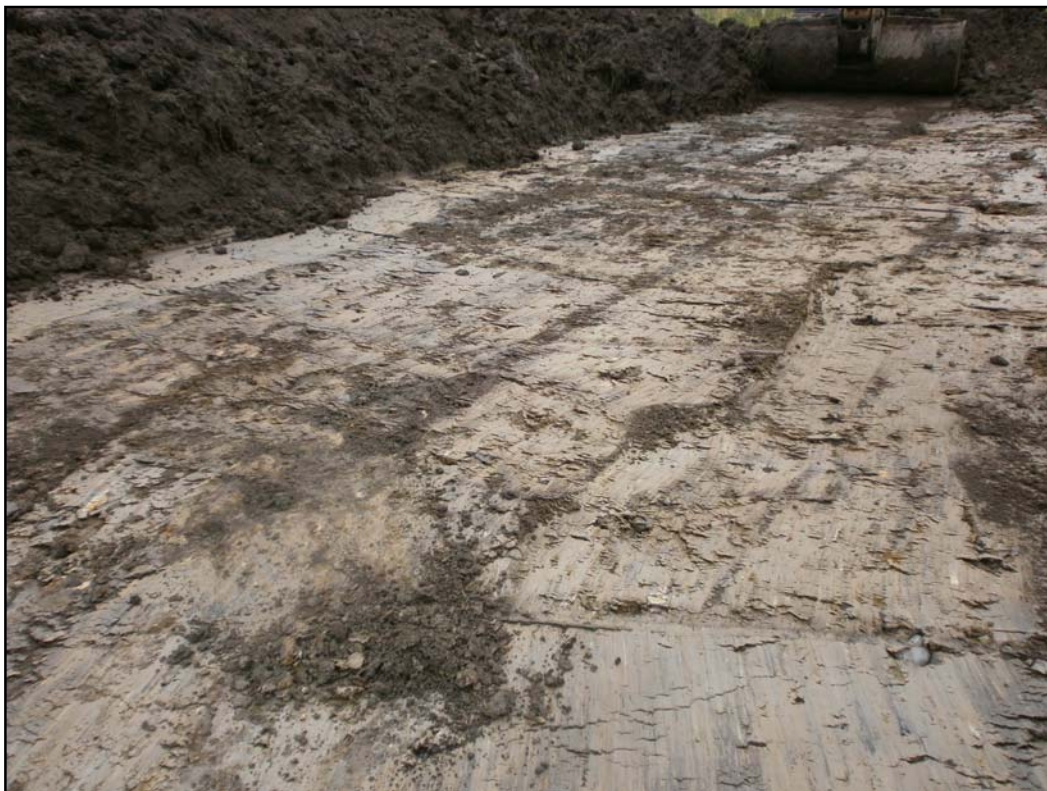
Figure 6b: Plough Furrows [010]

27. Further agricultural activity was noted in sporadic areas throughout the pipeline, mostly limited to the eastern side. These appeared to be modern plough furrows [010] which were orientated north-west to south-east, exposed below the topsoil (Figure 6b). These features were 0.13-0.22m wide, with a maximum depth of 0.05m; in section they were U-shaped, and filled with topsoil (001).
