**Ainville Farm Wind Turbine, Kirknewton,  
West Lothian:  
Archaeological Mitigation**

Data Structure Report

by Diane Gorman

issued 25<sup>th</sup> September 2012

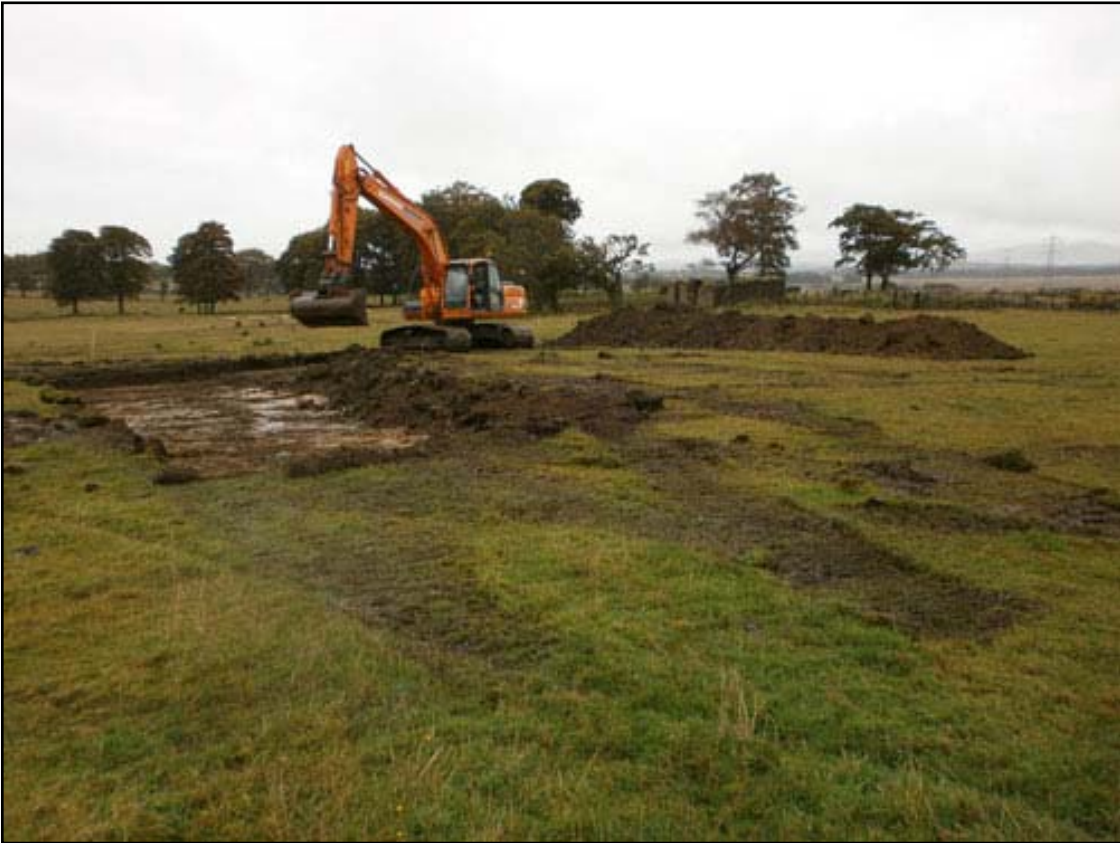
Figure 3a: Location shot, ground reduction (area of Crane Pads/Turbine base)

14. The area of the wind turbine base and the crane pads was located on sloping ground within enclosed green-field (Figure 3a). An area roughly square in plan measuring 133m<sup>2</sup> in total area was reduced to the level of subsoil, to accommodate the construction of the wind turbine base and the two adjacent crane pads. The area was reduced through topsoil (001) which varied from 0.1 to 0.2m in thickness, depending on position within the slope. Topsoil (001) consisted of mid brown slightly sandy clay containing frequent natural coal, frequent rootlets, and rare small stones with a line of turf above.

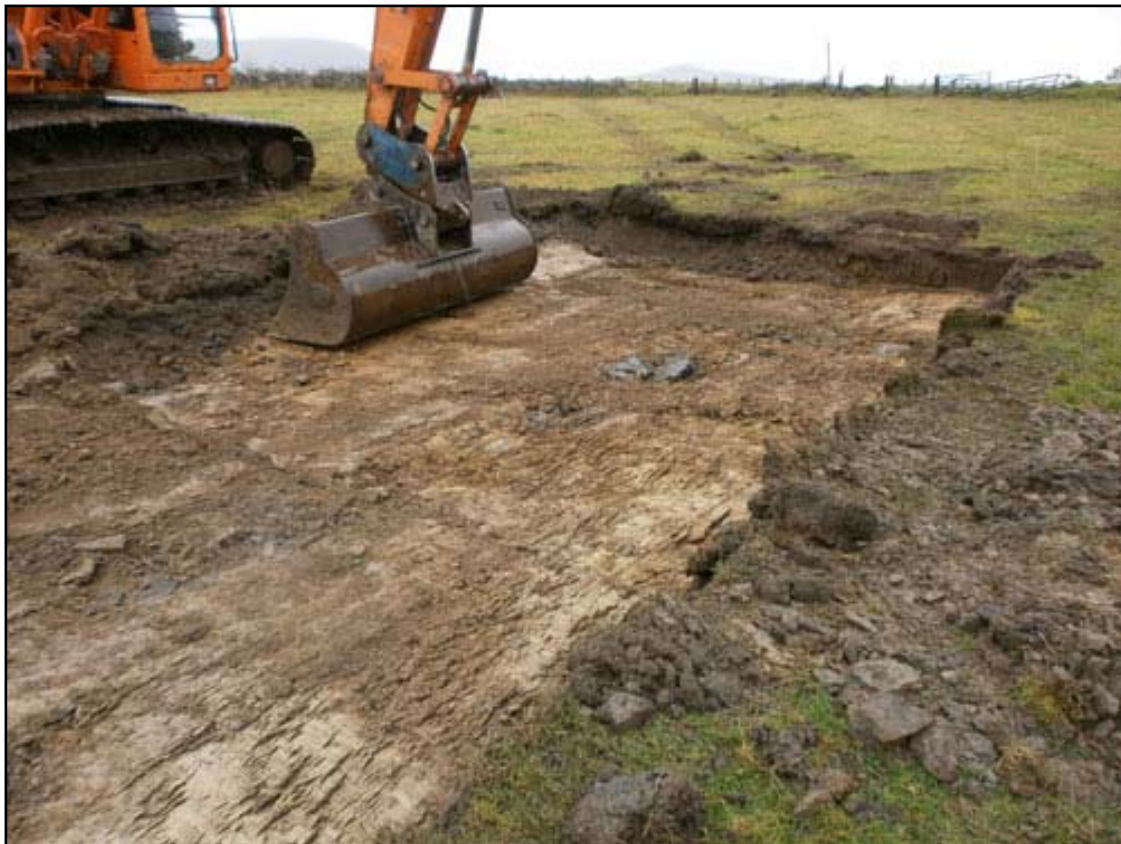
Figure 3b: As above, exposing subsoil (002)

15. Below the topsoil, lay either subsoil (002) or (003). Subsoil (002) was a light orange (mottled light grey and brown) slightly sandy clay, with frequent inclusions of bedrock fragments, in addition to the frequent natural coal pieces. This subsoil was exposed further down the slope, probably indicating less able drainage of the land in this area (Figure 3b).

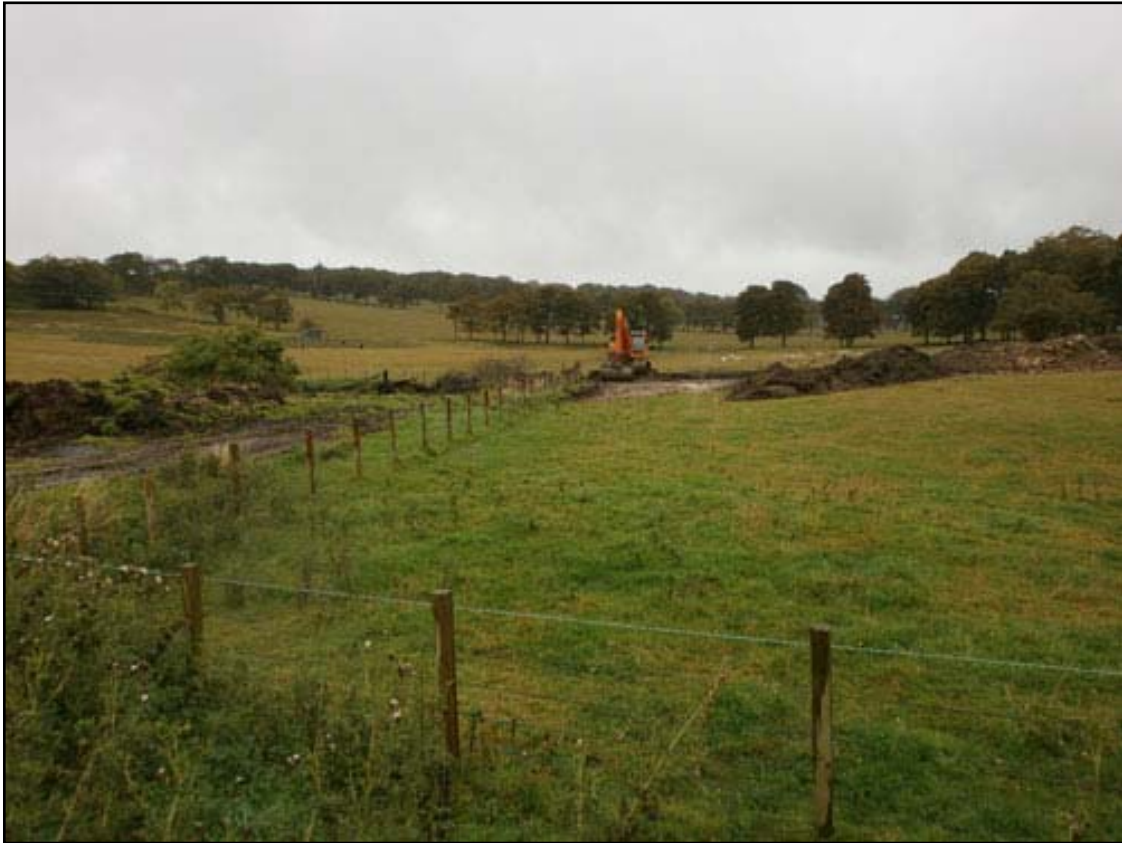
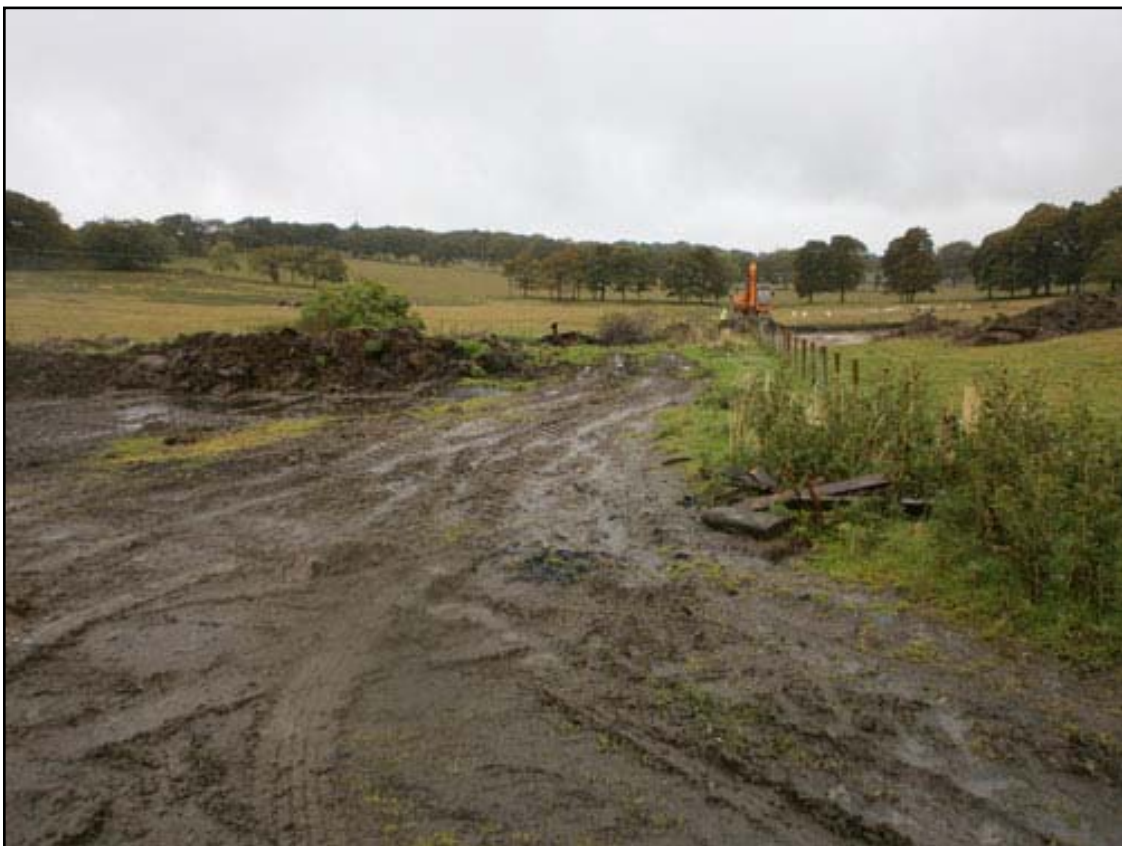
18. A further area was reduced, following on from the west and south-west of this, which revealed only made-up ground (Figure 4a, 4b). This was a linear strip, 3m wide by 8m long, covering a total area of 24m<sup>2</sup>, and was reduced only to the required depth for the construction of the access road. This area was reduced to a maximum of 0.15m thickness, and revealed only deposit (004). This was a mixture of modern rubbish such as bricks and plastic, within a deposit of (001), with a layer of turf above.

Figure 4a: Location shot

Figure 4b: Location shot; made-up ground area
