Souter Johnnie's, Kirkoswald: Archaeological Mitigation

Data Structure Report

issued 31st October 2012

on behalf of The National Trust for Scotland

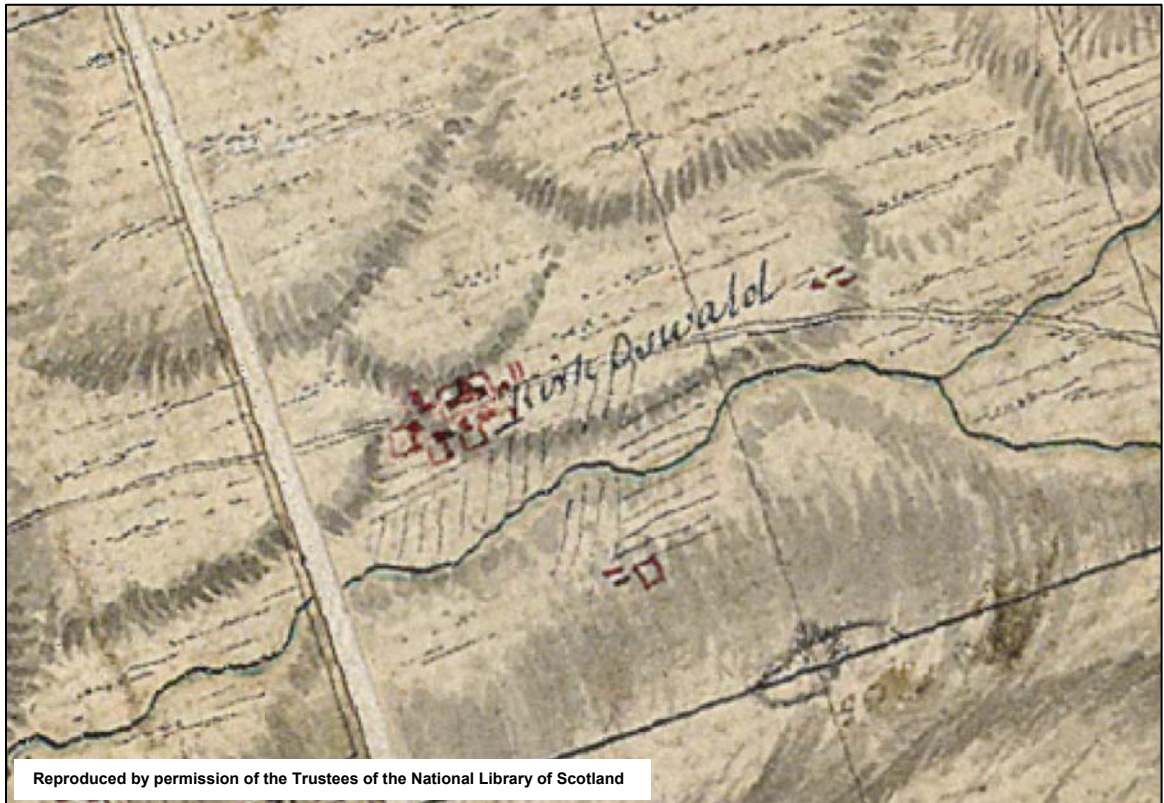
Figure 1a: Roy's Military Survey of Scotland 1752-55

5. The settlement layout is of a single street, which forms part of the main north-south routeway through Ayrshire. This layout is clearly visible on Roy's Military Survey of Scotland in 1752-55 (Figure 1a) and the town can be seen to still be relatively small in size on the 1st Ordnance Survey of 1859 (Figure 1b) where the town appears to have grown more through signs of "ribbon development" rather than from a more formal settlement plan.

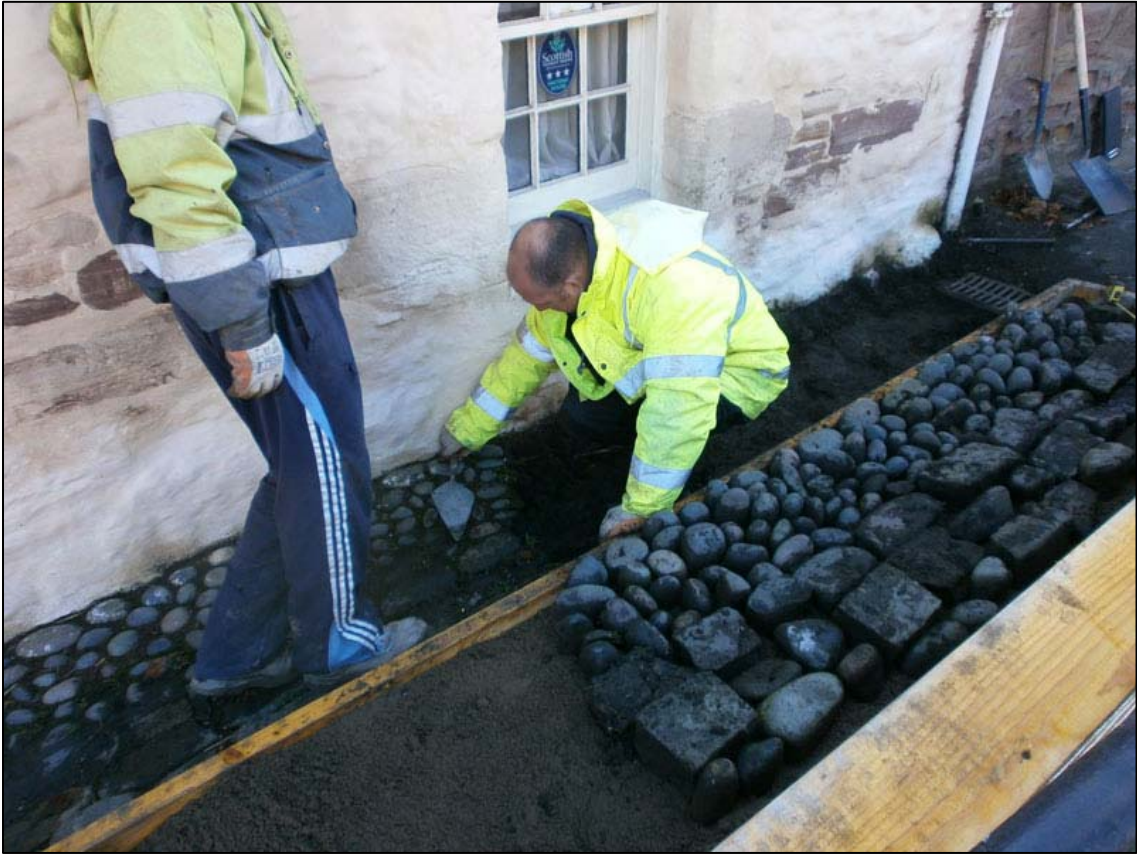
Figure 3a: Lifting the cobbles by hand

16. These cobbles were lifted by hand (Figure 3a) to reveal underlying deposit (002). This comprised of a compact mid orange brown silty clay. Fragments of sandstone rubble, with an individual average size of 100mm by 80mm by 50mm, appeared frequently within the upper layers of the deposit and may have been put in as extra support for any overlying surface. The deposit also contained occasional charcoal flecks and fragments of pottery (Find No.2), red tile field drain and salt-glazed drain pipe (Find No. 3). Deposit (002) ran outwith the excavated area and its full depth was not reached.

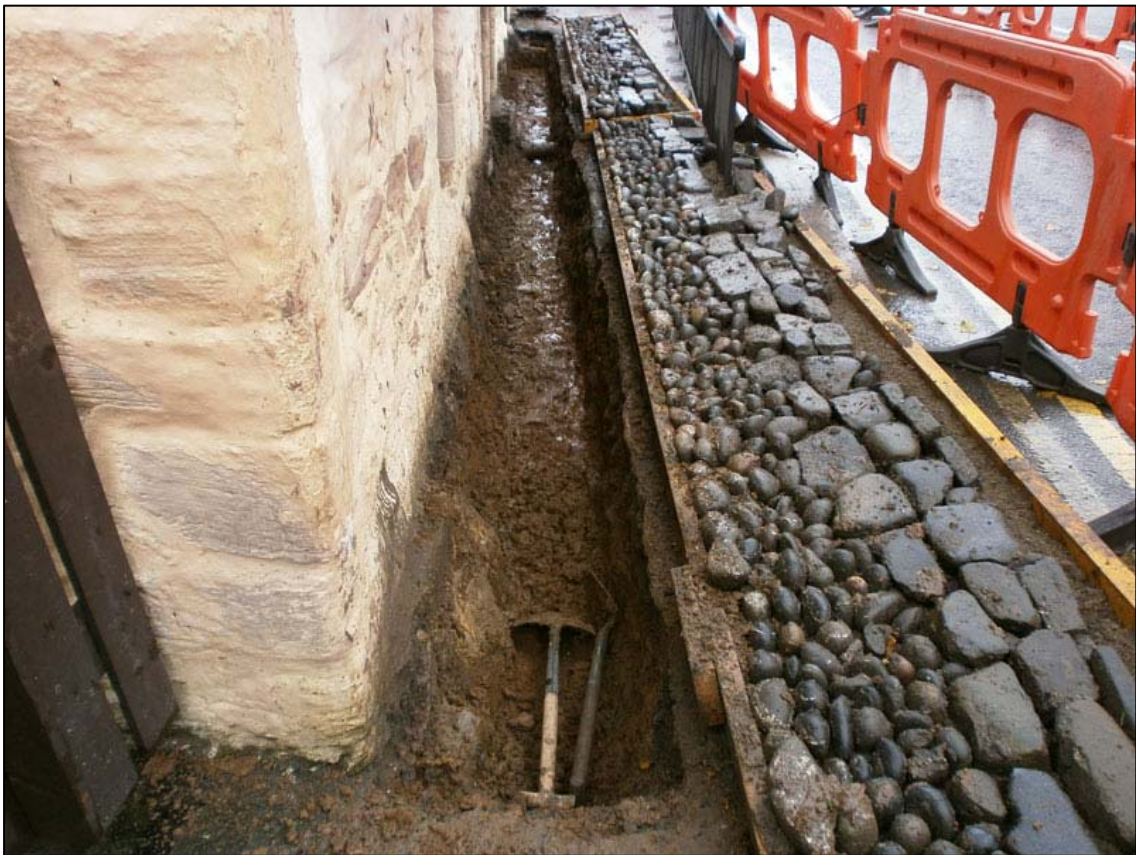
Figure 3b: General shot of trench after excavation works completed from the northeast

13. A trench was excavated for the placement of a new drainage pipe along the front of Souter Johnnie's cottage (Figure 2 and Figure 3b). The trench started at an existing drainage gully (003) at the southwestern end, and ran the full length of the cottage stopping at the northeastern corner. The trench measured 0.6m wide and 11.3m in length.

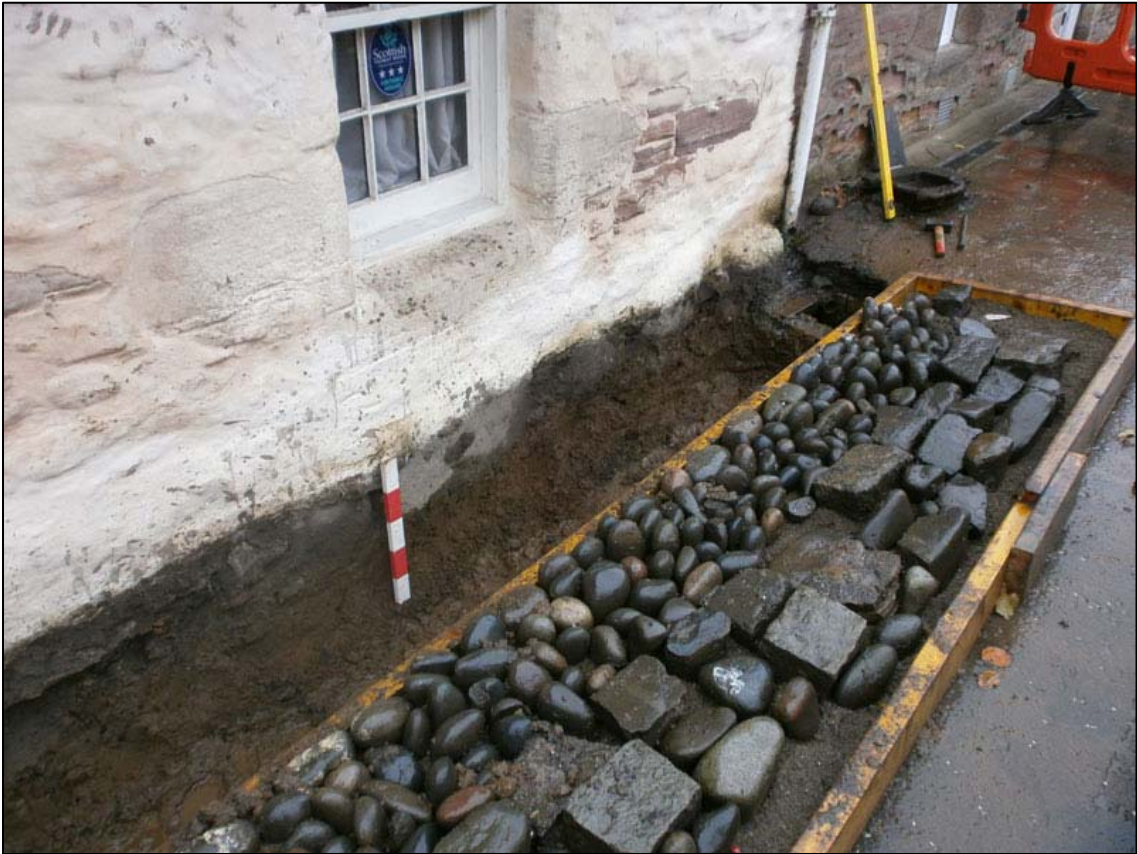
Figure 4a: Foundations (005) from the north

17. The removal of deposit (002) revealed the foundations (005) for the front northwestern wall of Souter Johnnie's cottage. These comprised of a single course (below ground level) of large rounded roughly rectangular sandstone boulders (Figure 4a). These ranged in size from 260mm wide by 200mm deep to 750mm wide by 400mm deep. The depth of the foundations below ground level reached a maximum of 240mm along the southwestern half and 340mm along the northeastern half. The boulders sat in a matrix of dark brown clayey silt and any gaps between the boulders appeared to have been infilled by smaller sandstone rubble fragments.

18. The foundations sat mainly flush with the wall of the cottage. At the northeastern end, near to the outer corner of the cottage, a large sandstone boulder sat into the underlying

deposit appeared to directly underlay the foundations (005) and may have been put in for extra support. The deposit which underlies foundations (005) appears very similar to deposit (002), but the presence of artefacts within (002) which date to at least the 19th century (see section on *Artefacts* below) suggests that this is not the case. Deposit (002) appears likely to have been disturbed at some point after the construction of the cottage in the late 18th century, but unfortunately a cut differentiating this from what lies below (005) is not visible.

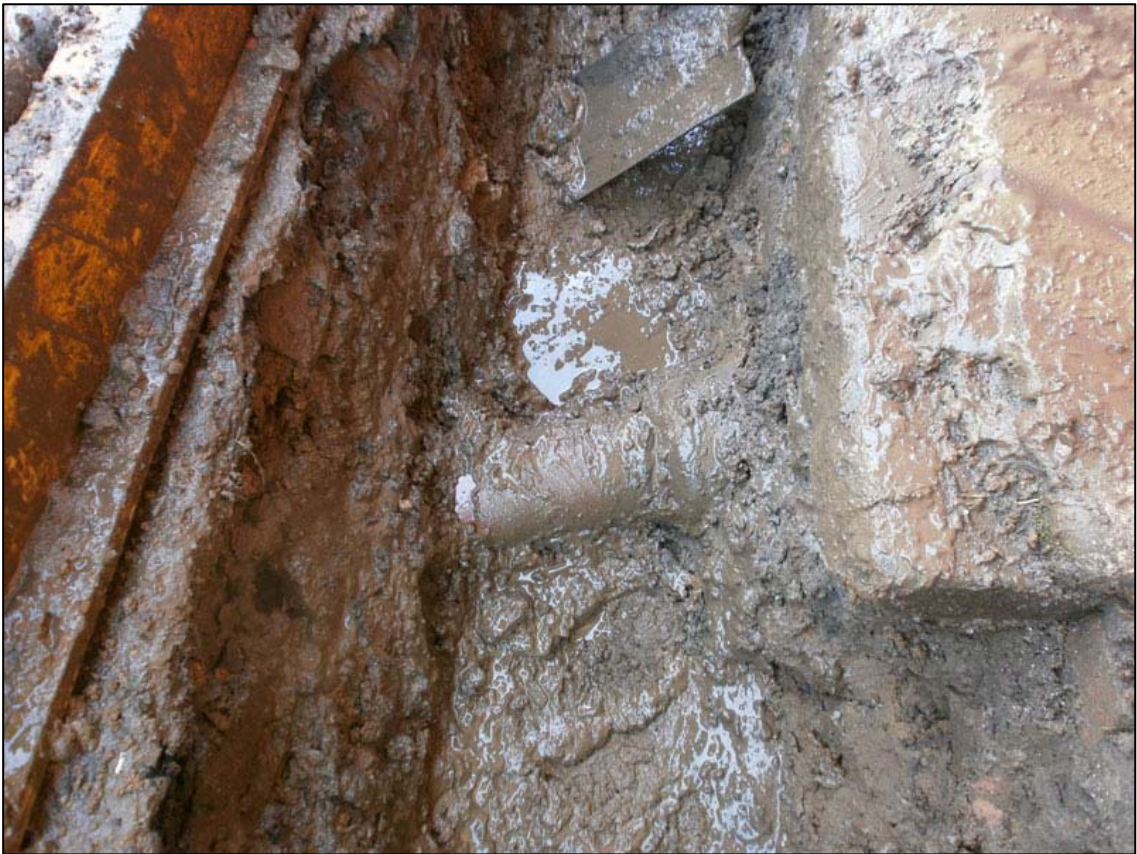
Figure 4b: Pipe (004) from the southwest

20. The only other archaeological feature uncovered by the works was the presence of a service pipe (004) which ran out from under the building's southwest doorway, across the trench and continued outwith the northeastern edge (Figure 4b). The brown glazed ceramic pipe measured 0.13m in diameter and sat in a cut measuring 0.45m wide. The cut had vertical sides and was filled by moderately compacted dark brown sandy silt with frequent small stone inclusions. Two small fragments of glazed white earthenware pottery (Find No.4) were present within the fill. The pipe sat at a depth of 420mm from ground level and appeared to be a later insertion due to the presence of the visible cut through deposit (002).

26. The pipe (004) running out from under the southwestern doorway does sit within a clear visible cut and as such appears to be a later insertion through (002) although how much later is difficult to determine.

27. The lack of a visible cut through the cobbled surface (001) for this pipe suggests that the cobbles may have been laid either at the same time, or after the pipe went in. Although this cannot be certain, if the cobbles had been lifted by hand and much care taken over their reinstatement, then it is possible that a cut through them might not be present.
