Thirstone Quarry, South Lanarkshire: Archaeological Mitigation

Data Structure Report

issued 19th December 2012

RATHMELL  
ARCHAEOLOGY LTD

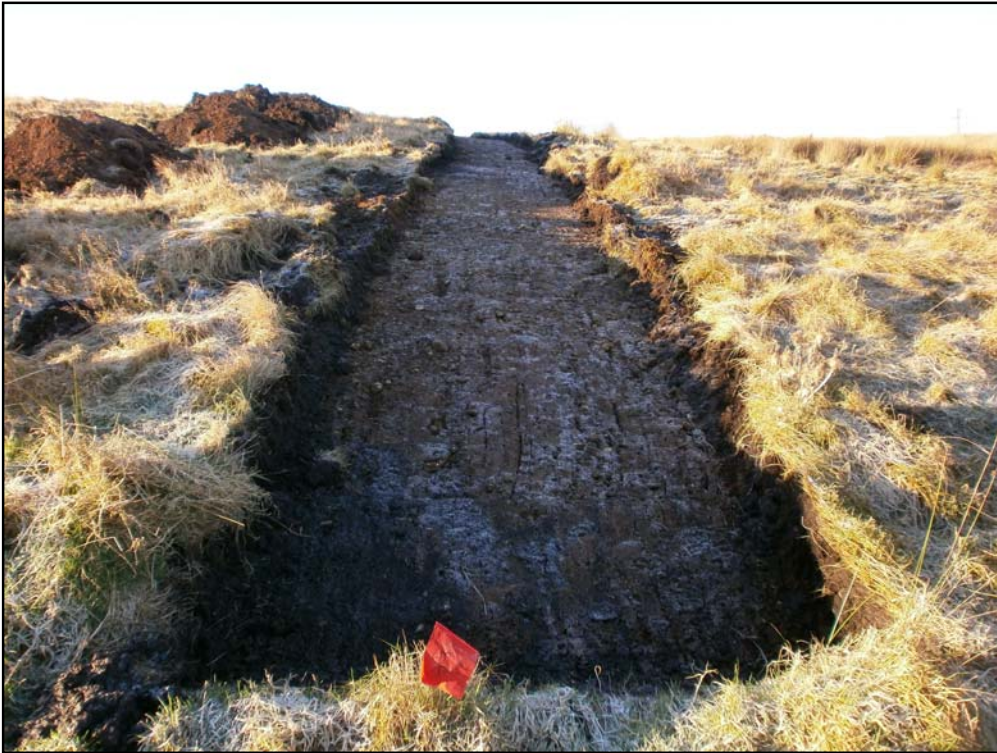
Figure 3a: Post-excavation shot, Trench 3

17. Natural peat (005) continues to the south of this area, forming the uppermost deposit along the majority of Trench 3 (Figure 3a), replacing the topsoil. It ranges in thickness from 0.2m to 1m, and sits above natural subsoil (002) and (004) exposed in the base of the trench. Backfilled deposit (003) is present again at +42.7m, for the remainder of the trench, and was excavated to 1m thickness.

29. The majority of the peat exposed around Trenches 1, 2, 3, 4 and 6, was disturbed, and looked to be the result of redeposition. This is further supported by the presence of the massive modern concrete pipe fragment which was removed from this deposit at the NNW end of Trench 6. It is possible the widespread disturbance of the peat in this area can be attributed to works in the nearby quarry, or from works on the adjacent M74 motorway in the 70s and 80s.

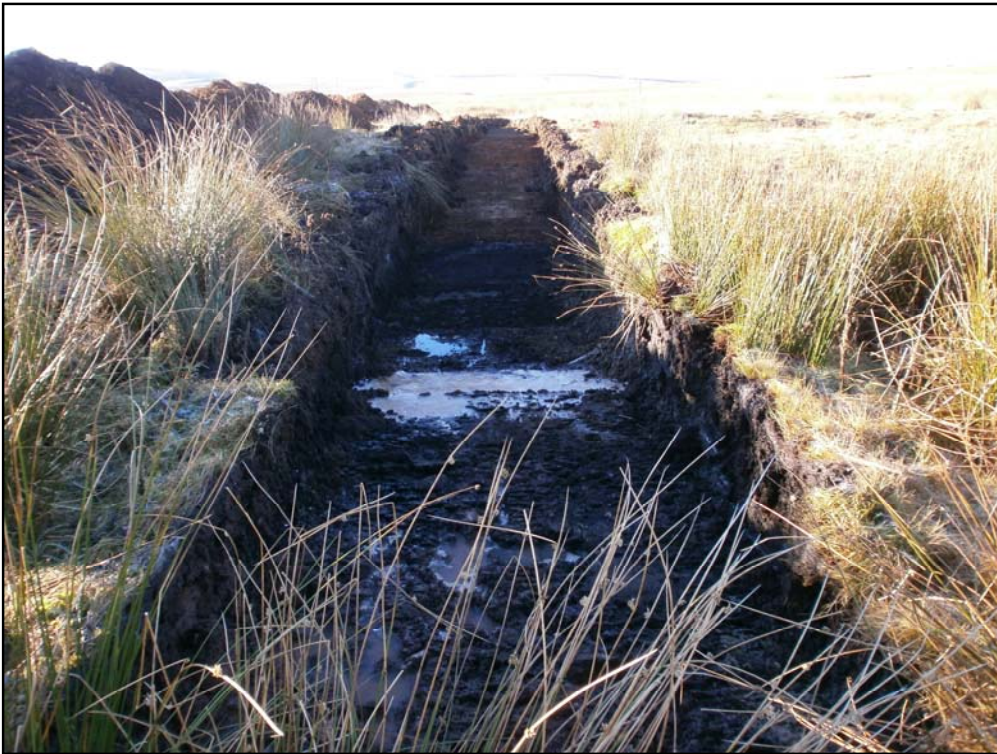
Figure 3b: Post-excavation shot, Trench 4

18. To the west of Trench 3 in Trench 4, topsoil changes to (006) that covered the entirety of Trench 4 (Figure 3b). Topsoil (006) consisted of a layer of turf over dark brown to black clayey silt, with high water content, and ranged from 0.2m to 0.54m thickness across the length of the trench. The backfilled peat (003) is present until +4m from the north-east end of Trench 4, below topsoil (006). Natural subsoil was not exposed in the base of the trench in this area. After +4m, (003) gives way to a backfilled subsoil deposit (007) until +5.8m. This deposit was exposed both in the base and the section of the trench.

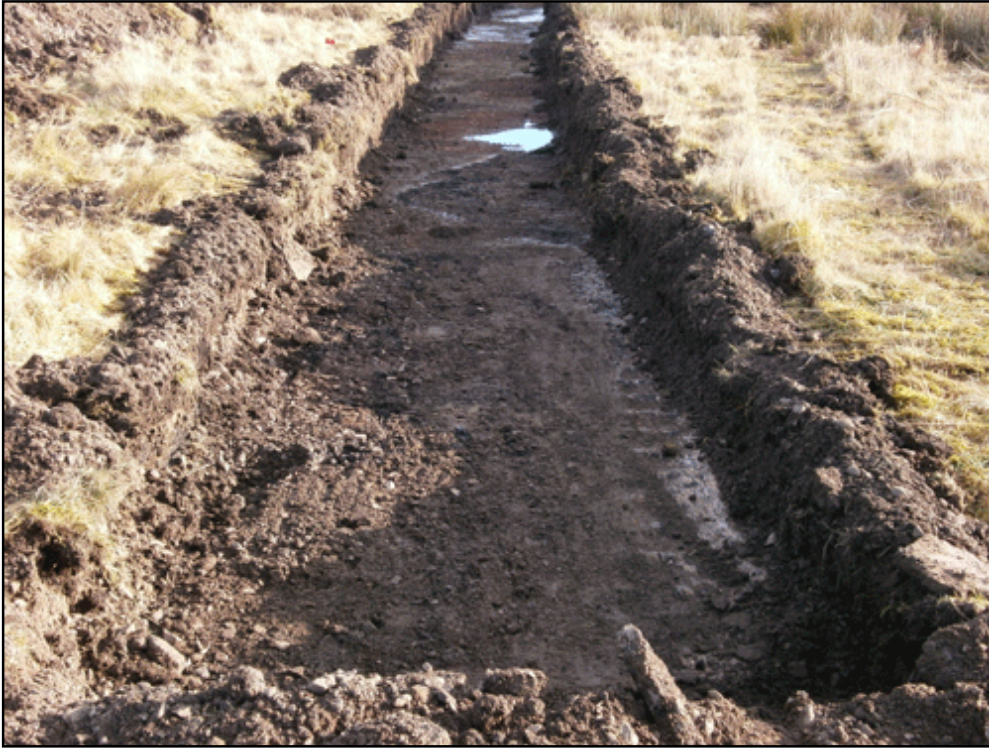
Figure 4a: Tarmac (010); W end Trench 5

20. The nature of the topsoil changes again in the area south of Trench 4, within Trench 5, to (009). This consisted of a layer of turf over dark brown to black clayey silt, and contained frequent root inclusions and small to medium rounded, sub-rounded and sub-angular stones. This topsoil covered all of Trench 5, ranging in thickness from 0.14m to 0.3m across the trench. At the west end of the trench, immediately below topsoil (009), the backfill deposit (007) was exposed, ranging in thickness from 0.19m to 0.5m, up to +26m. Below (007) was a deposit of modern tarmac (010); below this was found type 1 gravel (011) (Figure 4a). Deposits (010) and (011) were visible up to +24.5m, at which point natural subsoil (008) was exposed below (007); (007) is visible until +26m. After this point, excavation exposed natural subsoil (002) and (008) below (009) for the remainder of the trench.

30. The *in situ* tarmac found at the west end of Trench 5 seems likely to be a stretch of tarmac road, which probably extends outwith the limits of this investigation. Given the proximity of (010) to the quarry, it is possible this is an access road leading to a compound for previous works in the adjacent quarry. It was mentioned by staff at the current quarry that a compound and road were once located in this area. The probable redeposited natural deposits of (007) and (014) seem most likely to originate from works relating to the quarry.

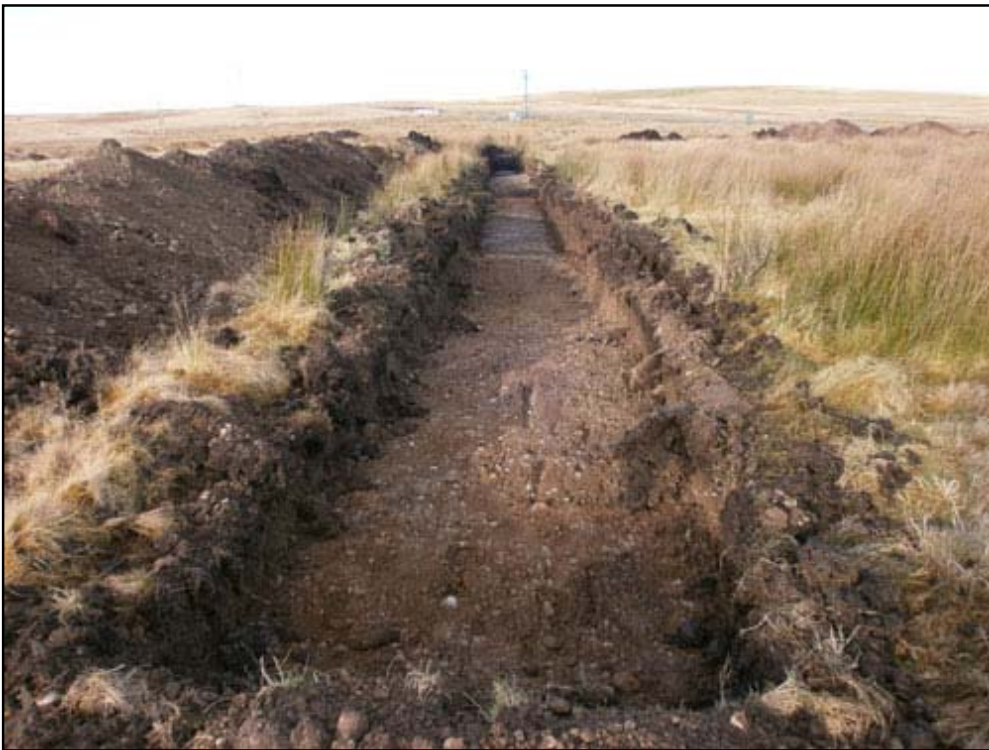
Figure 4b: Post-excavation shot, Trench 6

21. Topsoil (009) covers the entirety of Trench 6 (Figure 4b), which was located to the east of Trench 5. Subsoil (002) and (008) were exposed in the SSE end of the trench, immediately below topsoil (009). At +20m, backfill deposit (007) is once again present, below (009) and above subsoil (008). Deposit (007) is present for the remainder of the trench, varying in thickness from 0.2m to 0.73m, and in places sits immediately above natural subsoil (002).

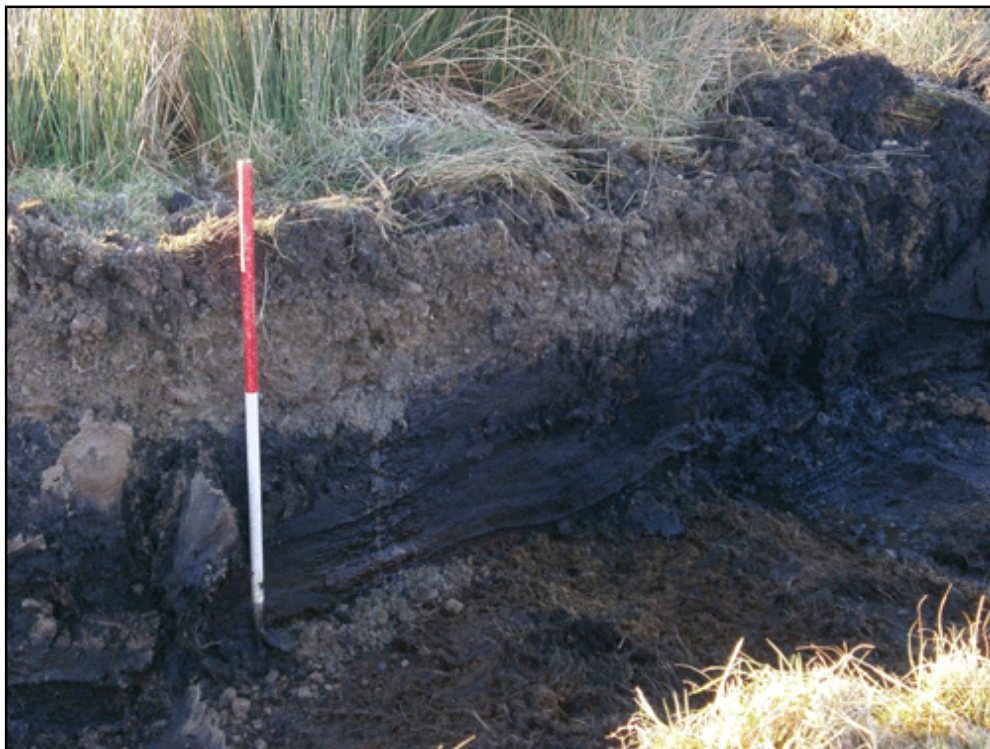
Figure 5a: Deposit (007) above (003); SE facing section Trench 6 (SE end)

22. At the centre point of Trench 6 at +25m, topsoil (009) sits above (007); below (007) is 0.1m thickness of deposit (013) and below that is natural subsoil (012). Deposit (013) was friable black clay and contained occasional small stone inclusions. This deposit was exposed in section and in the base of the trench from +25m to +28m. Subsoil (012) was gravel in orange sand matrix, the gravel consisting of small to medium sub-rounded and sub-angular stones. The NNW end of the trench showed evidence of heavy disturbance from recent activity in the area; the remainder of the trench from +33.9m was characterised by (003), which was found below 0.35m thickness of (007) (Figure 5a). Deposit (003) was excavated to 0.5m thickness, and was seen to include a massive fragment of modern concrete piping, along with modern plastic debris.

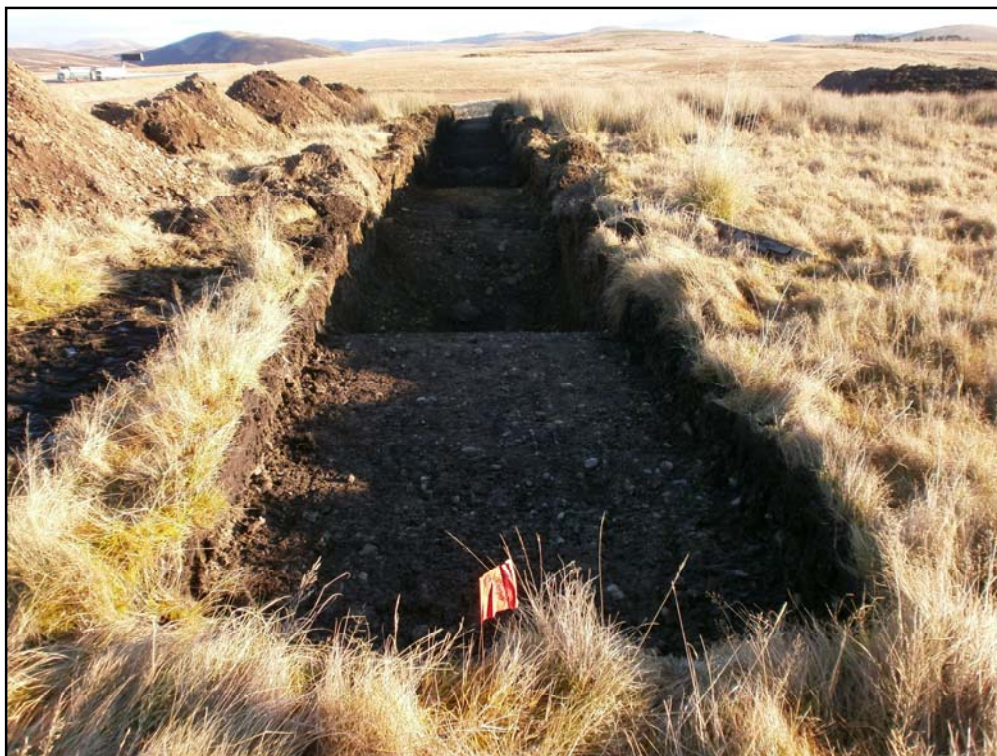
Figure 5b: Post-excavation shot, Trench 7

23. Further disturbance of the site was evident after excavation of Trench 7 (Figure 5b), which was located to the east of Trench 6. Topsoil (009) covers all of Trench 7, ranging in depth from 0.17m to 0.34m thickness. The trench was characterised by deposit (014) until +14.5m (from the west), which was found immediately below topsoil (009) (Figure 6a). Deposit (014) was gravel in a mid-brown and grey silty sand matrix, the same as (007), but tinged purple. This deposit also contained steel wire and plastic inclusions, and ranged in thickness from 0.29m to 1.2m. A cut for a modern plastic drainpipe [015] truncated deposit (014) at +3.5m and +11.5m, and covered the majority of the width of the trench. Deposit (014) and cut [015] were excavated to a depth of 1.2m from the top of the trench. Natural subsoil was not found at this depth.

24. After +14.5m, the base of the trench was characterised by (017), which was below (014). Deposit (017) consisted of a mixture of (014) and black silty clay; it contained such modern construction detritus as red bricks, plastic drainpipes and massive chunks of bitumen. This deposit was 0.22m to 0.3m thickness where found across the trench. Deposits (014) and (017) remain present in the trench until +34.9m; at this point, they give way to natural subsoil (004) and (016) for the remainder of the trench. A cut [019] through natural subsoil (016) was apparent in the south facing section at +34.9m (Figure 6b), which looks to have been filled with (014) and (017). Natural subsoil (016) was very light brown, fine to medium grained sand and contained frequent stone flecks and small to medium rounded, sub-rounded and sub-angular stones.

31. Deposit (017) that characterised the central stretch of Trench 7 looks like it is mixed with a dump of construction debris, such as red bricks, plastic drainpipes and massive chunks of bitumen (1m x 0.8m x 0.7m). This is most probably a result of the construction of the M74 to the east, given the bitumen inclusions. In addition, the location of (017) below (014) would seem to represent several dumps of material. The cut visible in the south-facing section [019] demonstrates truncation of the natural subsoil (016) in order to dump materials (014) and (017). It is possible the material removed during this activity was later redeposited elsewhere on site, and is possibly represented by (007) and (014).
