**Ardoch & Over Enoch Windfarm,
East Renfrewshire:
Archaeological Mitigation**

Data Structure Report

issued 15th July 2014

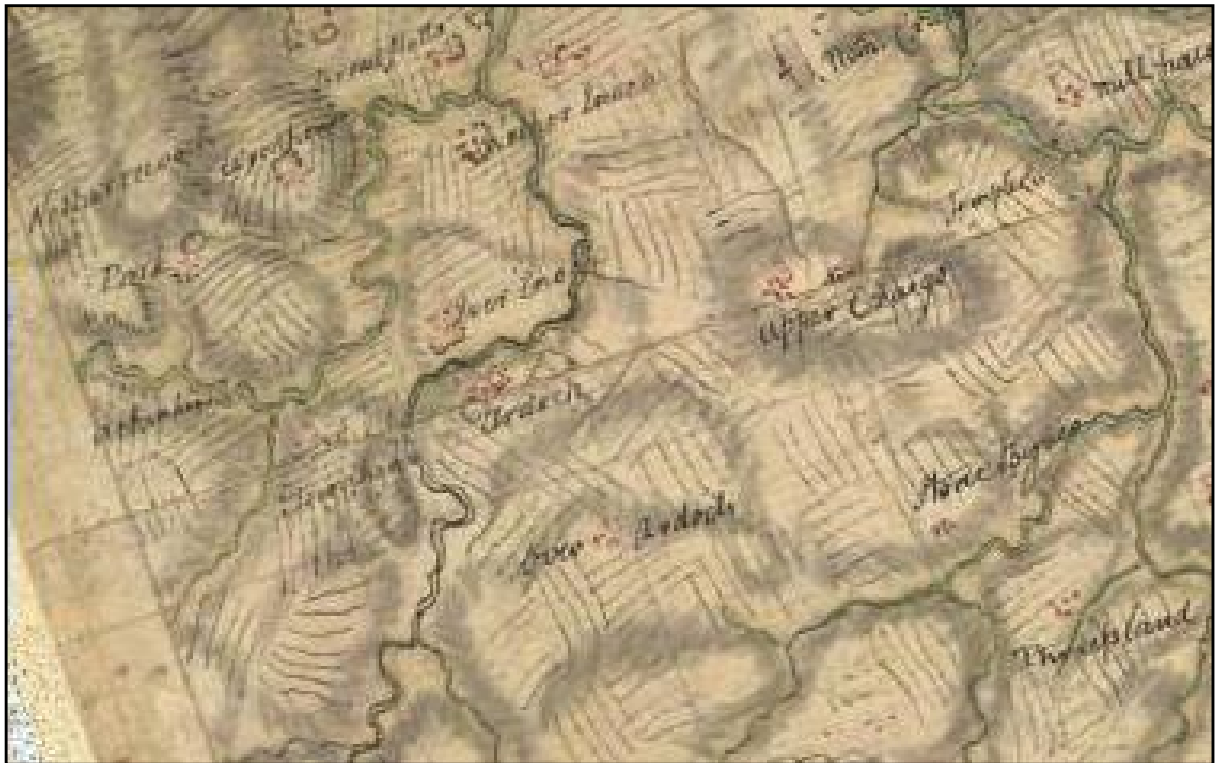
Figure 1a: Extract from Roy's Military Map of 1752-55

9. Roy's map of 1752-55 (Figure 1a) shows the area prior to the agricultural improvements which were underway in lowland Scotland at this time. It shows a number of farms on each

land location (e.g. *Over Enoch*). The surrounding land is heavily cultivated by way of rig and furrow, and is largely unenclosed. Cultivation is concentrated upon elevated ground: those areas lying in close proximity to the Munzie and the Netherton burns remain uncultivated, an indication of the marshy nature of the ground here.

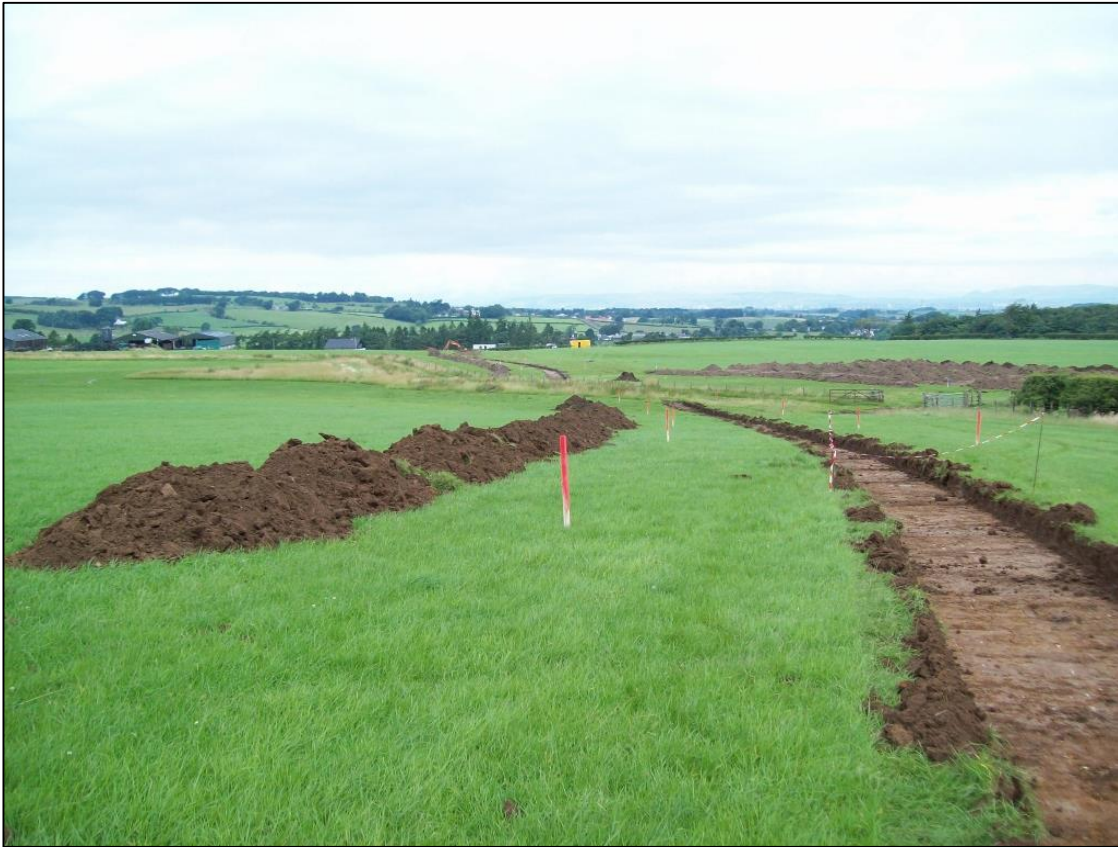
Figure 3a: General view of Ardoch axial trench with compound in background from the south-east

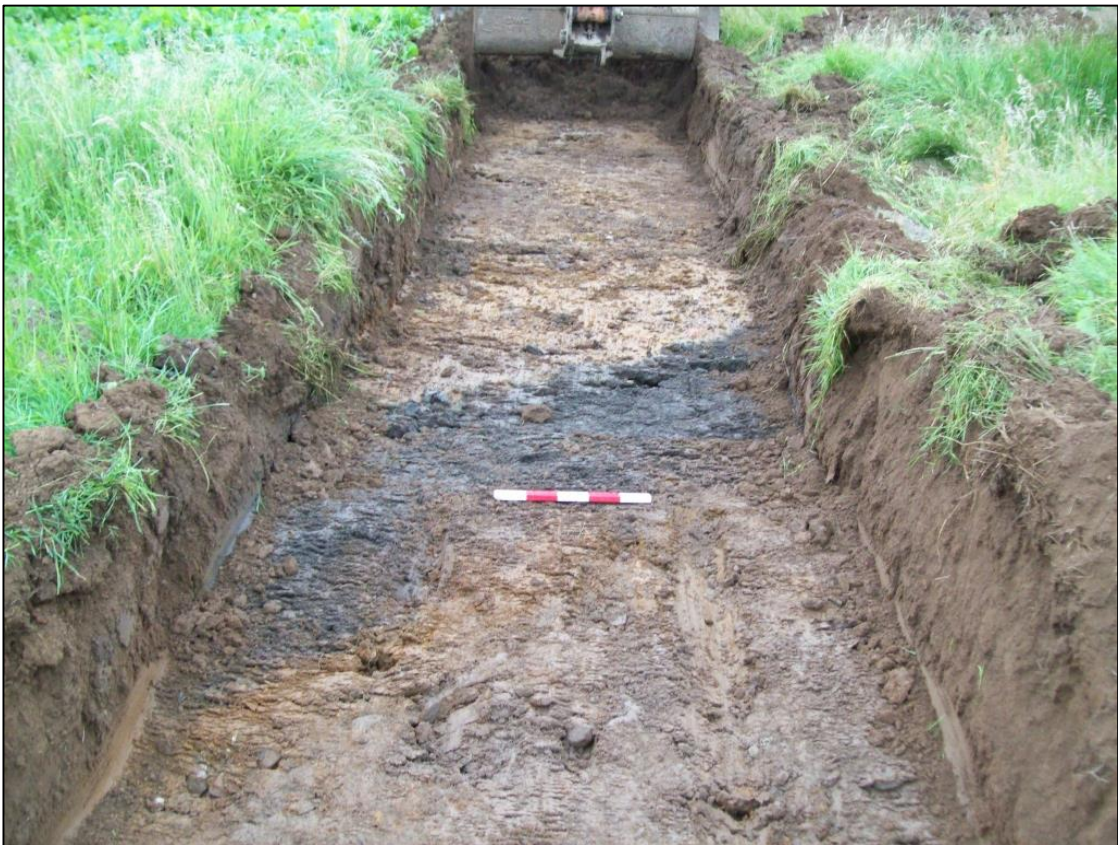
22. The axial trench exposed a number of modern agricultural services including modern land drains [012], red tile field drains [015], and rubble field drains [016] and a modern drainage ditch [010] (see Figure 3b). The red tile field drains were encountered in various locations throughout the axial trench at Ardoch, most notably in the western areas of WTG A1 and the sub-station spurs which were slightly waterlogged. The rubble drains occurred at various intervals throughout the axial trench. The land drains were encountered at approximately chainage 1240 and were orientated north-west to south-east. The drainage ditch was encountered at approximately chainage 1400 running north-west to south-east.

Figure 3b: Pre-excavation view of drainage ditch (011) from the north

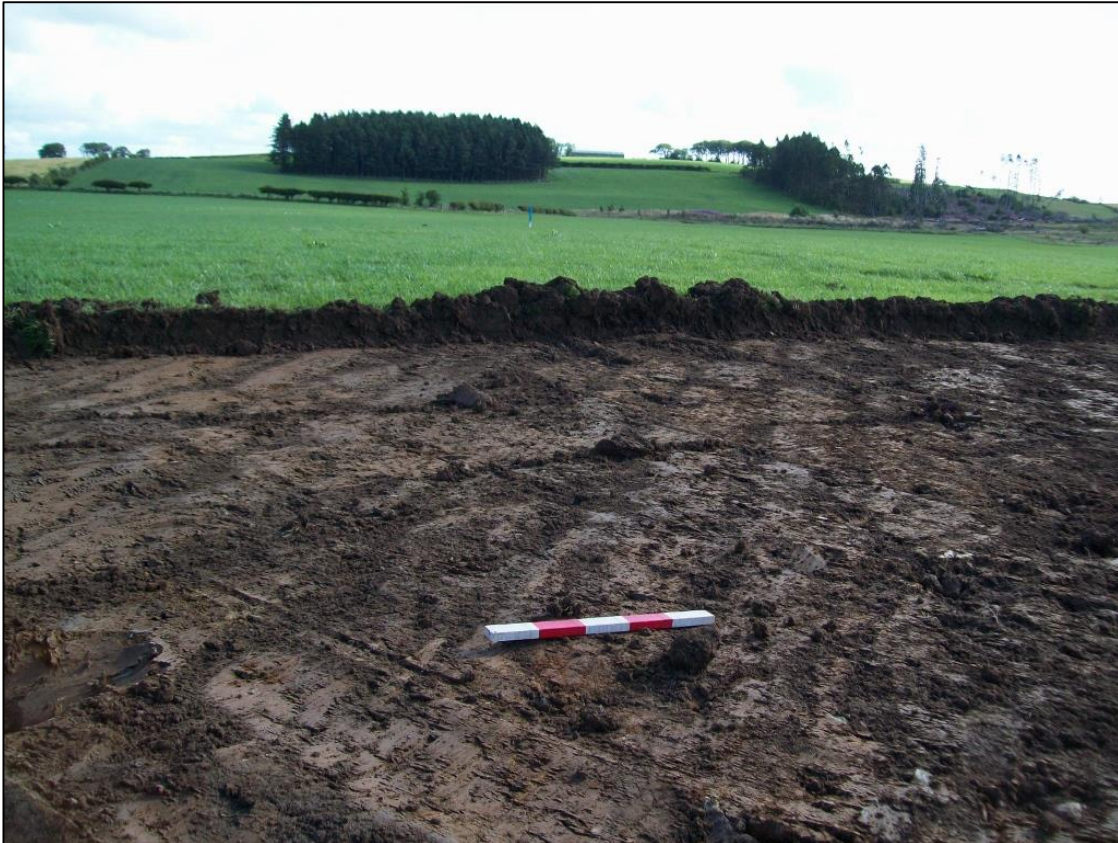
25. Monitoring of the reduction of the compound revealed extensive modern plough scarring [009] across the upper limits of the subsoil, suggesting that any surviving archaeological features in this area would likely suffer from plough truncation at their upper limits. Occasional red tile field drains and rubble drains were noted below the plough scars.

Figure 4a: View of plough marks in Ardoch compound area from the north-north-west

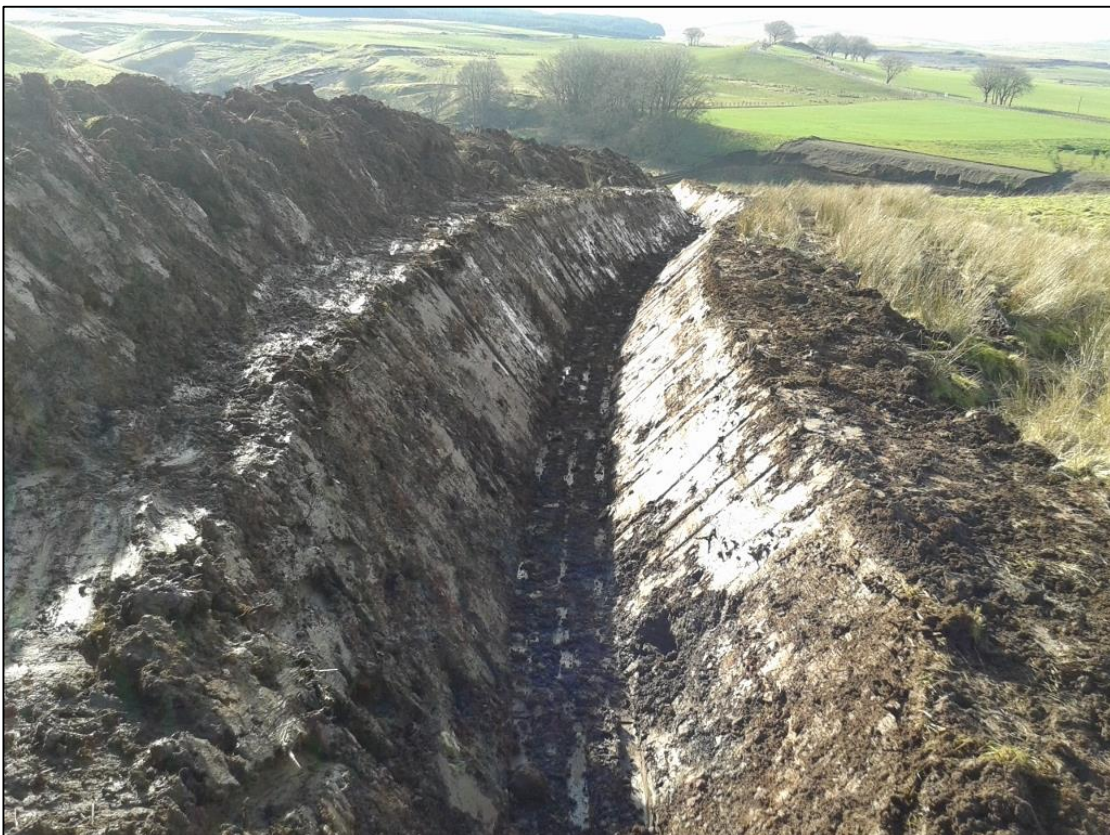
28. No significant archaeological features were found in any of the turbine pad areas.
29. The cable trench (see Figure 4b) which ran in an east-west direction from the Ardoch substation (located between turbines WTG A1 and WTG A2) towards the Over Enoch part of the scheme was partially monitored. A section of the cable trench had been previously disturbed and it was agreed that only a portion of its route may contain archaeological deposits and therefore only one section required monitoring. The area monitored ran from the access track to the immediate north of the substation, to the edge of a steep valley meeting Ardoch Burn to the west.

30. The trench was excavated initially with a toothless ditching bucket and subsequently with a V-shaped bucket and measured approximately 230m long by 1.8 to 2.5m wide by 1.2 to 1.4m deep. A drainage trench was also machine excavated using a small toothless bucket and was located approximately 5m to the south of the cable trench. The drainage ditch measured approximately 160m long by 0.6m wide by 0.4 to 0.7m deep.

31. Both trenches revealed a waterlogged topsoil (028), which was a mid to dark brown peat or clayey silt and had depth range of 0.3 to 0.45m. The natural subsoil (029) beneath consisted of a mid to red-brown clayey silt with occasional stone inclusions. Many of these stones appeared to be eroded most likely through water or frost action.

Figure 4b: Eastern stretch of the cable trench near the sub-station at Ardoch from the east.

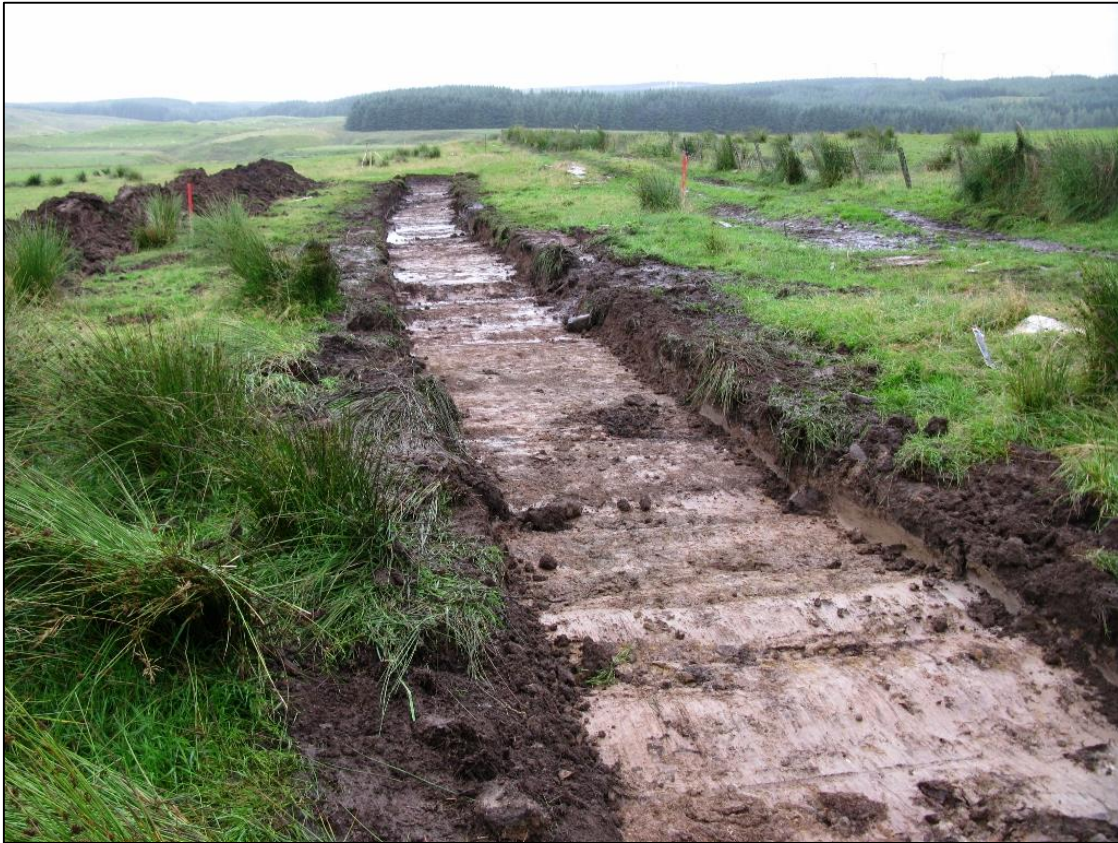
34. The majority of mitigation at Over Enoch was concerned with the excavation of an axial trench centred along the access road, as with that at Ardoch (see Figure 5a). The access road at Enoch partially incorporates an existing hardcore farm track which runs west to east along the southern limit of the site. The pre-existing track begins at the minor public road at the east side of the Over Enoch site, and continues west for approximately 200m. The new access road was constructed over or incorporates this existing track, which consists of rubble demolition material [1005]. Thus, archaeological mitigation was not carried out in the location of the existing access road.

Figure 5a: General view of the axial trench at Over Enoch from the west-north-west.

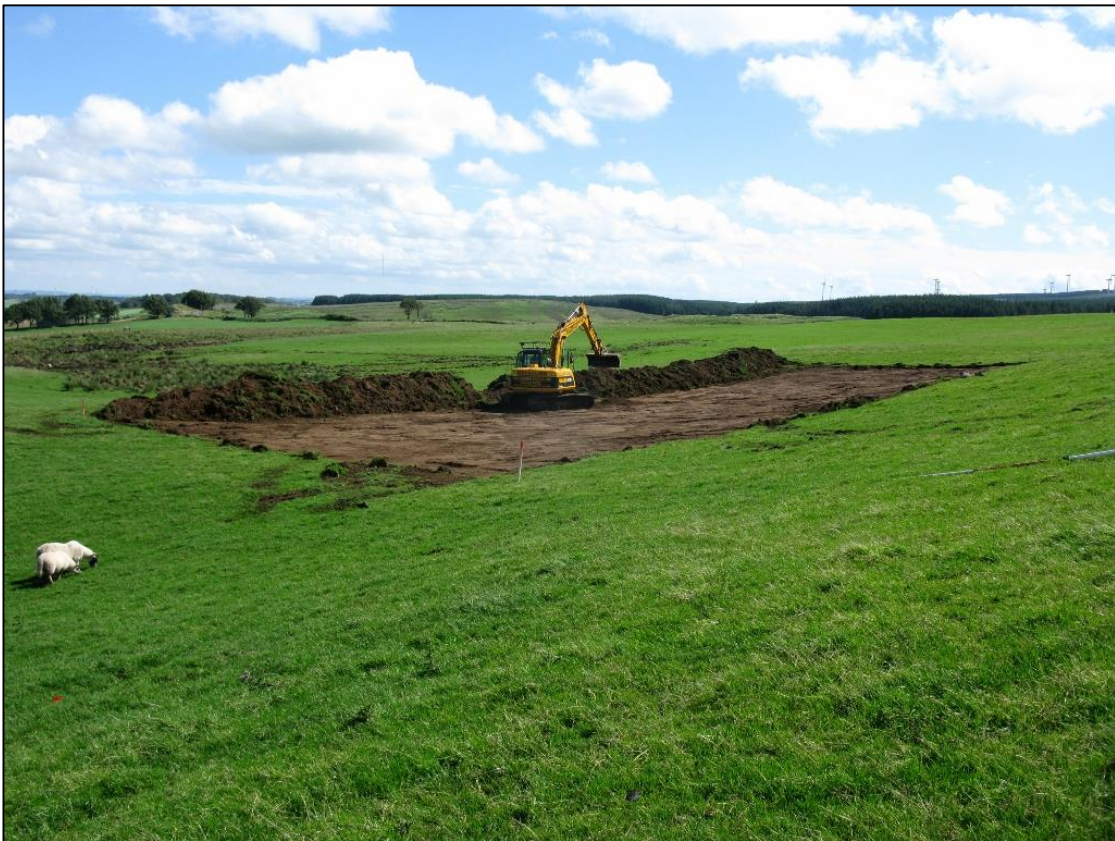
44. Monitoring of the reduction of the compound revealed no significant archaeological features during the stripping process (see Figure 5b). The compound strip measured 25m by 50m by an average topsoil depth of 0.20m. The topsoil (001) consisted of a mid-brown sandy clay above (1012) subsoil, a light brown sand with patches of gravel in a sandy matrix.

Figure 5b: Post excavation view of compound strip at Over Enoch from the south-west.

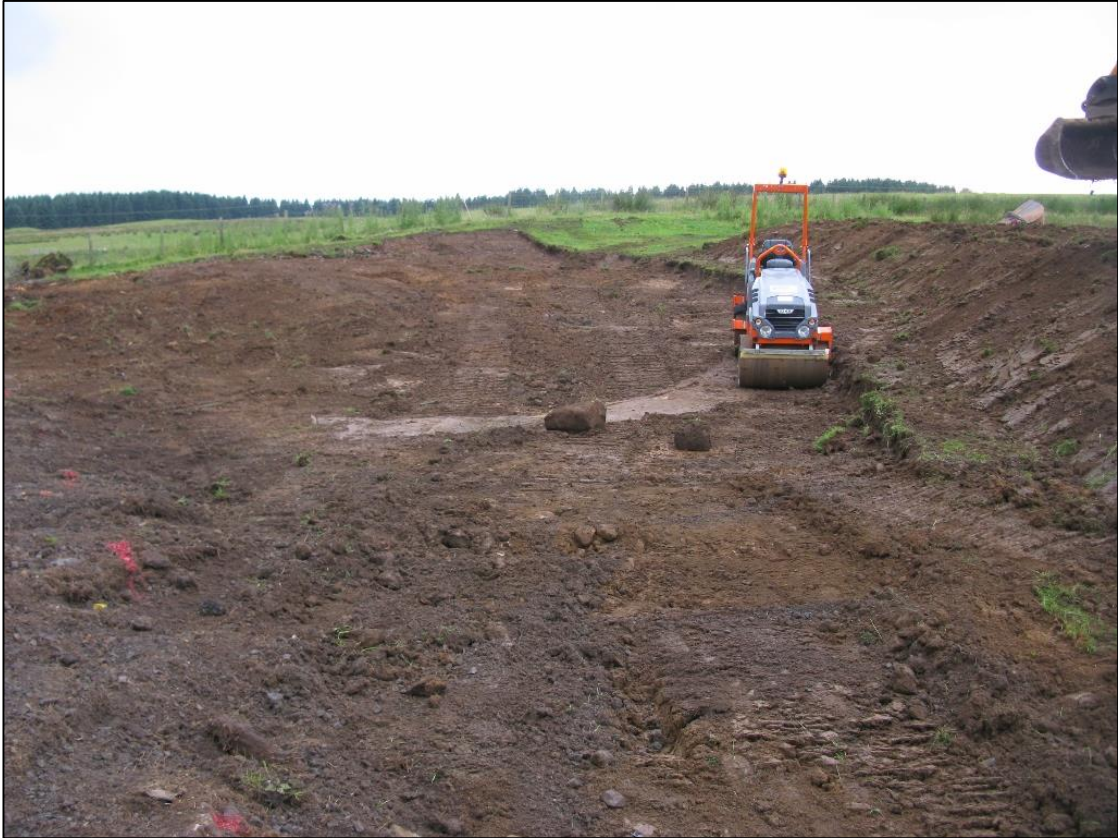
40. The reduction of the bell-mouth area was monitored to either the upper surface of the underlying natural subsoil or the maximum working depth, dependant on the area (see Figure 6a). A total of 210m² was excavated within the bell-mouth area to an approximate depth of 0.3 to 0.5m. No archaeologically significant features were encountered.

Figure 6a: Bellmouth area at Over Enoch stripped from the north-west.

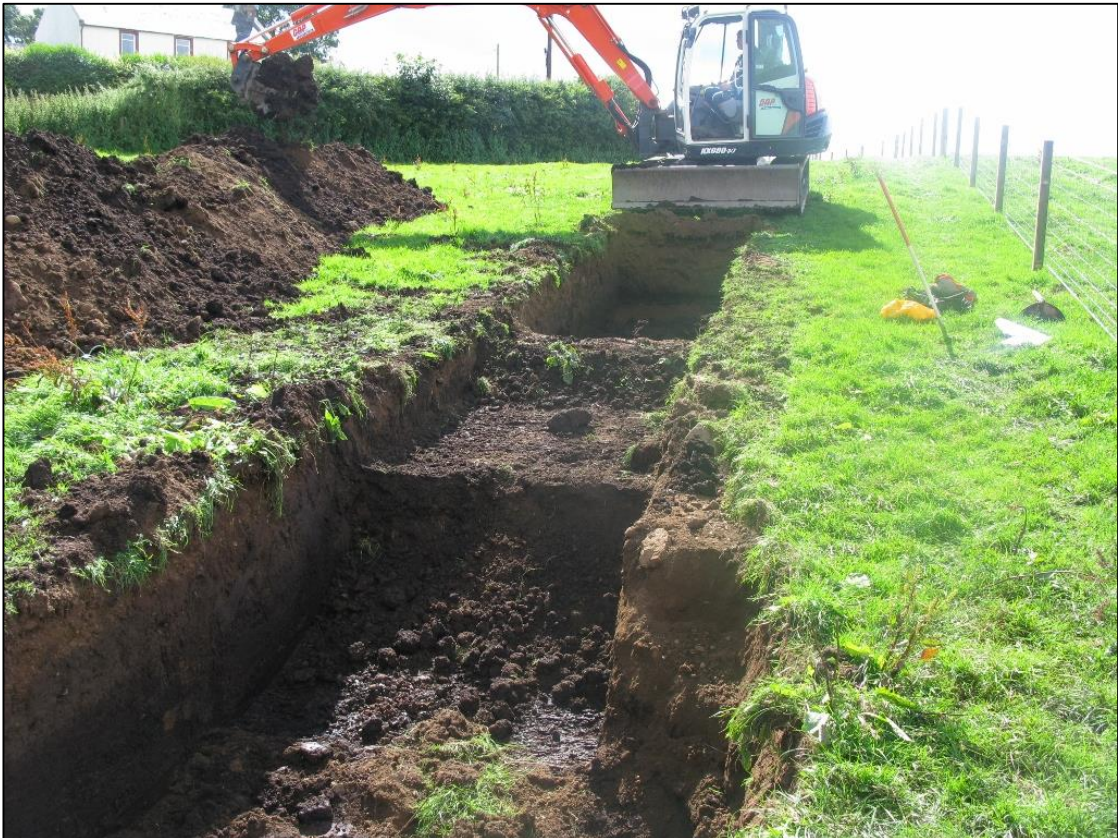
43. A series of four widenings, or pinch points, were sited along the farm road which ran to the south of the farm buildings at Over Enoch and between the Netherton and Ardoch Burns. Only pinch point 3 required monitoring and this only at its northern end (see Figure 6b). The excavations were halted as the depth and nature of the topsoil and subsoil, which were made up of waterlogged peats, made continued work untenable. It was then decided that pinch point 3 and the other pinch points would be floated over the existing ground level, negating the need for any further monitoring works in those areas.

Figure 6b: General view of pinch-point 3 trench before abandonment, from the north-north-east.
