**Kilwinning Community Archaeology Project:  
2010 Excavation Season**

Data Structure Report

issued 21<sup>st</sup> December 2010

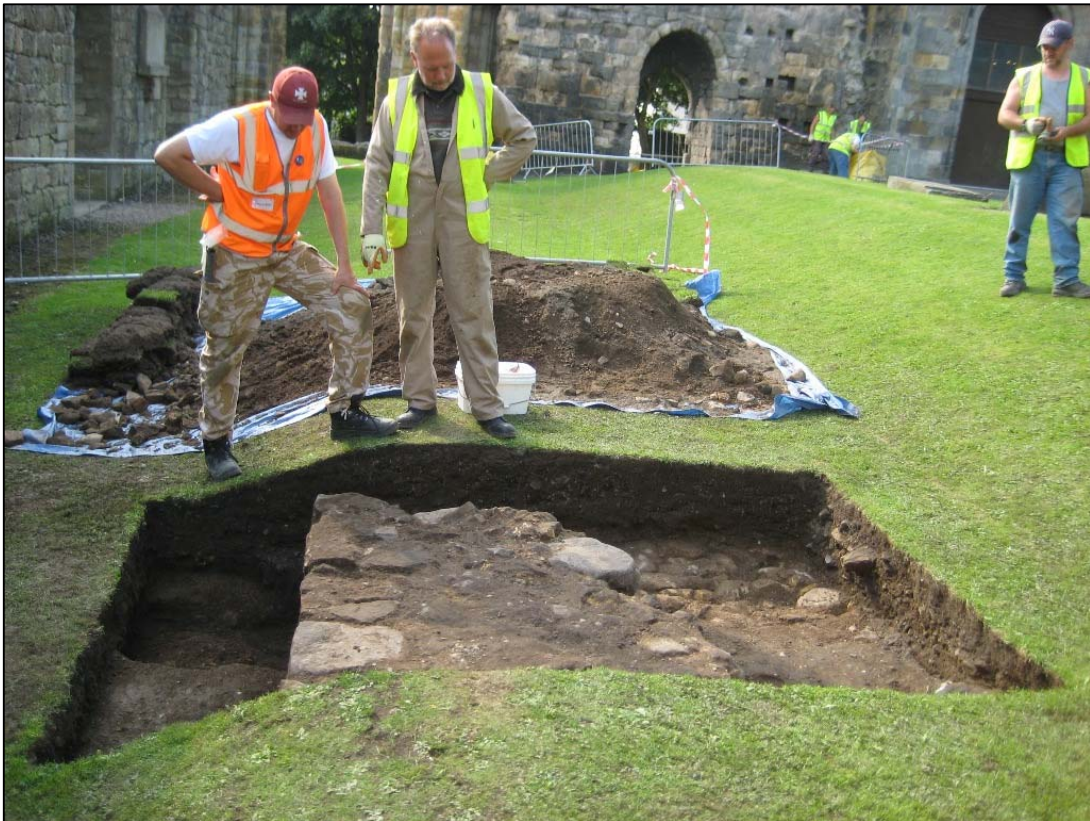
Figure 4b: Trench 4 showing wall structure with inserted Nave gable to rear

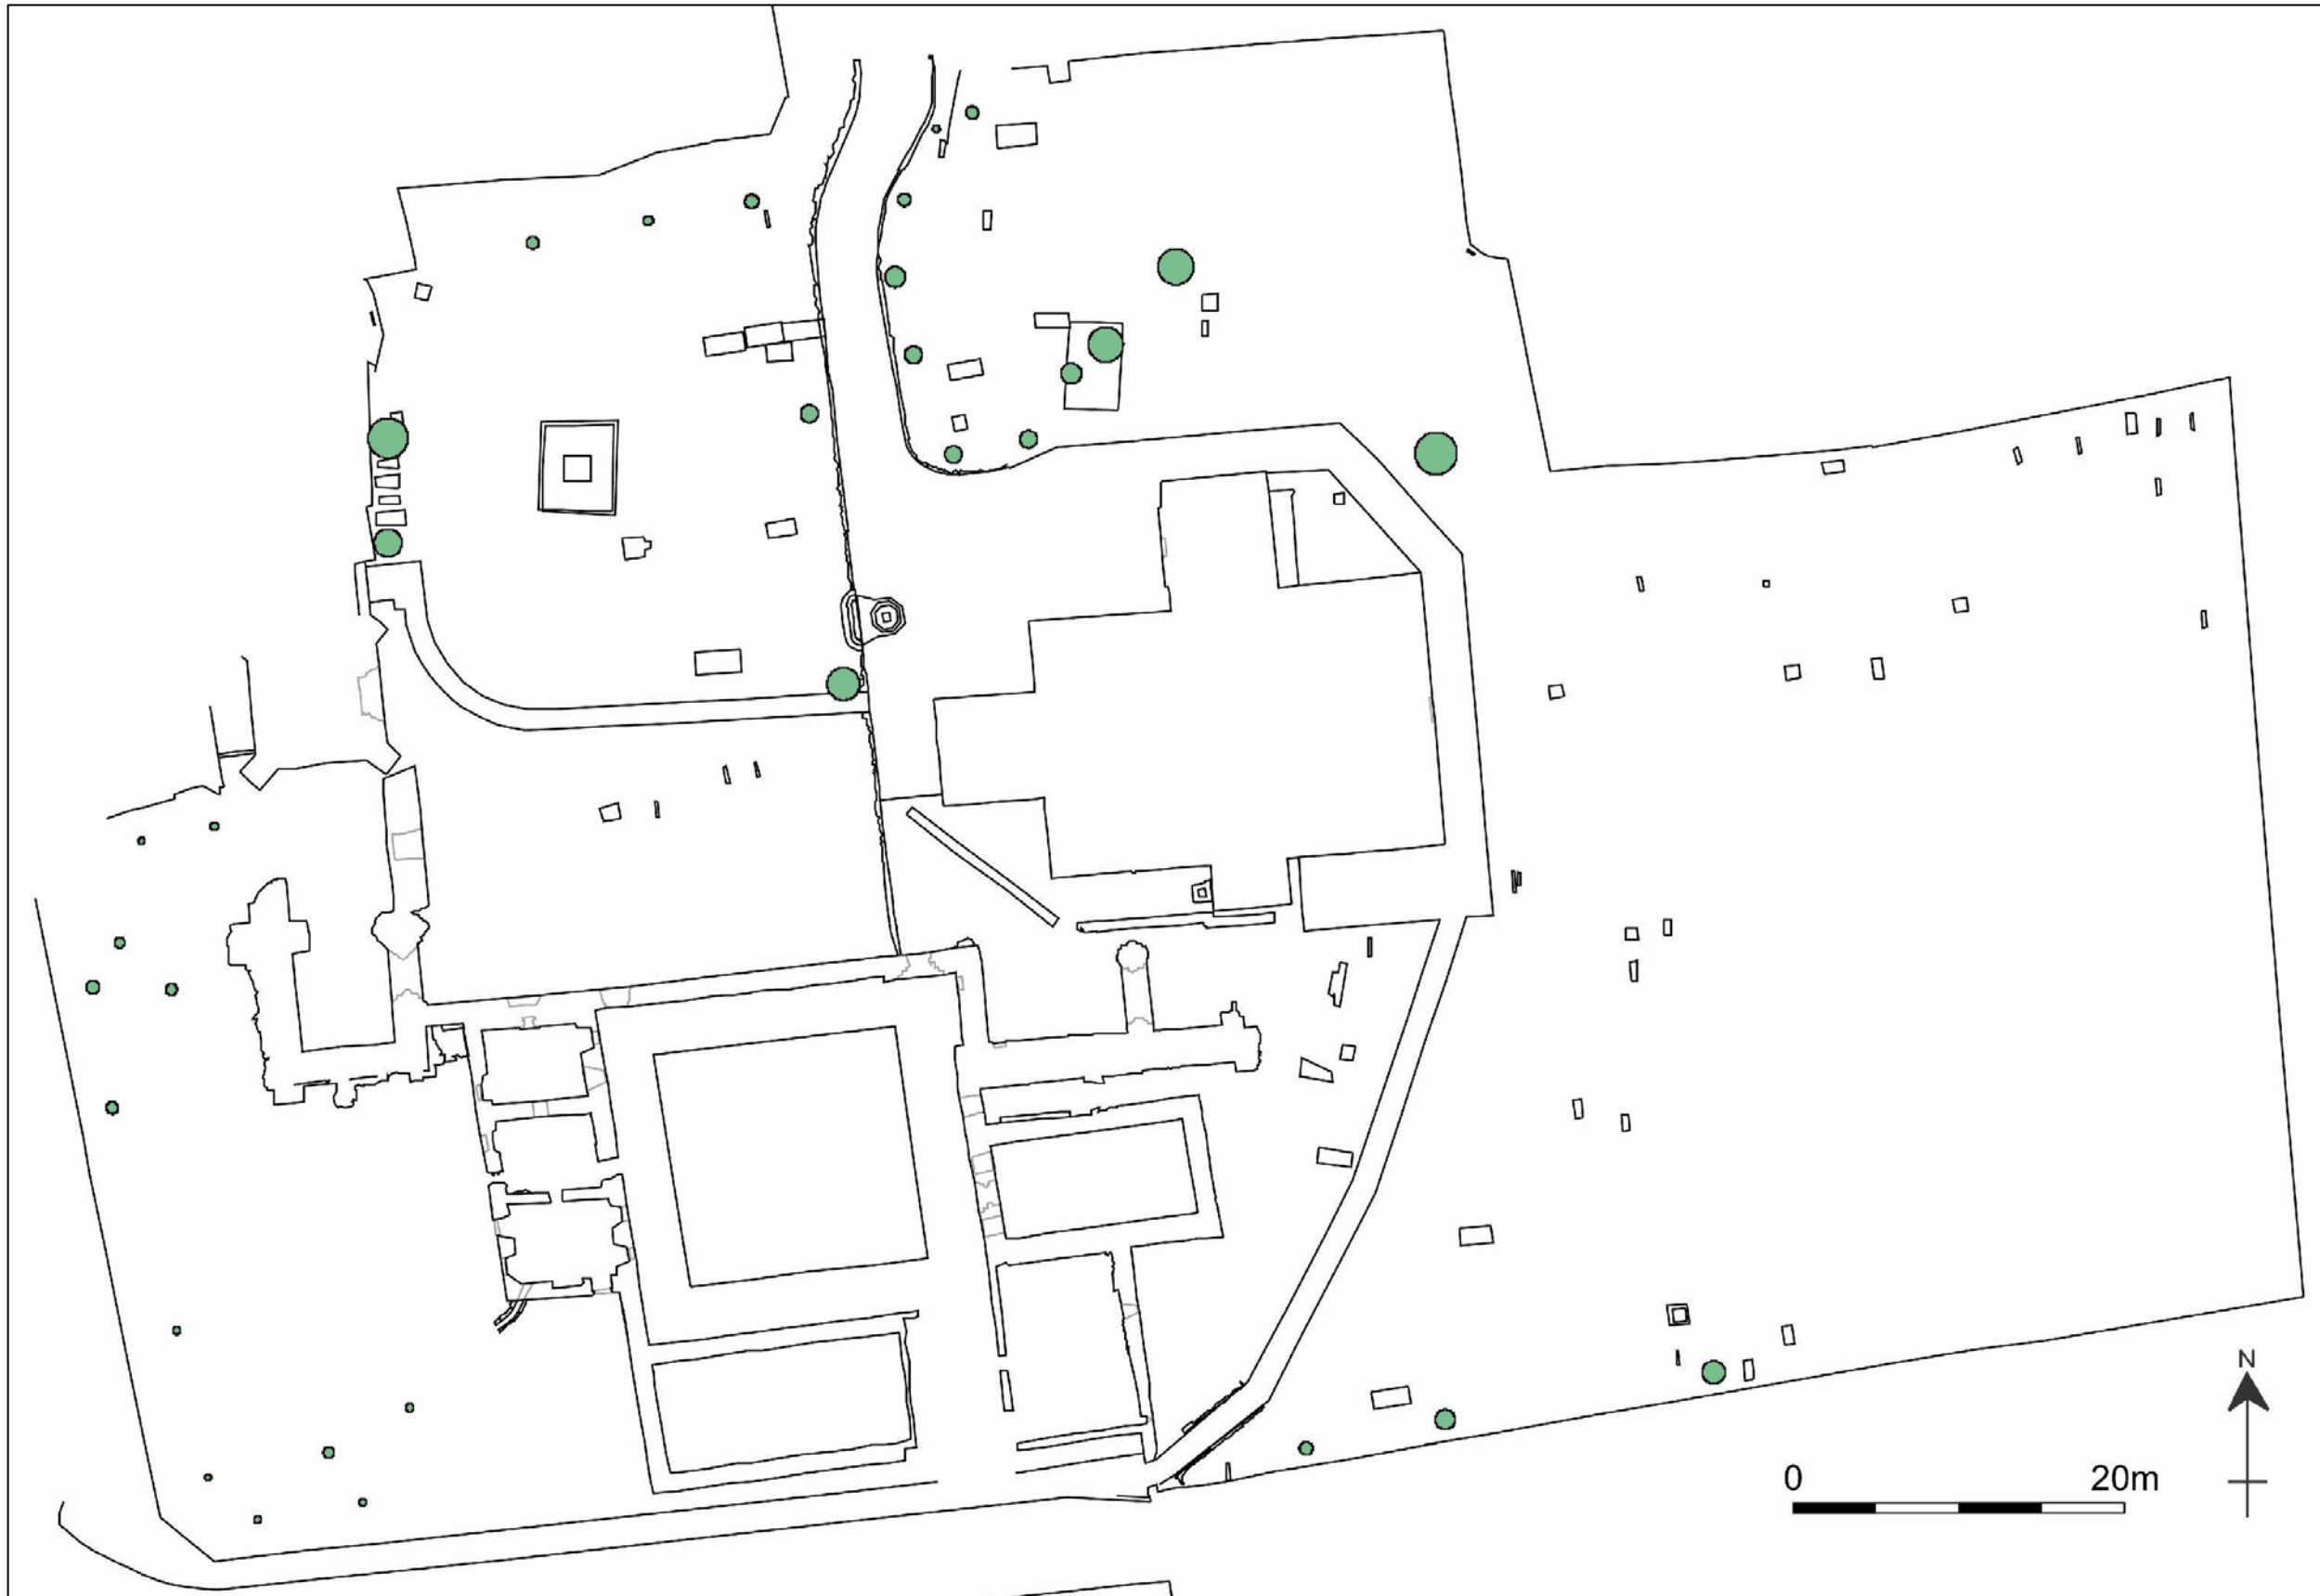
Figure 5: Detailed survey data of Kilwinning Abbey generated during Building Survey work

49. While, for the most part, the survey results are similar to current modern mapping of the area, they do highlight that some of the lines are slightly less square than had previously been shown, especially around the area of the Slype and Chapter House to the east. This could be a reflection of the original construction style or is maybe a result of the number of later additions and repairs, as well as the overall ruination of the Abbey over the years.

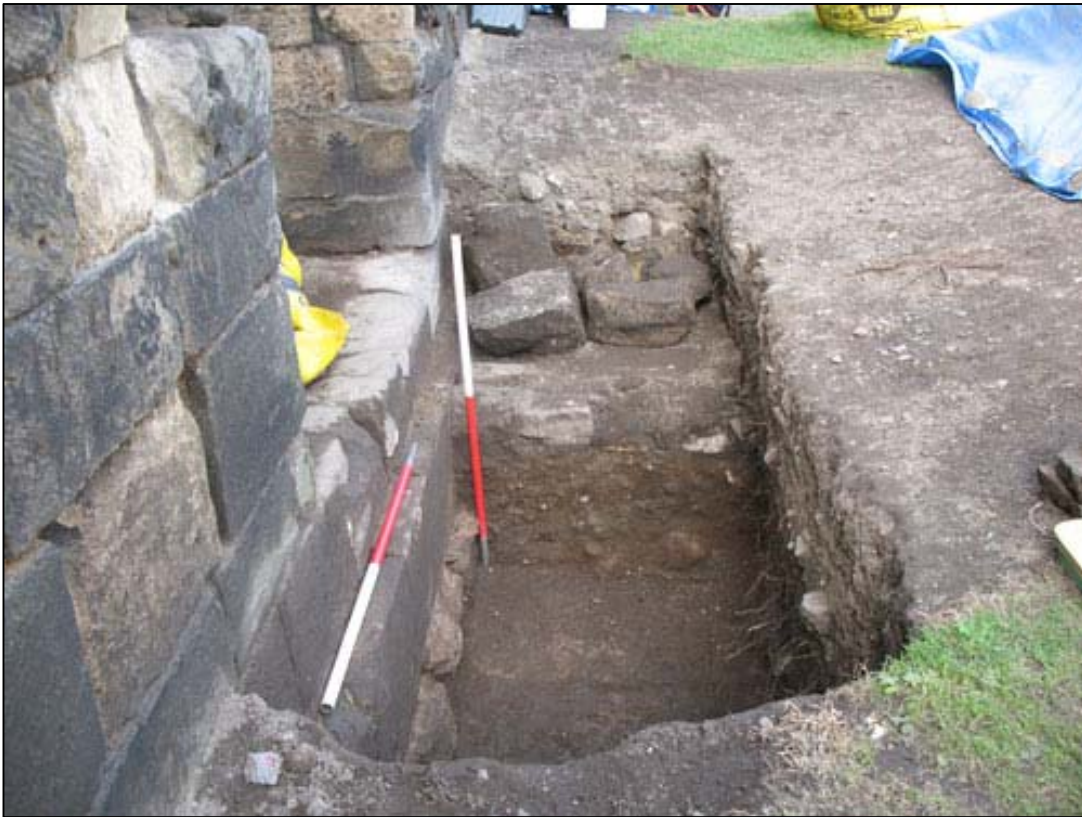
Figure 7a: Trench 1 from south showing foundation course of gable wall

Trench 1 (Figure 7a) was placed to re-expose the masonry face of the west gable of the nave. This would enable recording of mason marks noted during 1985 Kirkdale excavations. The trench was 3m by 1m in plan, aligned north-south, and was excavated through 1960s fill material (101) and disturbed deposit (105) to reveal the upper remains of two articulated skeletons (107), both with skulls intact, at 0.61m below ground surface.

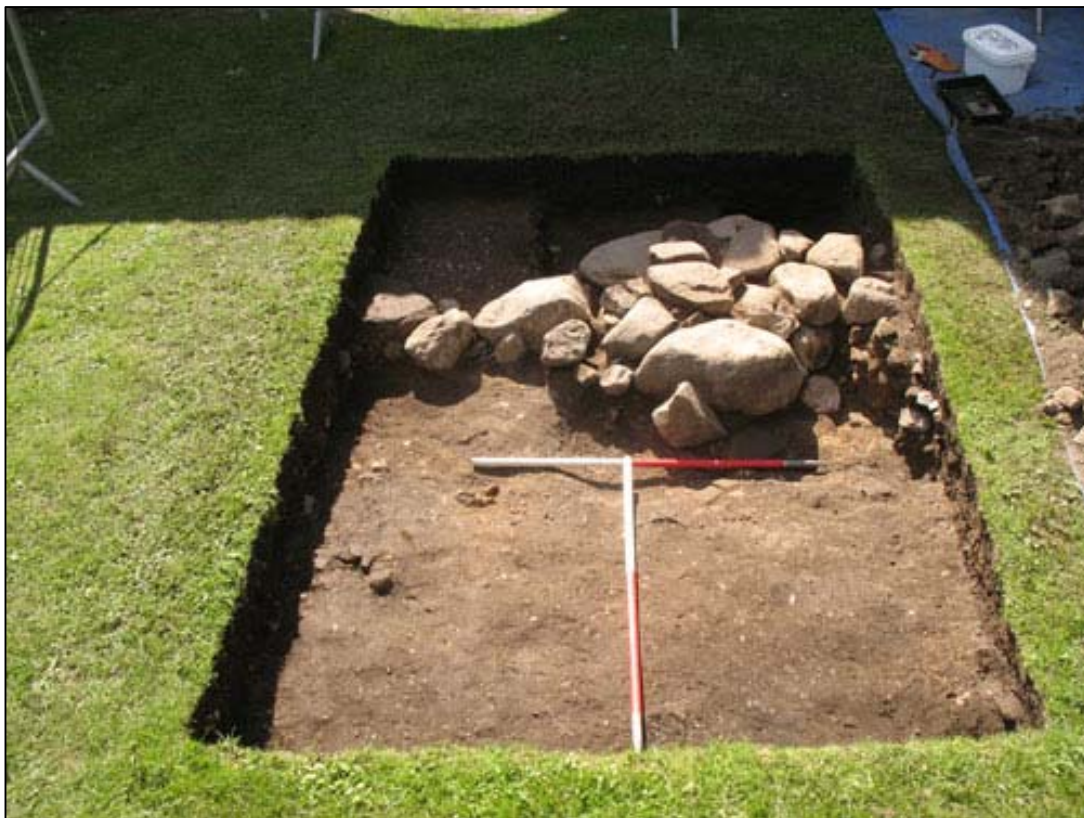
Figure 7b: Trench 3 from north showing fragment of wall foundation

57. Trench 3 (Figure 7b) was placed in order to re-expose the foundations of piers in the central section forming the south aisle of nave. This trench was 3m by 2m, aligned north to south, and was reduced through topsoil (301) until a stone foundation wall (303) was uncovered.

58. The foundation wall was aligned east to west across the width of the trench, and consisted of roughly shaped large and medium sized stone. The wall was 0.9m wide, with the eastern end being denuded of the majority of its stone.

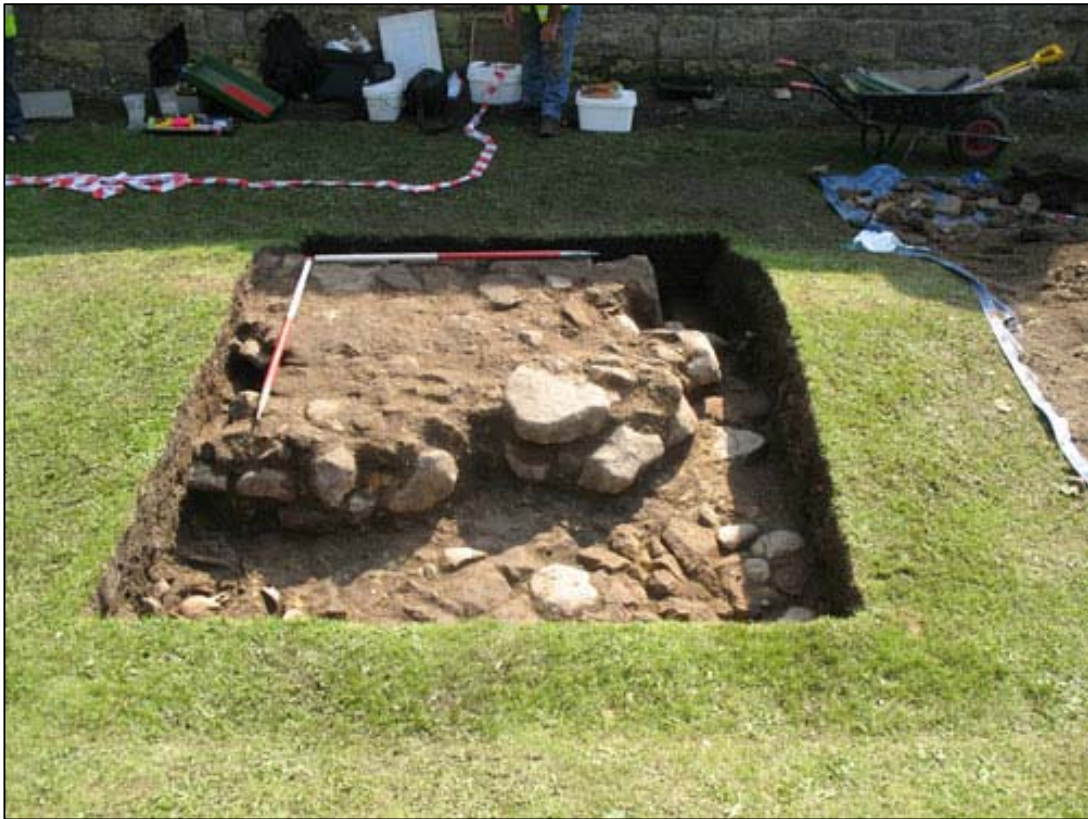
Figure 8a: Trench 4 from south showing mortared wall and floor surface

61. Trench 4 (Figure 8a) was placed in order to re-expose foundations for piers which formed the eastern end of the south aisle of the nave. Piers had been identified running east to west. The trench was 3m by 2m in plan and was aligned north to south. Trench 4 was reduced through topsoil (401) to expose 1960s backfill deposit (402) and remains of 16<sup>th</sup> century wall (403). Contexts (402) and (403) were exposed at approximately the same depth, which was almost immediately after removal of topsoil.

62. Wall (403) was surrounded by (402) on its north and south sides. Wall foundations run west to east from the west facing section across the middle of Trench 4 but stopped short of reaching the east facing section. Wall (403) consists of mainly rough, un-worked stones, except for the south edge which is faced with worked stone blocks. The north and west sides of Wall (403) are irregular and rough and look to have been robbed for stone at some point. The wall itself now no longer forms a linear feature but curves to the south; probably truncated due to stone robbing.

63. In addition to the remains of the wall foundations, (403) also includes a rough stone floor surface, which was exposed as the trench was dropped further through (402) on the north and south sides of the wall foundations. The floor surface is composed of the same rough, irregular un-worked stones as the wall foundations. The wall and the surface appear to run into one another and as they share stonework no specific boundary exists. This suggests that the wall and floor are not only contemporary but are in fact part of the same 16<sup>th</sup> century activities/structures.

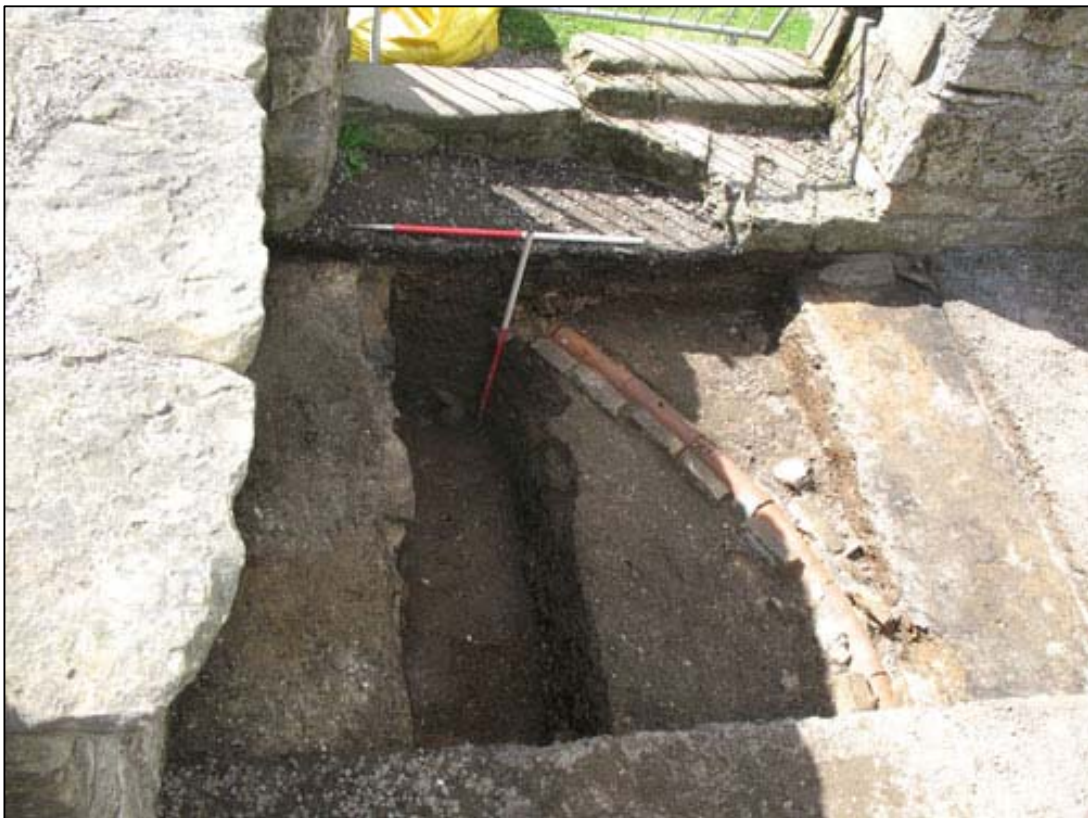
Figure 8b: Trench 5 from east showing re-excitation into part of filled 1960s sondage

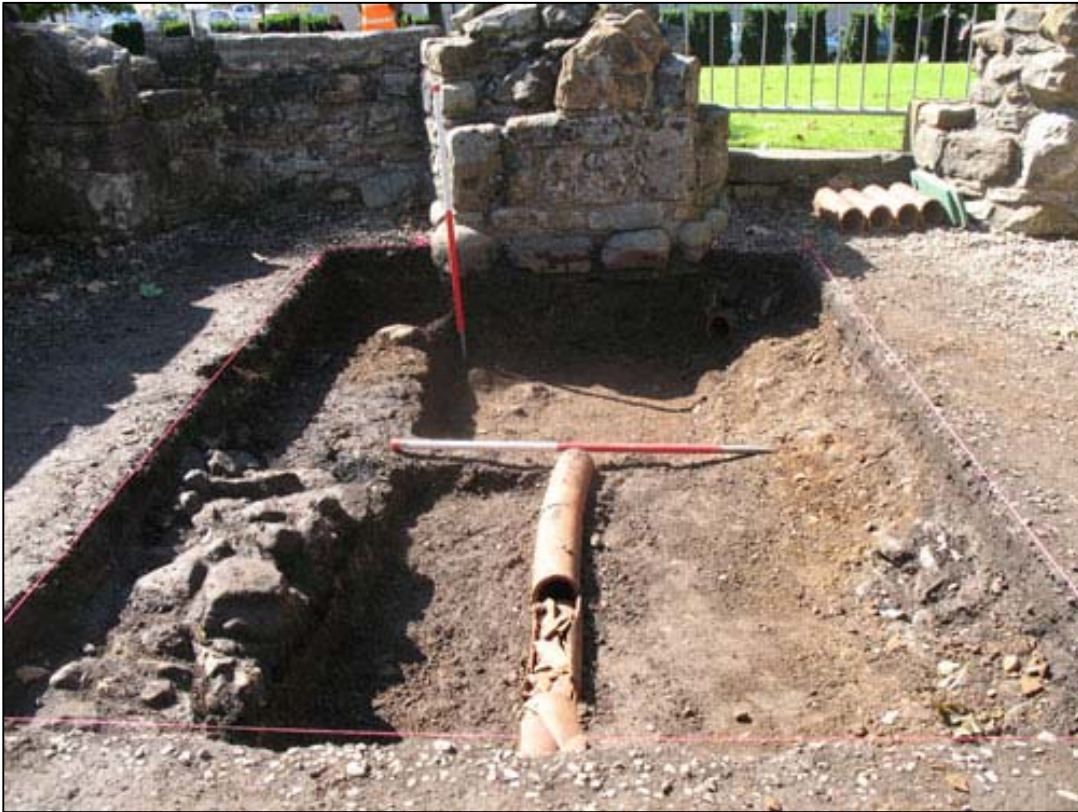
Figure 9a: Trench 6 from the east showing re-excavated shallow 1960s sondage

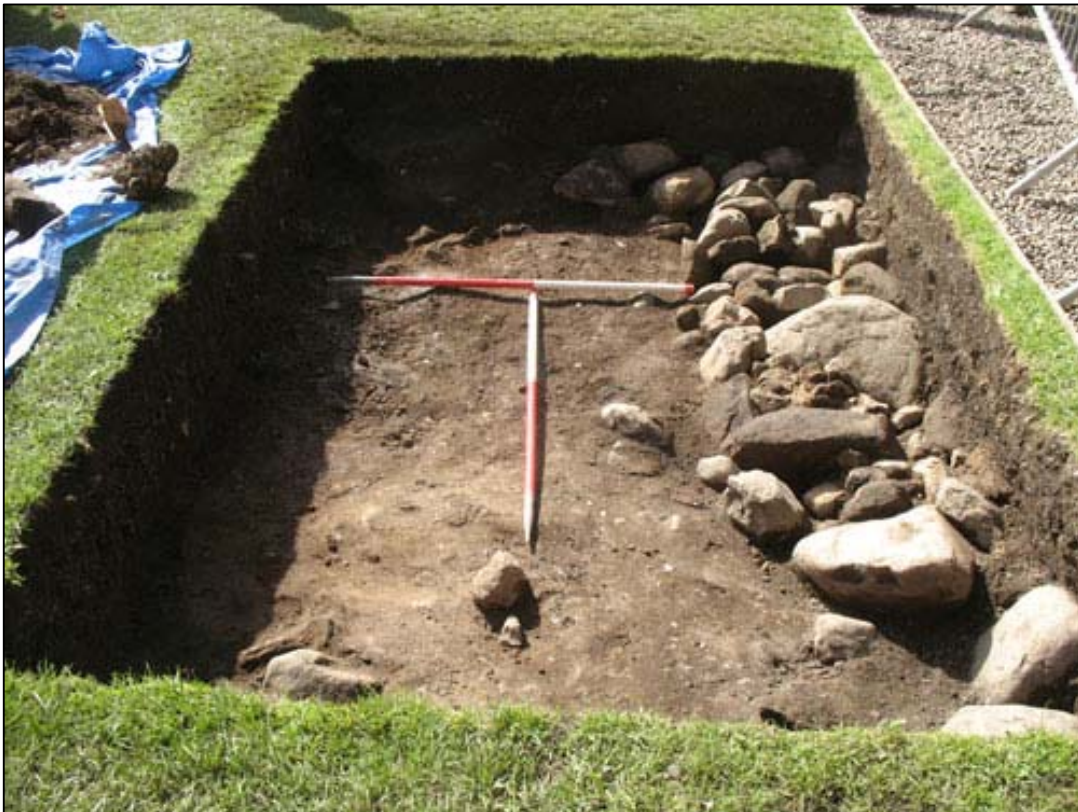
Figure 9b: Trench 9 from east showing irregular wall foundations

73. Trench 9 (Figure 9b) was placed in the northeast corner of the cloister garth to re-expose foundations of the possible cloister arcade. The trench was 3m by 2m in plan, aligned east to west, and was reduced through topsoil (901) until a possible foundation for the

cloister arcade (904) was exposed at 0.36m below ground surface.

74. The foundation (904) was aligned east to west and crossed the full length of the trench across its northern side. The foundation comprised of sub-rounded boulders and measured 0.65m wide. Subsequent removal of 1960s fill material (907) and (906) revealed there to be a cut [905] in the natural (902), and subsequent fill (903), for the foundation which was then left unexcavated. Natural subsoil (902) was also revealed in some areas of the trench although mainly the depth of the trench stopped at an interface which lay just above the natural. The trench was not excavated further and the lowest level was 0.45m below ground surface.
75. A range of 19<sup>th</sup> and 20<sup>th</sup> century and medieval pottery finds were recovered from the 1960s fill. Metal finds were also common, as were bone and glass. No sediment samples were recovered from this trench.

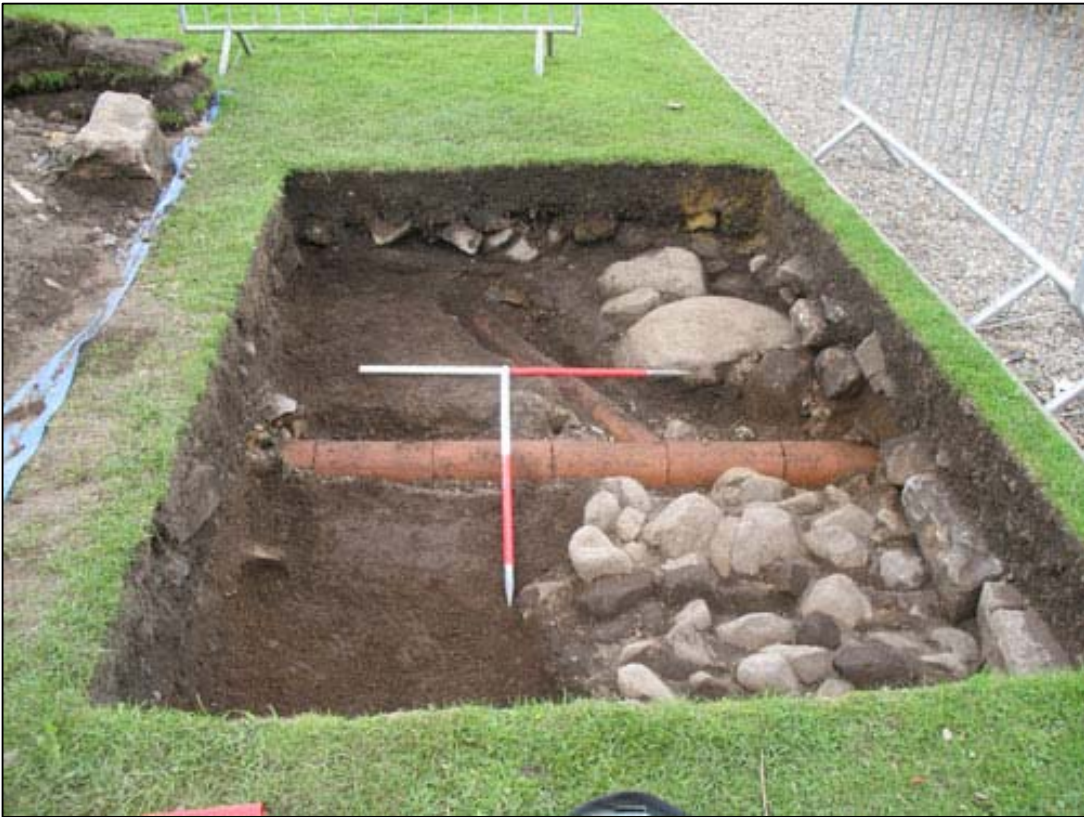
Figure 10a: Trench 10 from north showing wall foundation cut by later drains

76. Trench 10 (Figure 10a) was placed in the north-west corner of the cloister garth to re-expose the foundation of a possible cloister arcade. The trench was 3m by 2m, aligned north to south, and was reduced through topsoil (1001) and 1960s backfill (1002) and (1003) until the possible foundation layer of the Cloister arcade (1007) and (1008) was exposed. The foundation was aligned north to south and was cut in two by a modern field drain [1005].
77. A range of modern pottery, glass and metal finds were recovered from the 1960s fill as were bone, of which some were clearly disarticulated human skeletal material. Of particular note was a find of two inscribed pieces of slate <153>, one of which appears to have a Merelles game board scratched on it and the other with letters lightly scribed. No sediment samples were recovered from this trench.

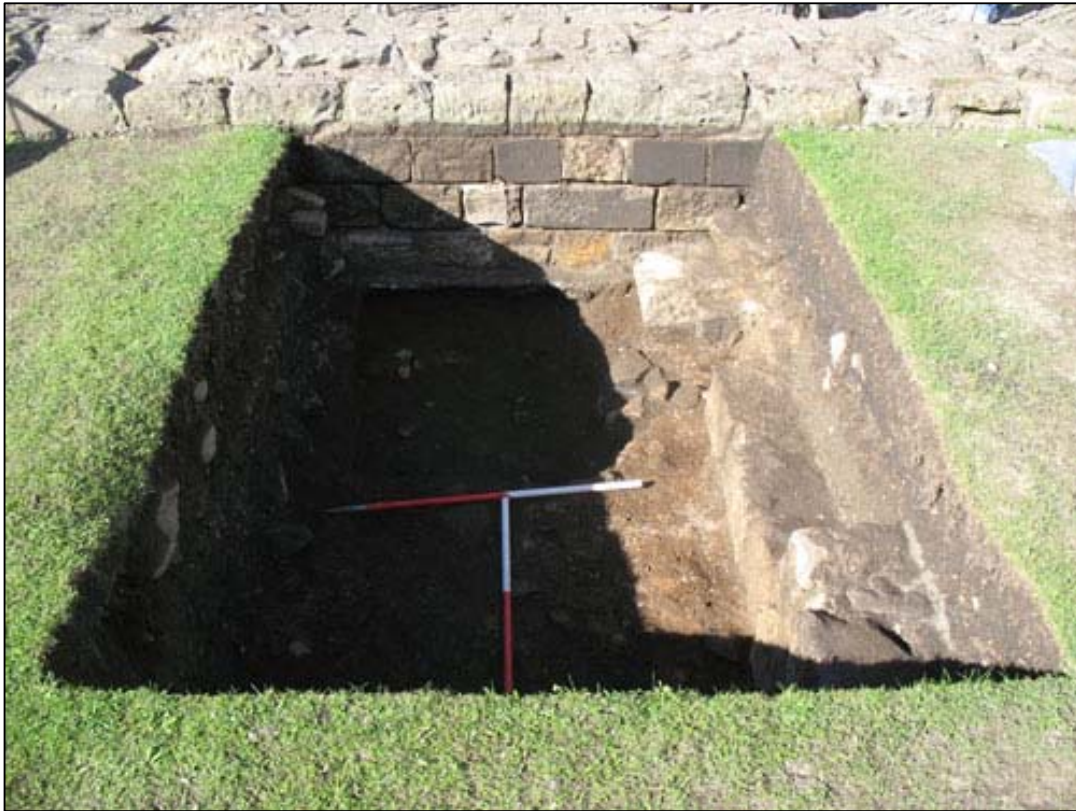
Figure 11a: Trench 14 looking north, note early wall in east face of trench

82. Trench 14 (Figure 11a) was placed to the immediate south of the internal face of the north wall of the south range. It was placed so as to expose foundations which may have been an internal division of the range. The trench measured 3m by 2m, aligned north to south and was reduced through topsoil (1401) and 1960s backfill material (1402) to (1405) and (1410) to (1411).

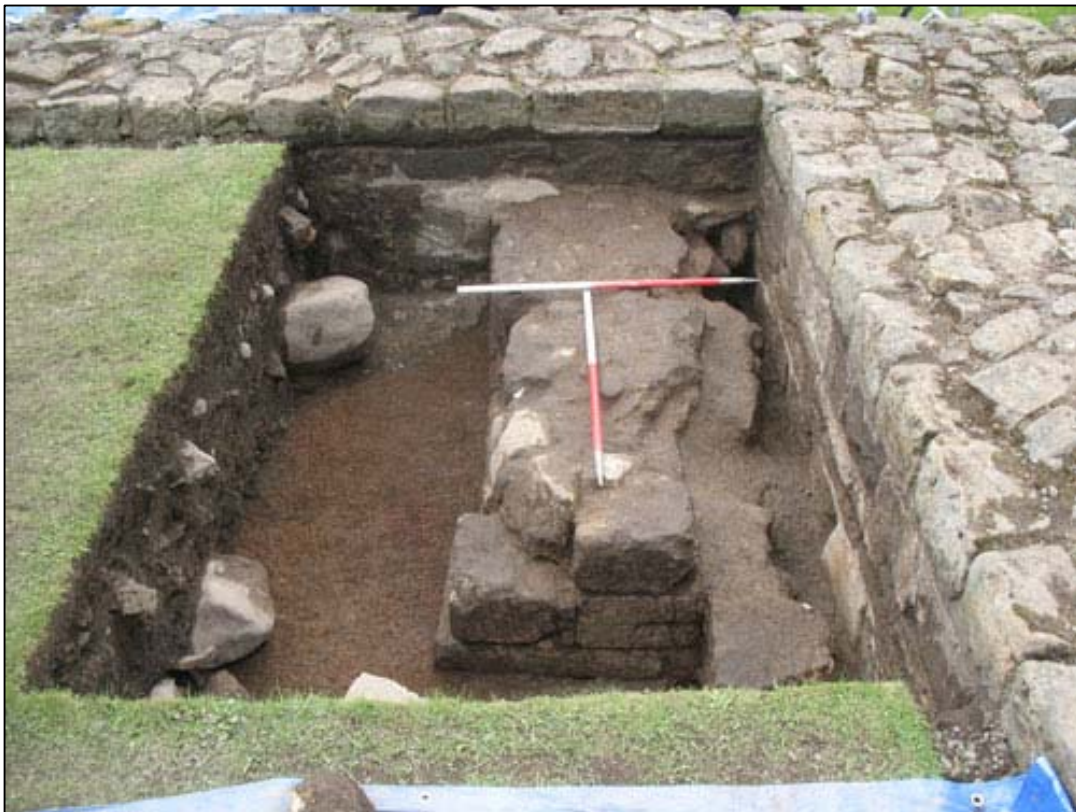
Figure 11b: Trench 15 looking west showing early wall

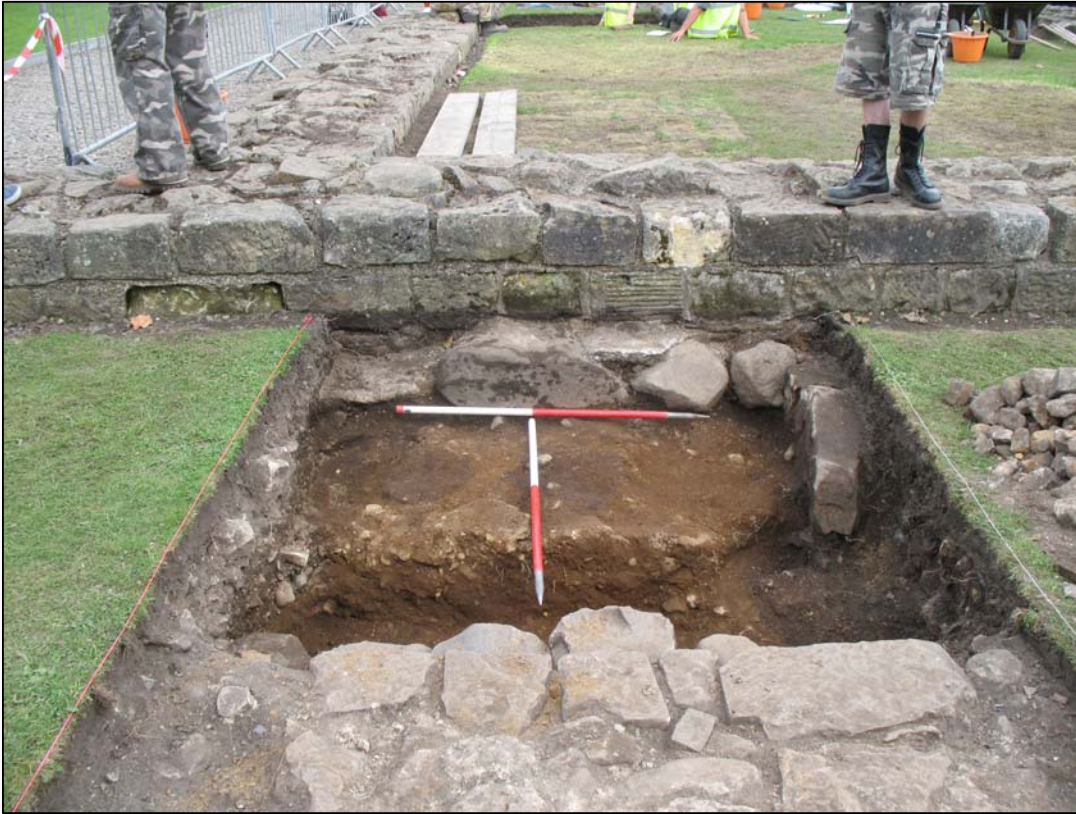
Figure 15a: Trench 16 from west with postholes (unexcavated) visible

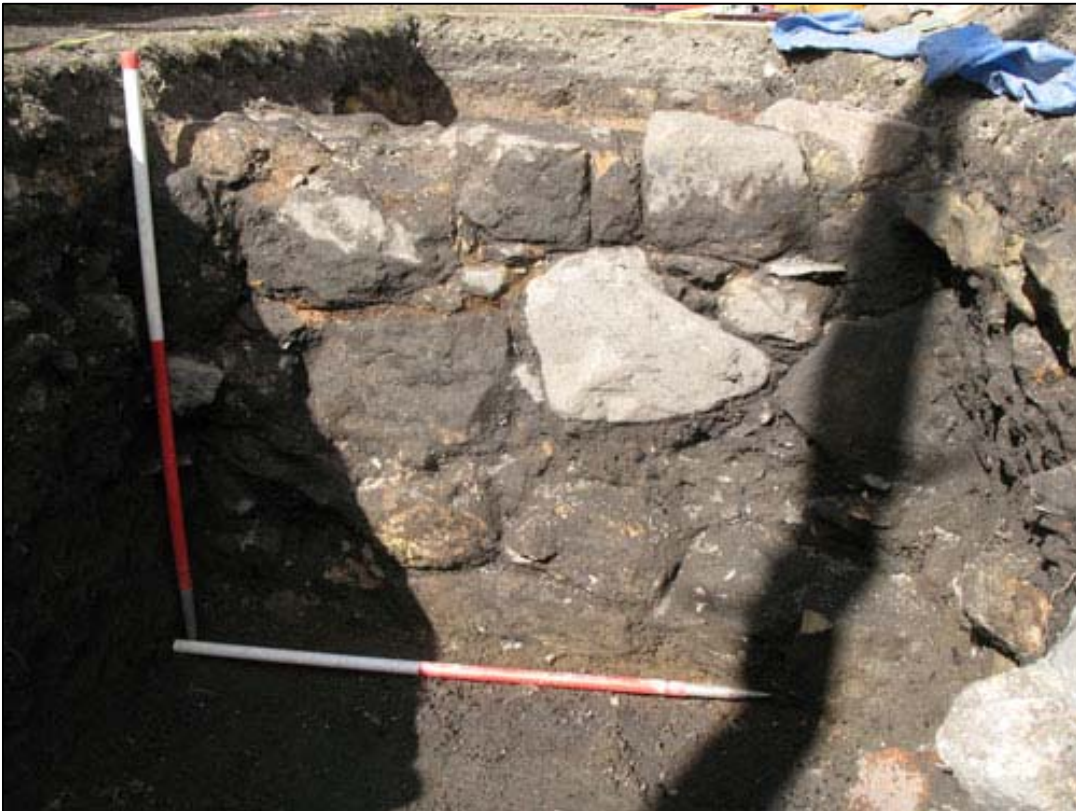
Figure 15b: Trench 17 from south showing surviving wall

104. Wall (1704) was, after deeper excavation, shown to be two walls one built above the other. Wall (1726) was exposed to a depth of approximately two courses beneath Wall (1704). Wall (1726) was at a slightly different alignment but both walls were composed of large, roughly cut, sandstone blocks. Wall (1704), maximum depth of 700mm, was initially interpreted as being the foundation courses of the tenement blocks known to have previously existed on site, however, the existence of Wall (1726), from 700mm to 1.1m depth, cannot be confidently be interpreted without further excavation. It is noteworthy that no cut could be seen in the section for either wall suggesting that they were in place before the area was brought to its existing level.
