# **Kilwinning Community Archaeology Project: 2011 Excavation Season**

Data Structure Report

issued 12<sup>th</sup> January 2012

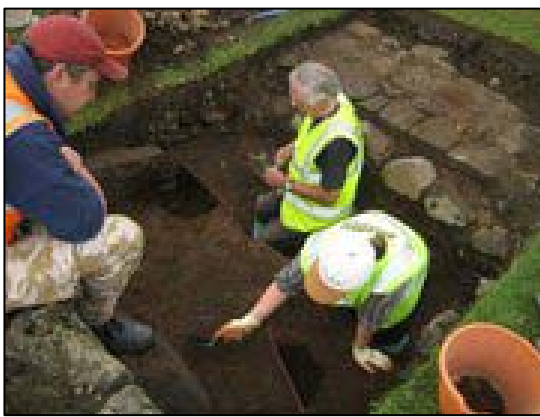
a: Post-holes under South Range

28. During these works medieval structural remains relating to the South Range of the Cloister were uncovered. This included the north and west wall of the refectory (the South Range) as well as a probable internal wall falling to the south that may derive from a subdivision of the range. In the same trenches a small number of postholes were also exposed, which suggest an early timber structure on the site, either contemporary to or pre-dating the Cloister. Excavations in the Cloister garth located two sections of the foundation for the Cloister arcade around the garth.

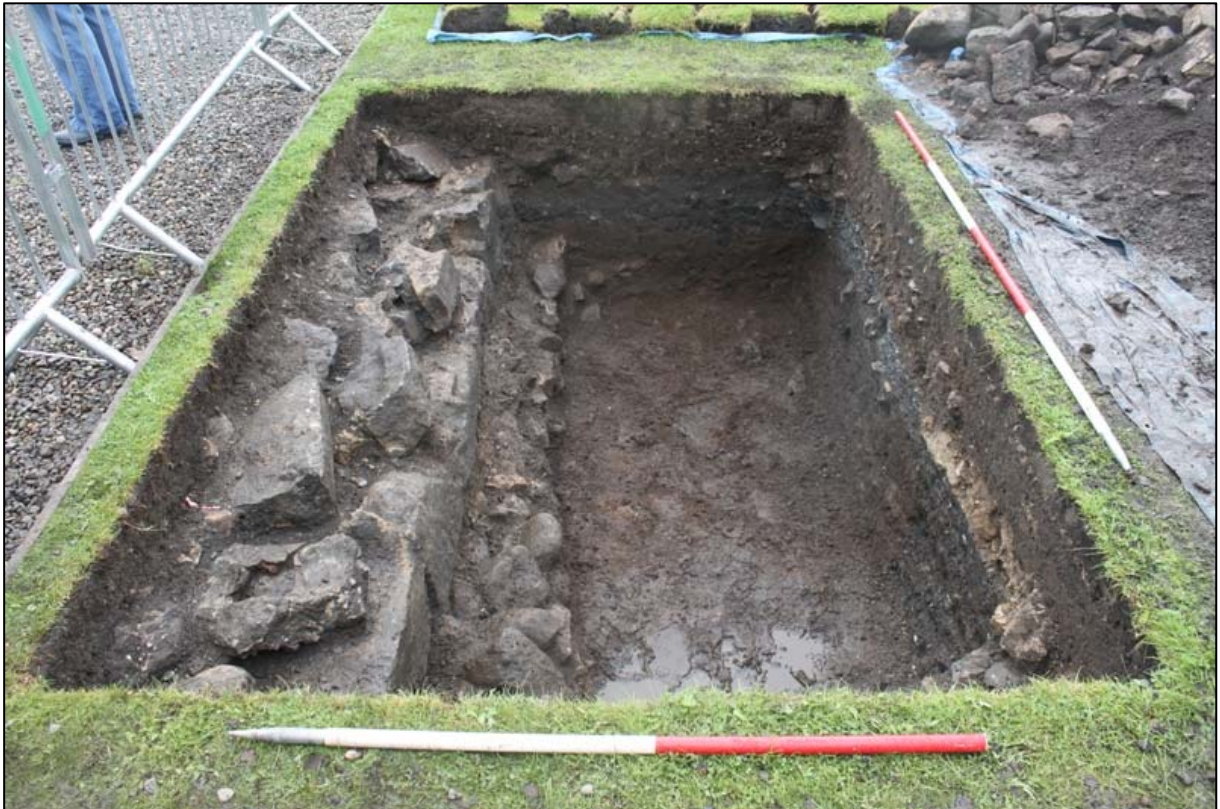
a: Trench 11 from east fully excavated

53. The trench was reduced through 150mm of loose dark-brown topsoil (1101) and 200mm of dark-brown silty sand material (1102) until the upper wallhead (1103) was located. The wall was aligned WSW to ENE and crossed the full length of the trench. The exposed section of the wall (1103) measured in maximum 0.6m wide and 0.5m in depth over two courses. The lower course consisted of rectangular shaped sandstone blocks while the upper course was a mixture of shaped sandstone and rubble. The wall was held together by cement mortar.

54. The wall sat on a bed of mortar with rubble foundations (1110) beneath. (1110) comprised of a mixture of angular and sub-angular stones in a matrix of mortar and compact clay. It ran the full length of the trench and extended north beyond the base of the wall (1103) by 0.33m. In revealing the north face of the wall multiple deposits (1114), [1115], (1104), (1105), (1116), (1106), (1107), (1108), (1112), [1111] and (1109) comprising drainage cuts and 1960s ground levelling were removed. (1109) was bottomed by a sondage which revealed a loose, sandy yellow-brown material thought to be natural (1113) at its base, 1.2m below ground surface. The trench was not excavated further and this was its lowest level (see Figure 7a).

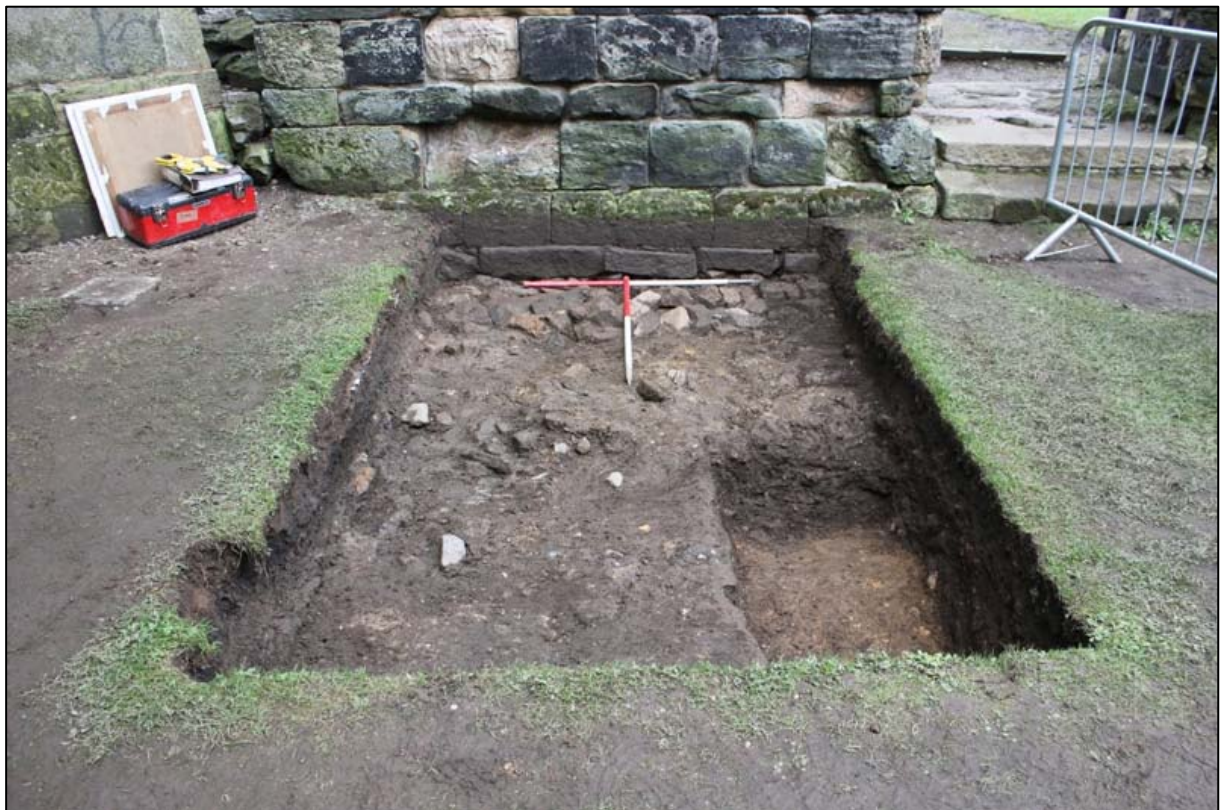
b: Trench 18 from west with sondage visible front right through (1806)(1810)

57. The uppermost horizon (1801) (topsoil and turf) was a loose mid-dark brown sandy silt and grass, 70mm deep. Removal of this exposed (1803) covering the whole of the trench. A loose, light-brown sand (1802) 50mm to 90mm deep was visible within the south facing section. This is a modern construction/levelling deposit above a plastic sheeting (only visible in section) and is attributed to modern service works in the area to the north of the trench. In contrast (1803) was loose mid-dark brown clayey silt 70mm deep containing rare coal/charcoal. Modern ceramics and glass with occasional medieval pottery sherds were removed from this deposit.

58. Excavation of (1803) exposed (1804) in the western and central areas of the trench – a compacted dark-reddish brown silty sandy clay, with pockets of light-brown sand. Large sandstone pieces/degraded sandstone and occasional areas of coal/charcoal were included within the deposit which was 170mm deep. Finds included modern and medieval pottery, bone, slate, metal, a fragment of wooden post, stone, glass, metal slag, slag, clay pipe, and shell. The mixed nature of this deposit would indicate that it is the result of backfilling or landscaping in the area, while the compacted nature suggests a layer of trample.

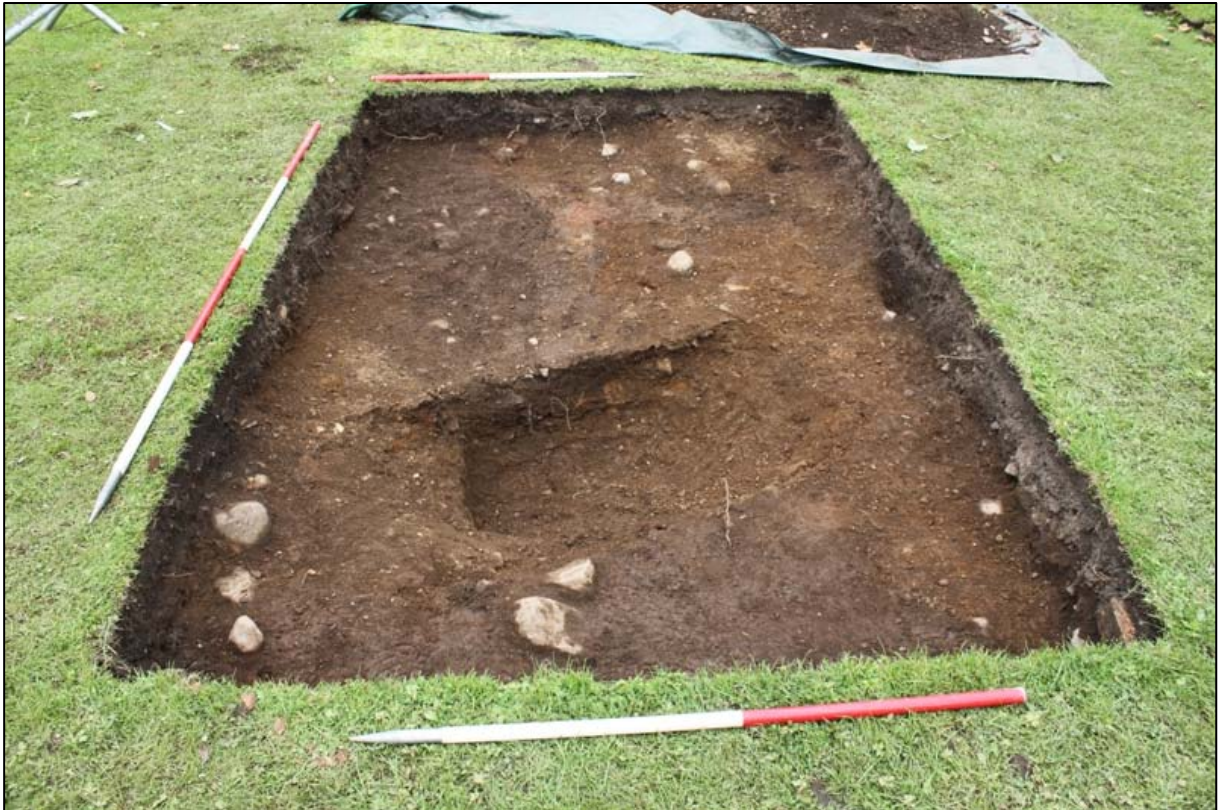
a: Trench 21 from east showing section through [2109]

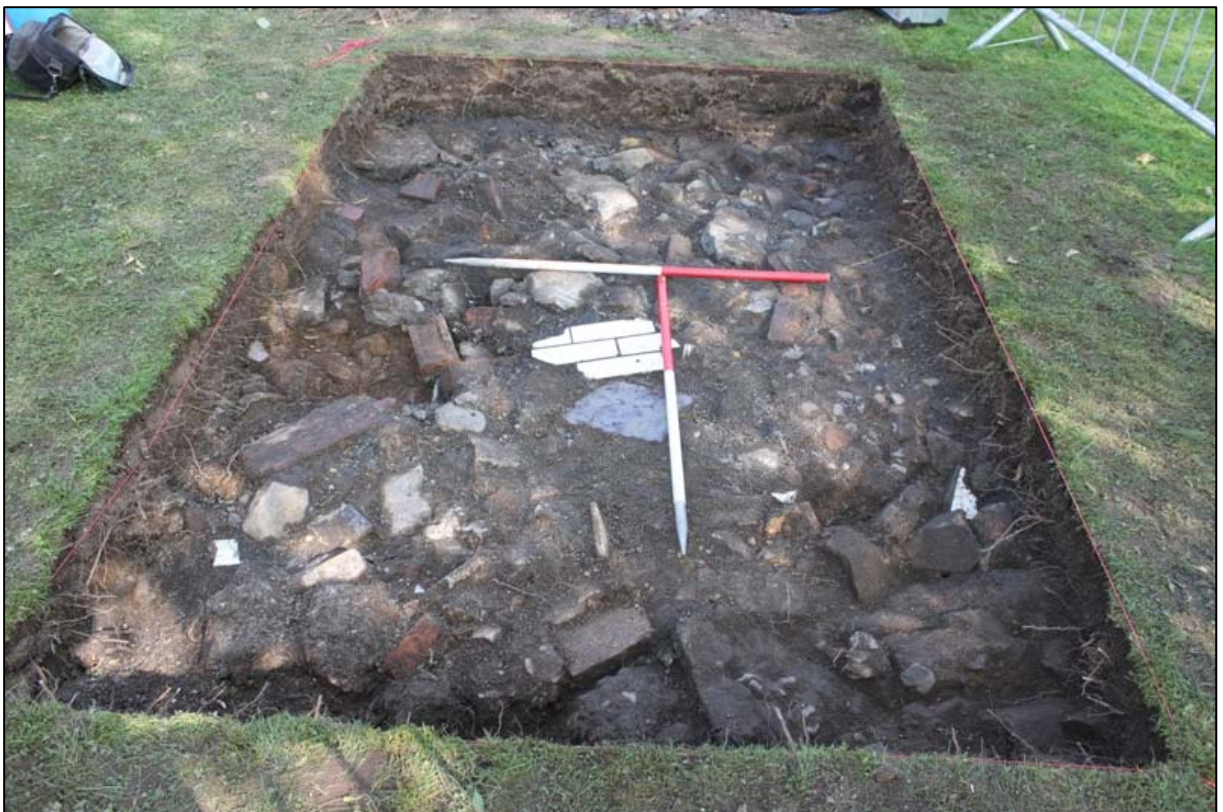
b: Upper surface of demolition rubble in Trench 22 from east

69. The turf and top soil (2201) was a fairly compact mid-brown silty sand level to a depth of 150mm sitting atop a layer of tightly compact twentieth century rubble (2202) – Figure 8b. A sondage was cut through the rubble to reveal the sandy gravel natural (2203) 100mm beneath. All of (2202) was then removed from the trench but no other archaeology was found.

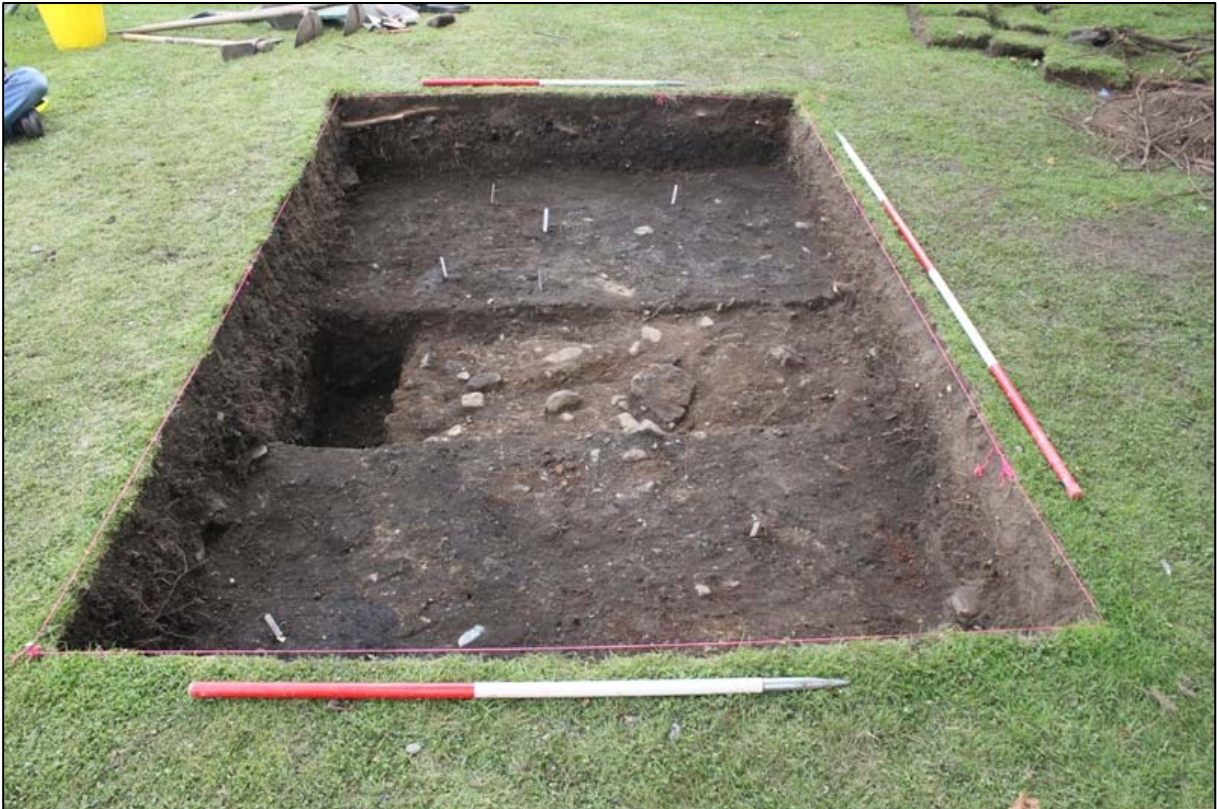
a: Trench 24 from north initial sondage to ascertain character of trench

72. The trench was reduced 350mm through loose dark-reddish brown/grey topsoil (2401) and a thin 50mm thick layer of hard compacted dark grey-black trample (2402). Investigation through the trample was undertaken by sondage (see Figure 9a) which clarified its shallow nature and supported subsequent excavation to expose (2403) a hard compacted yellowish red sandy gravel was exposed across the full bed of the trench (see Figure 9b). Several negative features [2405], [2407], [2408] and [2410] were discovered cutting into the gravel surface exposed at the 400mm depth:

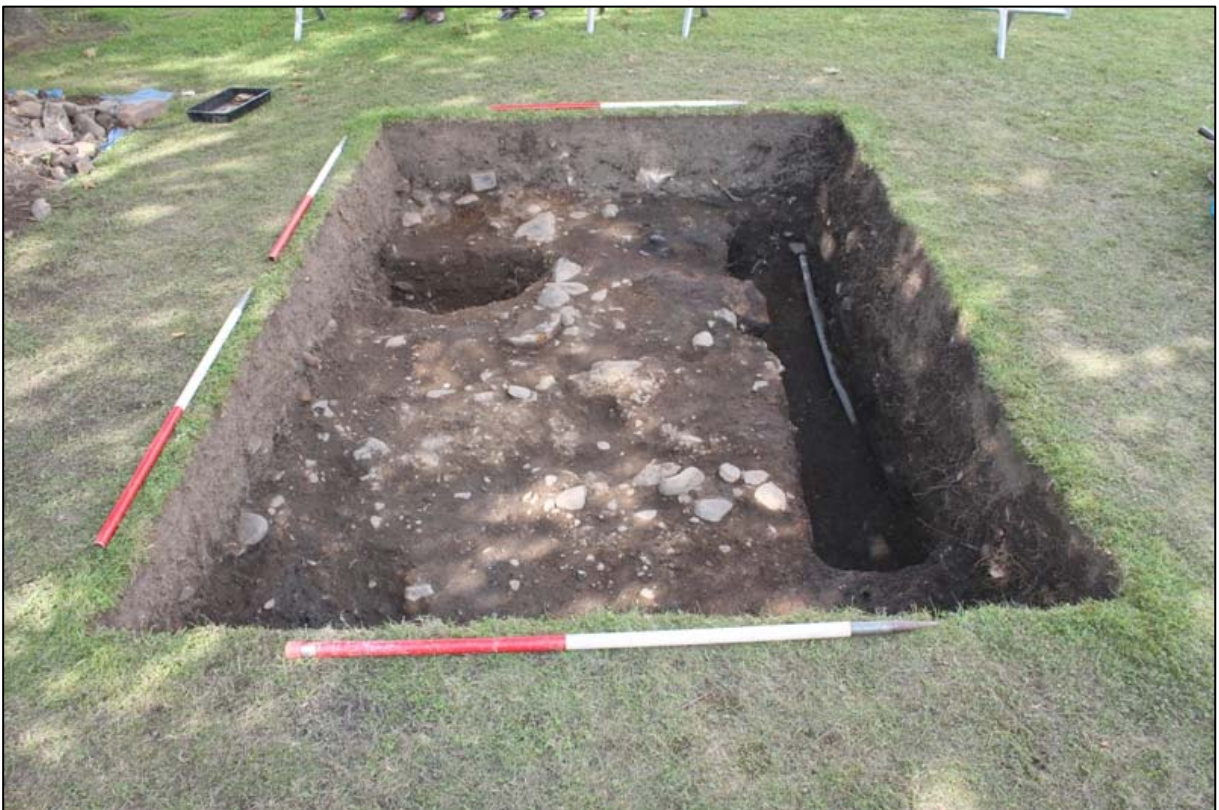
b: Trench 24 from south with features fully excavated including water pipe trench [2408]

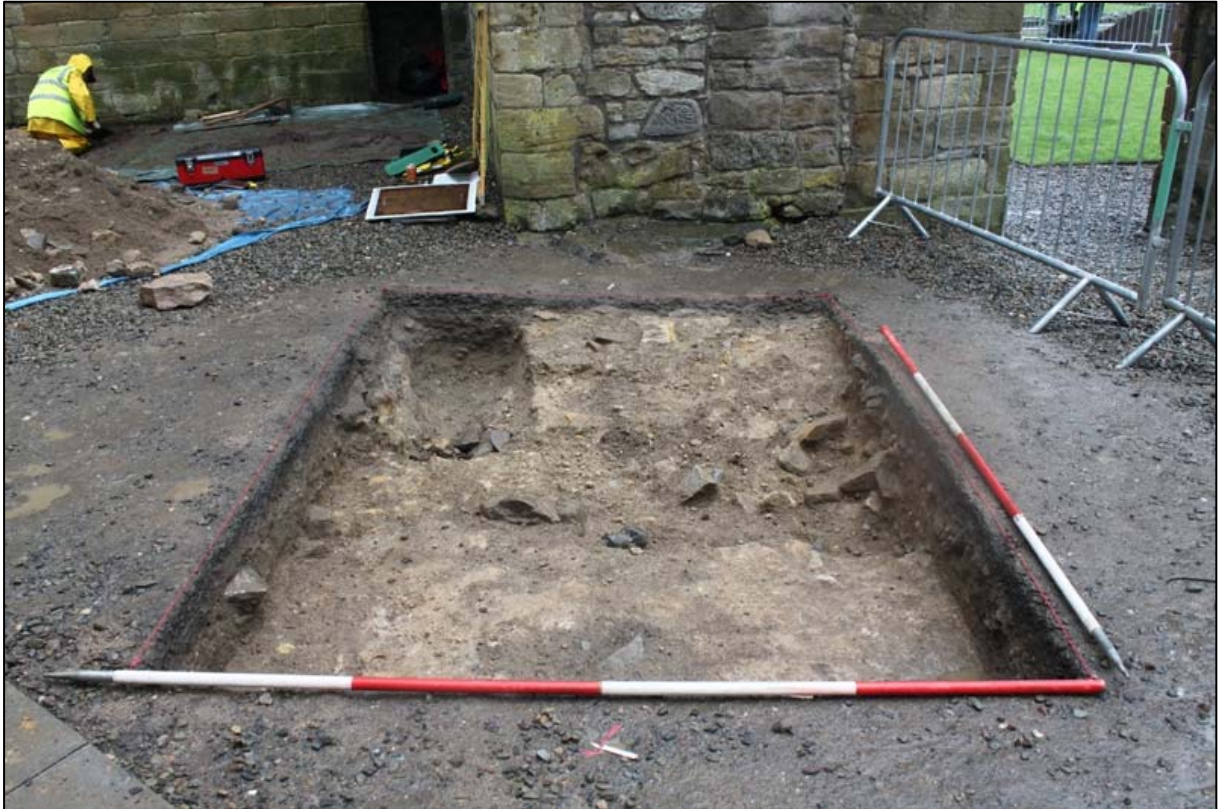
a: Trench 25 from north showing scale of modern disturbance

79. Pits [2510] and [2511] bottomed onto (2517), a very compact dark grey rubble which likely represented a medieval deposit although its exact date is unknown. It sat at a maximum depth of 630mm below ground level. The trench was not excavated further and this was the lowest level reached (Figure 10a).

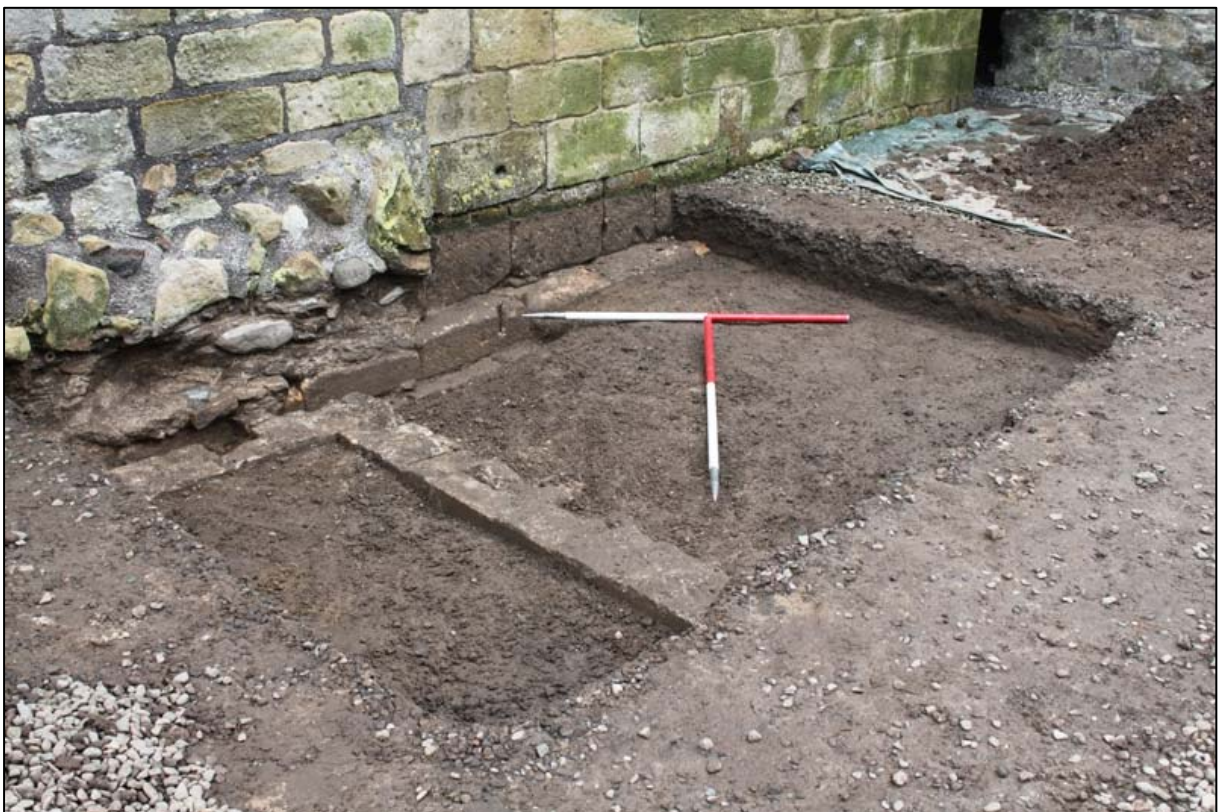
b: Trench 26 from northeast showing brick lair (2603) and South Transept wall

84. Excavation of the trench also revealed the base of the South Transept wall (2607) as well as the base of (2609). Both ran along the southern side of the trench with (2609) set into wall (2607) on the eastern side. (2609) consisted of mortar bonded yellow sandstone sub-round and sub-angular stones with human remains mortared *in situ* at the base. Both (2607) and (2609) sat on foundations (2608) at 0.27m below ground level. (2608) consisted of two courses of shaped sandstone blocks which were stepped and extended 0.3m out from the base of the wall above.

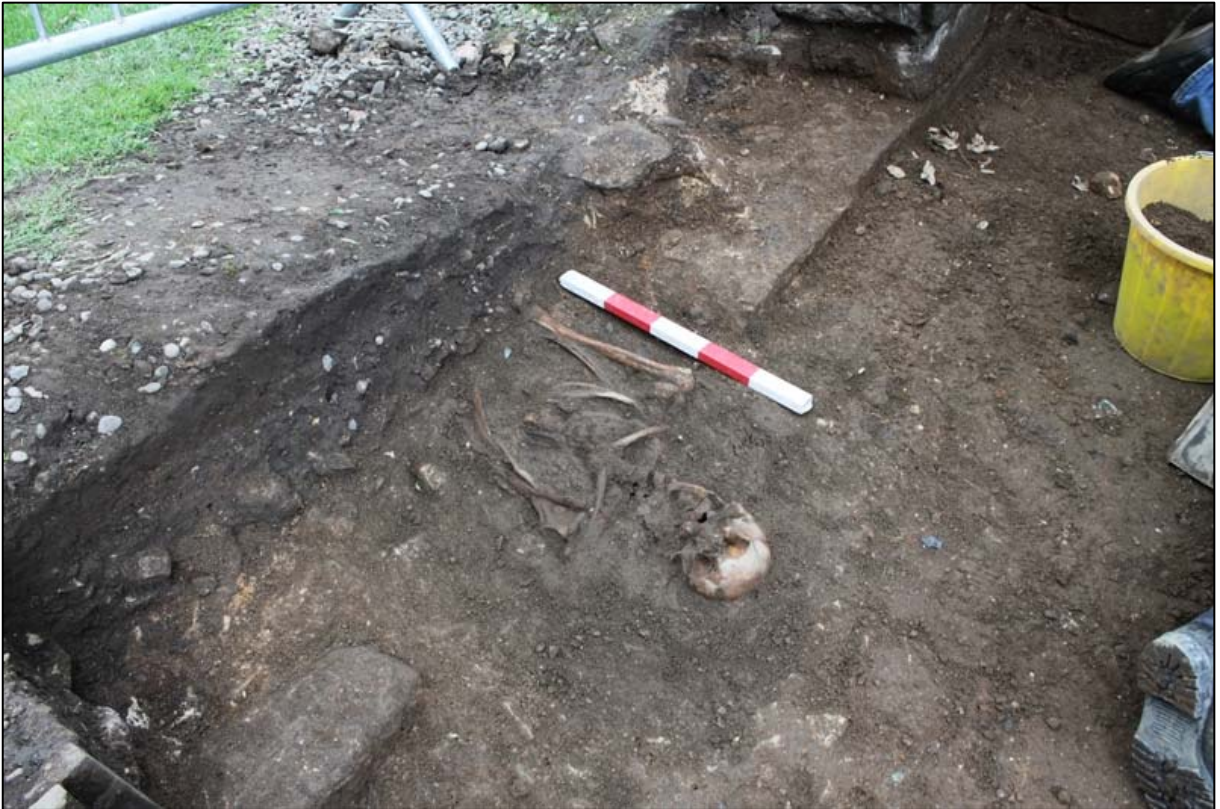
a: Trench 27 from northwest showing [2710] cut through eastern wall (2707)

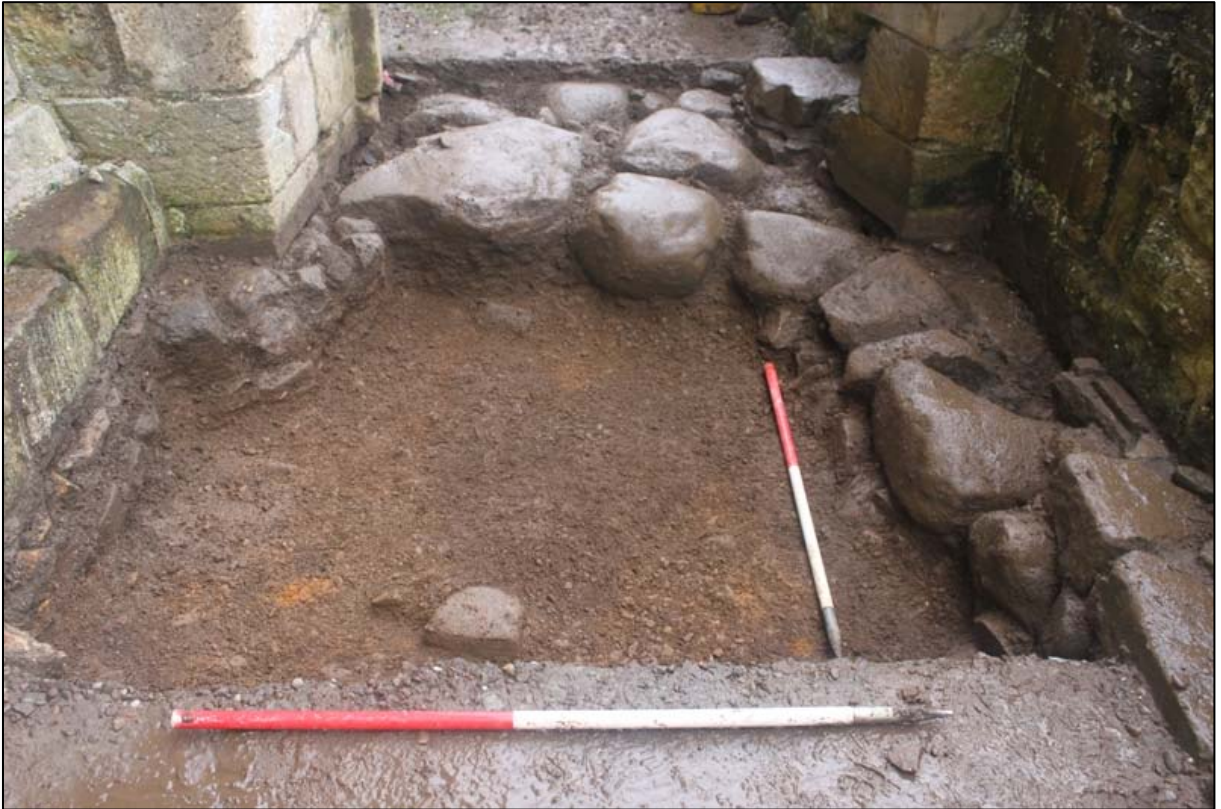
a: Trench 28 from west showing boulder foundations (2807) and (2808)

94. Beneath (2804) and across the western half of the trench was (2814) and (2818). (2814) was a medium to loosely compact dark reddish brown coarse silty sand while (2818) was a compact layer of reddish brown silty sand with rubble inclusions. Neither of these deposits were excavated although (2814) could potentially have been the natural subsoil (Figure 13a).

97. The foundations were all of a similar composition: a mixture of small to medium sized unworked angular and sub-angular grey and yellow sandstones varying in depth from 70mm to 350mm although some were not fully exposed. The maximum depth the trench reached was 430mm.

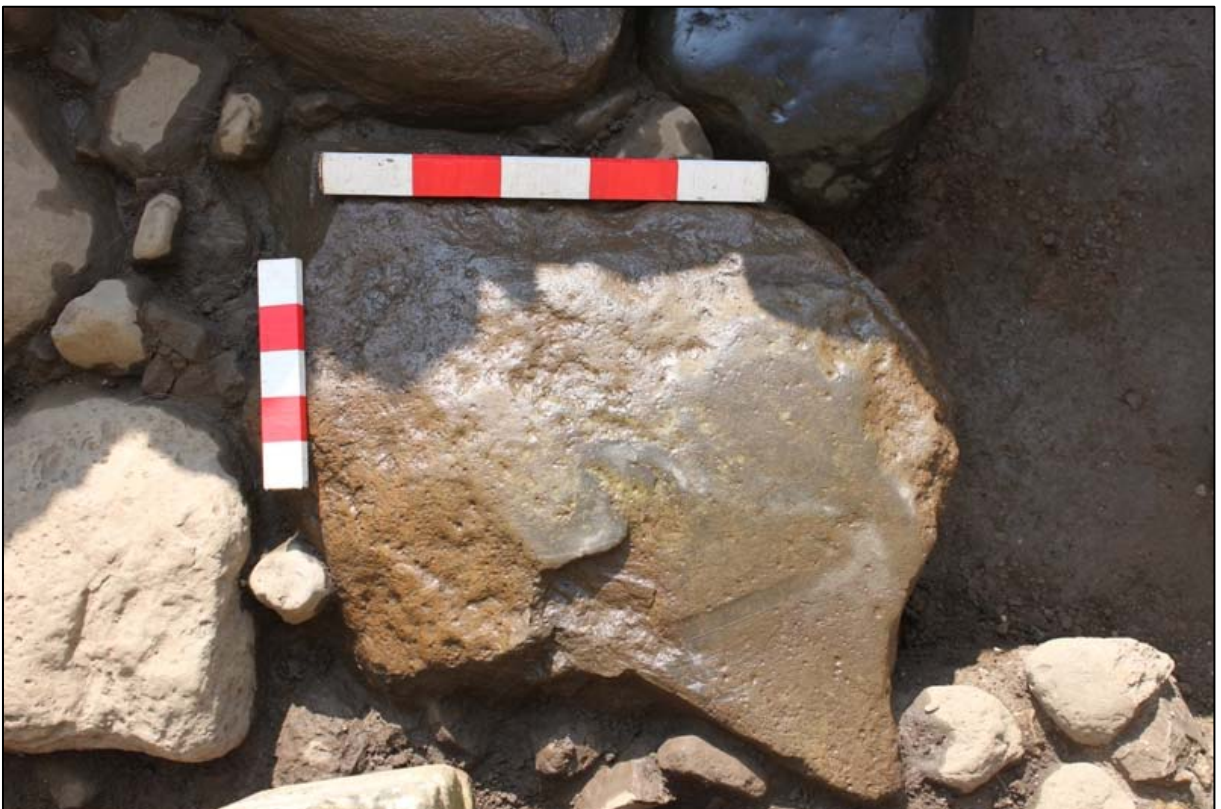
b: Trench 28 detail of abraded upper surface of boulder within (2808)

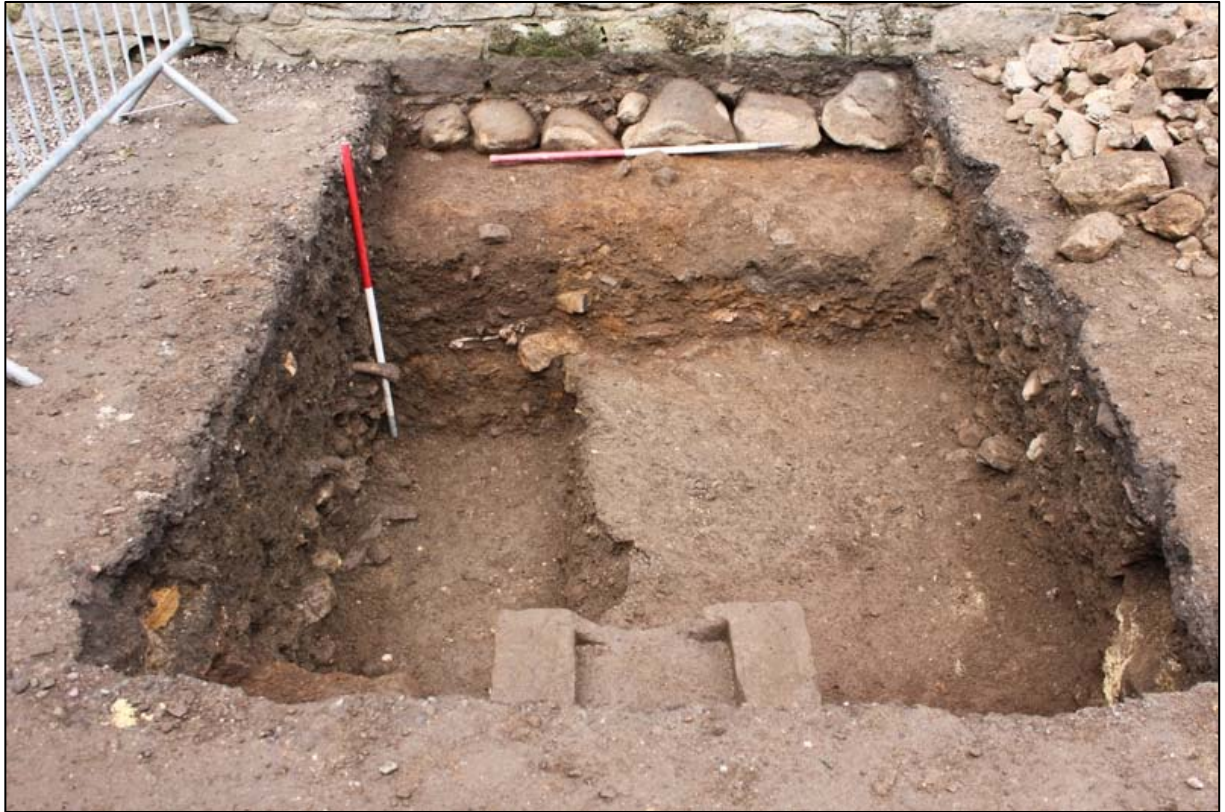
a: Trench 29 from south showing [2916] cutting through graves [2913][2915] to north

99. The reduction exposed the foundations of the northern Chapter House wall (2907) and the cut of a 1960s trench [2916]. (2907) consisted of large sub-angular and sub-rounded boulders with small stones mortared in and around the boulders to form the foundation for the north wall of the Chapter House. No evidence for the flooring was evident, nor any for benching along the wall.

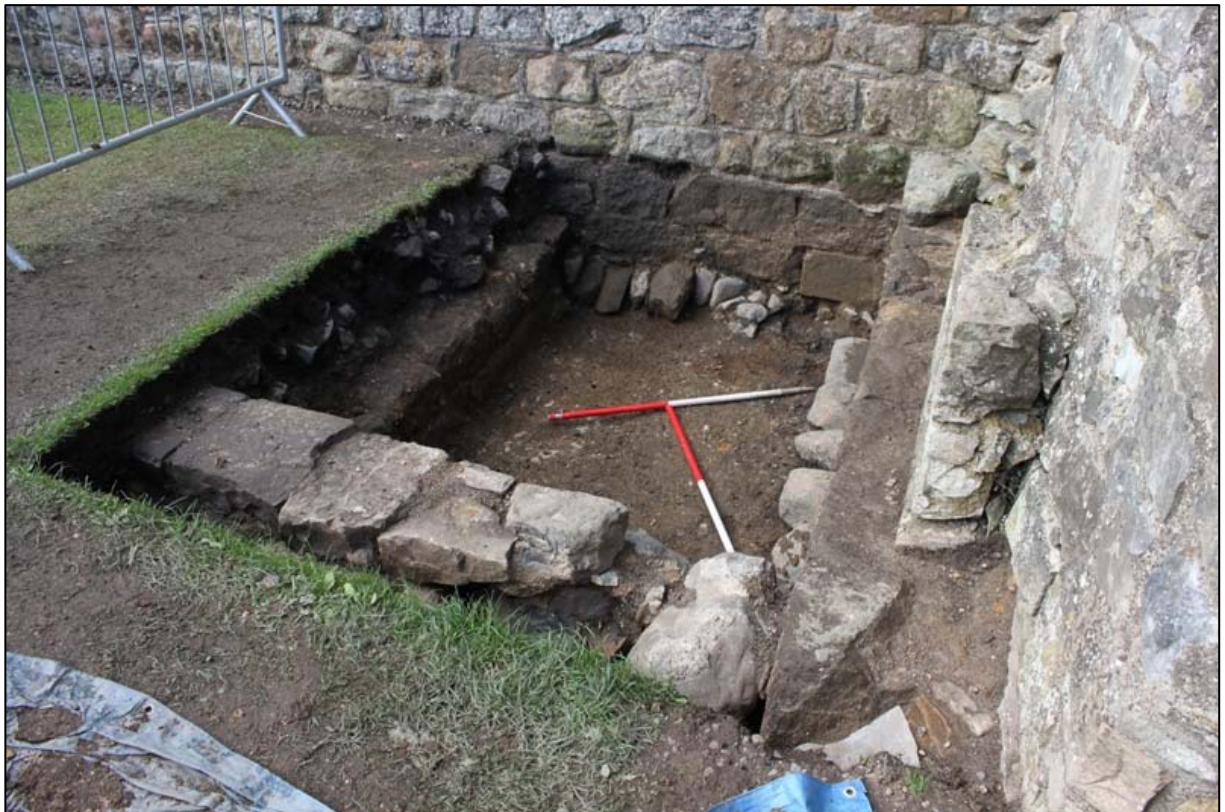
b: Trench 31 from southeast with walls (3105) and (3120) visible

117. Wall (3120) runs north-south along the east-facing section. Later wall (3105) sits on top of this wall. (3120) is rectangular blonde mortar bonded conglomerate sandstone blocks (range from 0.2m-0.92m by 0.15m-0.21m). The western edge of the wall is obscured by limits of excavation. Two courses visible as excavated. This feature extends from (3118) and possibly extends south beyond limits of excavation. It may have originally abutted (3118) but the connecting stone of the lower course is missing. The upper stone looks different and is not mortared in place, but an apparent recess just to the north indicates its possible location here at one time.

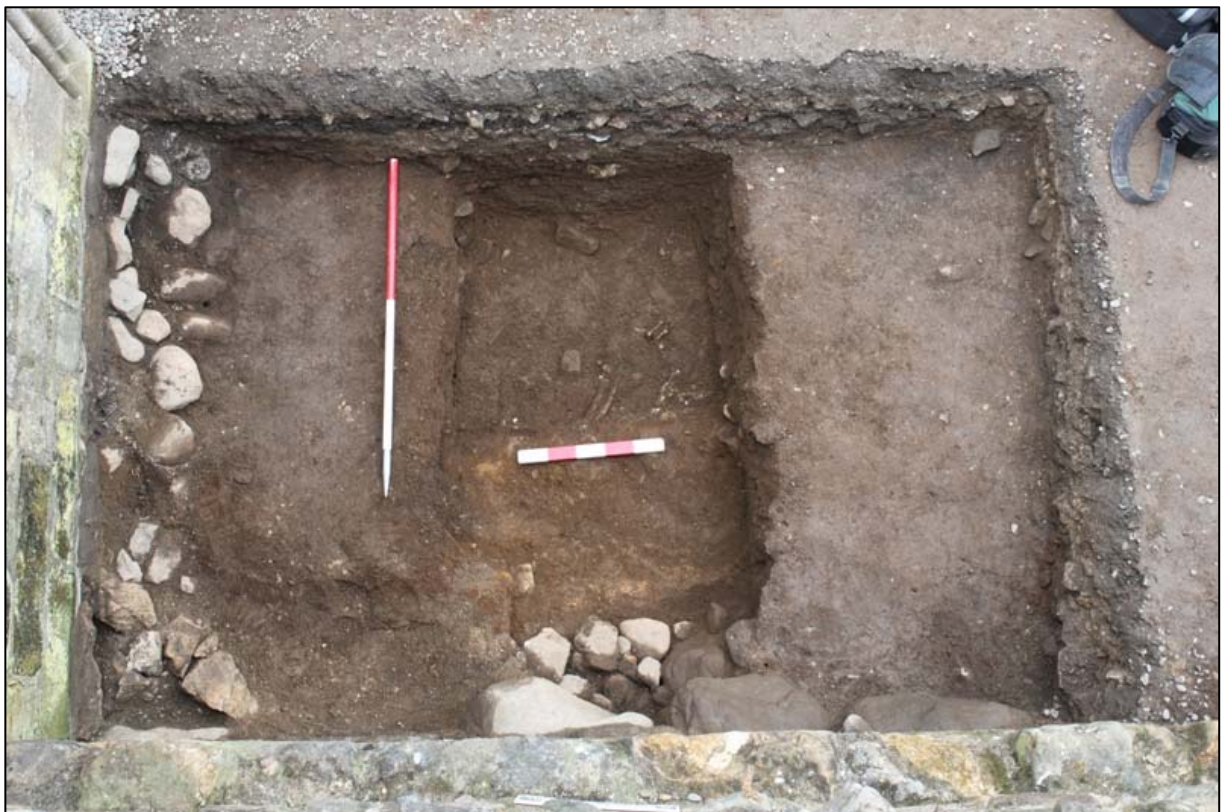
b: Trench 30 from above showing foundations, sondage and grave [3009]

105. Their removal revealed the lower reaches of (3012) the south wall of the Chapter House, (3014) the west wall of the Chapter House, and (3013) and (3015) the foundation layers of large boulders beneath these walls respectively. A sondage was dug through (3007) to reveal bedrock (3008), and [3009] a grave cut in the north side of the trench with (3010) a skeleton emerging from its upper surface. This skeleton was not excavated or disturbed further.

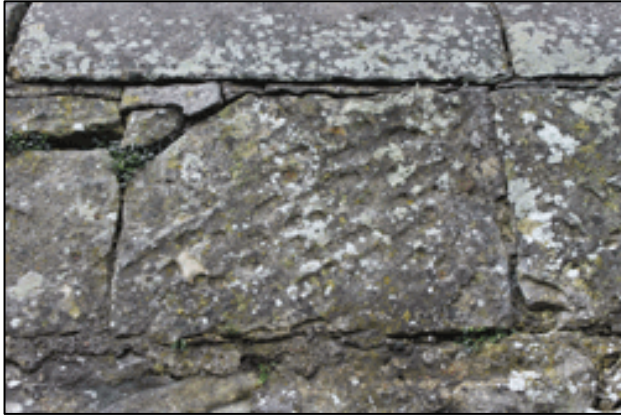
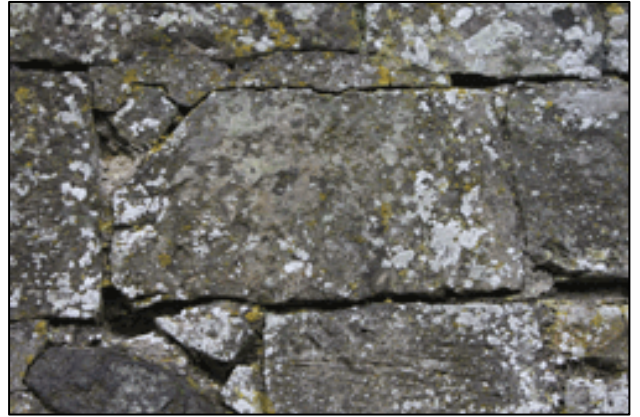
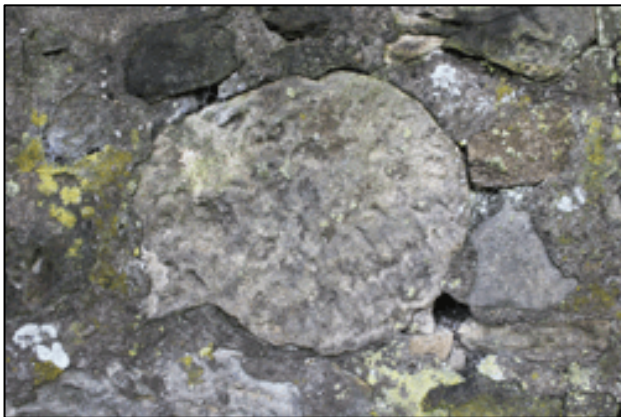
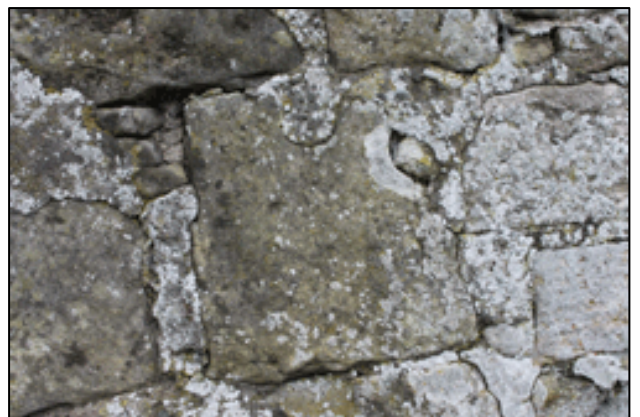
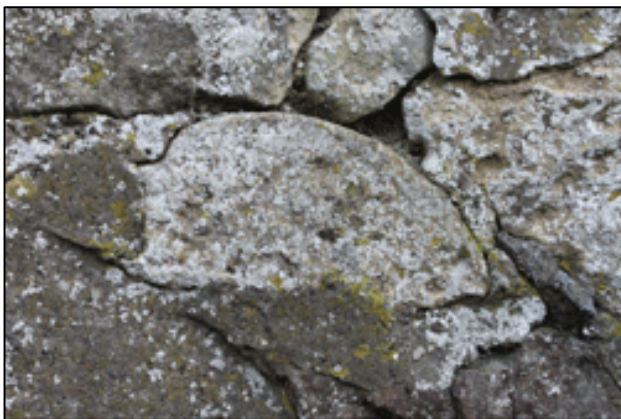
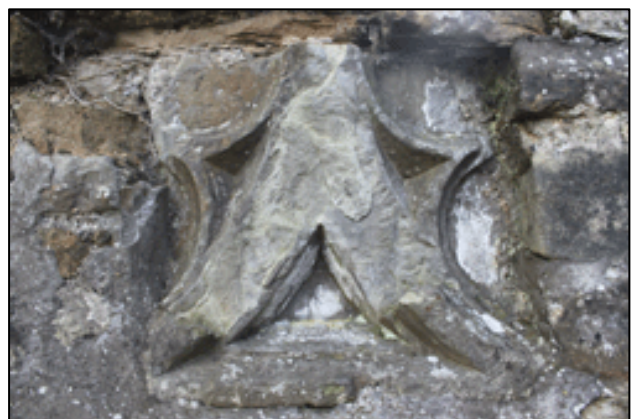
a: Stone with chamfered edge

b: Stone with chamfered edge

c: Shaft fragment

d: Fragment of roll moulding

e: Fragment of roll moulding

f: Fragment of blind arcade

Figure 19: Reused masonry fragments in graveyard wall

123. In total 22 fragments of shaped stonework were identified which could be placed under four main groupings: stones with a chamfered edge; fragments of column shaft; fragments of roll moulding and a piece which may have been part of a blind arcade. Thirteen pieces had a chamfered edge: the corner of the block has been cut off to create a surface, often found in the surrounds for a window or doorway. Six of the stones were possibly fragments from the shaft of a column or pier. Two possibly represent fragments of roll moulding: moulded decoration, often around windows or doorways, which is semi-circular in section. One fragment could possibly have been taken from a blind arcade: a series of arches with supporting piers or columns applied to a wall surface.

- f. The possible fragment from a blind arcade. Located on the exterior of the northern wall this comprised a roughly square block with a decorative motif carved into the centre. It measured 500mm wide and 460mm high and was located at 11.4m away the east end of the wall and 1.09m up from ground level.

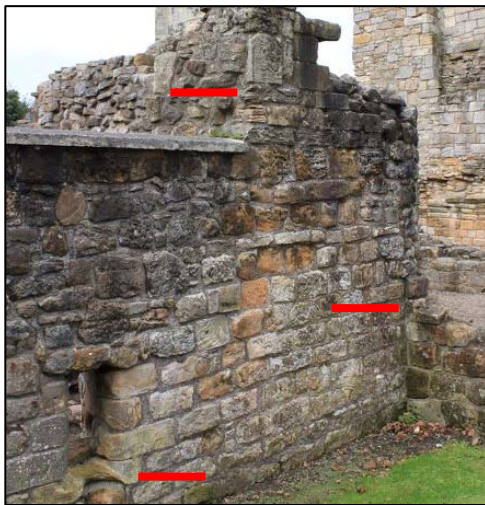
a: Three level of window cills

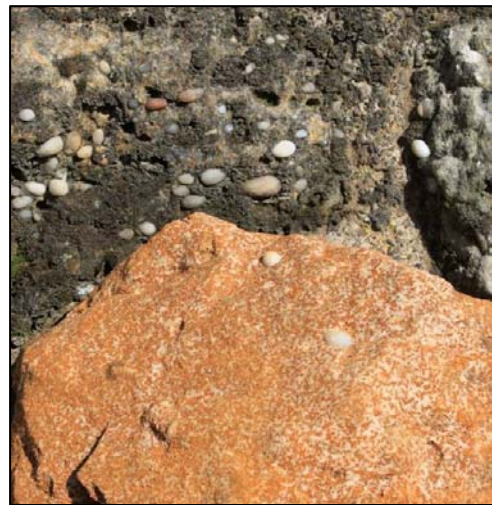
b: Weathered and fresh conglomerate

143. The facade of the East Range is dominated by the use of conglomerate blocks. These sandstone blocks are generally viewed as being challenging to work due to the frequent beds of smaller stones incorporated within them. However, the colour of the fresh split stone gives pause for thought as to how remarkable it would have looked as opposed to the dull masonry now visible (Figure 20b). In turn this suggests that this portion of the Cloisters at least was not subject to limewash.
