**Ardrossan Castle, Ardrossan, North Ayrshire:
Archaeological Watching Brief**

Data Structure Report

by Calum Henderson

issued 16th July 2012

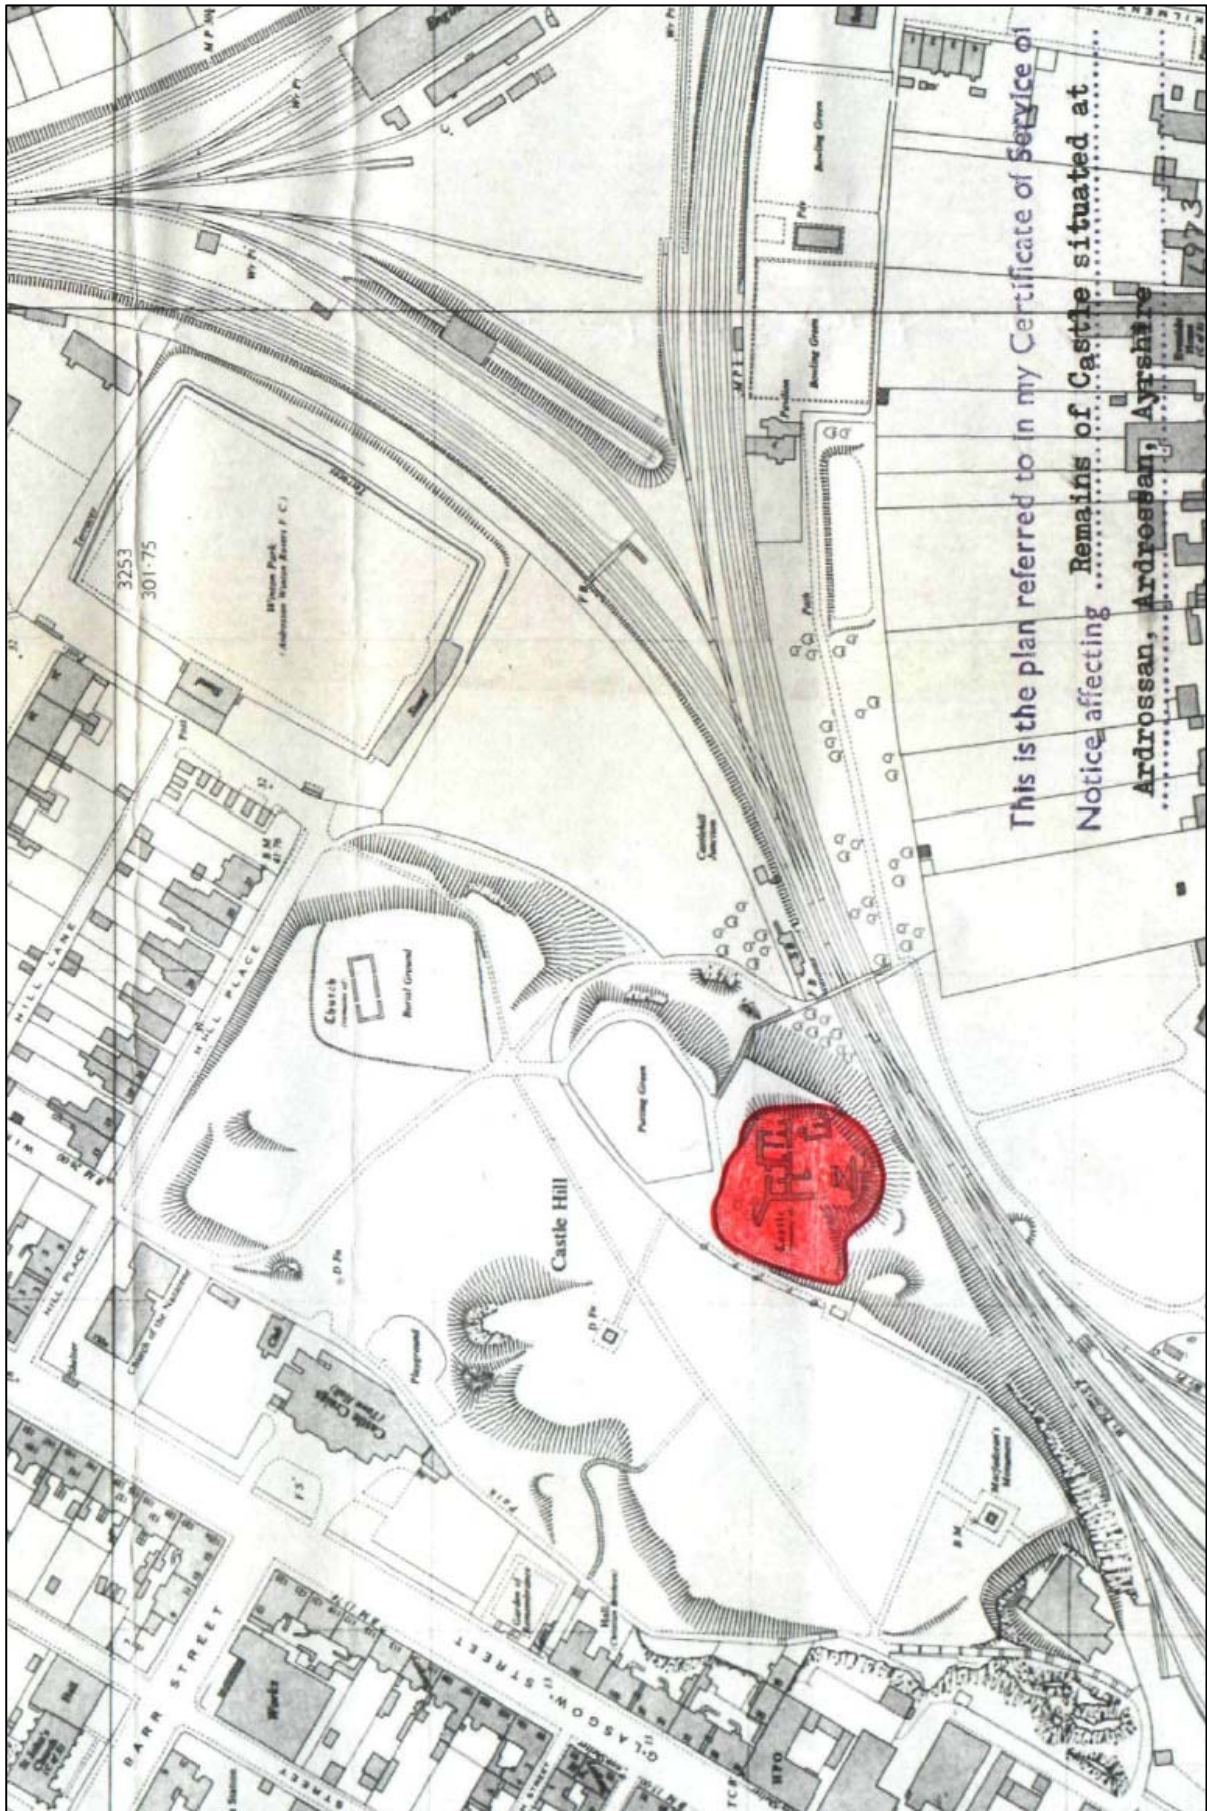
8. Ardrossan Castle is a scheduled monument (see Figure 1) under the terms of the Ancient Monuments and Archaeological Areas Act 1979 reflecting its National Importance, and a grade B Listed Building. Castle Hill is in the ownership of North Ayrshire Council; none of the works are programmed to occur within the scheduled area.

Figure 1: Scheduled Monument

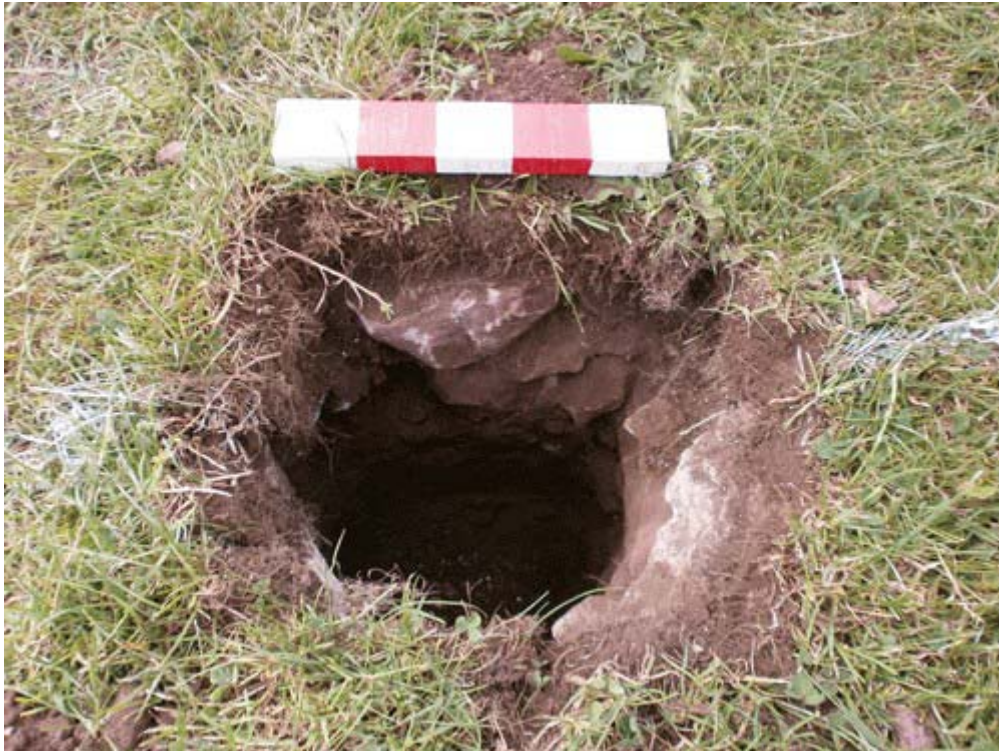
19. Towards the NE of the castle, findings within post holes 13–24 continued to be largely consistent with previous work. Occasionally the post holes were placed directly against the wall [004] revealing its lower foundations ending directly above natural subsoil (003) at a depth of 400–450mm. Post hole 24, located approximately 6m NE of the end of wall [004], contained a possible wall foundation [008] below topsoil (001) (see Figure 4a). This was composed of large water-worn boulders and rough sandstone chunks and bound by a sandy mortar. There were also fragments of limpet, razor and periwinkle shells in the wall fabric. Wall [008] also appeared in post hole 25 approximately 3m SE of post hole 24 but nowhere else. Again, foundations for [008] ended above natural subsoil (003) at a similar depth seen previously with [004].

Figure 4a: Shot of potential wall [008] within posthole 24.

23. During monitoring no archaeological features of any significance were discovered. The foundation wall within post-hole 24 and 25 [008] contained a sandy mortar that is relatively modern in date and sits above natural subsoil (003) sharing much of the same characteristics as wall [004]. The NE of the castle appears to have been heavily landscaped resulting in the discovery of made up ground deposits (009) and (011). This likely relates to work carried out in the early 20th century to clear debris from the area and restore and point walls. Indeed, made ground deposit (009) contains abundant fragments of pink sandstone which is presumably the reuse of rubble fragments of the castle itself. The made ground deposit (002) found along wall [004] also likely relates to this period of restoration. Indeed, the wall [004] appears to have been repaired, rebuilt and re-pointed several times, and dates back to at least the mid 19th century as seen on the First Edition Ordnance Survey (1858) (see Figure 2b).

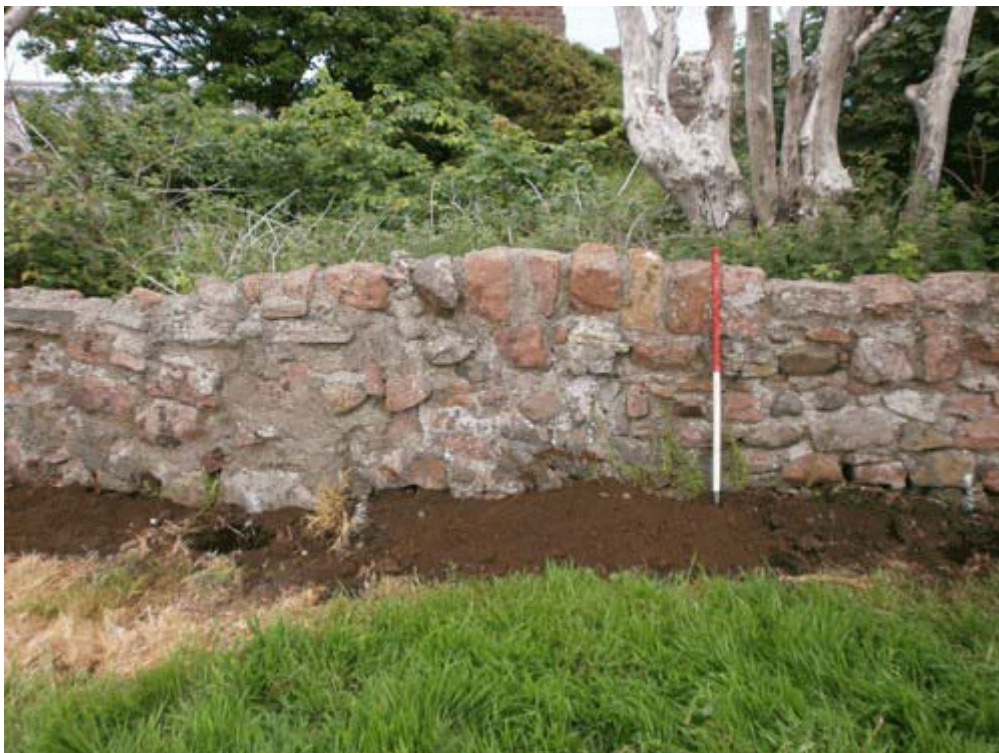
18. During initial monitoring the majority of post holes (1–12) at the SW extent of wall [004] contained natural subsoil (003), a loose light brown silt sand with frequent small angular stone inclusions. This was sealed by a made ground deposit (002) composed of loose mid greyish brown silt/sand with abundant inclusions of ash, occasional modern glass, cloth, plastic and small stones. This was overlain by a loose topsoil (001) composed of a light brown silt/sand with small to medium stone inclusions. In some of the post-holes (6–12) the topsoil became more sand based (005), with some (6, 7, 8 and 12) containing thin bands of demolition material (006). The wall [004] is 1–1.4m high, composed of small, medium and large red sandstone blocks, bound with a sandy mortar and has 5–8 irregular courses (see Figure 4b). Also, it appears to have been repaired and rebuilt along its length and survives at its best condition at the SE.

Figure 4b: Shot of post holes running alongside upstanding wall [004] surrounding Ardrossan Castle.
