89 Duke Street, Leith, Edinburgh: Archaeological Mitigation

Data Structure Report

issued 7th November 2014

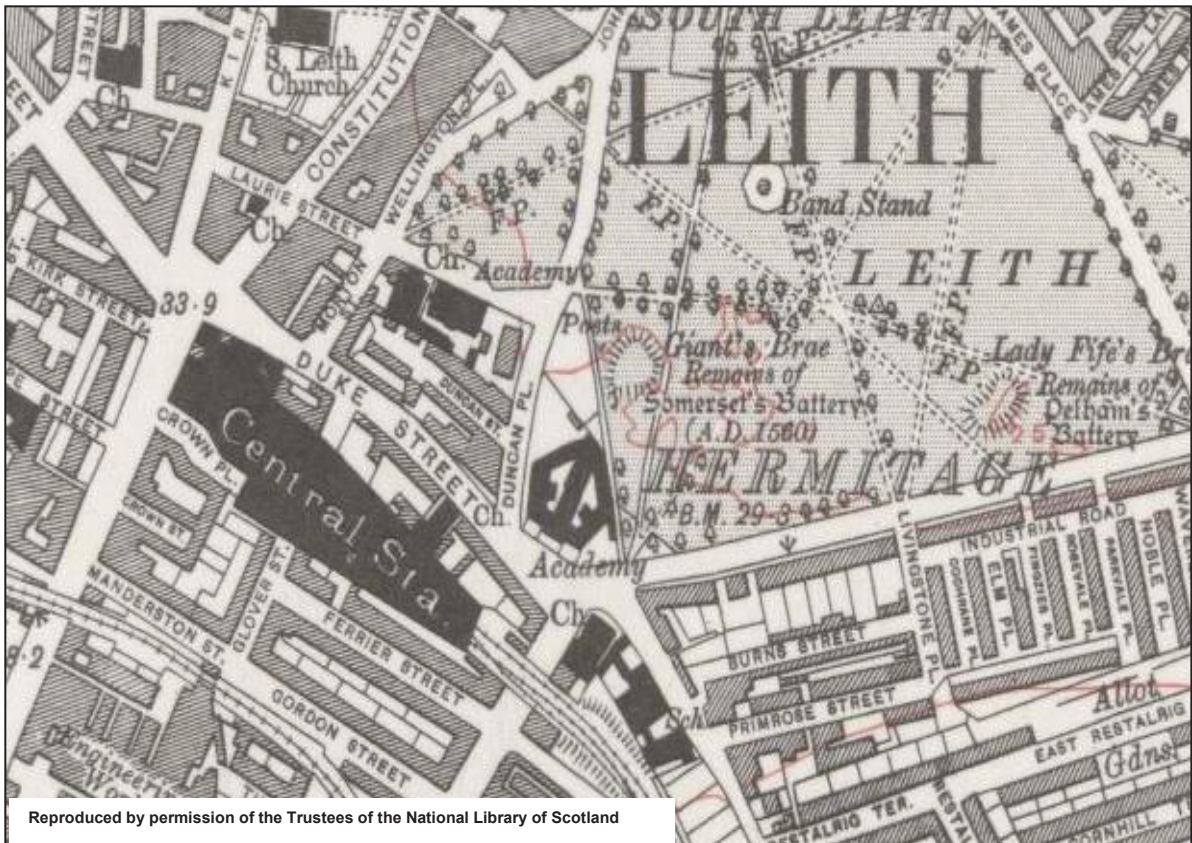
Figure 2a: Extract from the 6 inch 4th edition Ordnance Survey (1935)

7. The B listed Leith Academy Secondary School was designed by G Reid & J Smith Forbes and built between 1930 and 1931 (Figure 2a). The new school was a monumental 3-storey symmetrical classically detailed school of hollow pentagon-plan with a hall cutting across the central courtyard and built of red brick with cream sandstone ashlar ground floor and dressings. The school subsequently became the Leith Campus of the Queen Margaret College in 1993, but has since been disposed of as the College moved to a new purpose built campus.

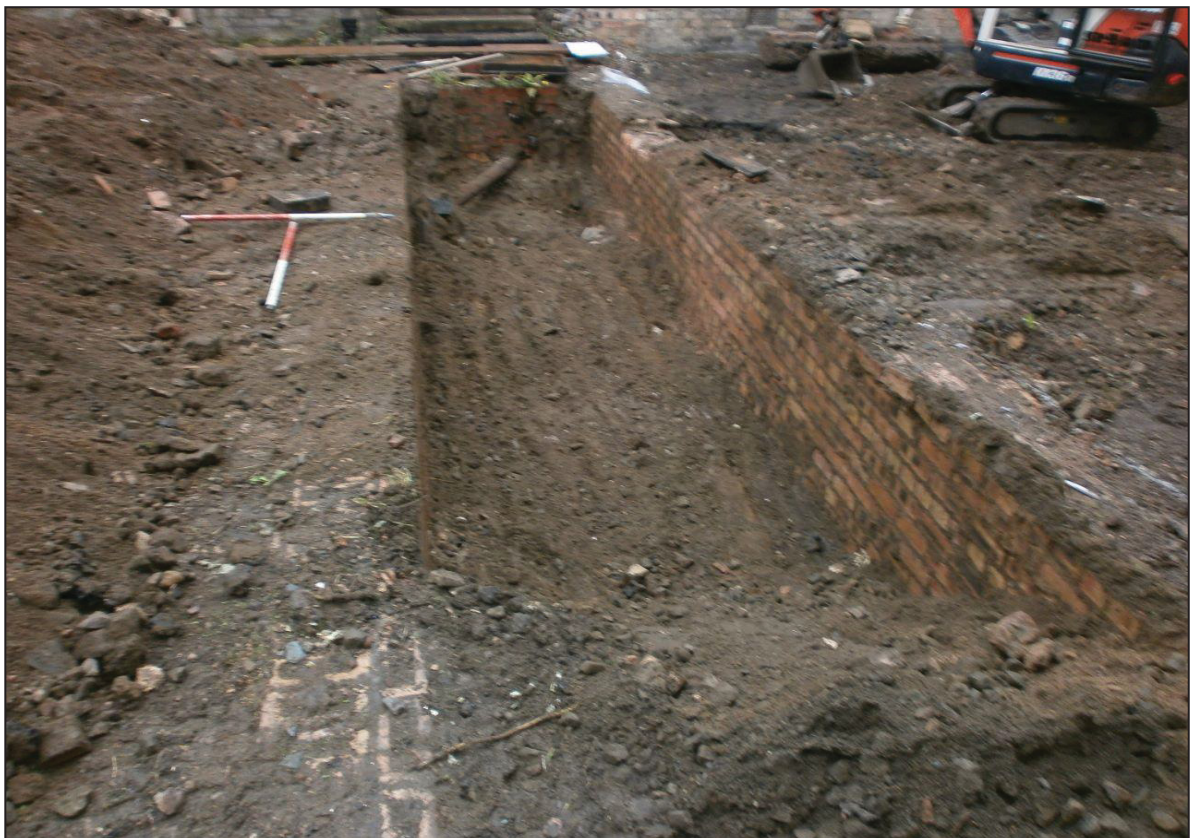
13. Monitoring commenced in the eastern courtyard (Figure 3) within the pentagon-plan formed by the construction the Academy Secondary School for a trench to take a mains waste pipe. The deposits that were excavated demonstrated an area that had been heavily disturbed. Dimensions for the trench were 12m in length by 2m wide and 1.4m in depth aligned approximately northwest-southeast. The trench used an existing brick foundation from previous structural works to form the sides (003) (Figure 2a). The deposit (001) removed from the trench was a loose brown sand with frequent brick and demolition material inclusions (Figure 2a).

Figure 2b: Eastern courtyard showing (003) and (001)

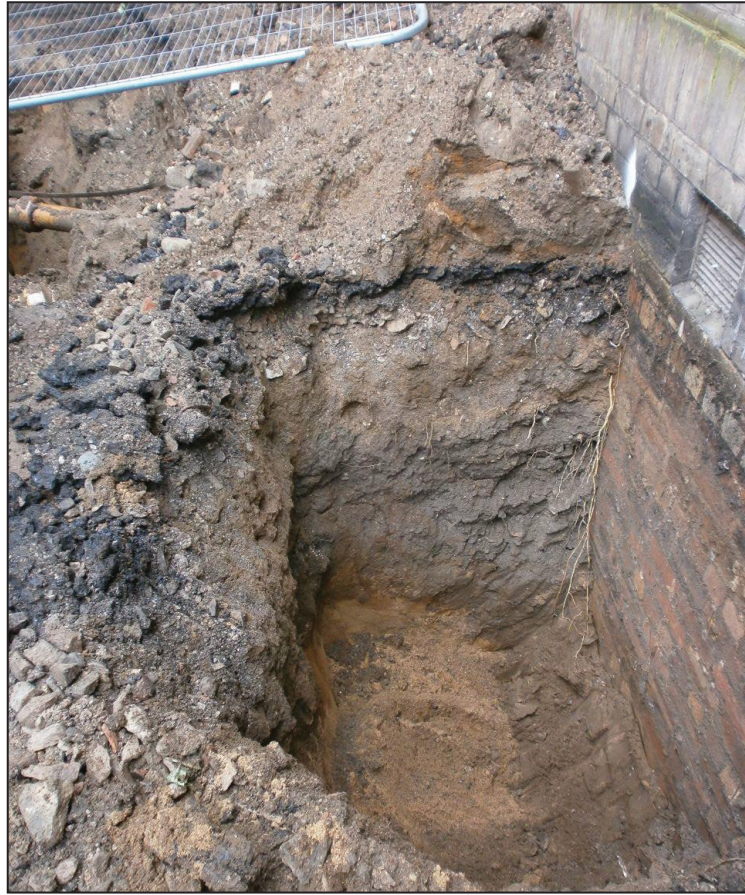
15. An exploratory trench was excavated in the southern end of the eastern courtyard to locate previous water pipes. The area excavated was approximately 2m by 7m to a depth of approximately 2m. The upper 0.80m was characterised by contexts (001) and (002) with the next 0.70m (004) formed of a sandy clay mix with inclusions of stone and brick. The bottom 0.50m was characterised by a moderately compacted yellow brown sand with fragments of shell (005) (Figure 4a). This was interpreted as the natural which has been disturbed and contaminated by previous activity.

16. Within (004) a linear feature was noted with a dark grey clay fill (006) and aligned approximately to the north. This feature was not able to be fully investigated but was interpreted as the possible remains of an old drain.

Figure 4a: Exploratory trench showing contexts (001), (002), (004) and 9005)

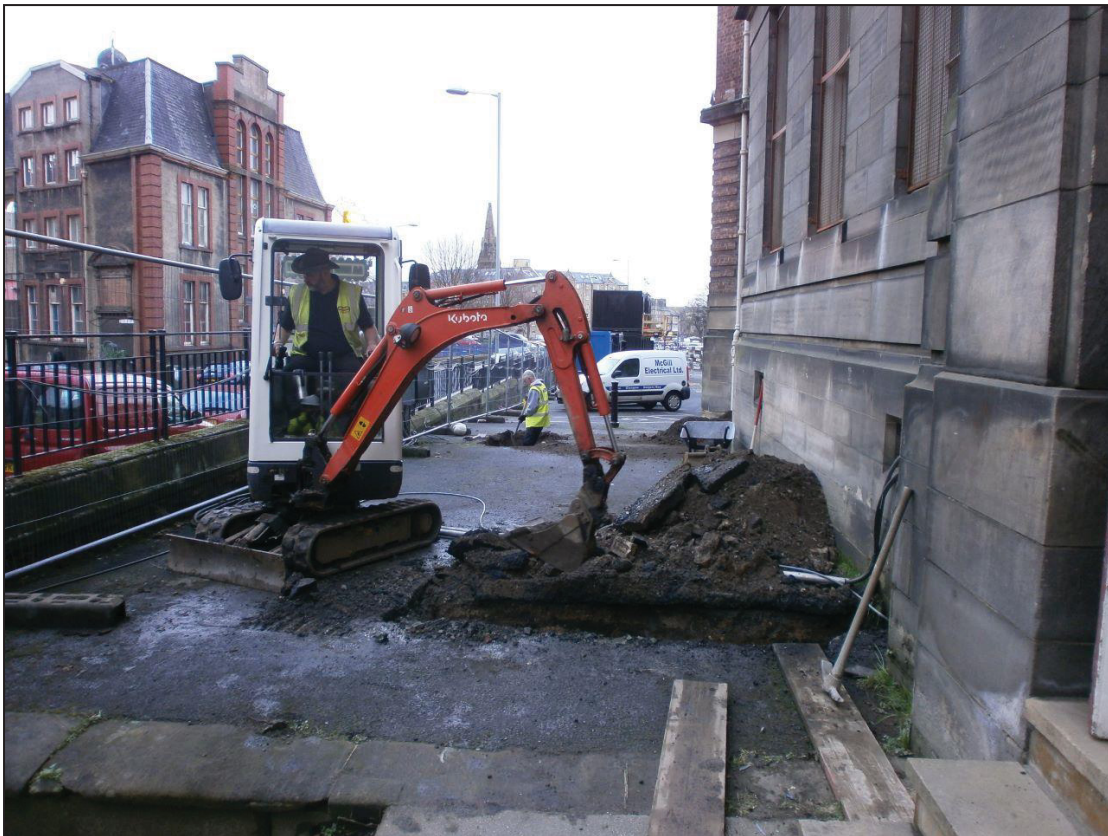
17. The next stage of monitoring works were undertaken within the outside grounds of 89 Duke St and associated with trenches needed for electricity cables. The first trench was excavated on the western side of the building fronting onto Duncan Place. The purpose for Trench 1 was to join cabling from the building to an exterior conduit box (Figure 4b).

18. The total area excavated for Trench 1 was 1.55m by 1.66m with a trench adjoining to the building 1m by 0.90m and a depth across the trench to 0.66m. The top 0.10m was formed by a compacted solid black tarmac (007) forming the upper road surface.

Figure 4b: Trench 1 being excavated

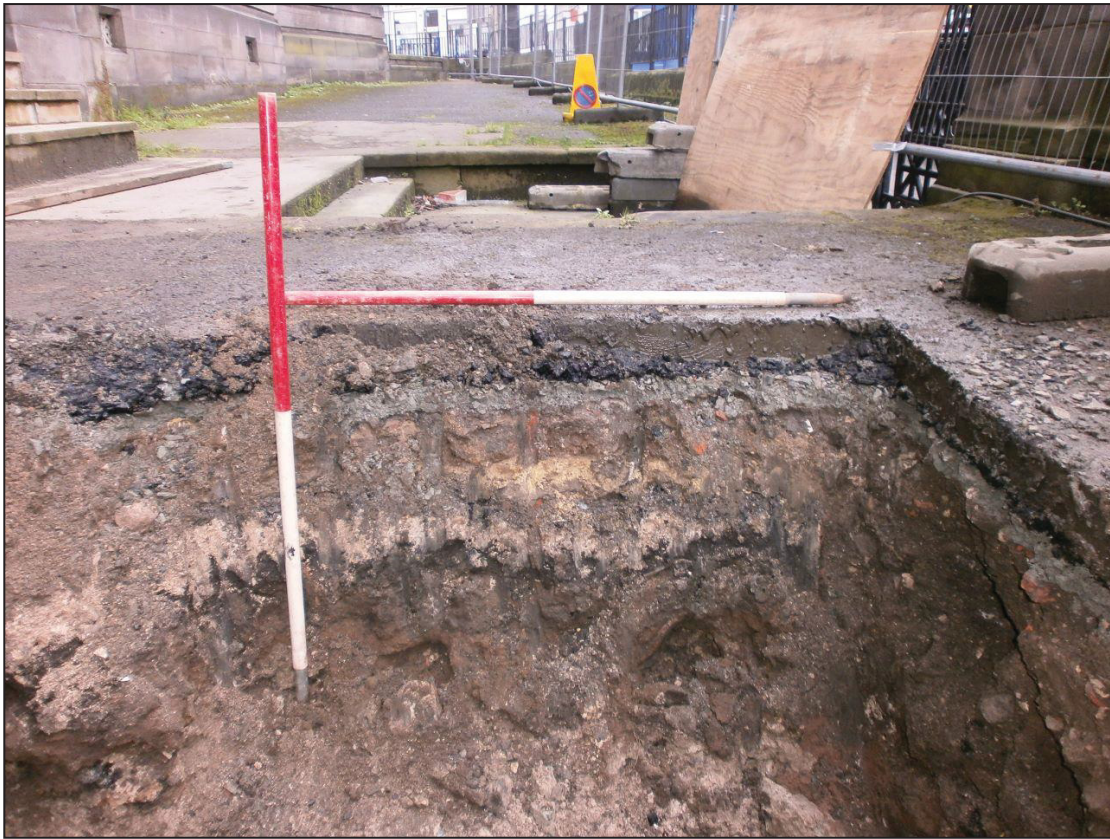
19. The following context (008) was formed by a moderate to loose compacted mid grey deposit with sub-rounded stones ranging in size from 200mm-500mm and 0.80m thick. This context forms a Type 1 aggregate levelling layer on which (007) was laid down onto. Below (008) there was a loosely compacted 0.20m thick layer of brick and CBM (009) (Figure 5a) representing a mix of demolition material and made-ground. Bricks recovered from (009) had the name '*Gilmour & Co, Kilmarnock*' upon them. A basic history of the company provides the information that the clay works were at Bonnyton near Kilmarnock in Ayrshire and were in existence from c.1876 to c.1940.

20. The bottom 0.28m was formed of a loosely compacted, pale yellow grey sand with fragments of slate, tile and broken sandstone throughout (010). Although (010) is distinguishable from (009) as containing more sand, both (009) and (010) most likely form a cohesive demolition layer but have been given separate context numbers due to a higher brick concentration in (009) and more sand in (010) (Figure 5a).

Figure 5a: North facing section Trench 1 showing contexts (007), (008), (009) and (010)

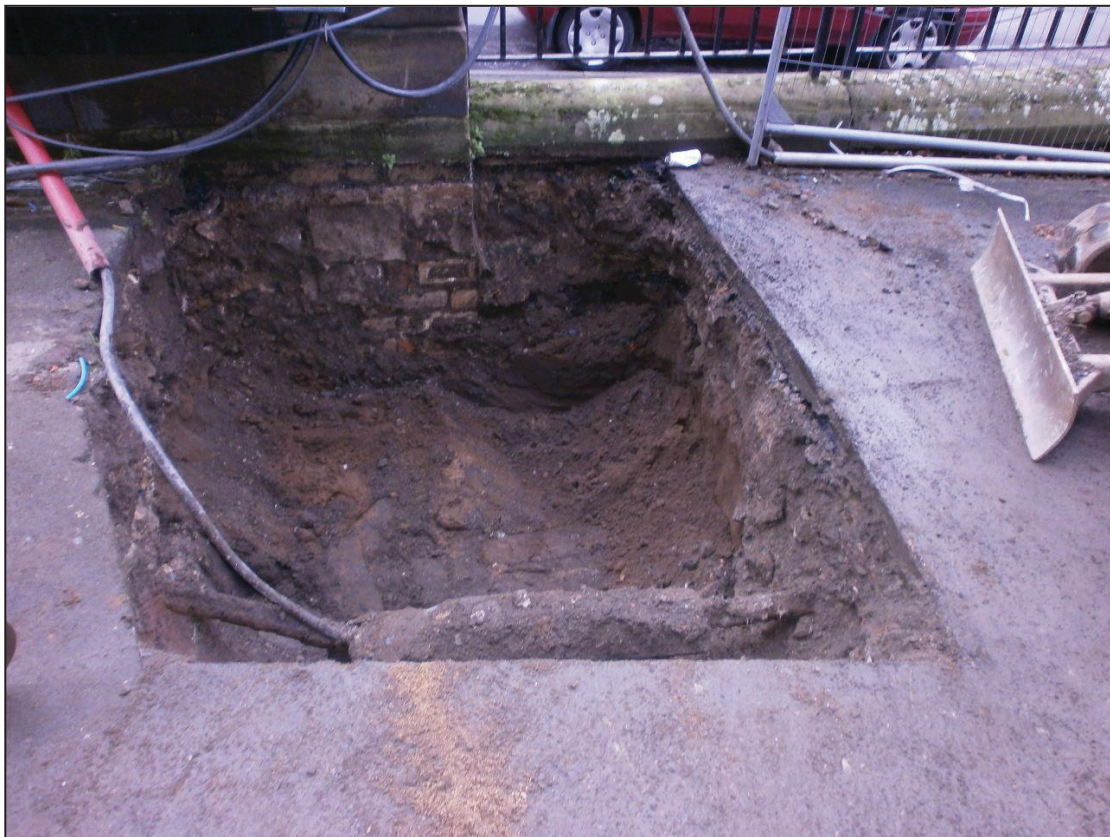
21. Trench 2 was located approximately 10m to the north of Trench 1 and located along the fence line fronting Duncan Place. The area excavated was an extension to a previously disturbed area for a trench to take electricity cabling and a junction box with a total area of 2.20m by 1.50m and 1.20m deep (Figure 5b). The fill was heavily disturbed and a mix of the demolition material (009) and (010) characterised by modern brick, CBM, tile, glass and dark yellow sand which most likely represents sand brought in for construction purposes.

Figure 5b: Trench 2

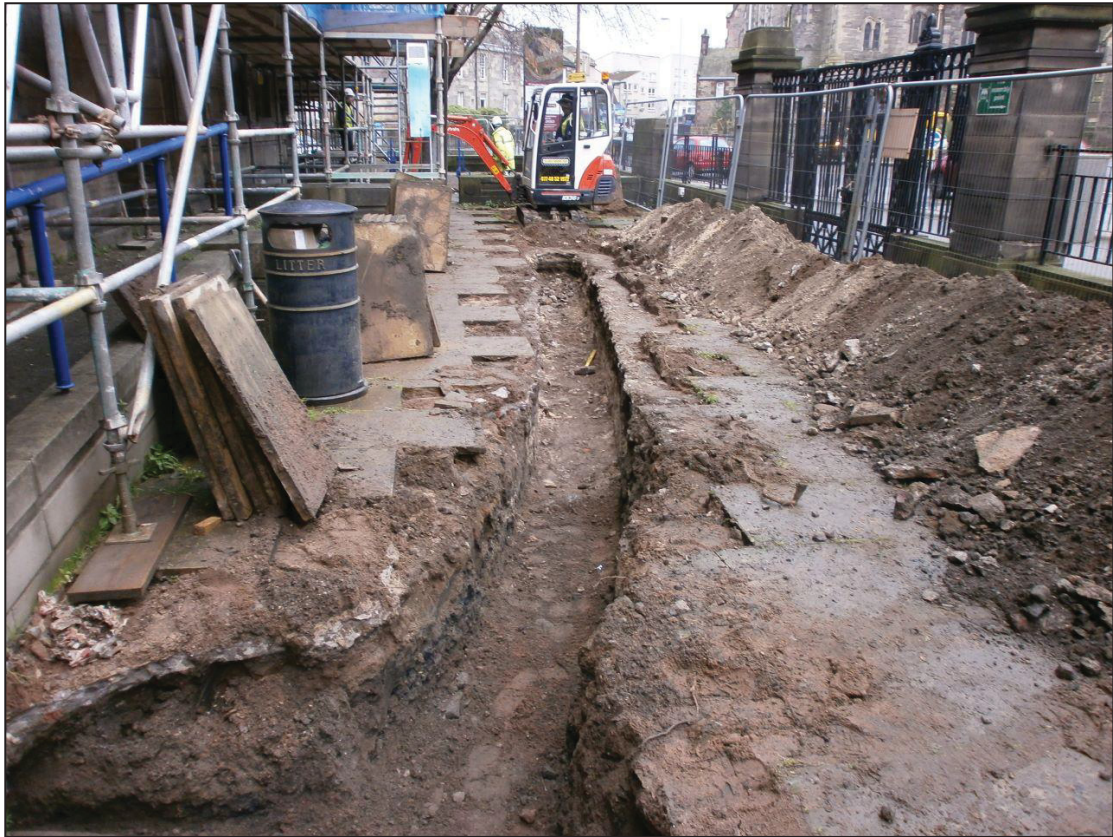
22. Trench 3 was approximately a total of 50m in length along the front southern side of the 89 Duke St and then along the eastern side (Figures 6a & 6b). Both the southern and eastern stretches of Trench 3 are approximately 25m in length and excavated to a width of 0.50m by 0.60m in depth. The first 13m of Trench 3 along the southern side of the building was formed by paving slabs 0.90m by 0.60m by 50mm with a levelling sand of 50mm (015). Below (015) was a very compacted 0.10m thick layer formed of concrete (012). The concrete layer (012) was found along the first 13m and the final 25m along the eastern side and possibly represents a former levelling or floor surface.

Figure 6a: Route of the Trench 3 along the southern side of the development area

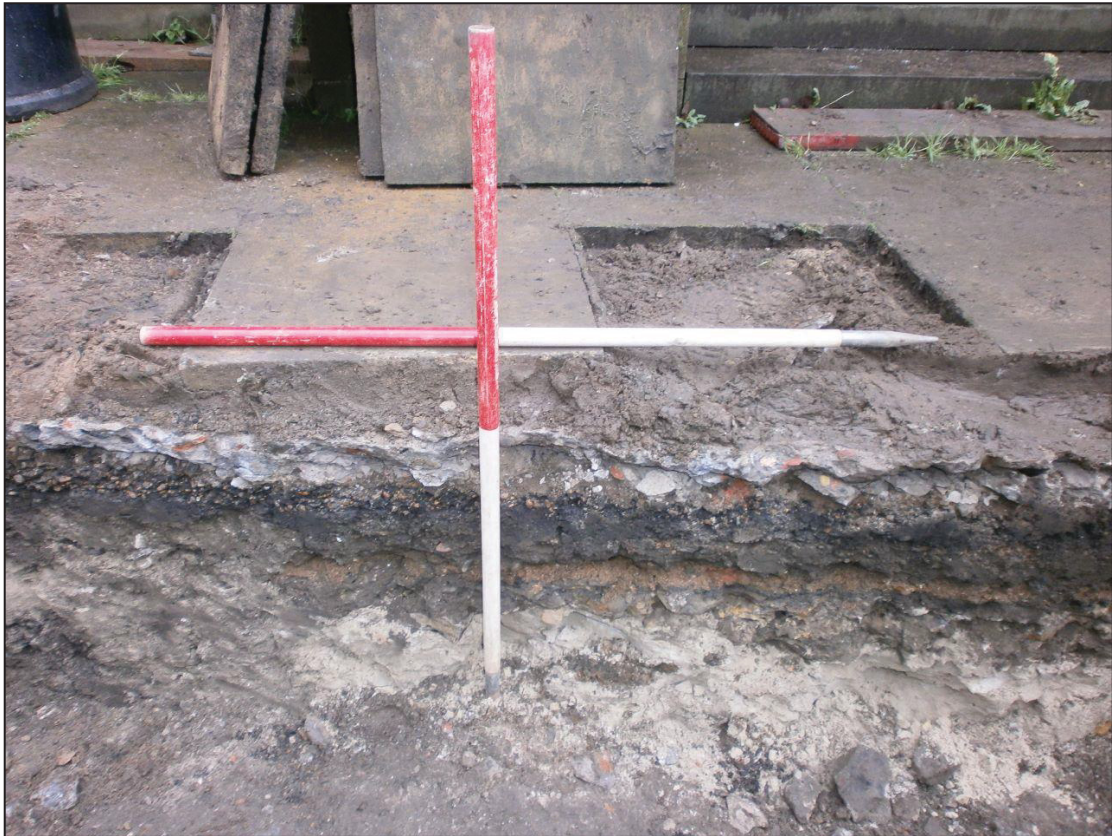
23. The context below (012) was (011) and formed by a loosely compacted brown sand with rounded demolition material characterised by CBM and small rounded and sub-rounded stones ranging in size from 50-30mm and 0.15m thick. The final context (013) below (011) was a loosely compacted yellow sand and sandstone fragments throughout and 0.25m thick (Figure 7a).

24. After 13m along the southern side of Trench 3 the make-up of the deposit changes for 12m where it meets an area where a tree is located. Context (014) was removed to a depth of 0.60m and formed by a loosely compacted, humic and dark brown loam soil with frequent roots, characteristic of a garden soil and suggesting that the area had possibly been a small garden or flower bed which was now removed with just the tree present.

Figure 7a: South facing section of Trench 3 showing contexts (012), (013), (014) and (015)

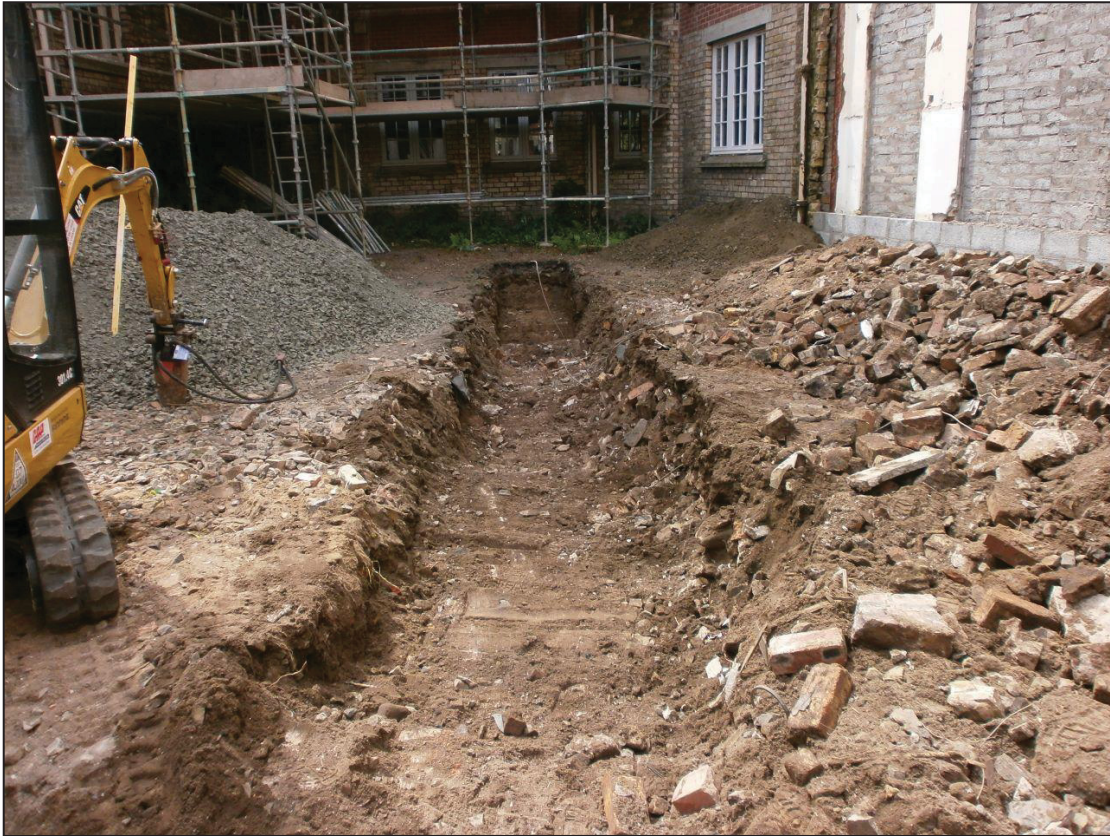
26. The third stage of monitoring focused in the western courtyard for trenches associated with waste pipes. This took the form of a centrally located trench aligned approximately north-south and 21m by 1m by 0.75m deep. A further three smaller trenches were excavated; two (Tr1 & Tr2) aligned northeast-southwest, 6.5m in length by 1m width and 0.65m in depth, and another trench (Tr3) which was 3.5m in length, 1m in width and 0.50m in depth (Figure 8a).

Figure 8a: Central Trench in the western courtyard

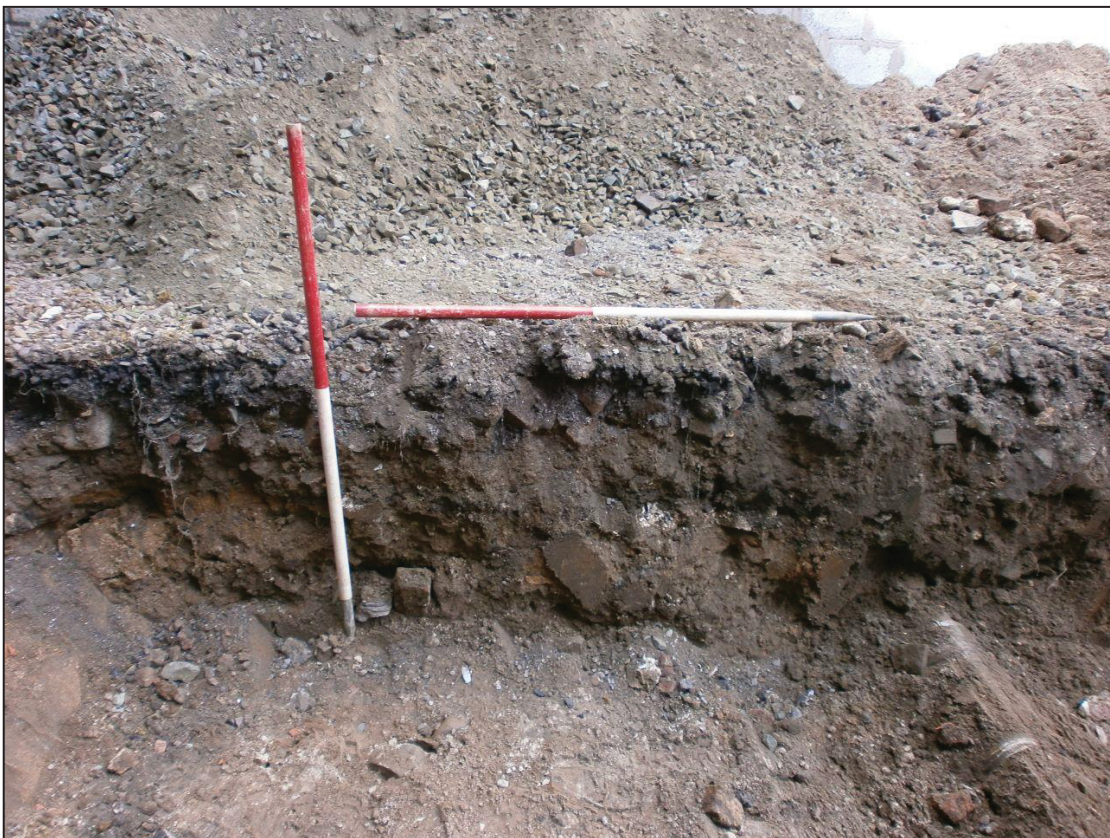
27. Context (016) formed the fill of all the trenches excavated within the western courtyard and was characterised by a highly mixed and disturbed deposit formed of a moderately compacted sand and soil mix with brick, slate, drink cans, glass, metal pipe and reinforcement bars (Figure 8b).

Figure 8b: Demonstrating the mixed deposit of (016)

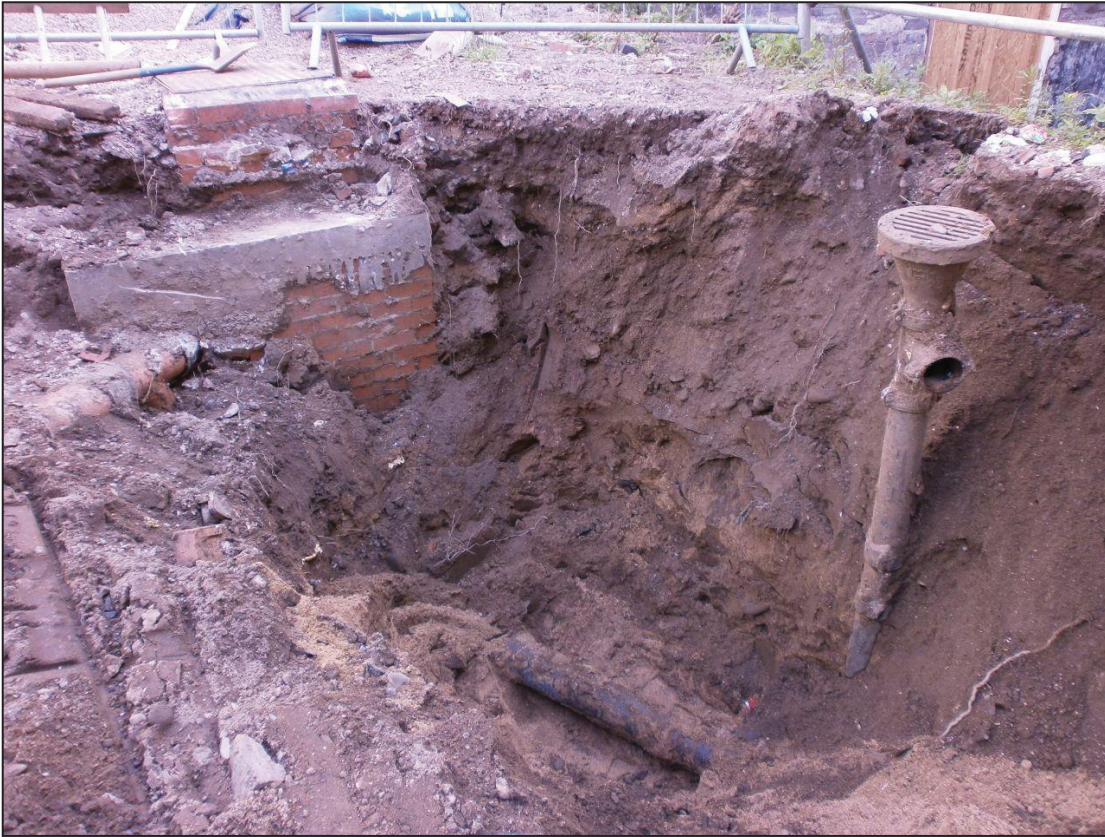
28. At the northern of the Central Trench an area approximately 3m by 3m and 2.5m in depth was excavated to uncover the existing main waste water pipe. The deposit that was excavated (017) was a loosely compacted dark to mid brown sand that showed signs of being heavily disturbed due to the presence of drink can and plastic bottles (Figure 9a). On finding the mains pipe the plumber recognised the *plumbing join/valve* as those that were commonly used in the 1980s (Figure 9a). This further confirmed that the area had been previously disturbed. The natural sand (005) was just visible in patches at the bottom of the excavated area.

Figure 9a: Demonstrating the highly disturbed deposit (017) and the modern waste water pipe

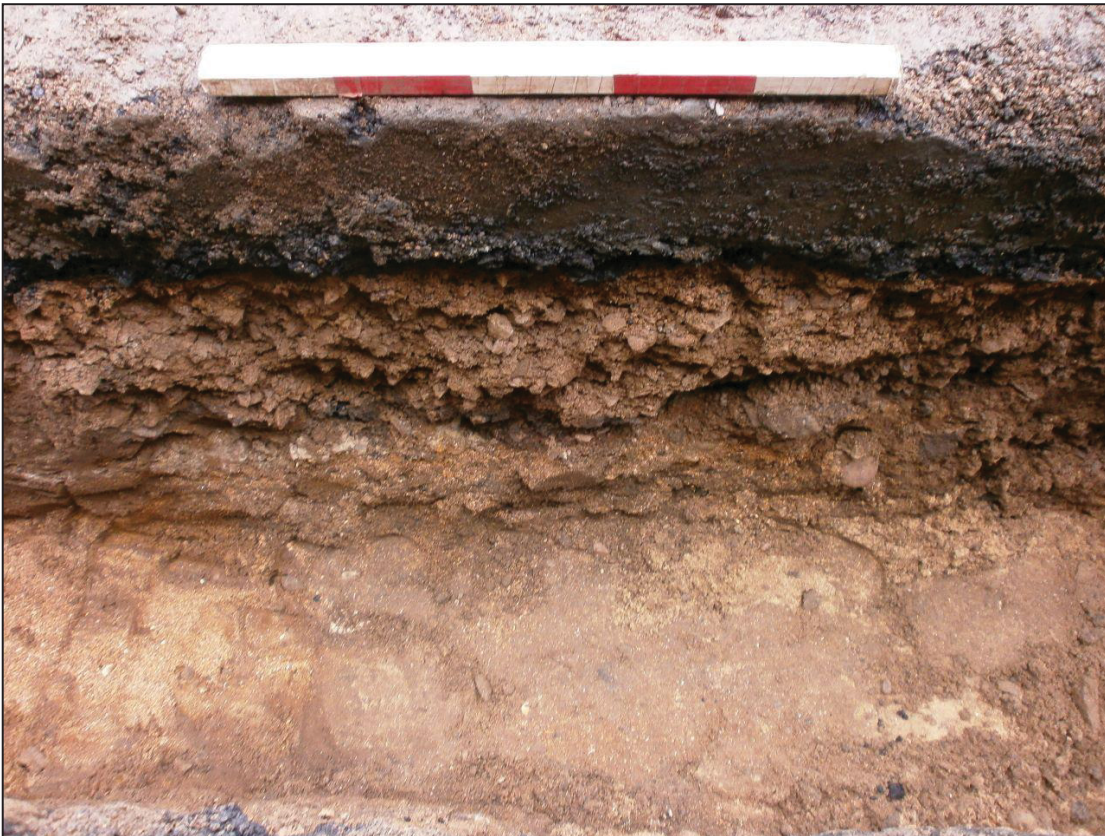
30. Along the whole length of Trench 4, the upper surface was formed of (018) which was the same as (007) and formed by a 0.10m thick very compacted tarmac layer. Context (019) was a moderately compacted light brown deposit 0.20m thick with sub-rounded stones ranging in size from 20mm-50mm and similar to (008) in Trench 1 and formed of a Type 1 aggregate used as a levelling surface for (018).

31. Below the levelling deposit (019) in the west end of Trench 4 context (020) was formed of a moderately compacted dark brown grey sand and 0.30m thick with frequent building material inclusions: brick, sandstone fragments, tile, pipe and glass. The remaining 22m was characterised by (022), a loosely compacted mottled brown grey sandy clay 500mm thick with brick, sandstone and frequent mortar inclusions, similar to (011) (Figure 9b).

Figure 9b: Demonstrating contexts (018), (019) and (021) along Trench 4
