32 Main Street, New Abbey, Dumfries & Galloway: Archaeological Monitoring

Data Structure Report

issued 28th November 2013

on behalf of William Waugh & Sons (Builders) Ltd

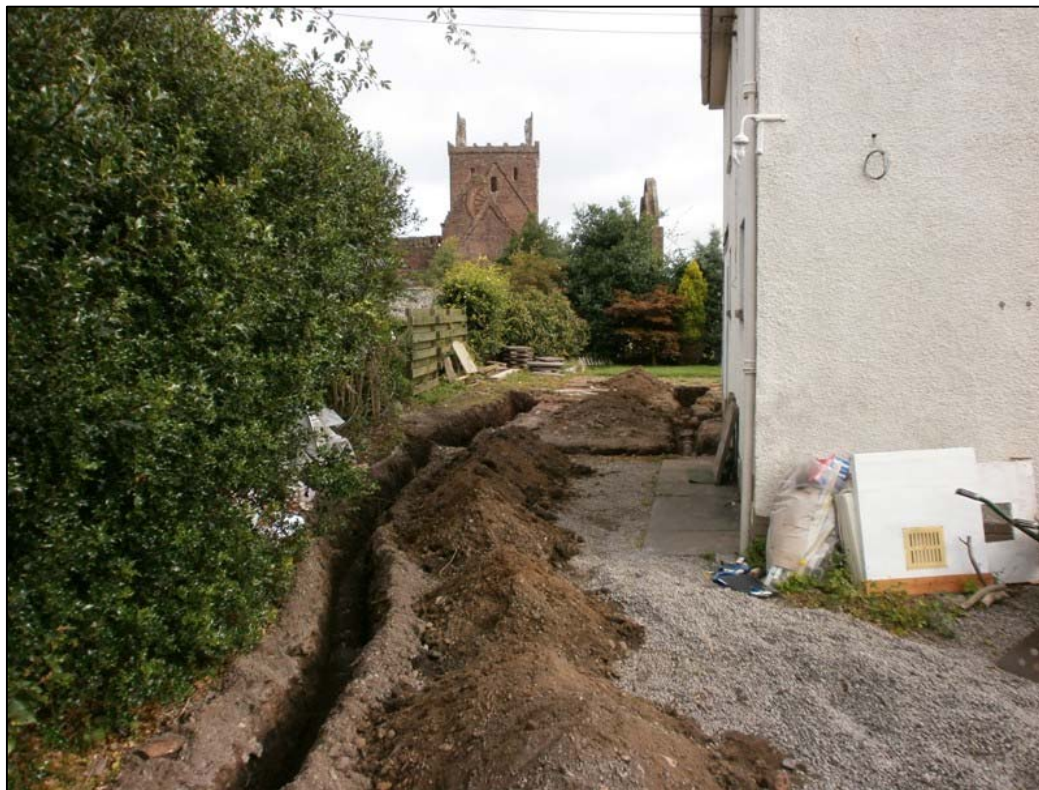
Figure 3a: Oil Line and Water trench running south from outline foundation trench.

23. Running south of the outline foundation trench over the present driveway (001), a trench for a new oil line and the new water pipe (replacing a copper pipe) was dug (Figure 3a). It was completed using a mini-digger using a flat-edged bucket and measured 220mm wide by 450-500mm deep by approximately 35m long. The gravel (001) was removed, followed by the topsoil (003) down to subsoil (005) at 450mm depth.

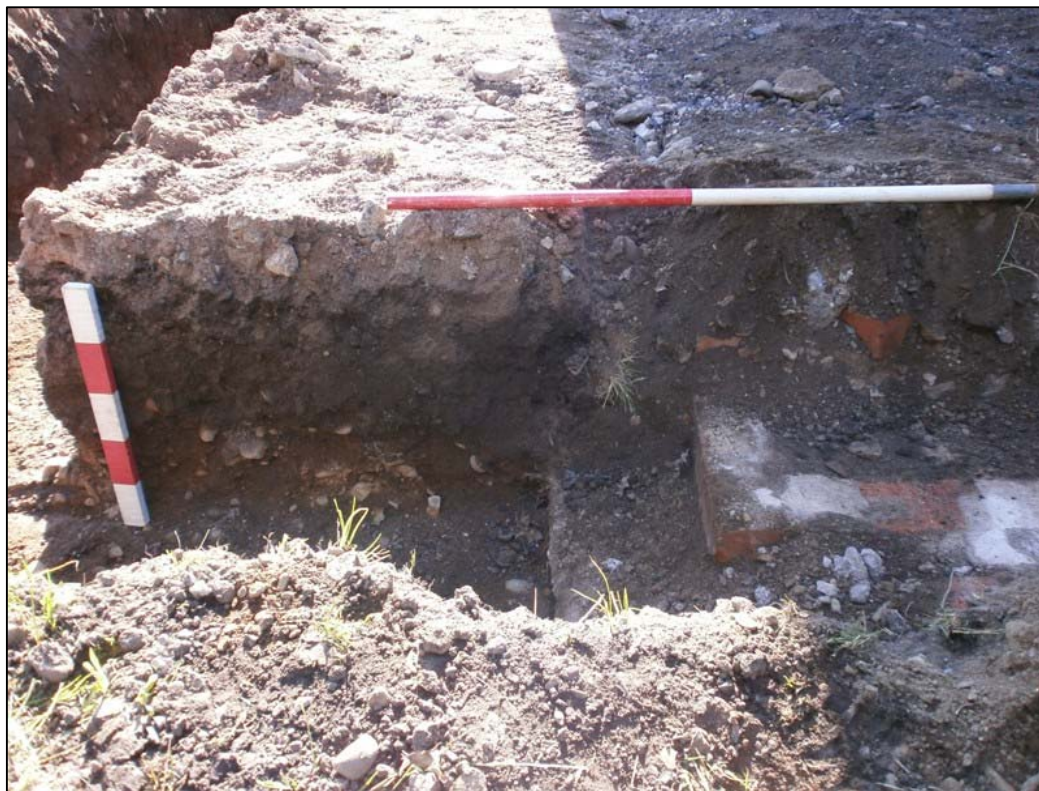
Figure 3b: West Facing Section of the foundation trench with [007] founds of previous extension.

21. The foundations of the previous extension [007] were pecked out and removed along the western leg of the outline trench; to a depth of 450mm also reaching subsoil (005) (Figure 3b). The trench skirted the southern extents of foot paving [004], which had also been partially removed prior to monitored works. Surface [004] measured 3.5m by 3.5m by 200-250mm deep (including dry cement and foundation stones).

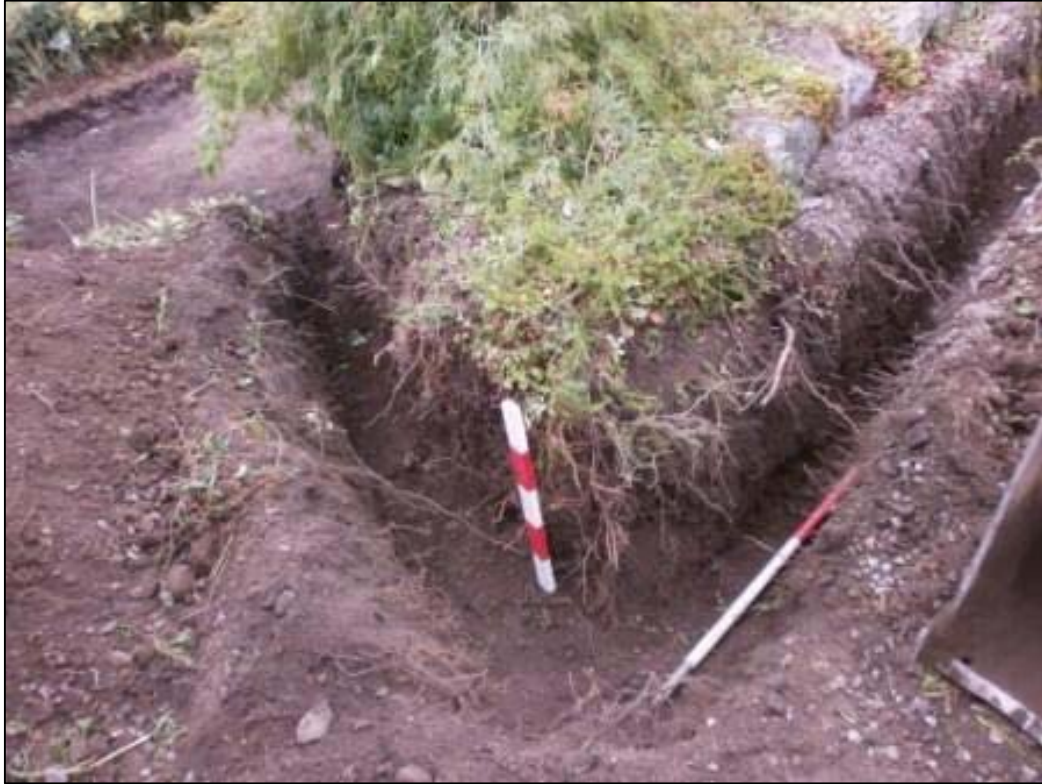
Figure 4a: Shot showing leg of trench connecting Oil Line to Oil and Water trench.

25. The tank base was connected to the oil line and water trench (Figure 4a) with a 220mm

by 250mm by 2 metre long trench through the garden into the driveway. This was made through humic layers encountering (001) gravels and again only removed 100-200mm of the (003) topsoil deposit, deepening until it met the water trench at 450mm in the driveway.

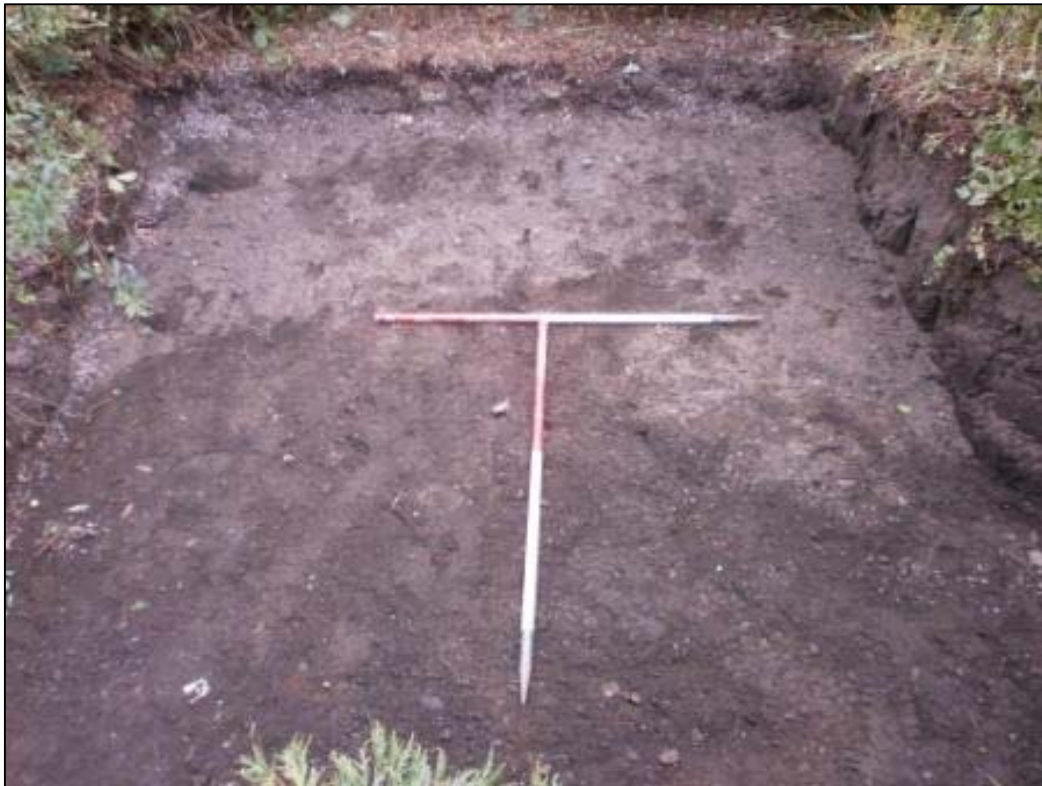
Figure 4b: Post-Excavation of Oil Tank Base

24. The oil tank base was emplaced in the front garden (Figure 4b) (southern side of site), using a 700mm wide flat-edged bucket and measured 2.4m by 2.6m by 200-300mm deep. The garden was overgrown and the initial deposits were humic topsoil (003), 100mm thick over (001) gravel at a thickness of 100mm. The subsequent topsoil (003) was removed to an average depth of 100mm. The overgrowth then, concealed modern surfacing of this area and the topsoil (003) was reduced to about 100mm below gravel (001).

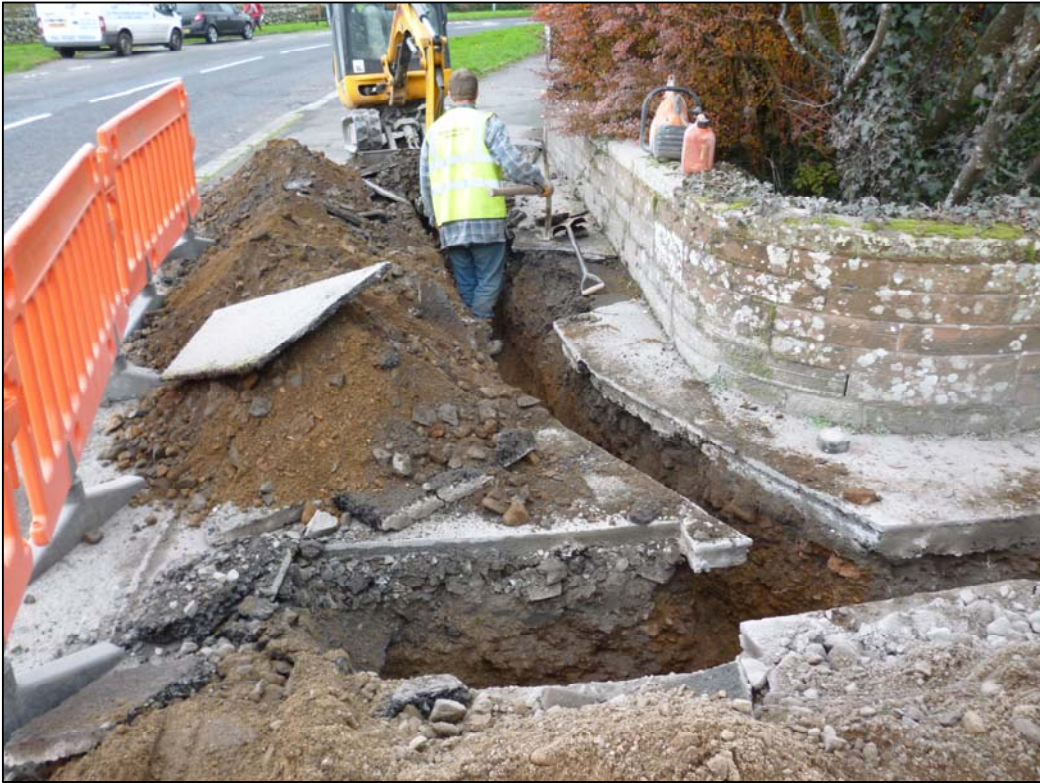
Figure 5a: Excavations on the pavement to connect water main

27. The extension of the trench for the new water pipe was completed on the 15th of November 2013. This involved the excavation of a trench from the end of the driveway out onto the pavement of Main Street and then along the pavement to connect with the existing water main. This involved digging an L-shaped trench approximately 5m from the driveway to the centre of the pavement and then 4.5m along the pavement to the existing water main (Figure 5a). The trench was typically no more than 400mm wide and 700mm deep. A deeper section, 900mm, was excavated in the centre of the pavement while trying to locate the existing water main. The sediments encountered during this work, (101), (102), (103) and (104), were all modern deposits or the upper layer of natural subsoil.

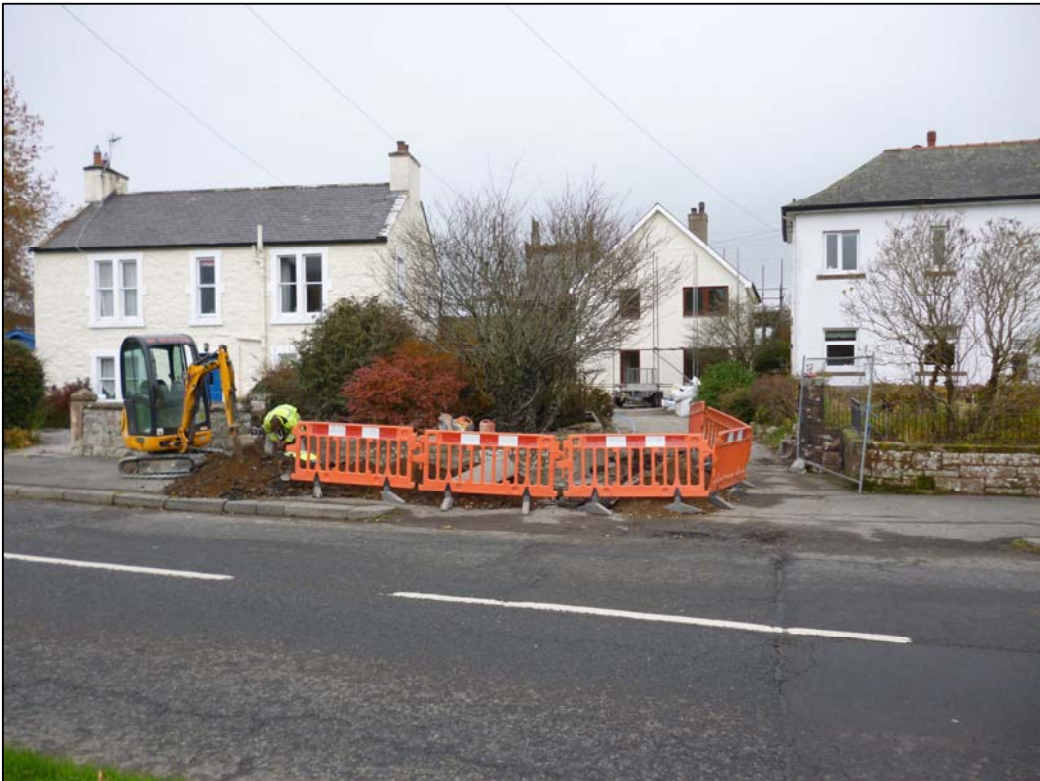
Figure 5b: Excavations on Main Street, New Abbey.

31. It should be noted, however, that outside the footprint of the new extension the archaeological potential of the area has not been tested. The importance of Sweetheart Abbey and the surrounding area supports the possibility for older historic remains to survive in the surrounding grounds and along the course of the main street (Figure 5b).
