Site to the rear of 83 High Street, Sanquhar: Archaeological Watching Brief

Data Structure Report

issued 15th August 2014

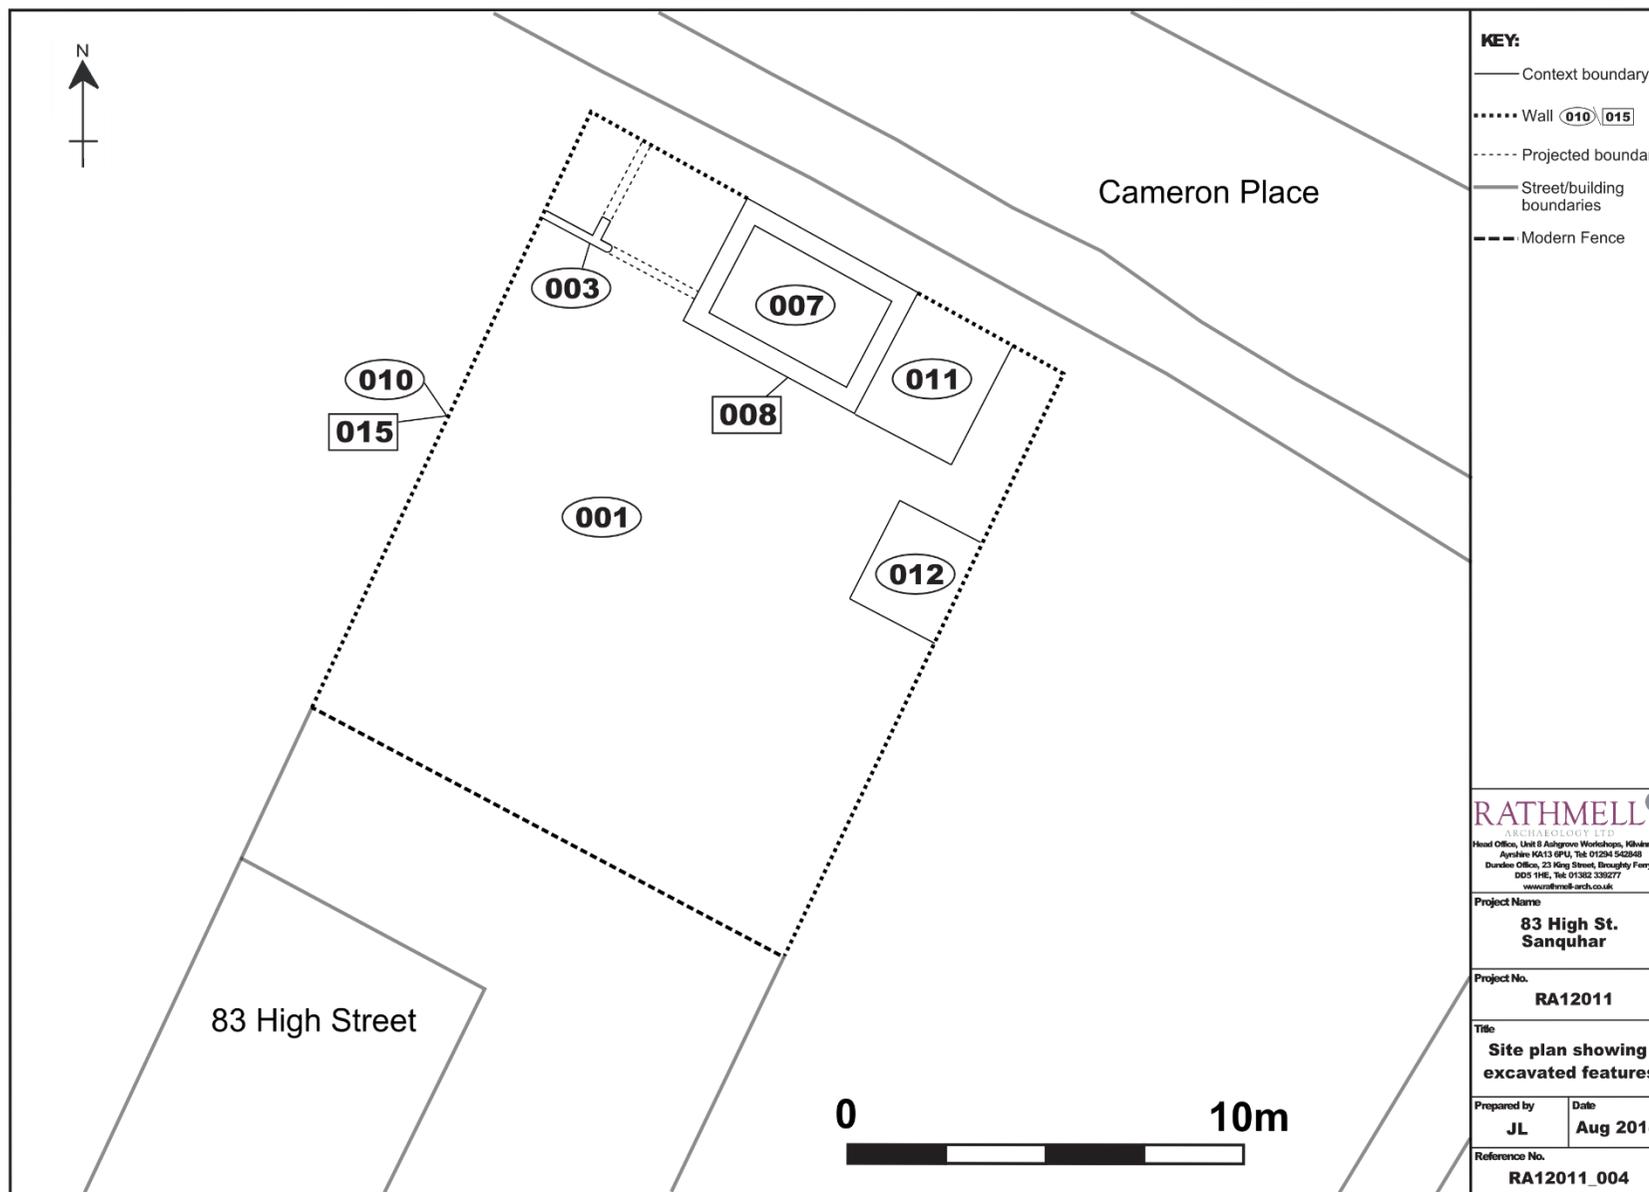
Title
**Site plan showing
 excavated features**

18. All the features identified within the development area were 19th or 20th century in date (Figure 4). These included the red sandstone boundary wall (010): this enclosed most of the site, with the exception only of the southwest side, where a wooden fence separated the site from the main garden for 83 High Street. The wall's northeast side was incorporated into the north eastern wall of outbuilding (008) on both sides though only the subsurface foundations survived on the north western side as it had been mostly demolished to create a driveway (Figure 8). The wall was approximately 1.5 m to 2m high. It was 0.5m wide at the base, tapering to 0.3m wide nearer the top. The wall was constructed with roughly faced stone which was mortared into place. In areas (mainly the southeast side) it had been raised in height somewhat though the building style was cruder.

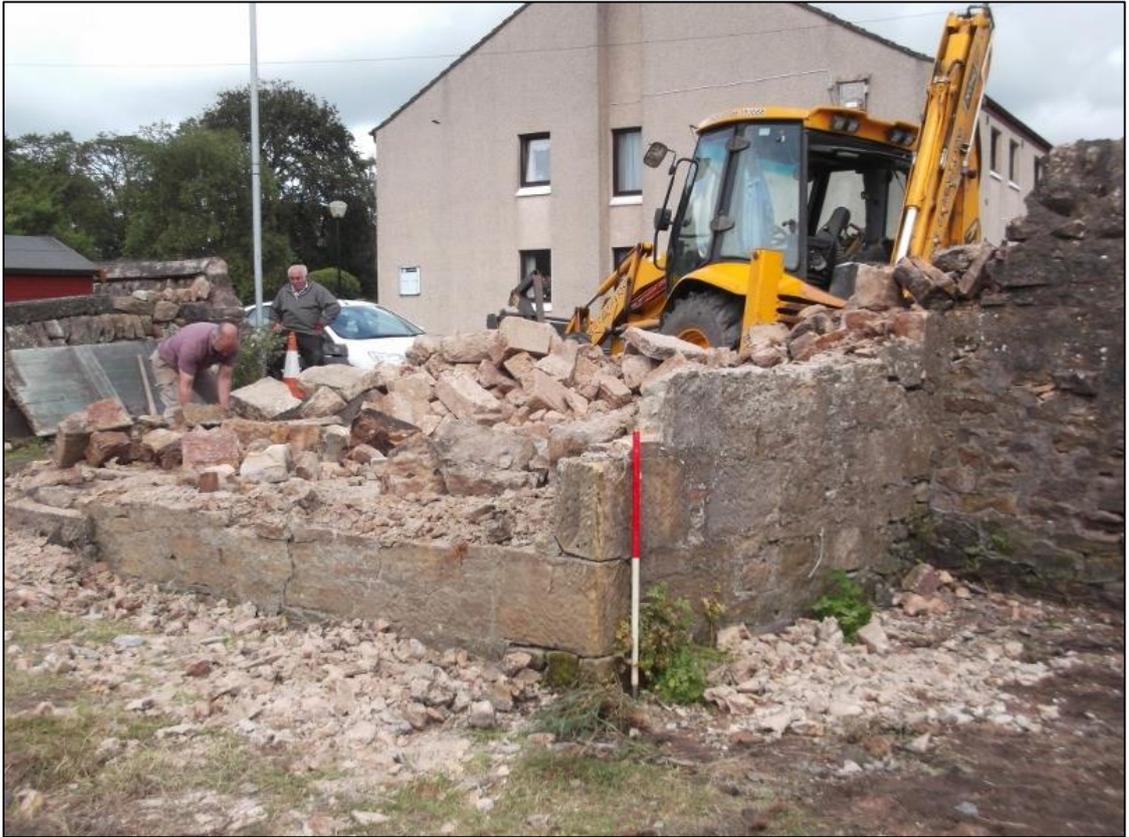
- 14. The area to be stripped measured 12.15m from northwest to southeast by 11-12m from northeast to southwest. It was rectangular on plan (excluding a small portion of the site used as an access ramp at the NE corner) and bounded by a 19th century wall (010) on its northwest and southeast sides. This wall also partially bounded the north eastern side where it joined onto the north eastern face of a small 19th century outbuilding (008) which was demolished as the works commenced (Figure 5 and 6).

Figure 5: Outbuilding [008] and wall [010] under demolition. From the S.

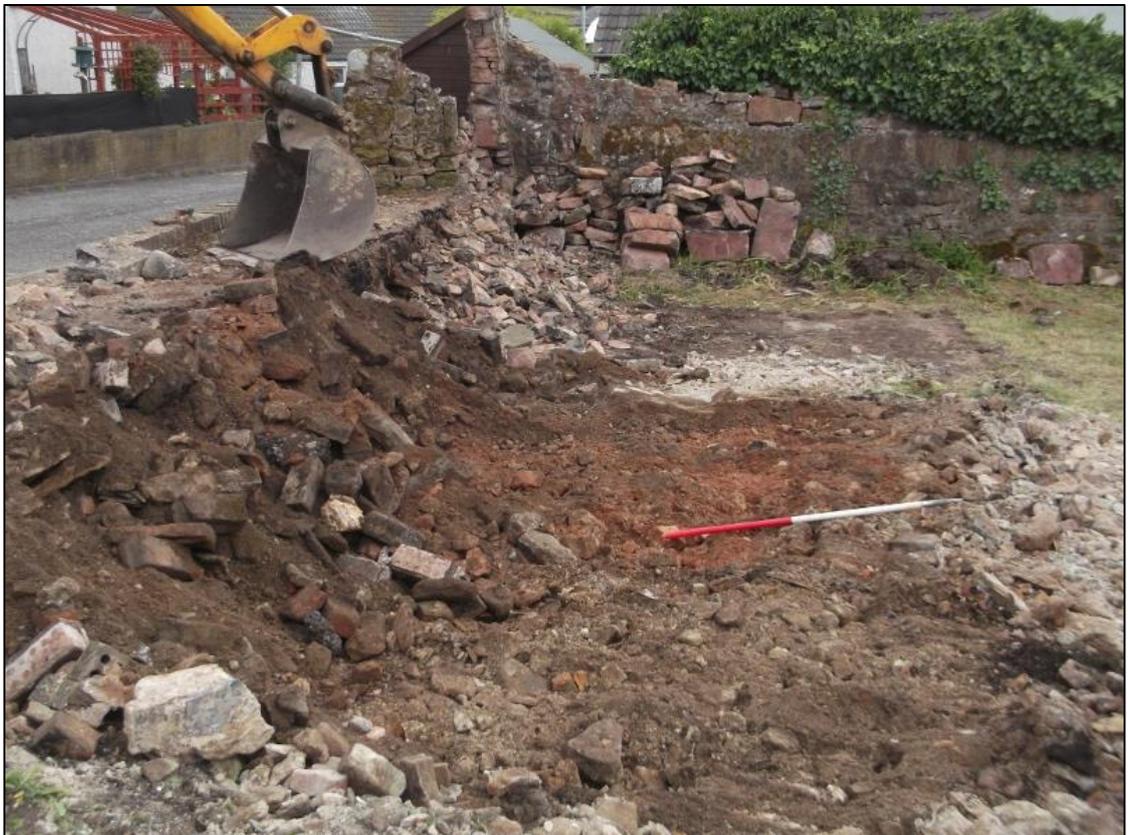
19. The outbuilding (008) which was incorporated into the boundary wall was rectangular in plan and measured 4.5m from northwest to southeast by 3.6m transversely. Its foundations were approximately 1m deep below the ground level of the street (the height of the structure before demolition commenced was approximately 3m above street level). The wall was 0.4m to 0.45m thick and was constructed using straight edged/faced red sandstone blocks which were 0.3 to 0.45m x 0.4m to 0.45m x 0.25m to 0.35m in size. These blocks were mortared into place. The flooring (007) within the outbuilding consisted of a layer of concrete and brick which in turn overlay a rubble core layer which consisted of mid to dark grey brown sandy silt with very frequent inclusions of brick and orange/red sandstone fragments (80%). The layer had a depth range of 0.25 to 0.46m.

Figure 6: Outbuilding [008] and wall [010] demolished. From the NW.

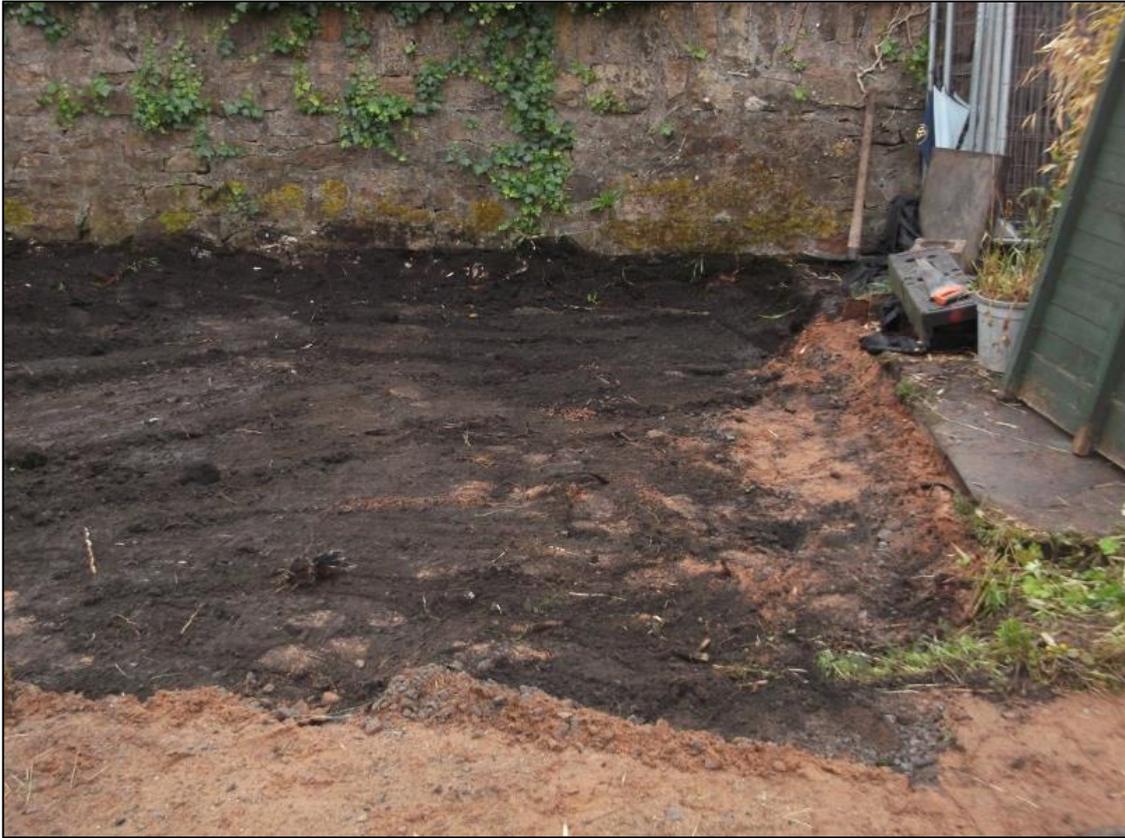
24. The whole garden area to the rear of the main house was until recent times undivided and sloped down from the northeast to the southwest. At some point in the early 20th century an attempt was made to level and raise this area up and this is when the made up layer (016), which included frequent 19th and 20th century building debris, was deposited over the entire site.

Figure 7: SW part of development area stripped to made-up layer (016). From the NW.

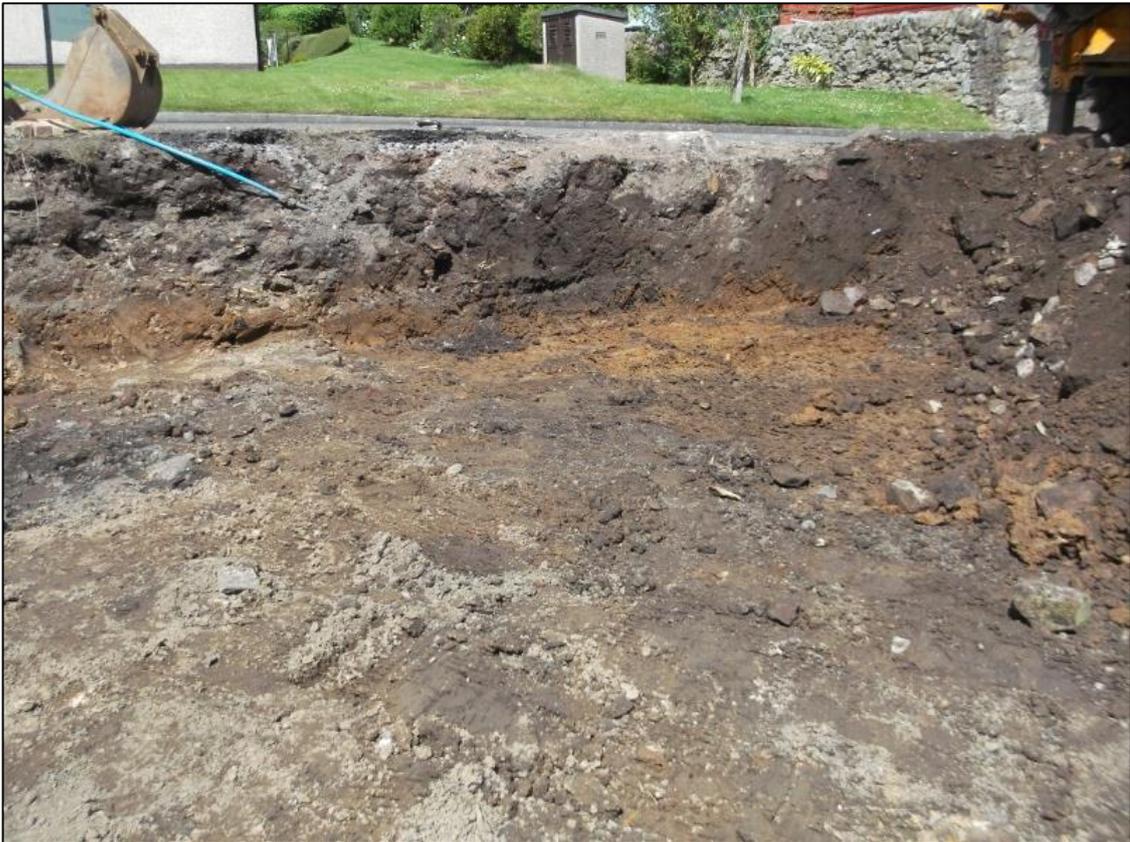
Figure 8: View of natural subsoil (002) at NE side of development area. From SW.

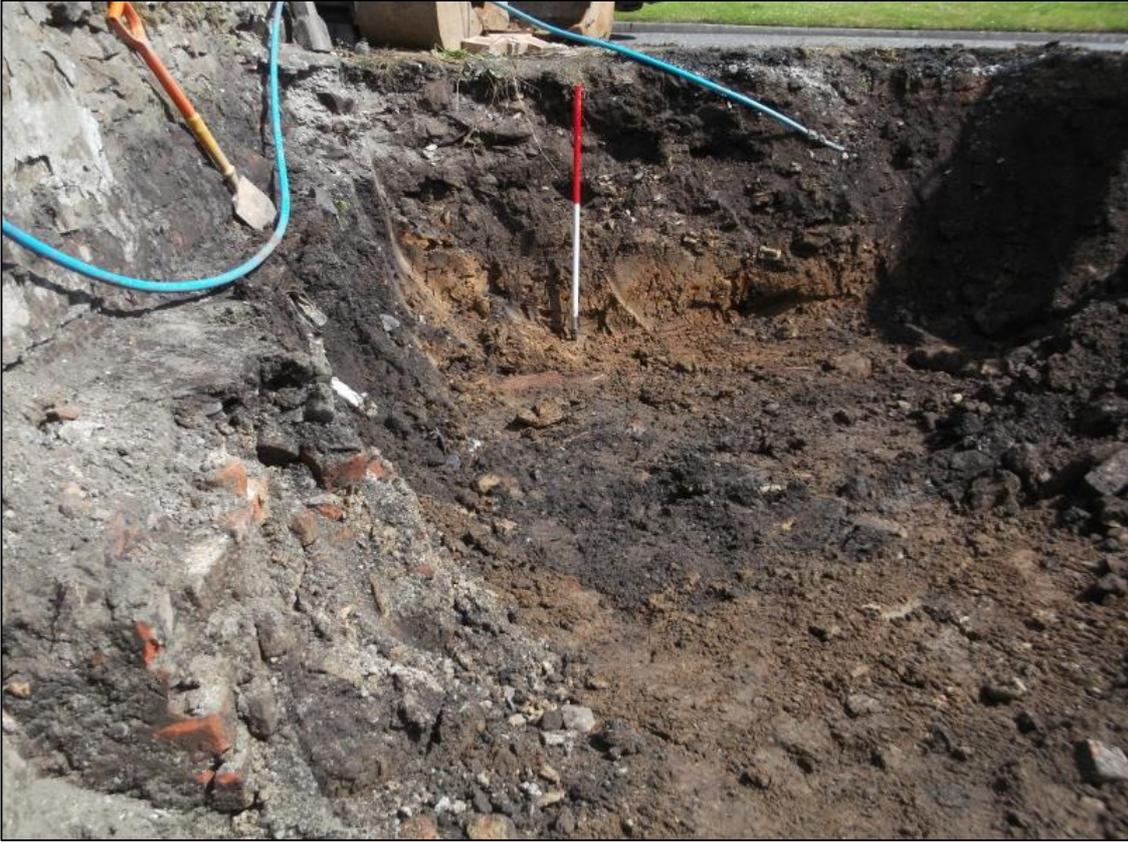
20. The remains of a brick wall (003) were uncovered in the northern corner of the development area (Figures 9 and 10). The wall, which ran in a northwest – southeast direction, appears to have formed a lean-to extension which utilised parts of the boundary wall (010) and the north western wall of outbuilding (008) to form its overall structure.

Figure 9: View of brick wall (003) abutting wall (010) and foundations of (010). From SW.

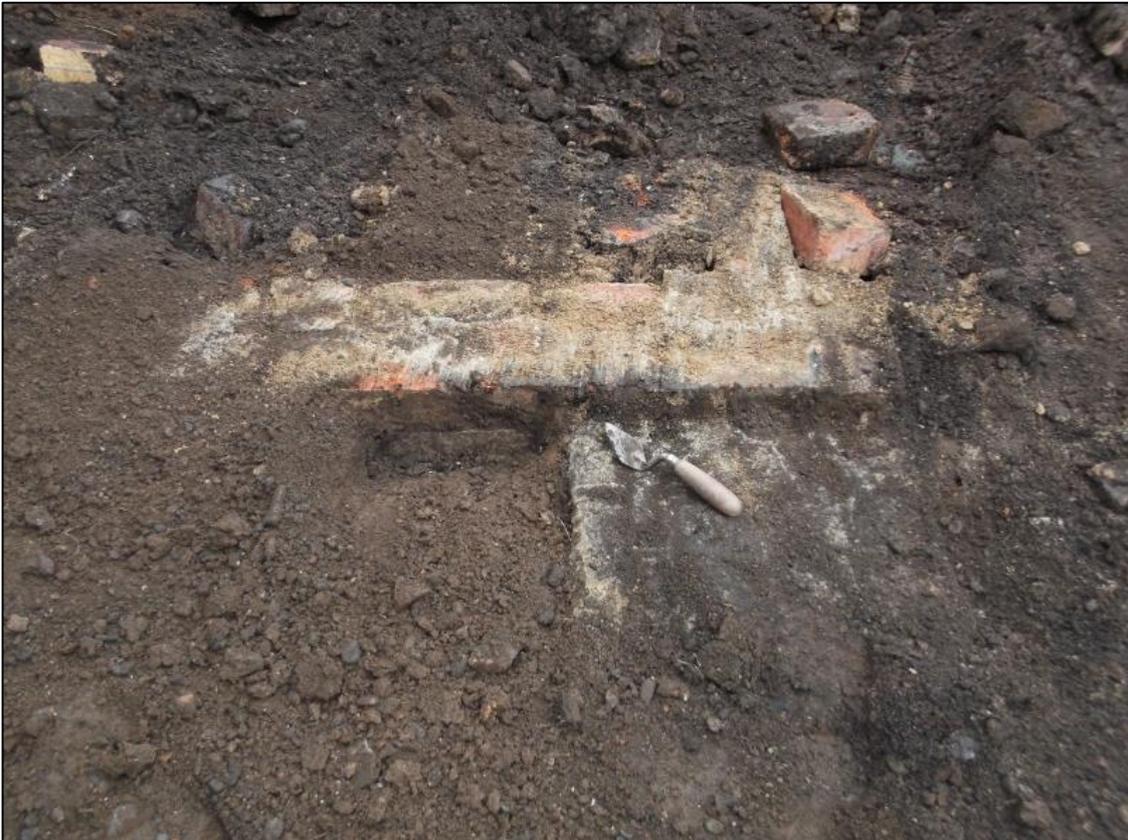
21. There was also the suggestion of what may have been an internal wall division or a projection from the main wall (010) approximately 1.5m from the wall's northwest end. This small, northeast–southwest orientated stretch of walling (003) was of a similar width and height as the main wall but only 0.28m of it survived in plan. The individual blocks making up the wall measured 0.25m long, 0.13m wide and 0.07m thick. The blocks were mortared into place and 4 courses survived. The wall was 1.8m long, 0.24m wide and 0.38m to 0.42m high. The wall abutted the 19th century boundary wall and there was a roughly 1m gap between the wall and the outbuilding (008) which may have served as an entrance.

Figure 10: View of brick wall [003] uncovered during main stripping. From SW.

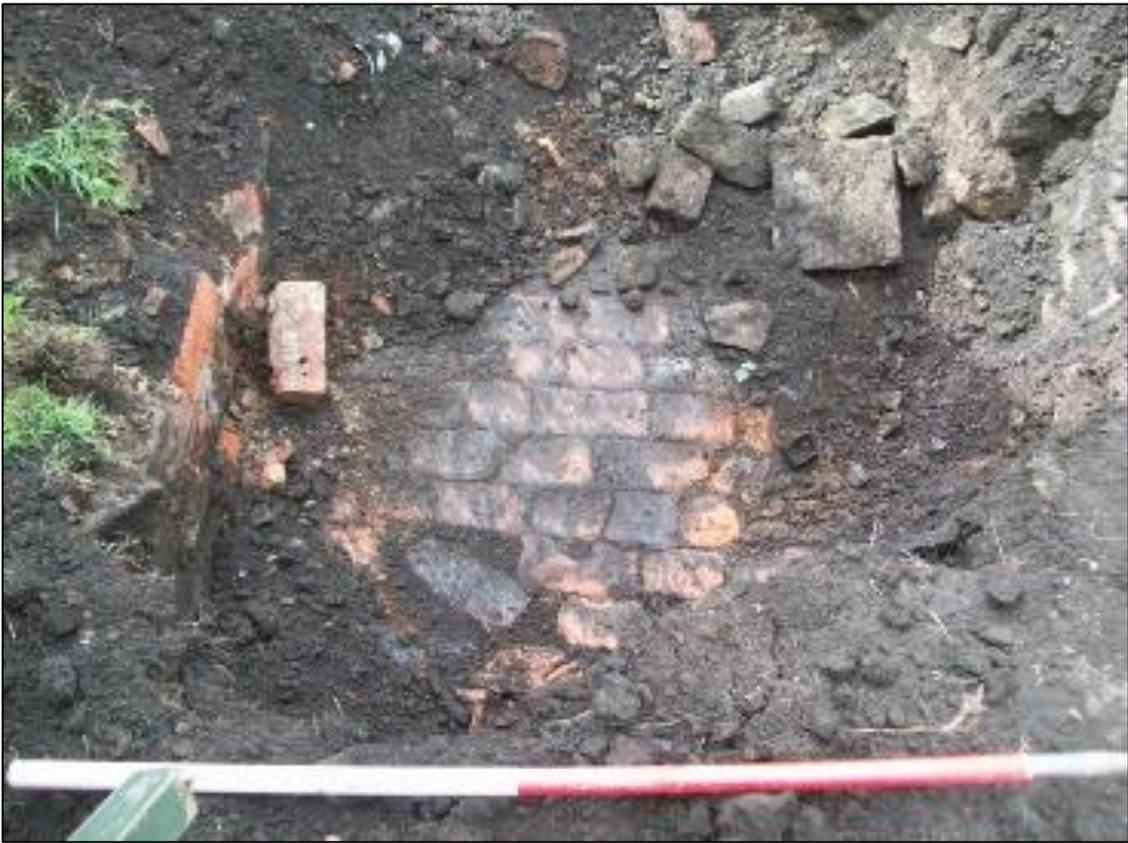
22. The remains of an associated floor surface [004] were also identified in what would have been the structure's interior (Figure 11). Bricks similar to those used for the wall's construction were used for this floor surface suggesting that they were both contemporary. Confined between the boundary and brick walls was a highly disturbed re-deposited layer (005) which consisted of compacted dark grey orange clay which underlay the brick floor (004). The layer had a depth of between 0.4-0.5m and overlay the natural subsoil and enclosed a red ceramic pipe (006).

Figure 11: Brick wall [003] and surface (004) within early test pit. From SE.

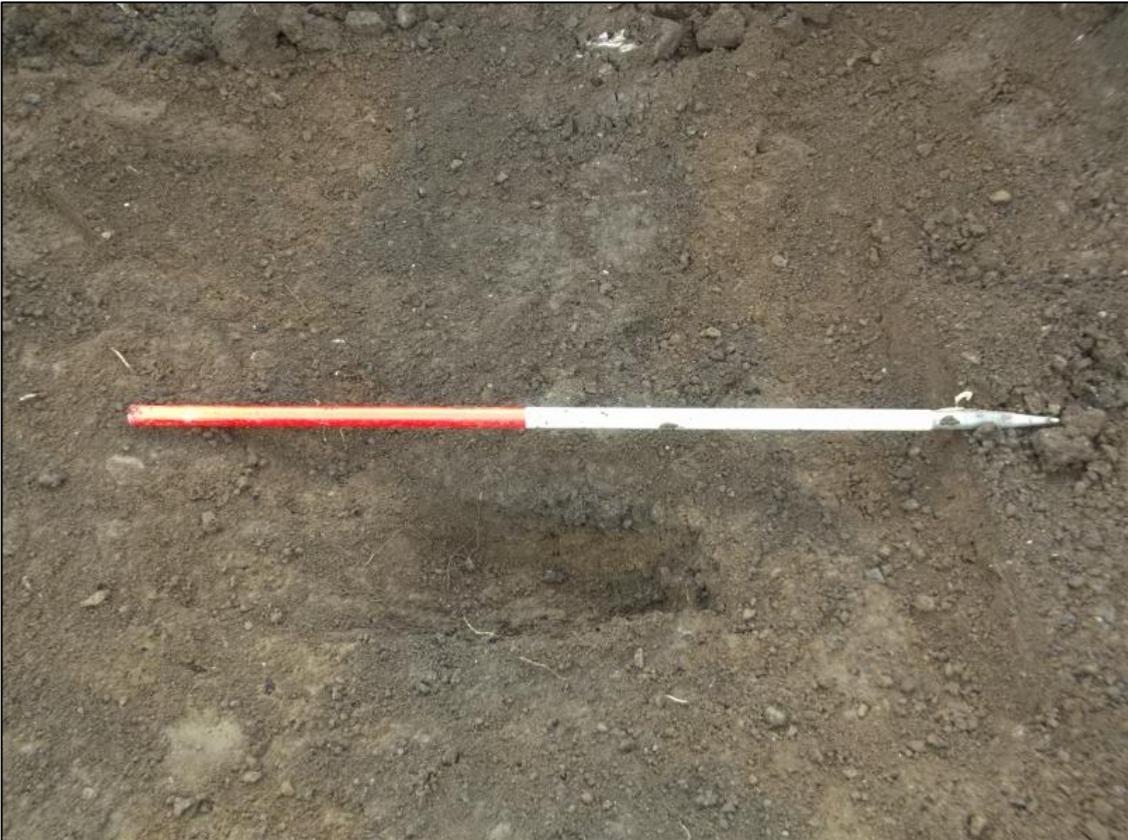
23. Two shallow furrows [013] were identified close to the south western edge of the development area (Figure 12). These features ran in a northwest – southeast direction and measured 0.4m wide, 6.7m to 12.15m long and 0.12m deep. They were filled with a relatively modern made up material similar to (016). A number of 19th – 20th century ceramic sherds and small fragments of animal bone were recovered from the furrows which would suggest a relatively modern date.

26. The furrows [013] identified in the south western end of the development area, from the finds recovered within them, also seem to have been 19th or 20th century in date. These furrows may relate to small scale agricultural, horticultural or gardening activities at the rear of the main house.

Figure 12: View of furrow (013). From the NW.
