Pearson Cars, Largs, North Ayrshire: Archaeological Mitigation

Data Structure Report

issued 7th November 2014

RATHMELL  
ARCHAEOLOGY LTD

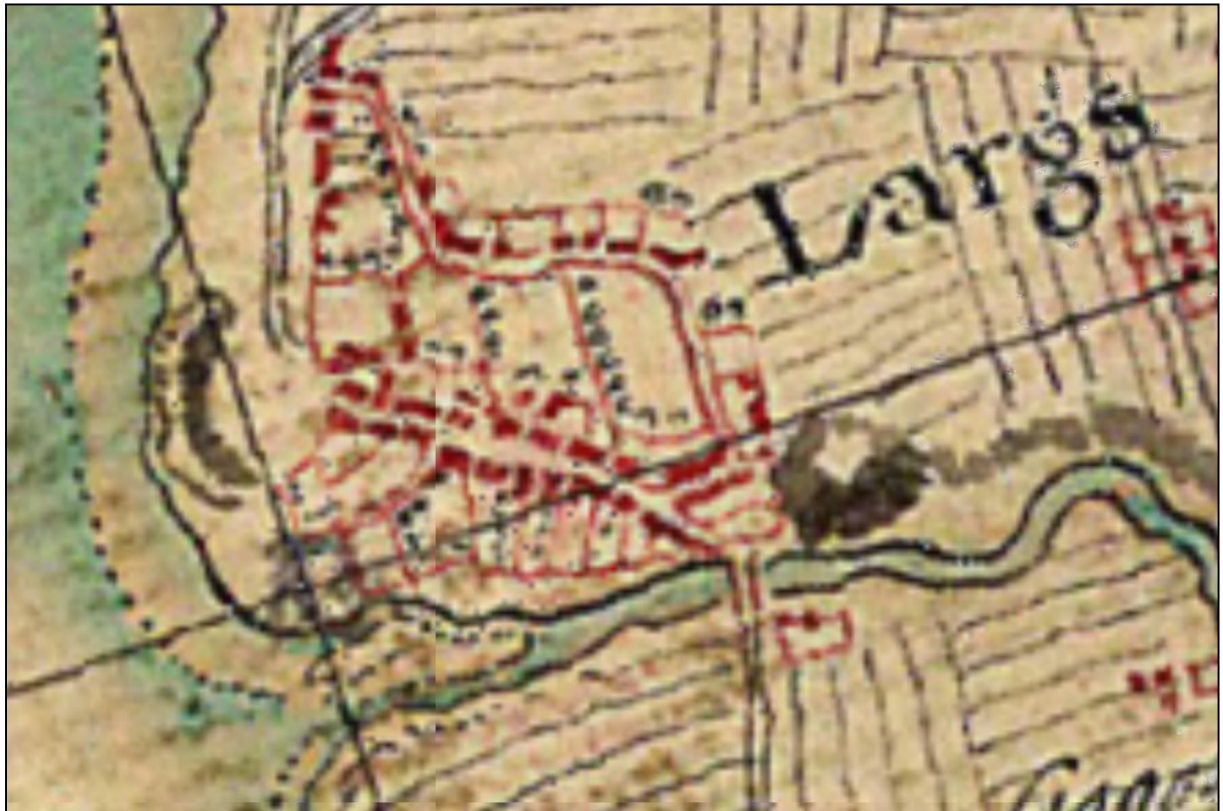
Figure 1a: Roy's Military Survey Lowlands 1752-55

5. Largs has a medieval origin, illustrated by the 1263 reference to its Parish Church. Early maps of Largs show it to be somewhat dispersed in terms of its settlement character, with settlement focused in linear bands along the road network. Roy's Military Map of Scotland, surveyed between 1752 and 1755, shows that by the mid 18th century a street with structures fronting it appears to be established on the line of Fraser's Close (Figure 1a).

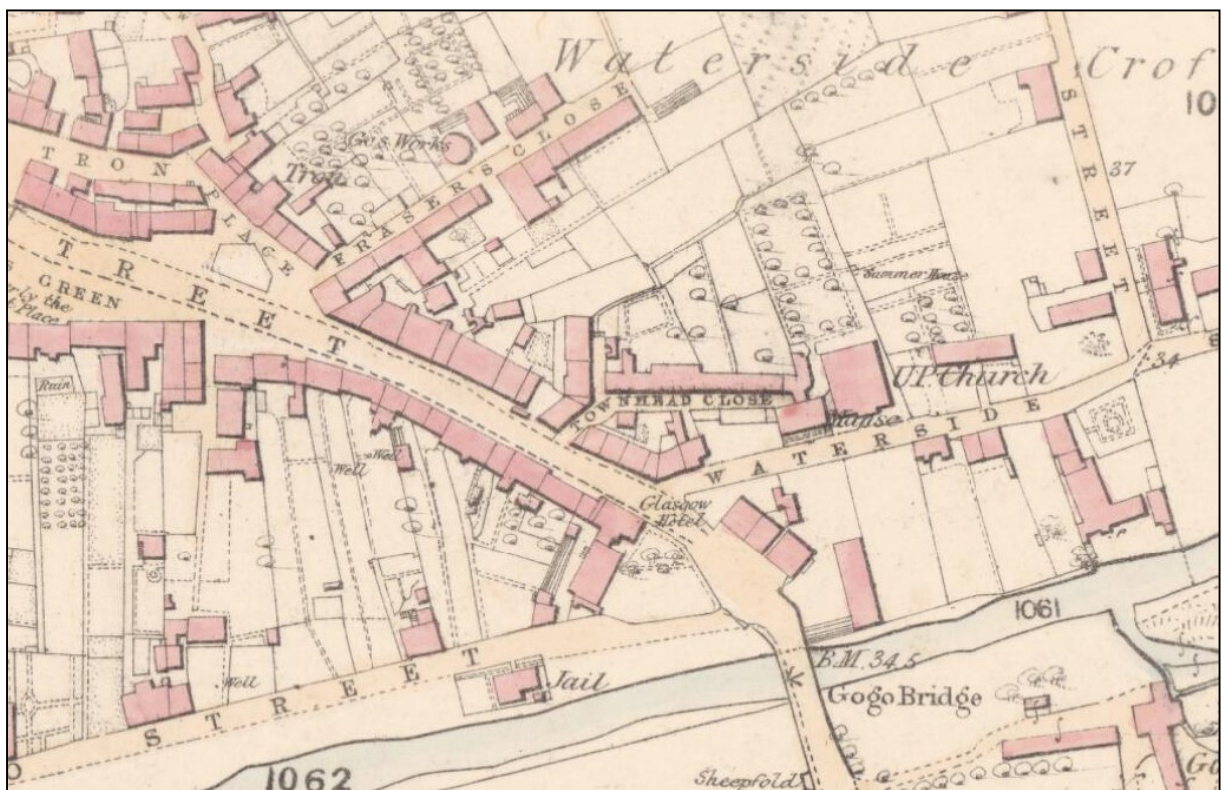
Figure 1b: 1st edition Ordnance Survey (1857).

6. The subsequent Ordnance Survey (Figure 1b) mapping shows an intensification on the frontage onto Fraser's Close and onto Waterside to the southeast. These two roads and their frontage buildings enclose the ground which is now the subject of development. There do not appear to be any significant structures built at this location between the mid 18th and the late 19th century, which suggests that the site has potential more for traces of ancillary activity from the medieval and post-medieval period.

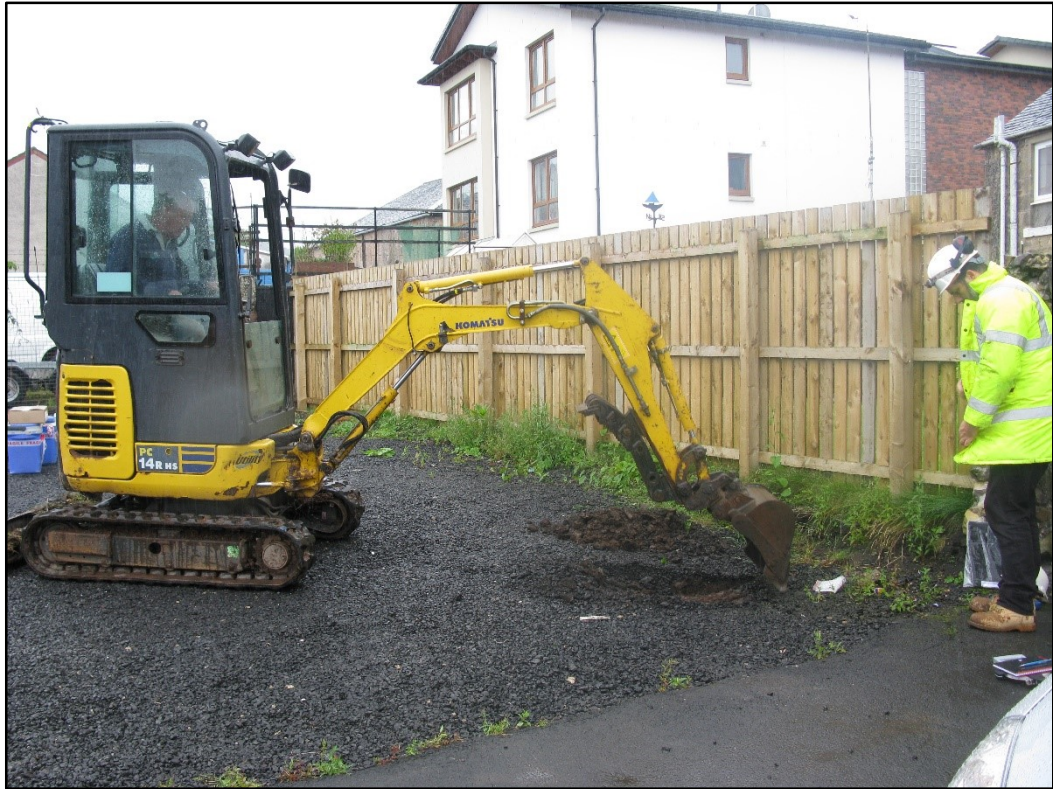
Figure 2a: Working shot of test pit excavation, 15th August 2013

10. The first programme of works commenced on the 15th of August 2013. These works consisted of the monitoring of twelve test pits within the work area. During these works a mini digger was used to excavate three small test pits through the modern surface for site investigation purposes. These works were all undertaken within the day.

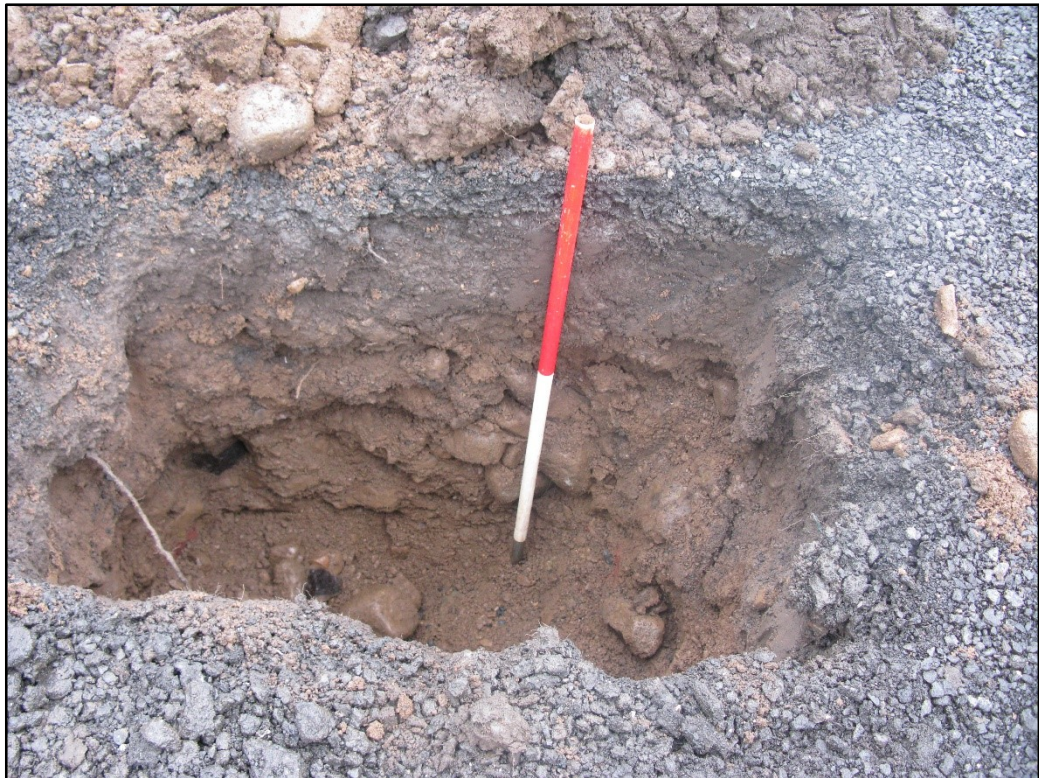
Figure 2b: S facing section of Test Pit 1, 15th August 2013

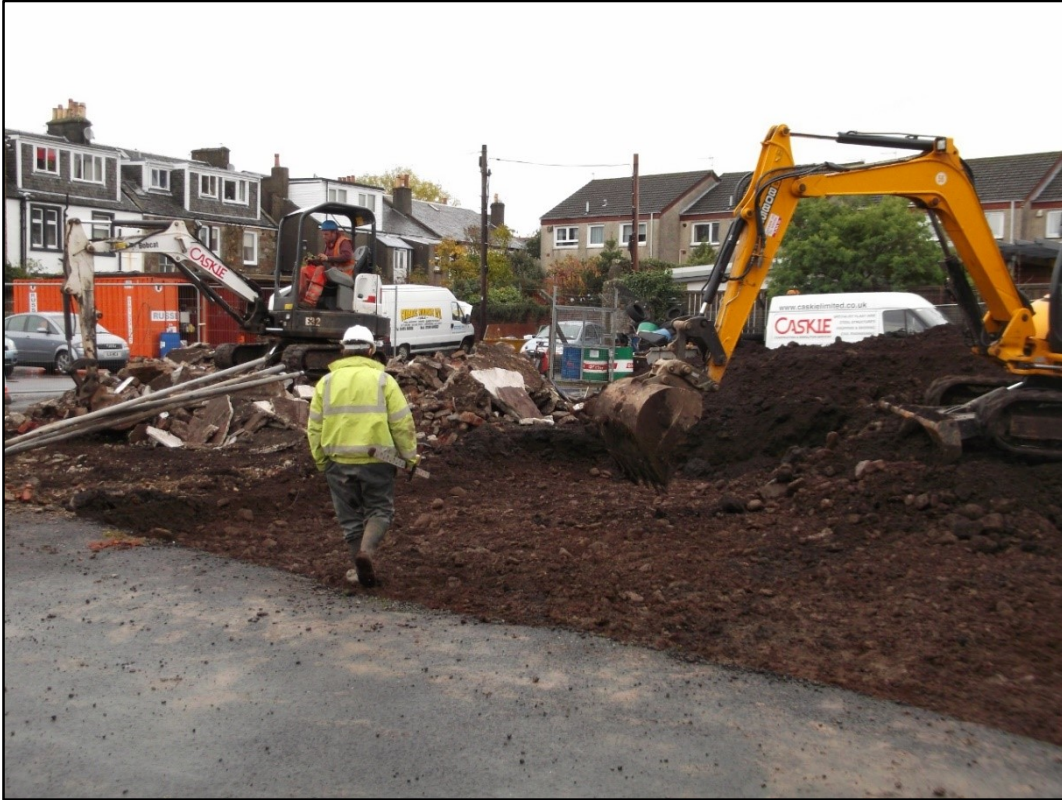
Figure 3a: Commencing works on reduction of ground level SW corner of site and removal of demolition debris in NW corner of site.

18. The reduction of the ground surface within the second programme of works began at the SW area of the site, while the debris from the demolition of the existing garage was being lifted and removed from site (Figure 3a).

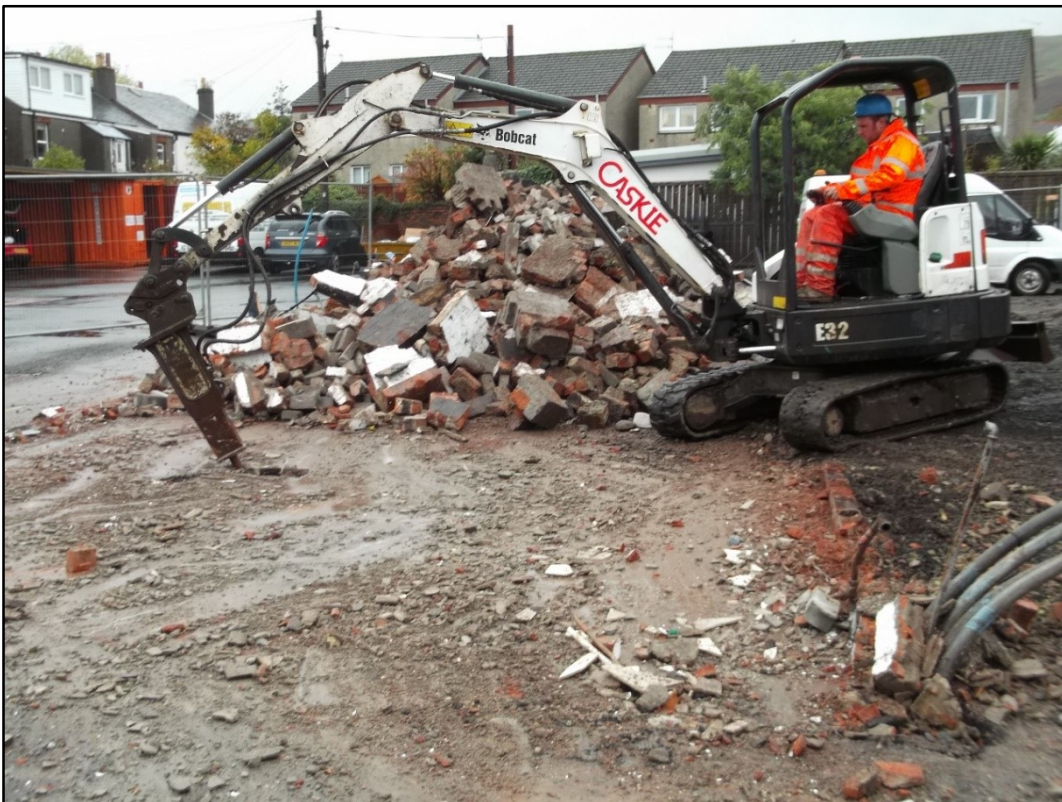
Figure 3b: Removal of concrete floor of demolished garage.

19. Topsoil (001) across the site was rare, and mainly concentrated underneath the concrete floor surface of the demolished building. This concrete floor (003) had been poured directly onto a thin layer of topsoil (001) overlaying the subsoil (002).

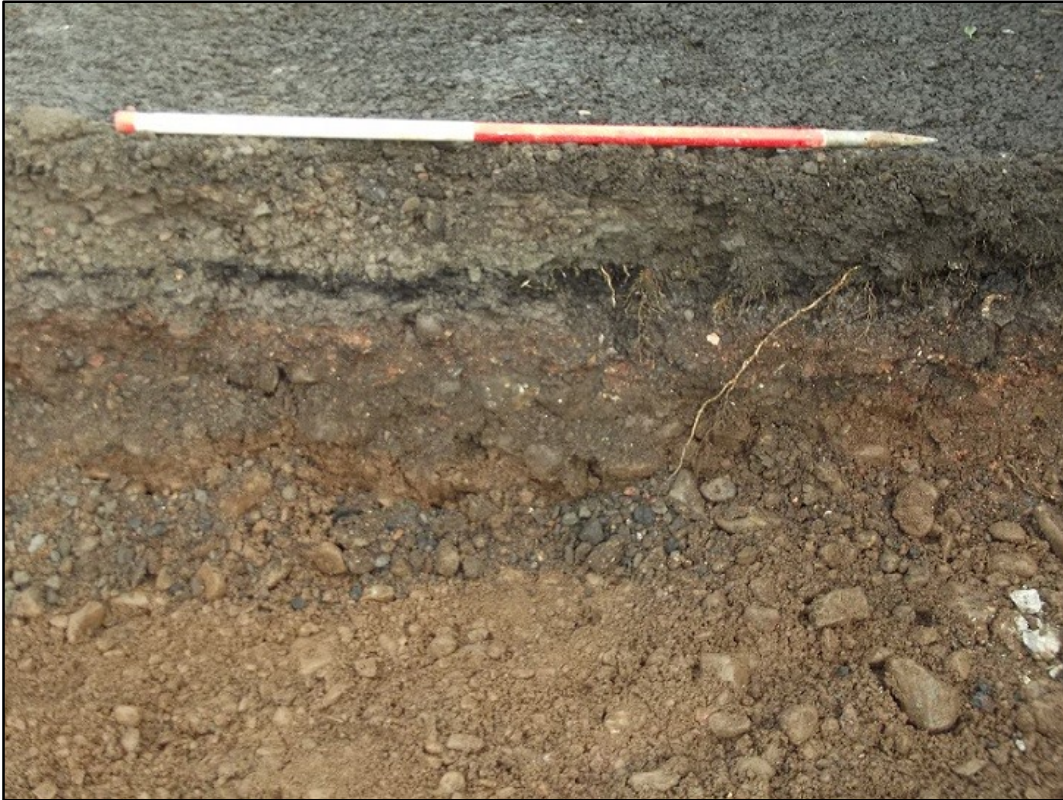
Figure 4a: SW facing section of trench showing Type 1 deposition layers

21. It was clear from the stratigraphy that the area had been subject to modern landscaping for working use. The upper surface of the sediments beneath the Type 1 stone to the south and east had been levelled for the laying of this engineered surface. This stone material (009) had two distinct layers; it was inferred that it had been overlain with a new Type 1 surface more recently (Figure 4a).

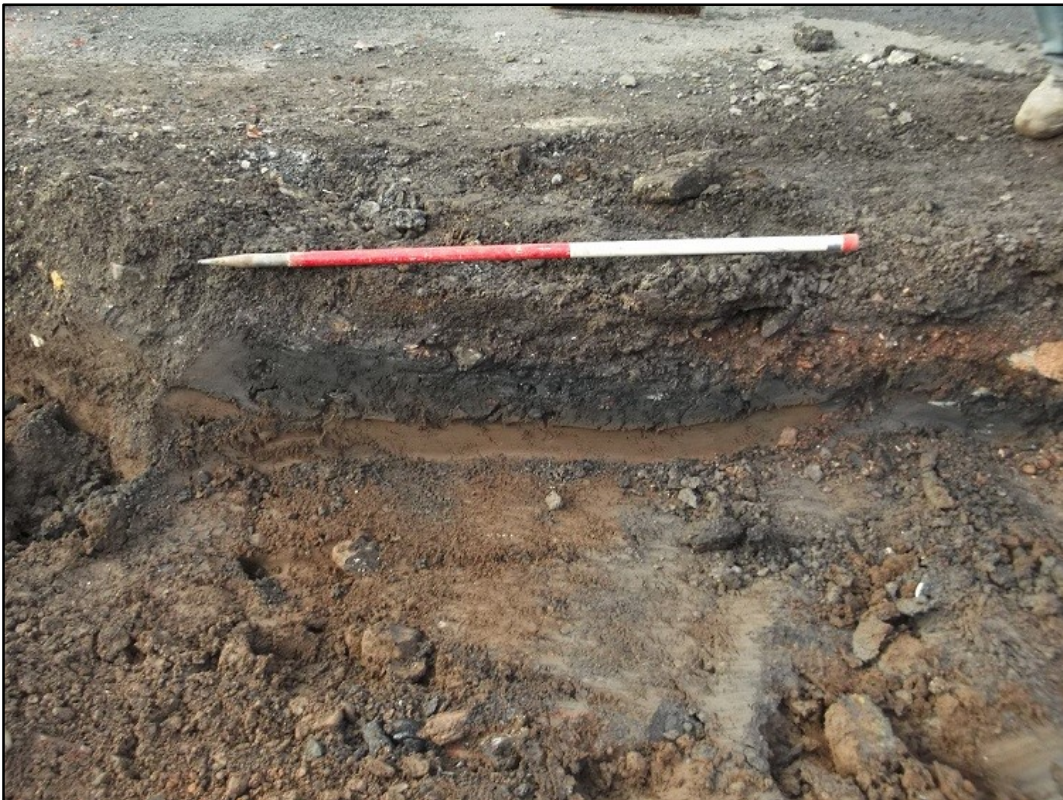
Figure 4b: Section through ground to the rear of modern brick revetment, showing topsoil/garden soil (001) directly overlying subsoil (003)

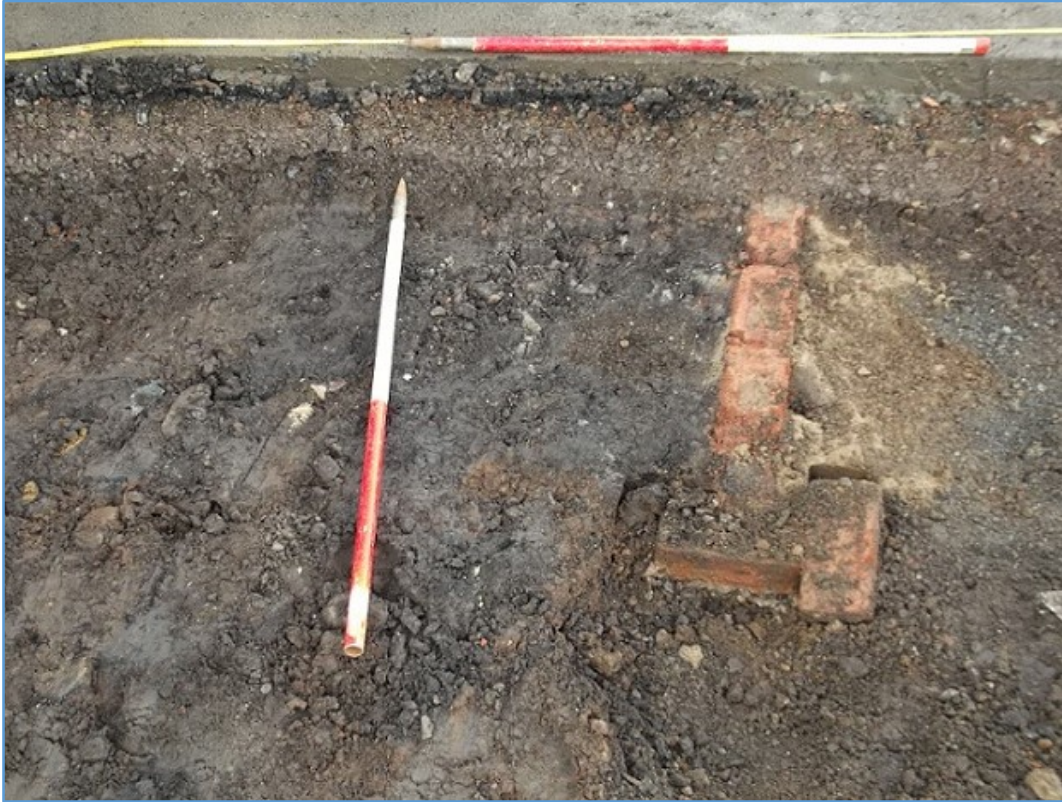
Figure 5a: SW corner of site showing (005) deposit and [006] 20th century yard wall remains.

24. Directly to the rear of the northwest corner of the Fiddlers and Oceans Nightclub the remains of a relatively modern red brick garden/yard wall of two courses (006) was uncovered, set in a heavily compacted beige/yellow sand (008). From its truncated appearance, it is clear that the wall remains had already been disturbed in previous works. Surrounding the wall remains was a firm dark brown/black silty clay deposit with inclusions of small to medium rounded stones and plant material (005). The finds from this deposit consisted mainly of modern waste materials such as animal bone, glass fragments and modern white glazed ceramic sherds.

28. The only archaeological feature of note was the discovery of the remains of a yard wall (006), likely previously belonging to the Fiddlers and Oceans Nightclub building. This small remnant foundation was surrounded by the deposit (005) which was characterised by modern ceramic sherds, glass fragments and organic waste. As none of the finds pre date the modern period, this deposit was interpreted as a waste deposit from earlier occupation of the surrounding buildings and likely dates from the 19th to 20th century.

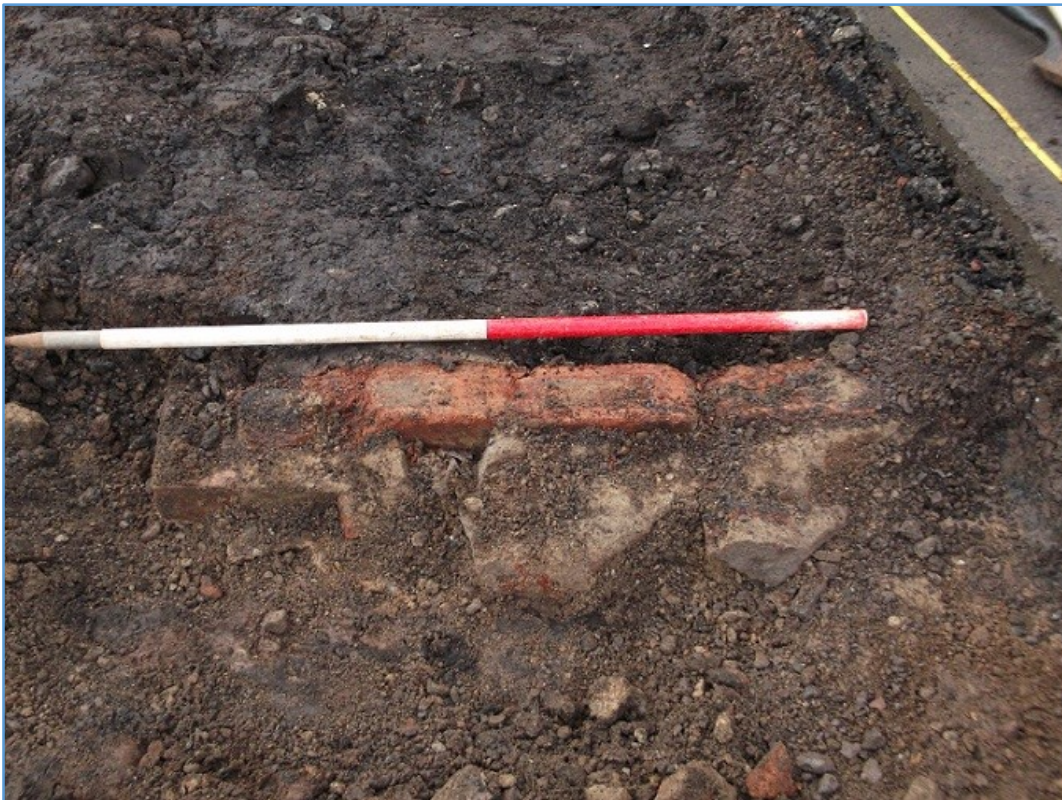
Figure 5b: [006] 20th century yard wall remains.
