Inveraray Water Treatment Works, Security of Supply Project: Archaeological Mitigation

Data Structure Report

issued 28th May 2014

on behalf of Scottish Water Shared Services Delivery

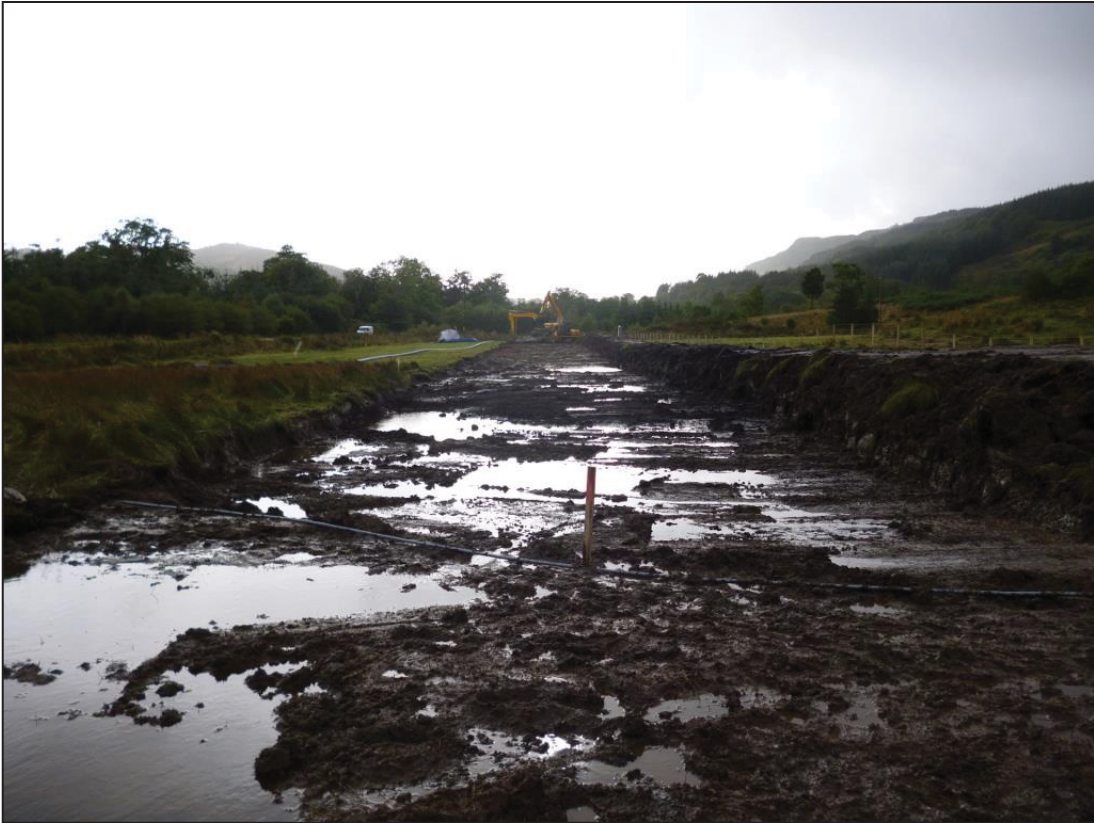
20. The only area where natural subsoil was not revealed was for the final 43m at the northeastern end of the area, where peat compacted dark brown peat (007) was revealed as underlying the topsoil. The peat was not removed during the on-site works and therefore its full depth was not revealed. This area was very waterlogged (Figure 4a) and ran up to where the burn was located at this end of the area. It was also covered by a high concentration of rushes.

Figure 4a: Stripped section in Area C from the northeast

steep slopes, such as in Area H (Figure 5a), and it is possible that the waterlogging evident in Area C (Figure 4a) has been affected the site for a long period of time. It is also possible that the consistent disturbance stemming from the site's prolonged use for agriculture may have affected the survival of archaeological features, especially any upstanding structures which would have been removed for access with ploughing and the insertion of drainage removing any footings.

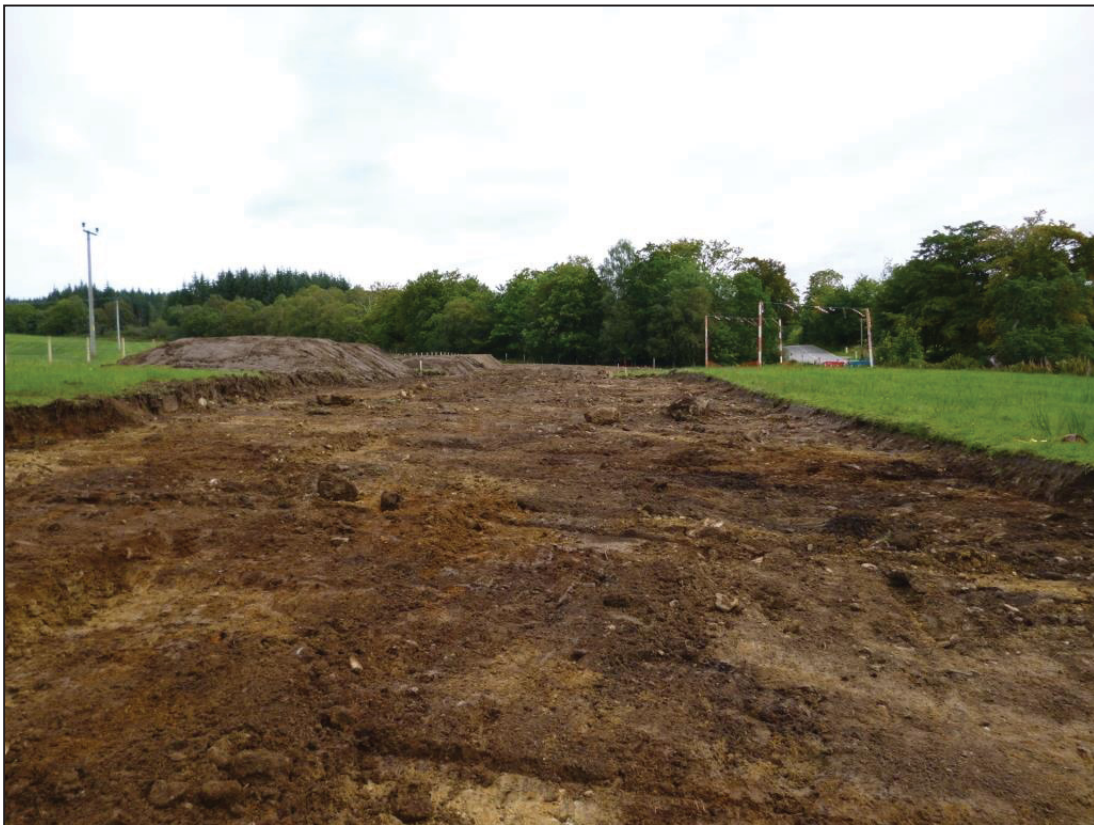
27. The works removed the topsoil, and where present (005), to reveal natural subsoil underlying it. This consisted of (002), a moderately compacted mottled pale yellow and mid-dark orange sand and gravel with occasional medium to larger boulders (Figure 4b). This was present across the entire area.

Figure 4b: General shot of Area D from the southwest

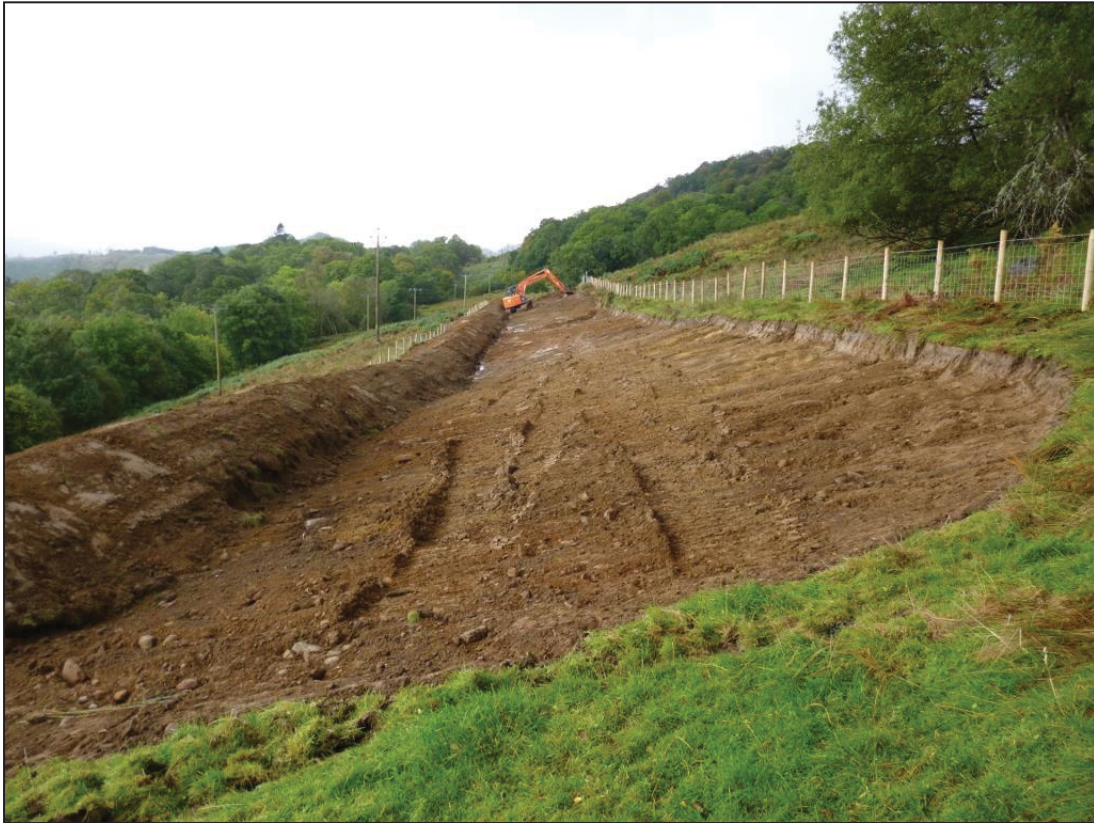
35. The third section started approximately 32m to the southwest of the track and ran to the southwest, curving towards the southeast close to the southwestern end. The area stripped measured approximately 259.2m by 10m wide, totalling an area measuring 2592m² in size. This stopped at the edge of an area covered with dense trees near to the road at this end of the area. The area was excavated down to a depth of 200 to 400mm (Figure 5a).

Figure 5a: Third section in Area H from the northeast

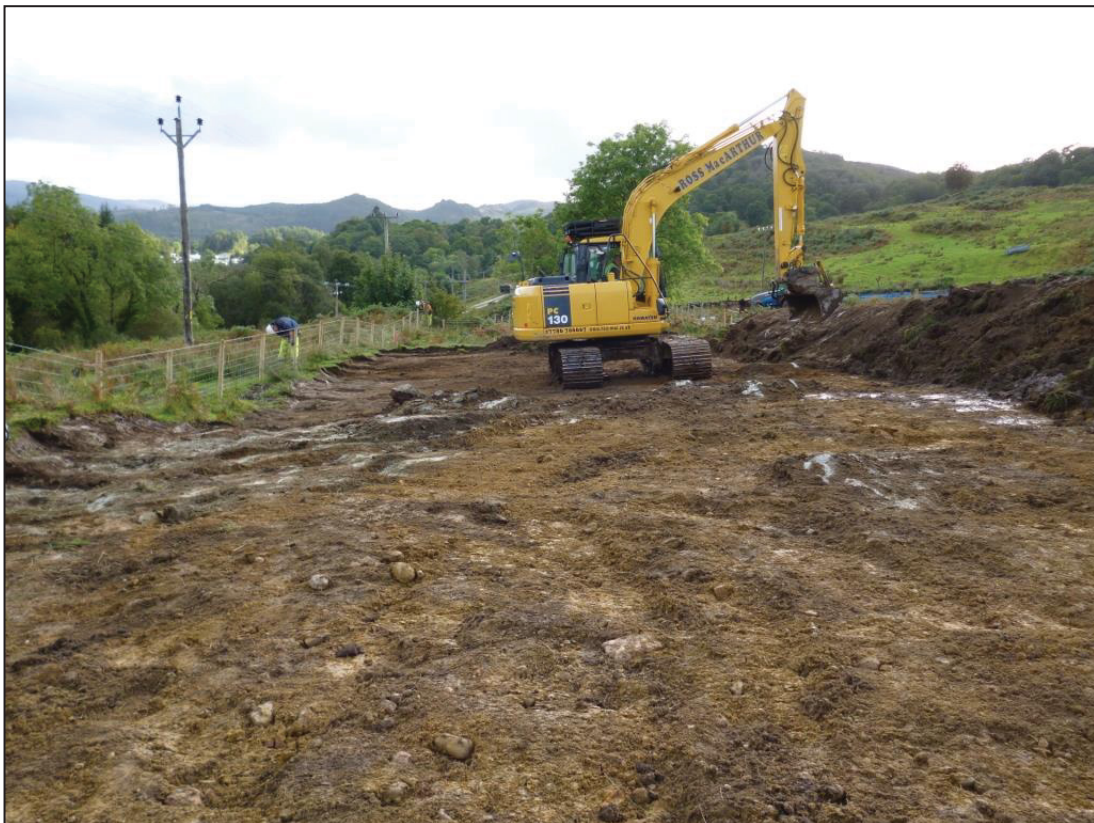
38. Patches of natural bedrock (013) were also visible in the first stripped section sitting within (012) (Figure 5b). These appeared to consist of pale grey granite and were mostly quite compact although some sections had been broken up. A few of the patches stood high from the surface of the subsoil forming outcrops or mounds visible on the surface. These measured up to 550mm high above the upper surface of the subsoil.

Figure 5b: Northeast section of Area H showing patches of bedrock (013) from the northeast

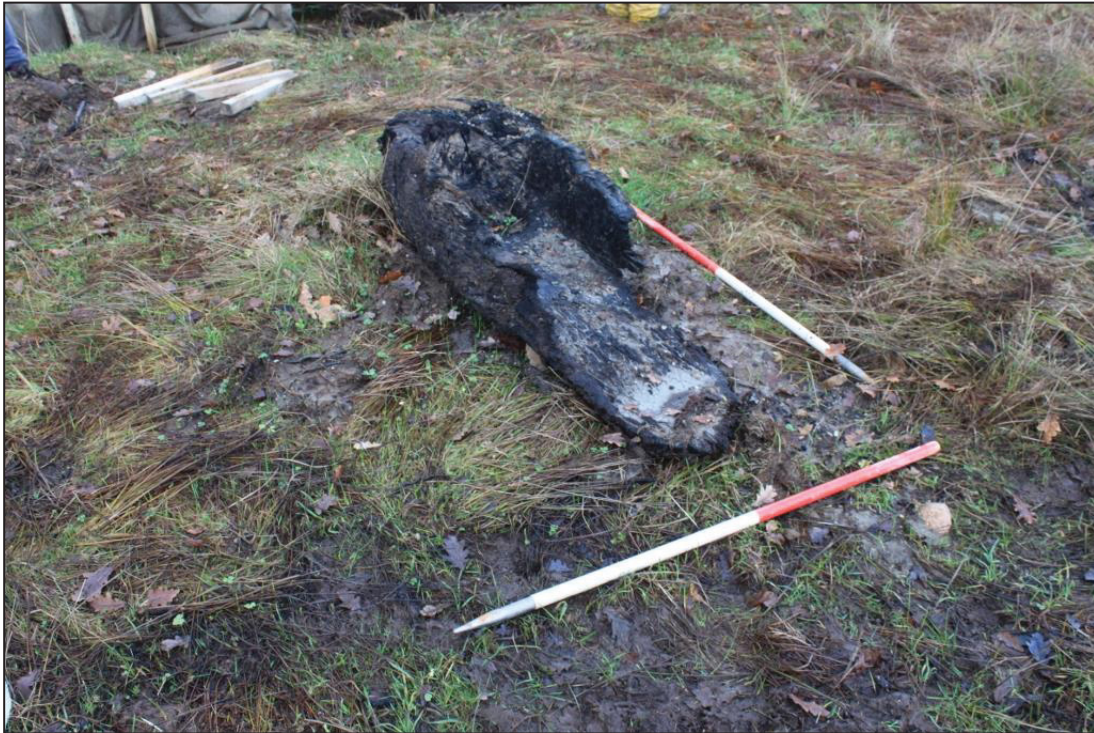
Description: The object comprised a section from a hollowed-out log or tree trunk, split in half longitudinally prior to the removal of the heartwood (Figure 6a). It was broken at one end, with the other, complete end, comprising a roughly squared off external surface, and a neatly finished internal face. The exterior surface was deeply fissured, with the bark of the tree potentially still *in situ*.

Condition: The object is blackened as a result of its long-term immersion in peat. There has been some cracking of the *in situ* heartwood at the 'butt' end. Over the portion of the interior located close to the 'butt' end, the surface is very well-preserved with traces of tool marks. The edges of the circular hole are also associated with surviving tool marks. It is fragmentary, with the surface poorly preserved at the incomplete end. The upper edges of the sides and rear, 'butt', end are also in poor condition.

Figure 6a: General shot of wooden object

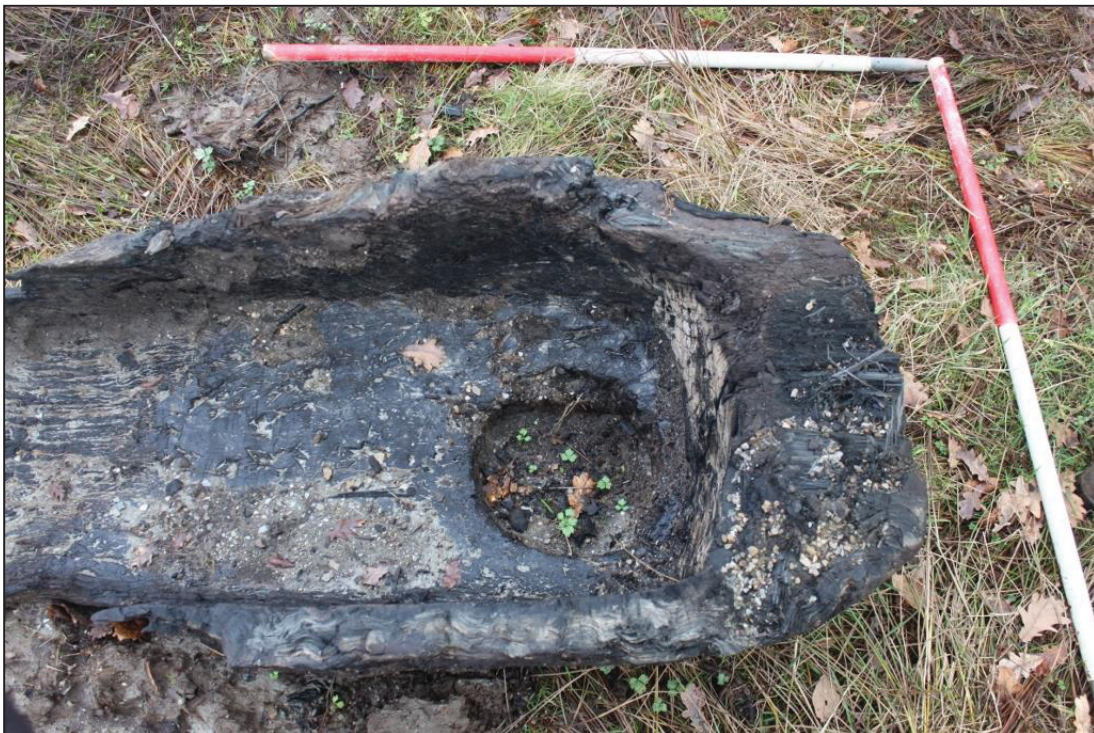
Possibly the most striking feature of the interior was a circular hole (Figure 6b), measuring 0.23m in diameter. This was located in the centre of the base, close to the surviving 'butt' end of the object.

Figure 6b: Hole in base of object from above
