482-484 Lanark Road West, Balerno: Archaeological Mitigation

Data Structure Report

by Callum Allsop & Peter Klemen

issued 14th March 2014

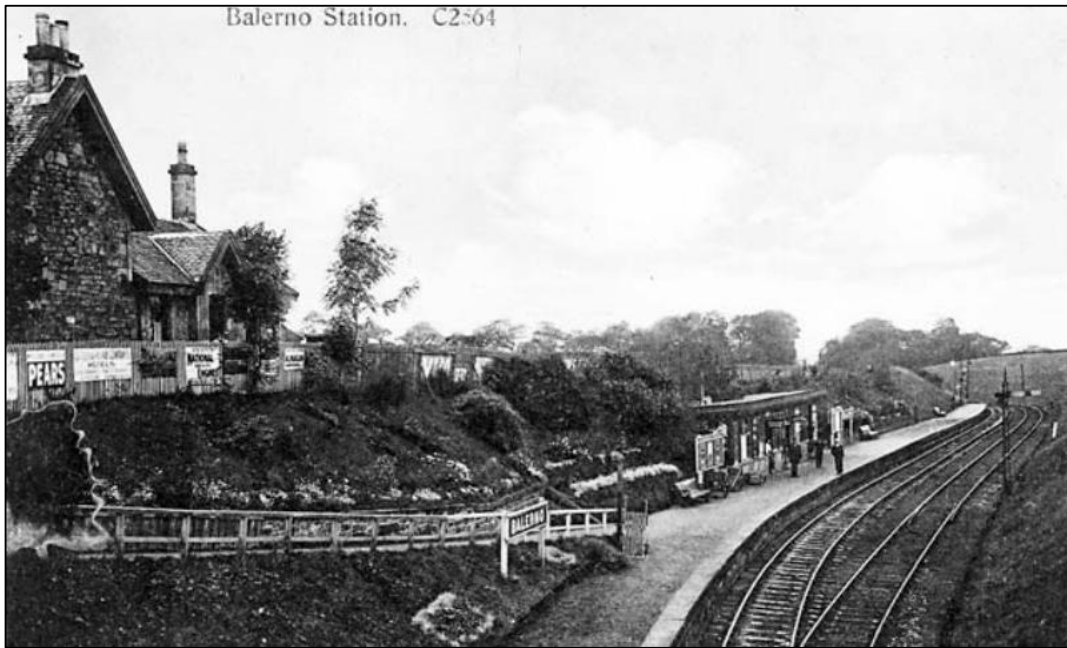
Figure 3a: Photo of Balerno Station taken c1910 illustrating the location of the platform and railway line with the Station Office visible to the left of the photo (www.edinphoto.org.uk 20/02/2014).

13. The station office is depicted as a 'C-shaped' structure in the 6 inch 2nd edition Ordnance Survey map (Figure 2a) with the platform sited a little to the north-east and depicted as an unfilled rectangle. By the time of the 6 inch 3rd edition Ordnance Survey map (1908) the station office is depicted as an 'L-shaped' structure with the longest side of the building fronting the route of the railway line (Figure 2b). The platform is depicted in the same position as a black solid rectangle. The relationship of the station office, platform and local topography is illustrated by Figure 3a.

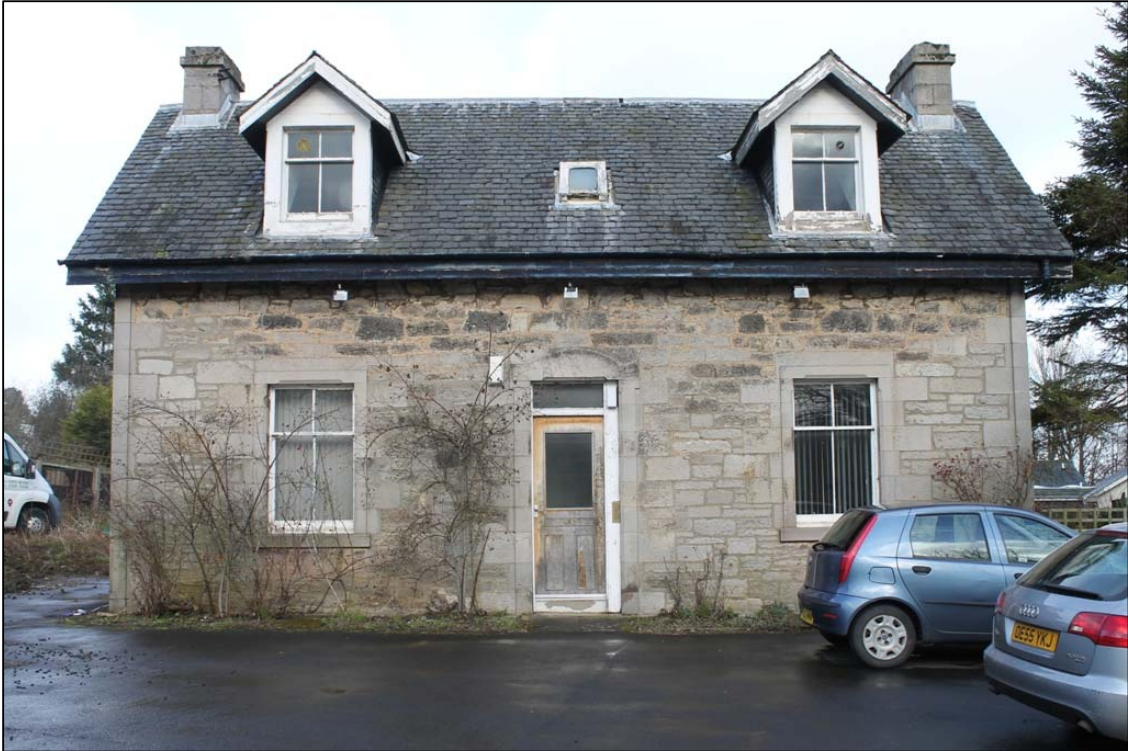
40. Figure 7a: N elevation of Building A taken from the S.

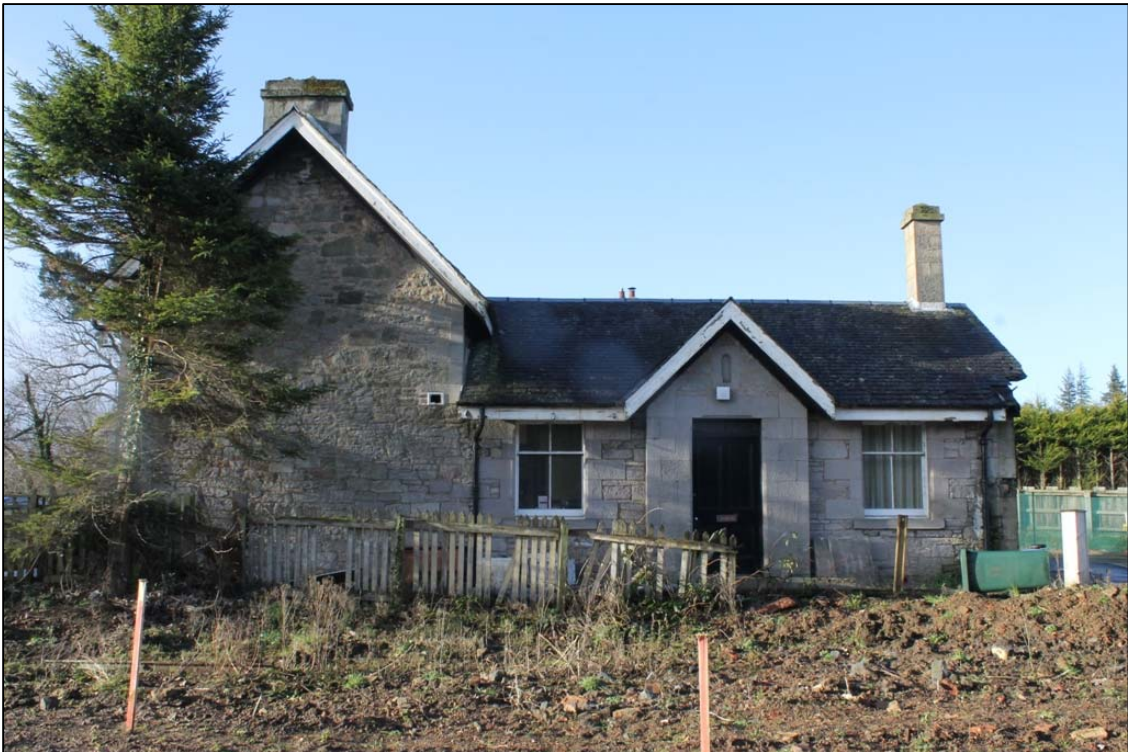
Figure 7b: W elevation of Buildings A and B taken from the E.

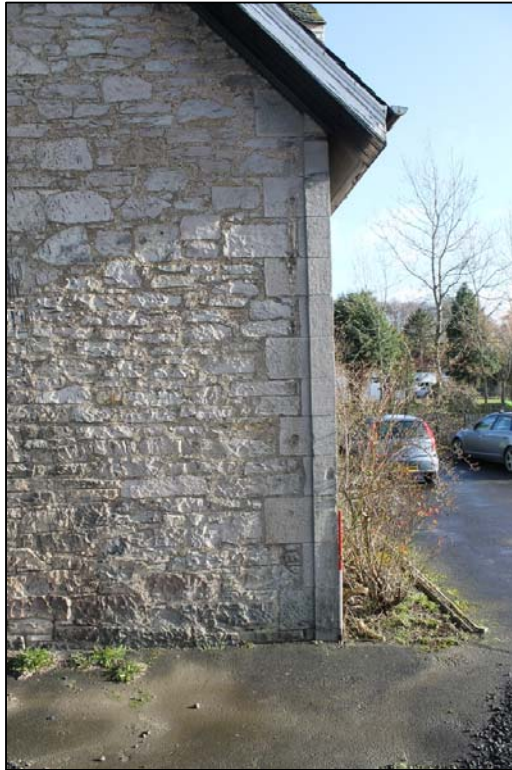
Figure 8a: Detail of quoins on E elevation taken from the W.

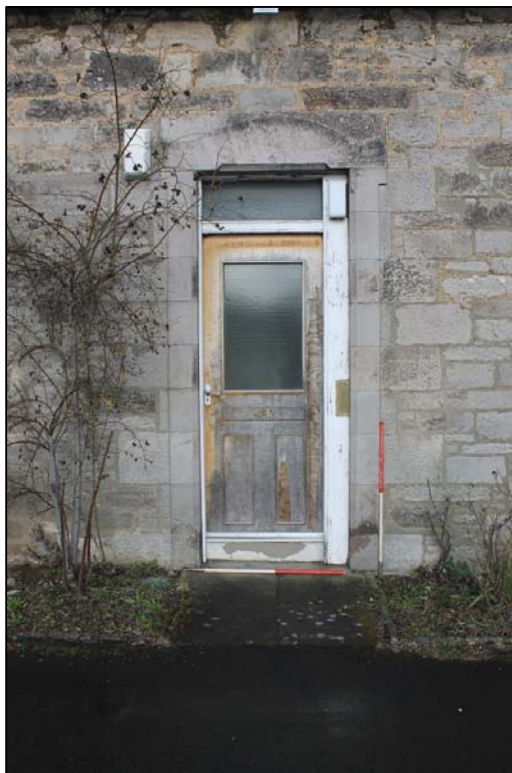
Figure 8b: Detail of main access on N elevation taken from S.

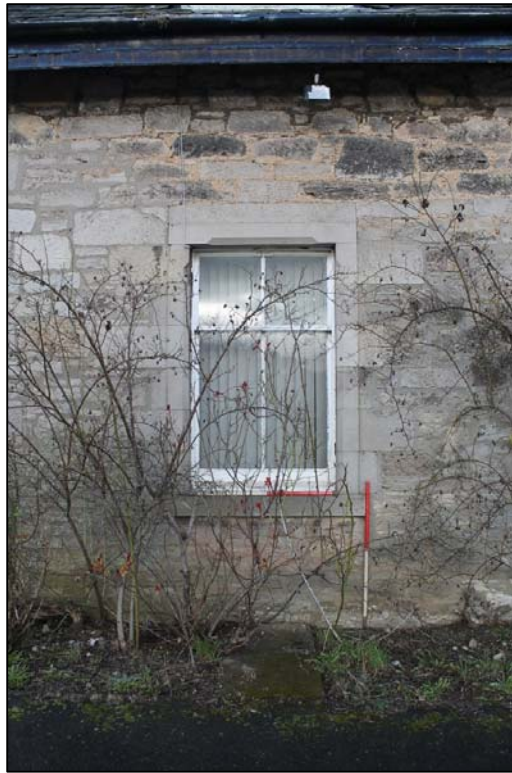
Figure 9a: Detail of Window A on N elevation taken from S.

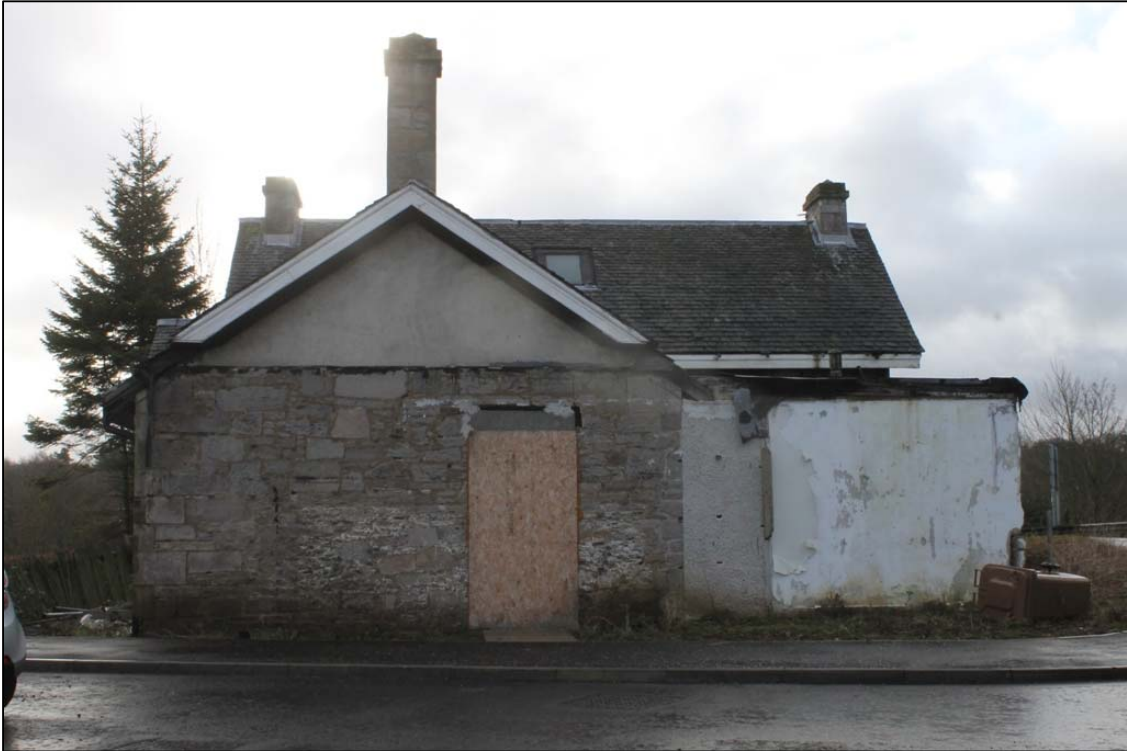
Figure 11a: S elevation of Building B and modern extension taken from the N.

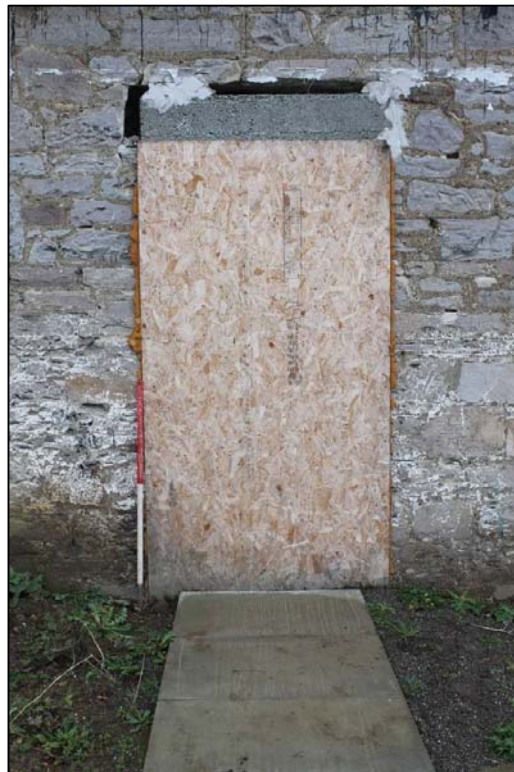
33. The south elevation of Building B, which forms the external side elevation of the structure, had a boarded-up doorway which appears to have been a later insertion, as it lacked rybats and appears to have been equipped with a woefully inadequate lintel. The wallhead had been extended upwards to form a gable end – this later feature is concealed beneath a coat of render, but the construction is presumably contemporary with the modern extension and comprises either brick or breeze-block. The uppermost quoins had also been cut to accommodate the line of the roof. The chimney stack, located in the S wall, was unusually tall. Where the modern extension abuts Building B, a gap is evident in the wallhead between the pitched roof of Building B and the flat roof of

Figure 11b: Detail of boarded up doorway on S elevation taken from the N.

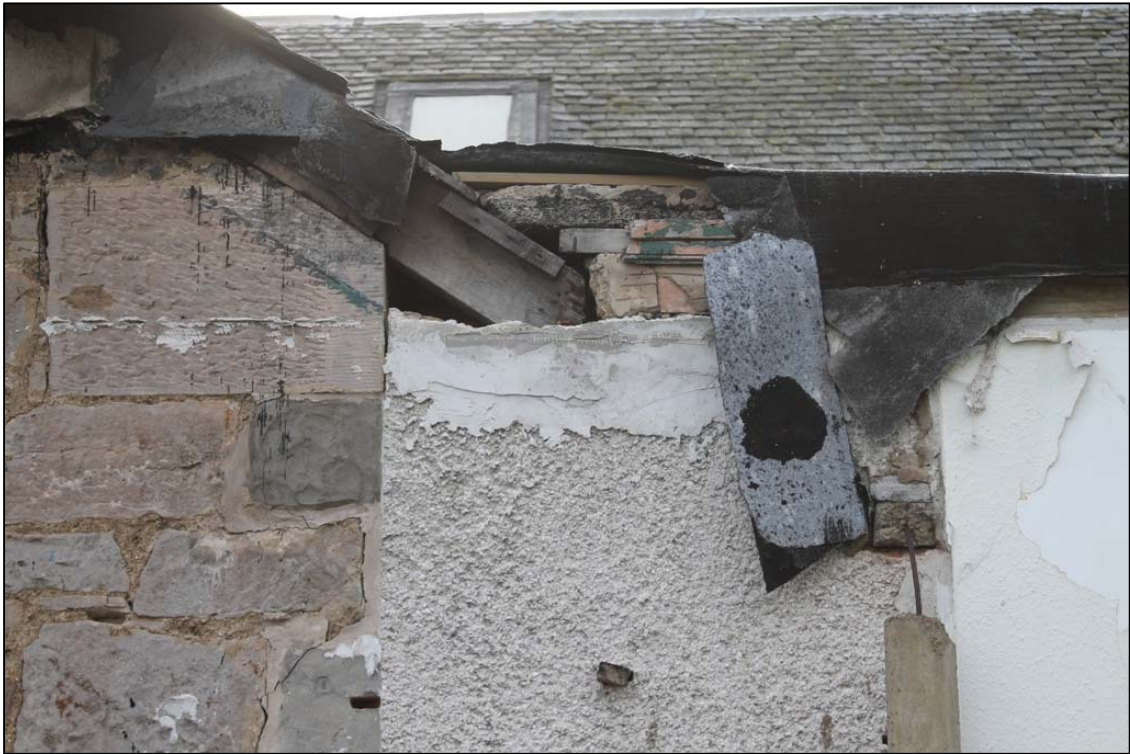
the modern extension. This would originally have been concealed beneath bargeboarding and/or lead flashing, but this has now been removed.

Figure 12a: Detail of damage on the S elevation taken from the north.

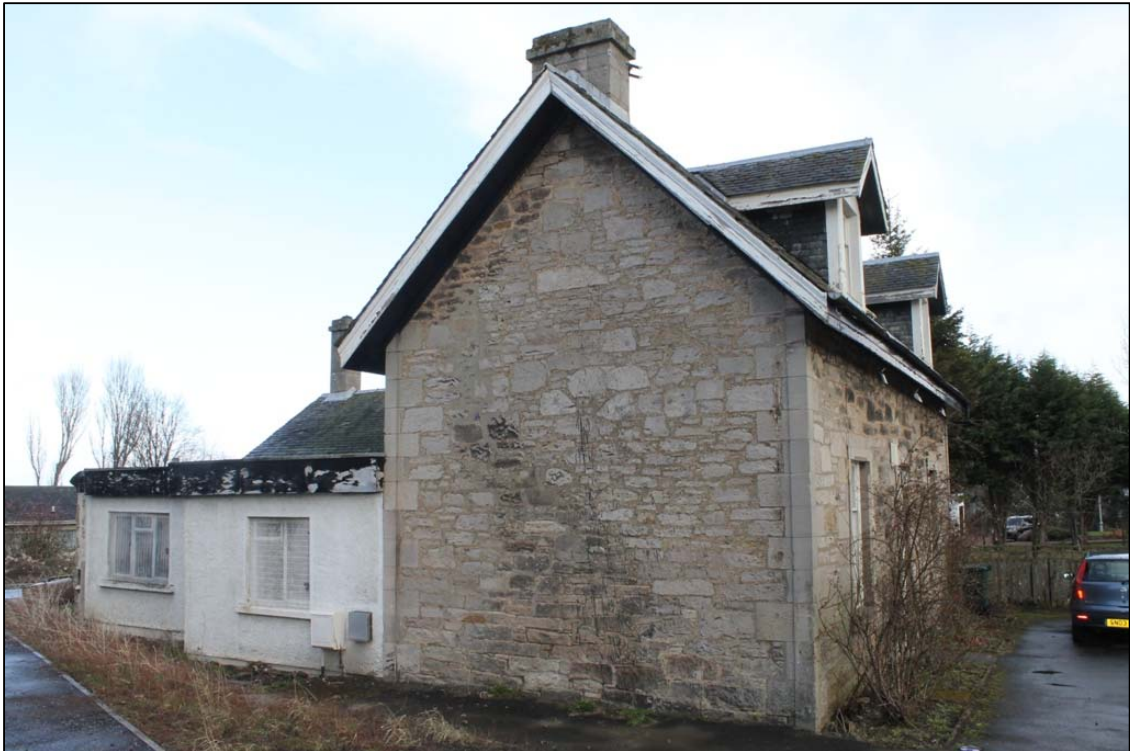
34. The modern extension (Figures 12b & 13a) abutted Building A on the north side and Building B on the west side. It was 'L'-shaped on plan, with a boarded-up doorway and two windows, A and B, on the east elevation. The roof was flat, and constructed of timber covered with bituminous felt.

Figure 12b: E elevation of Building A and modern extension taken from the SW

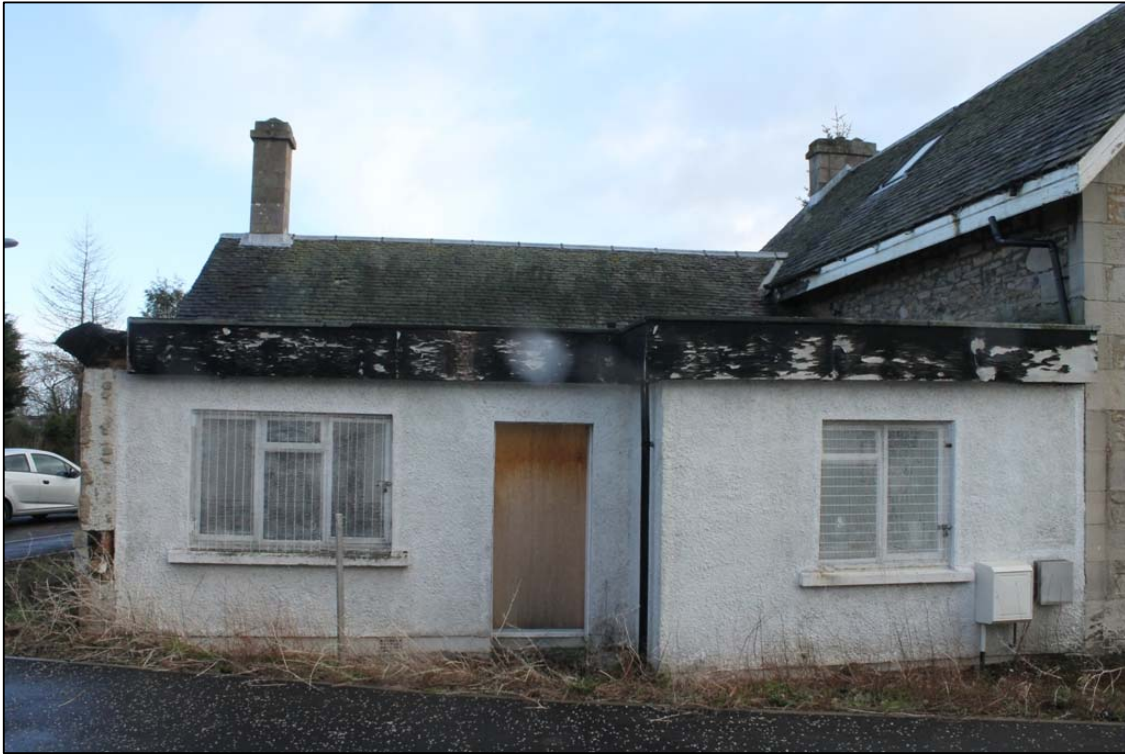
Figure 13a: Doorway and Windows A and B on E elevation of modern extension taken from W.

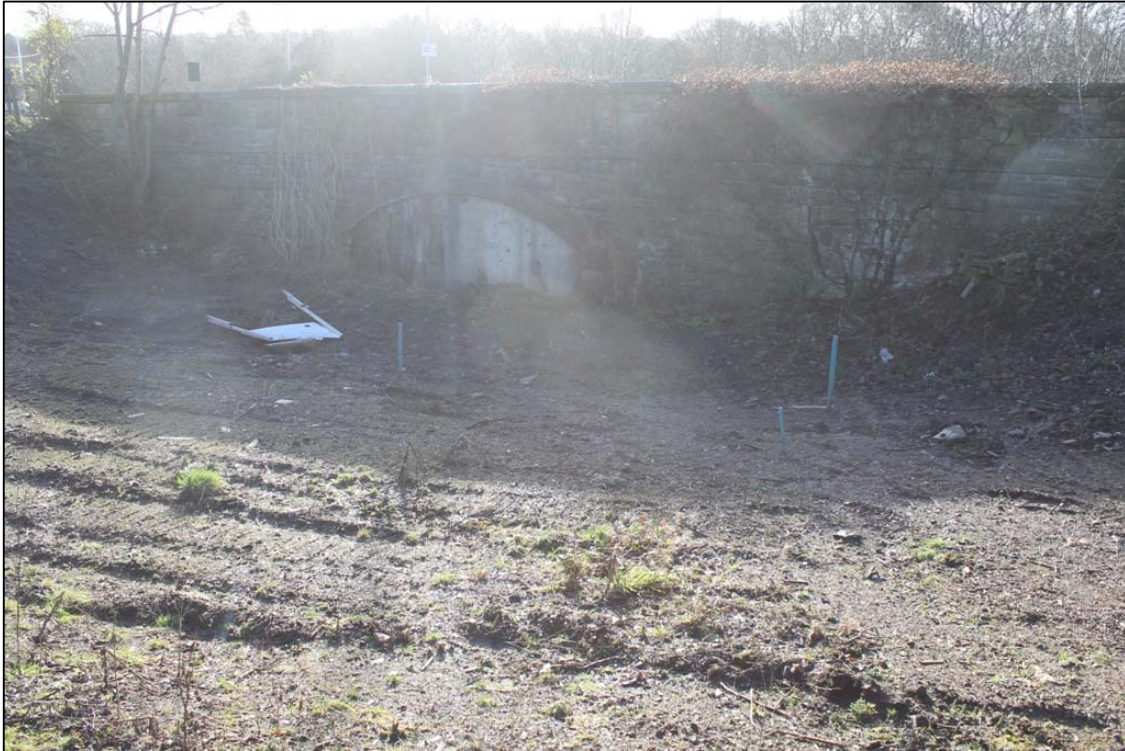
35. To the south west of the structure there was a single span skew overbridge (Figure 13b) measuring 25.15m long that carries the road now known as the A70 over the railway. It was constructed from large, rusticated red sandstone blocks, with ashlar voussoirs measuring 360 x 320mm in extent. An ashlar stringcourse defines the line where the spandrel wall abuts the parapet. The opening has been bricked up with large masonry, the base of which could not be seen due to a build up of soil and vegetation (Figure 14). The internal dimensions of the arch measured 6.70m by 2.65m in height (maximum). The arch was supported by sturdy ashlar piers.

Figure 13b: S elevation of railway bridge taken from the NW.

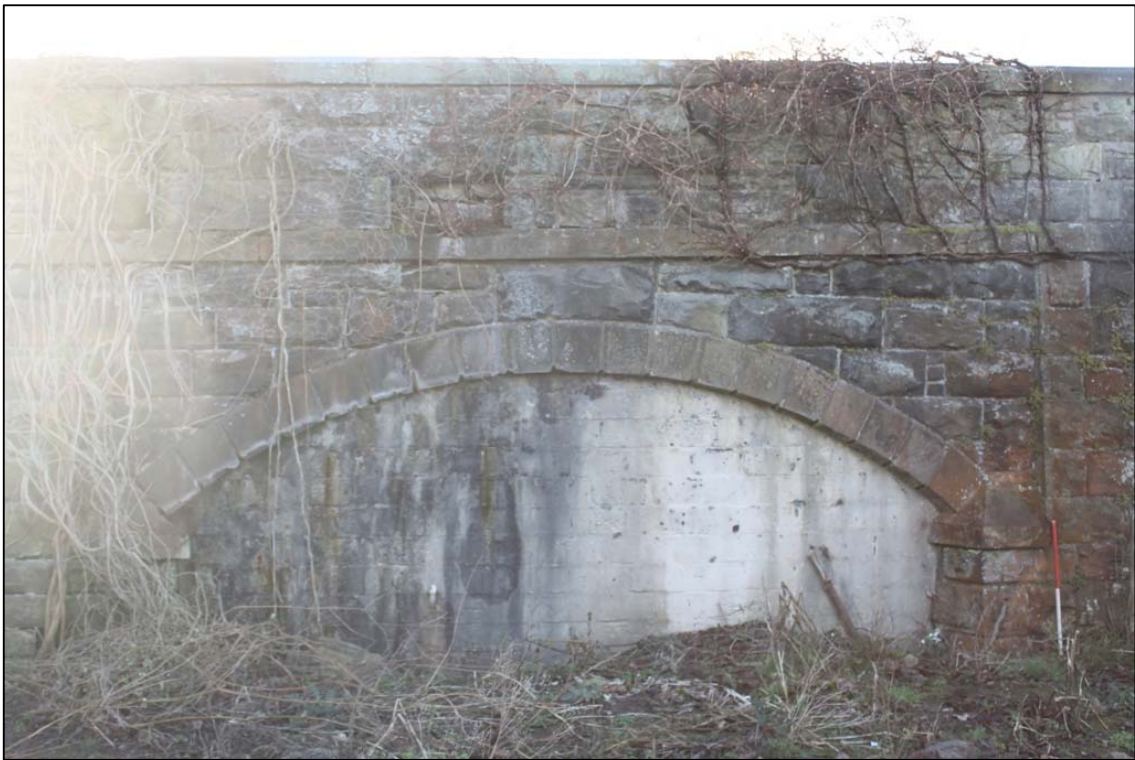
Figure 14: Detail of arch on S elevation of railway bridge taken from the N.

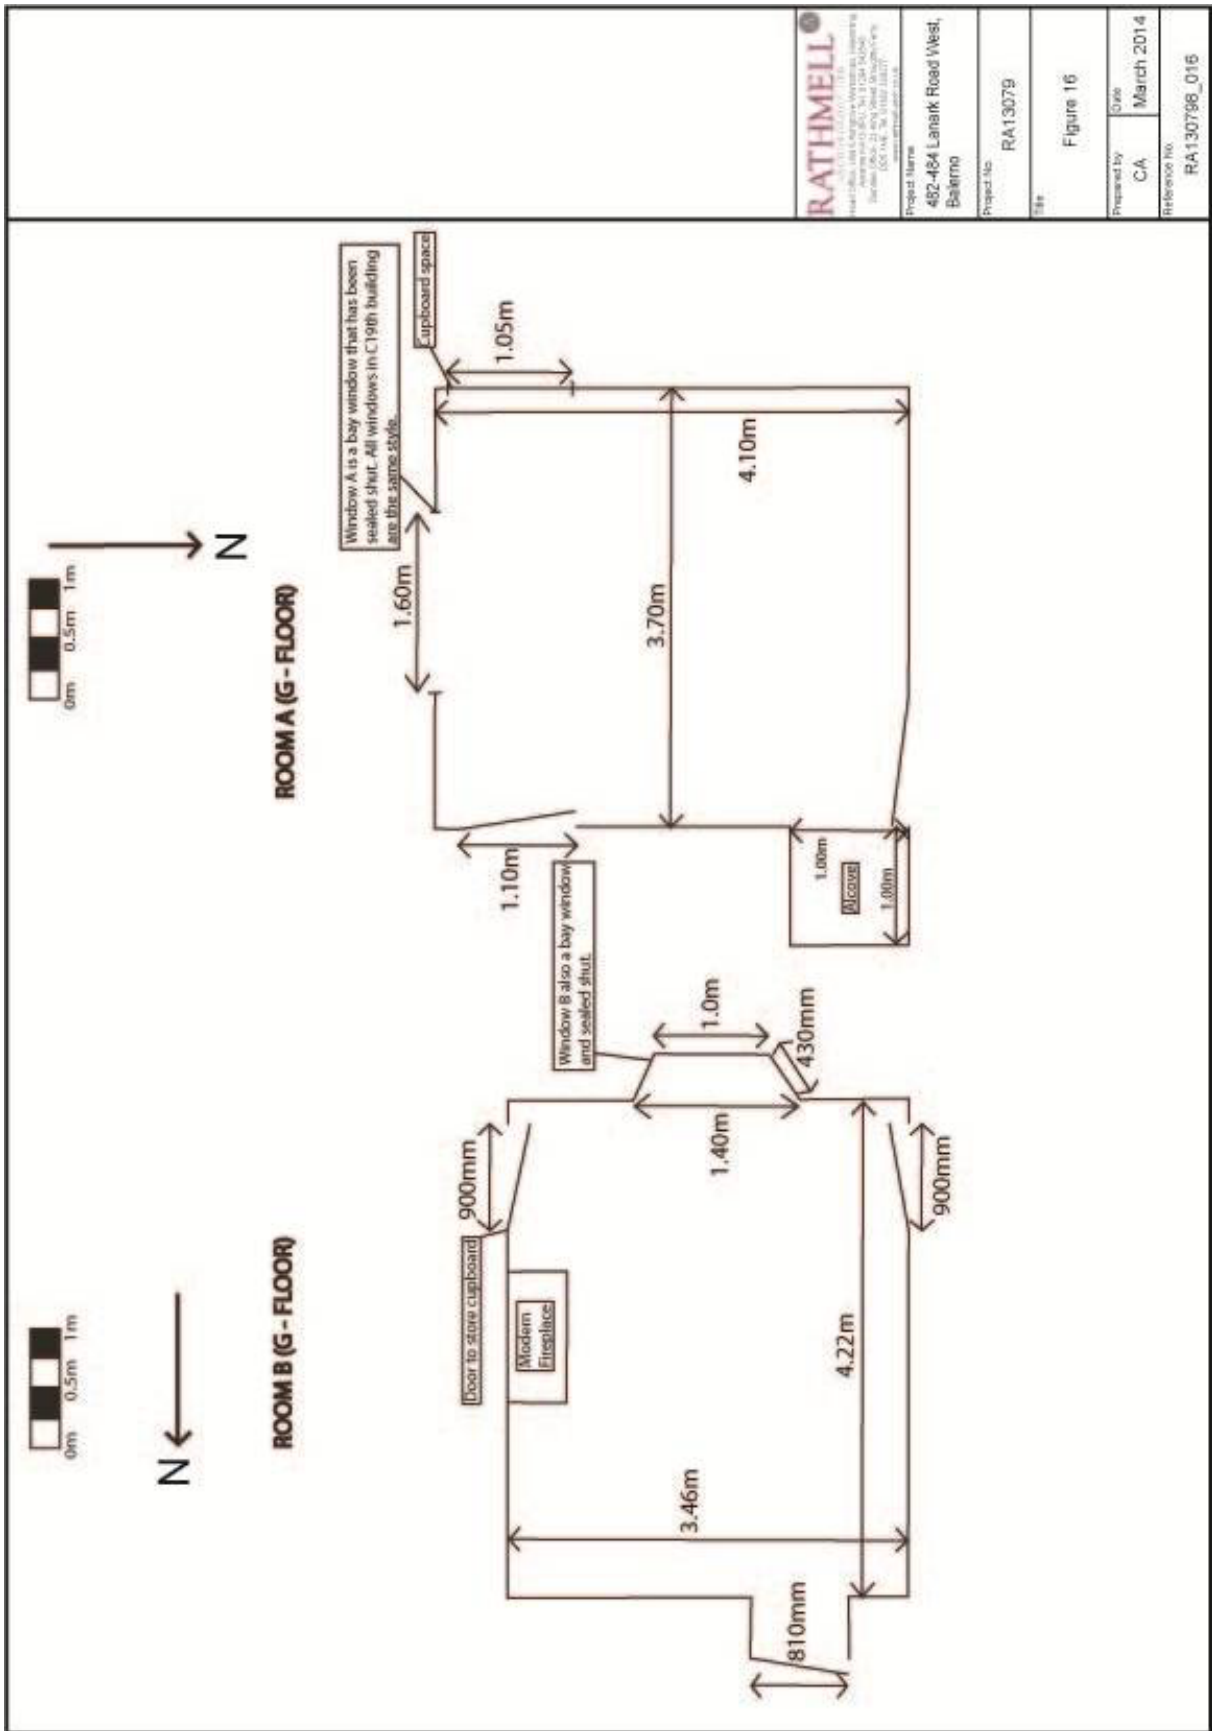
37. Room A on the ground floor (Figure 16) was square in plan and measured 4.10m by 3.70m. It was accessed from the hallway via a doorway in the east wall (Figure 17b), with another doorway (possibly later) in the north wall (Figure 17a). The east wall also had a small 1.00m by 1.00m recessed alcove or cupboard (Figure 18a). On the south wall was where Window A on the north elevation was located (Figure 18b); it sat within a splayed embrasure measuring 1.60m wide which was located 1.10m from the east wall and 1.00m from the west wall. There was another small cupboard present on the west wall (Figure 19a) that measured 1.05m wide. The timber panelling around the window and the associated cupboard (excluding the doors) and both recessed cupboards may have been original features but the ceiling (Figure 19b) had modern light fittings and a smoke alarm with no original cornice present.

38. Room B on the ground floor (Figure 16) was square in plan and measured 4.22m by 3.60m. It featured doorways on the north and west walls respectively (Figures 20a and 20b). The doorway on the north wall was recessed, and appeared to be an original opening. The east wall also had a small alcove or cupboard (Figure 21a) that measured 0.91m wide and was locked. The south wall featured a central window - Window B on the north elevation - (Figure 21b); this featured a splayed embrasure, with original timber panelling present, and relict shelving still *in situ* below the window opening. There was also a modern gas fireplace where the original fireplace would have been (Figure 21a). Both the window and the small alcove may have been original features in this room. The ceiling (Figure 22) had a modern light fitting and the original cornice was present.

Figure 16: Building A - Plan of Rooms A and B on the ground floor.

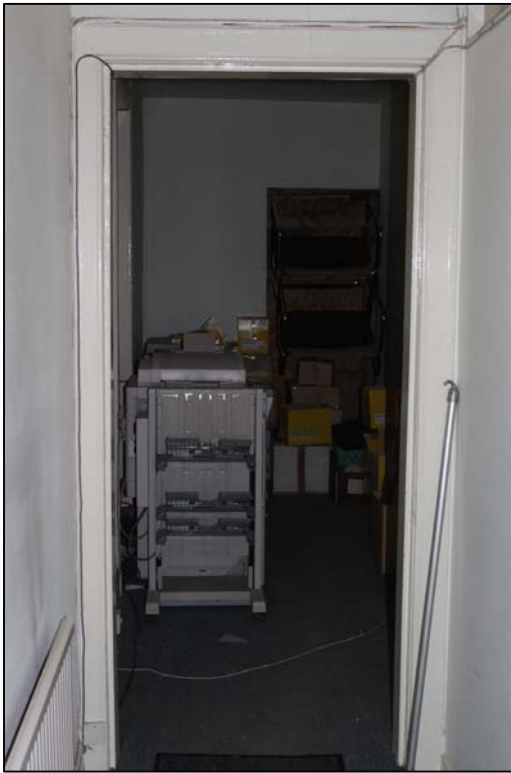
41. The hallway on the ground floor (Figure 23) was 'L-shaped' in plan and at its greatest extent measured 2.62m by 8.00m. The north wall (Figure 25a) had a blocked doorway measuring 0.82m wide. Before the hallway narrowed the width measured at 1.75m and featured doorways into Room D on the east wall and the Boardroom on the west. It had a window on the west wall looking into the Boardroom that may have possibly been a part of the original building and an access to the attic (Figure 25b) that had been nailed closed and could not be accessed. The hallway then narrowed to 1.12m width and featured two stud walls, orientated east-west and north-south respectively, that formed the interior walls of Room C. These walls had widths of 1.50m and 1.03m respectively. The doorway for Room C was also located on the east wall of the hallway. On the west wall towards the south side of the room there was an access through to the hallway of the modern extension that measured 0.9m. The south wall featured a doorway to Room B that measured 2.10m by 800mm.

Figure 25a: Hallway of Building B, N wall and boarded-up door taken from the S.

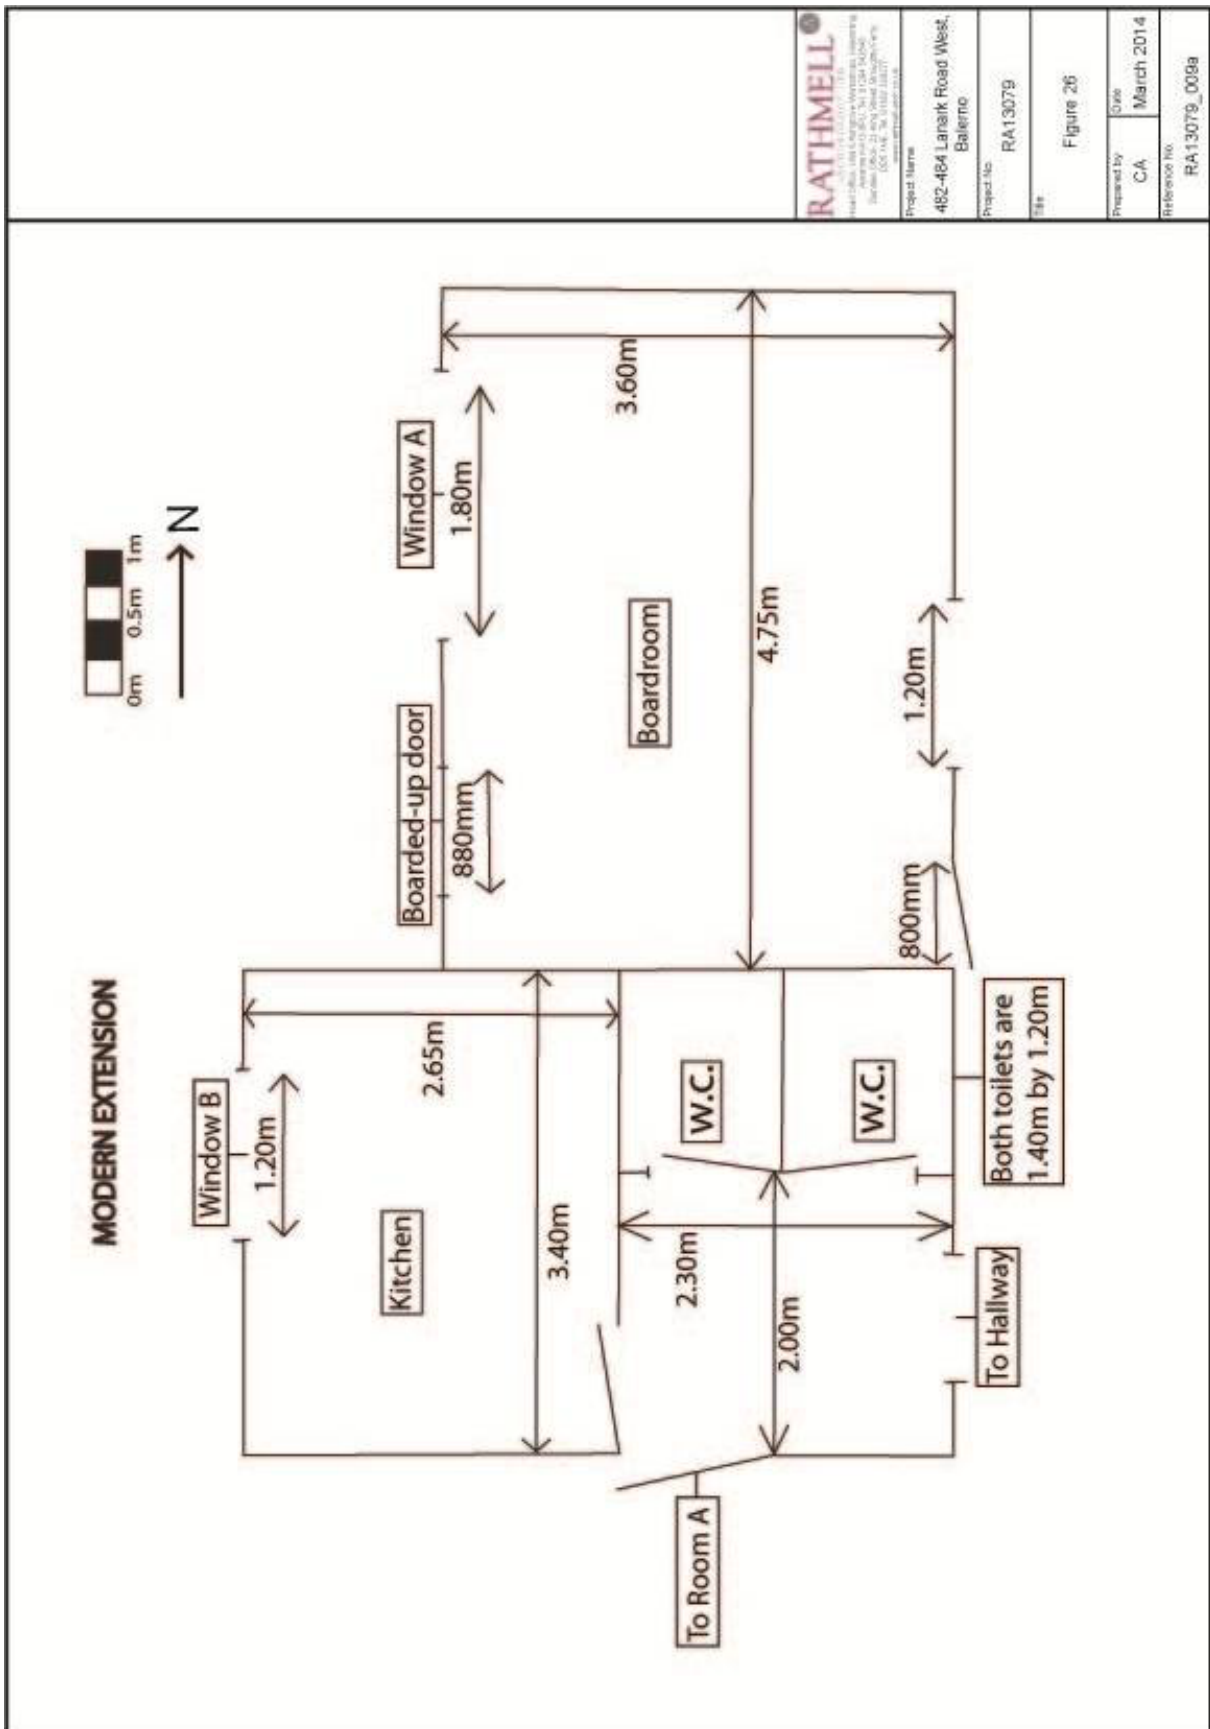
42. The modern extension (Figure 26) was sub-rectangular in plan and comprised of two rooms, kitchen and boardroom, a hallway and toilet facilities. The hallway (Figure 27a) measured 2.30m by 2.00m and had doorways on all four sides. There were two doors on the south wall leading to the W.C.'s (Figure 27b). Both W.C.'s measured 1.20m by 1.90m. The Kitchen (Figure 28a) measured 2.65m by 3.40m and featured Window B on the east elevation and a doorway. The Boardroom (Figure 28b) measured 3.60m by 4.75m and featured an internal and external door (boarded-up) and Window A on the east elevation. All rooms had the same ceiling; both the Kitchen and Boardroom ceilings had signs of damp and physical damage.

Figure 26: Modern Extension - Plan of hallway, Kitchen and Boardroom.

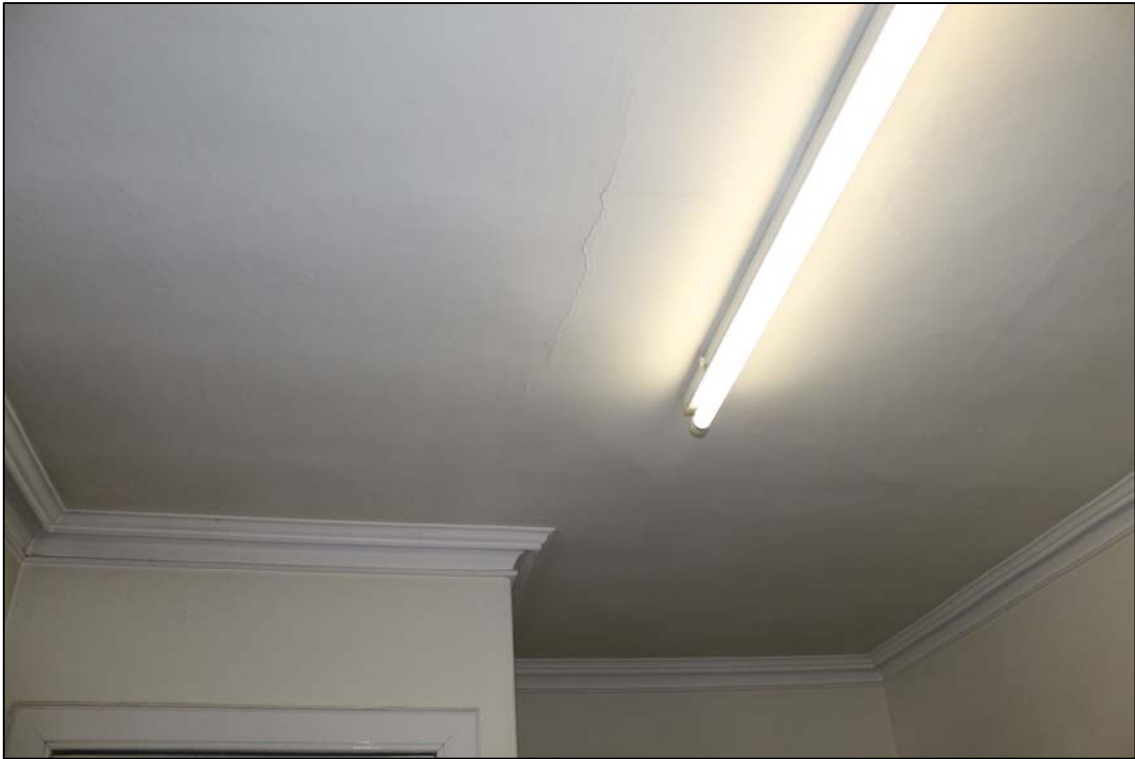
44. Room D on the ground floor (Figure 29) was sub-square in plan and measured 3.12m by 4.45m. It featured two access doors on the west and south walls (Figures 31b) that measured 2.10m by 900mm and 2.00m by 900mm respectively. The access on the south wall led to the porch of Building B but could not be accessed. On the east wall was where Window B on the west elevation was located (Figure 32a and 32b); it had a slight bay/angle with a measurement of 1.45m by 1.50m. There was a modern gas fire on the north wall where the original fireplace would have been and there was visible corncicing around the ceiling (Figure 33).

Figure 33: Room D, ceiling and cornices taken from N.
