# **Blairquhan Castle: Archaeological Watching Brief**

Data Structure Report

issued 25<sup>th</sup> July 2014

on behalf of CASA Design Architects

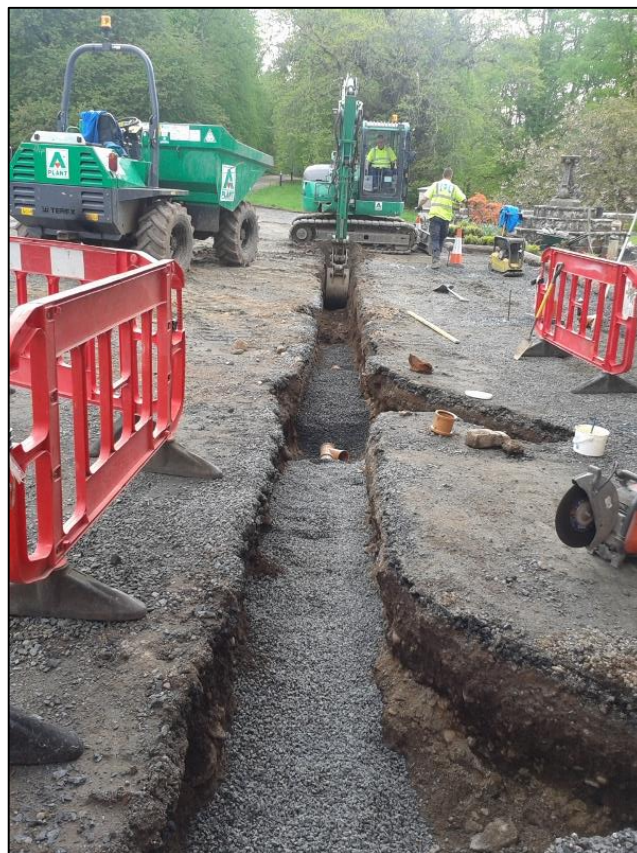
Figure 7: View of drainage trench in progress in area T4. From the east.

14. Area T4 consisted of a 24m continuation of the drainage trench to the immediate west of the castle's main entrance and had a depth range of 0.94m-1.04m. Area T4 contained the same fills as T1-3, though being deeper, a further natural deposit, (006), was identified underlying subsoil layer (004). This deposit consisted of a moderately compacted mixed mid grey/dark orange brown silt with moderate stone inclusions. A linear stone foundation, [008], (009) and [011], was identified within area T4 approximately 16m west of the south western corner of the main castle building (between NS 36498 05449 and NS 36493 05448) which was orientated in an north-south direction. The foundation underlay a modern rubble layer (007) which seemed to be contemporary with the forecourt's foundation layer (002). The structure lay within a linear cut [011]: the latter measured 0.5m in length, 1.58m wide and 0.4m deep, extending further beyond the baulks to both the north and south. Break of slope at top was moderate, and the sides almost vertical. The break of slope at the base was moderate and the base was flat. The structure itself measured 1.22m wide and 0.4m thick and rested on a lining of blue grey clay (009) which had a thickness range of 0.06-0.2m. It consisted of 1-2 courses which were visible in section and partially in plan. The stones were sub-rounded/sub-irregular shaped and measured 0.56m x 0.43m x 0.43m. They were laid out with the flatter edges of the stones forming an almost straight edge on the eastern side. This also seemed to be the case on the western side though it was only partially visible due to modern disturbance. The bonding material consisted of a mix of lumps of clay similar to the lining (009) and a dark grey sandy material.

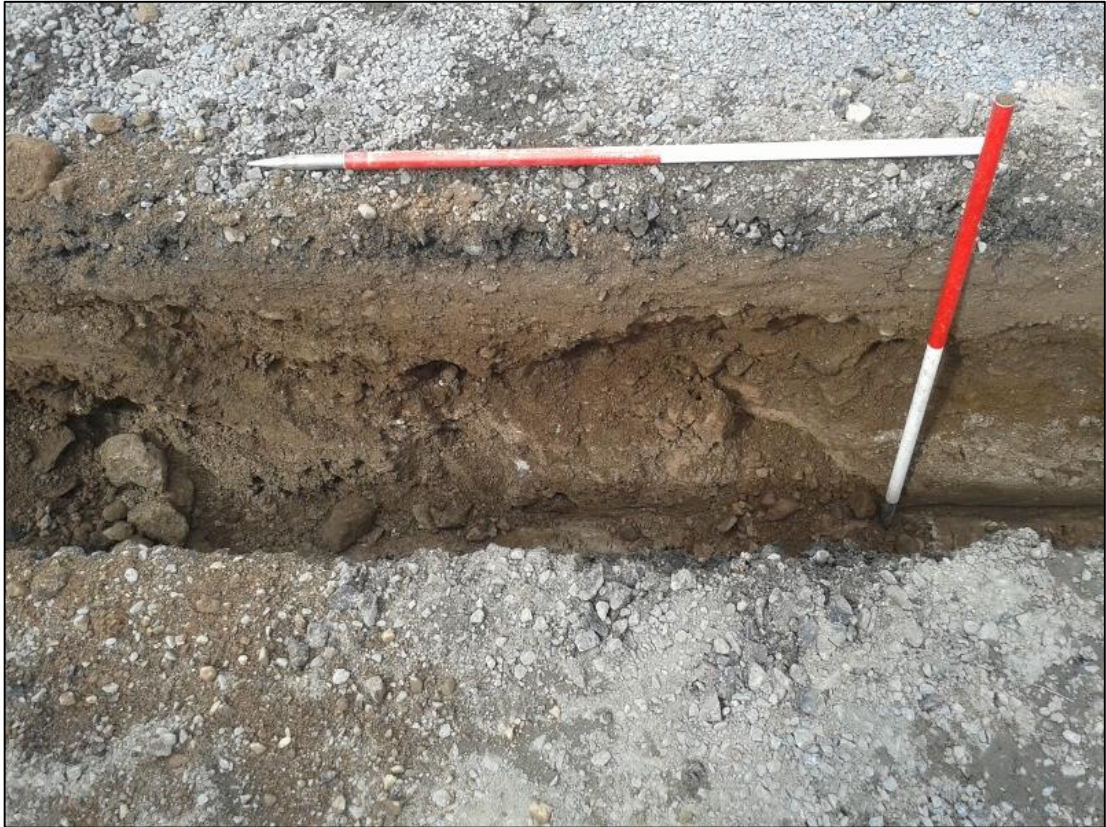
Figure 8: South facing section at T4's western end.

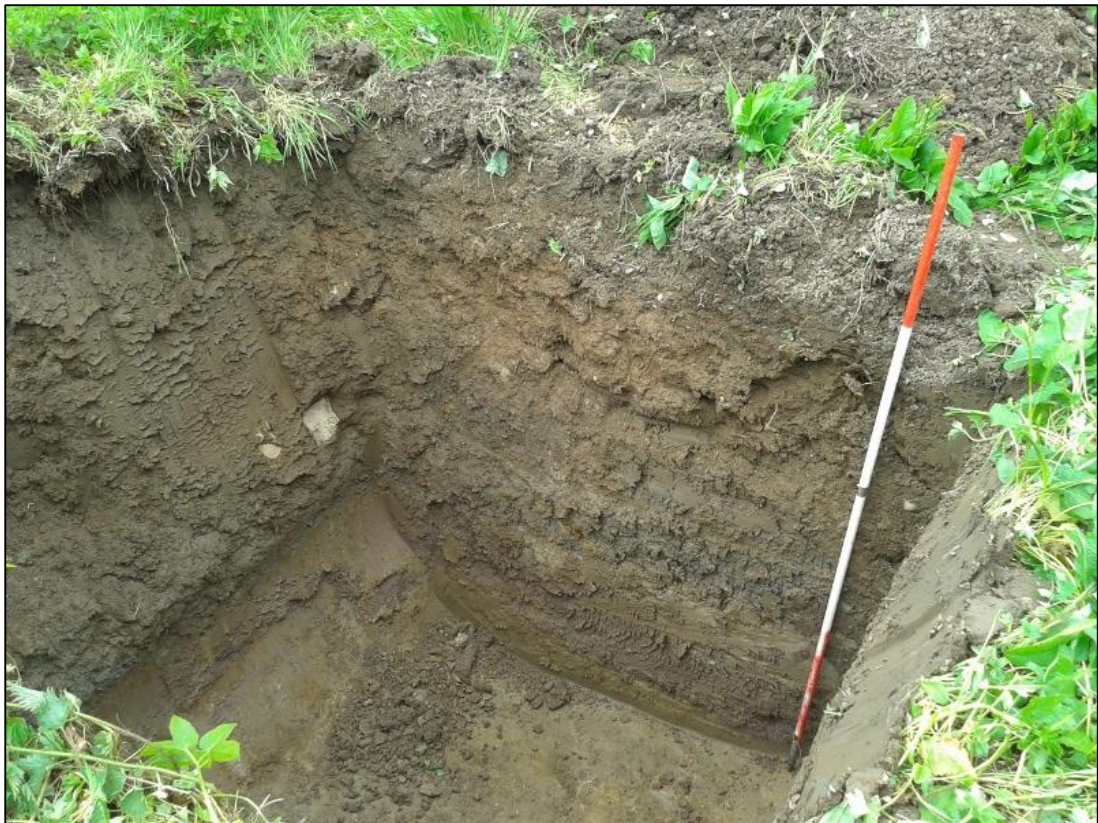
Figure 9: Post excavation view of soak away pit. From the east southeast.

western end of T5 and measured 2m by 2m and was excavated to a depth of 2m. The topsoil (010) within the grounds consisted of moderately compacted mid grey-brown sandy-silt with occasional small stones and root inclusions. The topsoil had a depth range of 0.14-0.23m. The three naturally occurring subsoil layers identified in the other areas within the drainage ditch, (003), (004) and (006), continued within T5 and the soak away pit. A further layer of naturally-occurring subsoil (012) was identified underlying (006). This layer consisted of moderately compacted mixed light-mid grey/light-mid orange brown clayey-silt/silty-sand with occasional to moderate small stone inclusions. No archaeology was identified within this area.

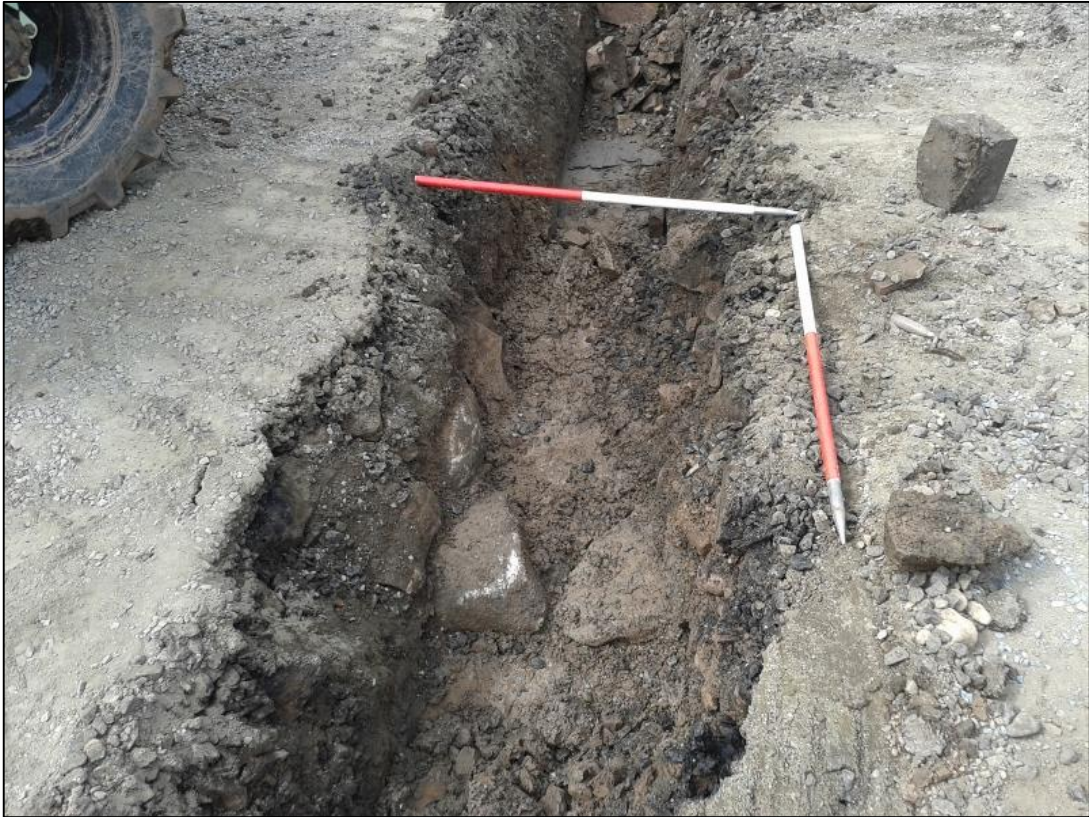
Figure 10: View of stone foundation [008] in area T4. From the east.

16. The monitoring works within the forecourt of Blairquhan Castle revealed a stone foundation - represented by [008], (009) and [011]- from what may originally have been a sizable stone wall. This wall may relate to the remains of the earlier medieval castle, said to be located under the lawn which sits to the immediate south of the forecourt. The original castle, a Kennedy stronghold, was said to date to 1346 with a later extension built in 1573. This extension may have been constructed in response to an act passed by the Scottish parliament in 1535 which decreed that "each landowner of £100 rental should build in a convenient place for himself and his tenants a barmkin, 60ft square with walls 3ft thick and 18ft high, with tower if necessary, into which his tenants could bring their goods and livestock in troubled times" (Stell 1992). A wall with approximately these dimensions still stands at Buckholm castle in Selkirkshire and it too was constructed during the mid to late 16<sup>th</sup> century (MacGibbon and Ross 1887-92). This may suggest that the wall uncovered within the drainage trench could be the base of a barmkin wall around the original castle or tower building similar to that found at Buckholm and other castles in the south of Scotland rather than the wall of say a large building. The stone foundations [008] width of 1.22m would be only slightly wider than the 3ft thickness stated in the 1535 act of parliament. That and the clay lining and bonding used in the construction would suggest that the foundation was at least 16<sup>th</sup> century in date though an earlier date cannot be ruled out.

18. The archaeological monitoring works uncovered the foundation of a probable medieval or late medieval wall, perhaps associated with the original medieval castle at Blairquhan, or alternatively, an enclosure or barmkin wall added in the late 16<sup>th</sup> century. The upper layers of the existing forecourt, 0.2m-0.3m thick, were all 19<sup>th</sup> or 20<sup>th</sup> century in date but beneath this the earlier foundations survived to a height of two courses (0.4m deep). It is highly probable that further remains associated with the medieval and late medieval occupation of Blairquhan survive under the forecourt and in the grounds to the immediate south. It is therefore recommended that any future works in the forecourt or grounds which exceed 0.3m in depth should be monitored.

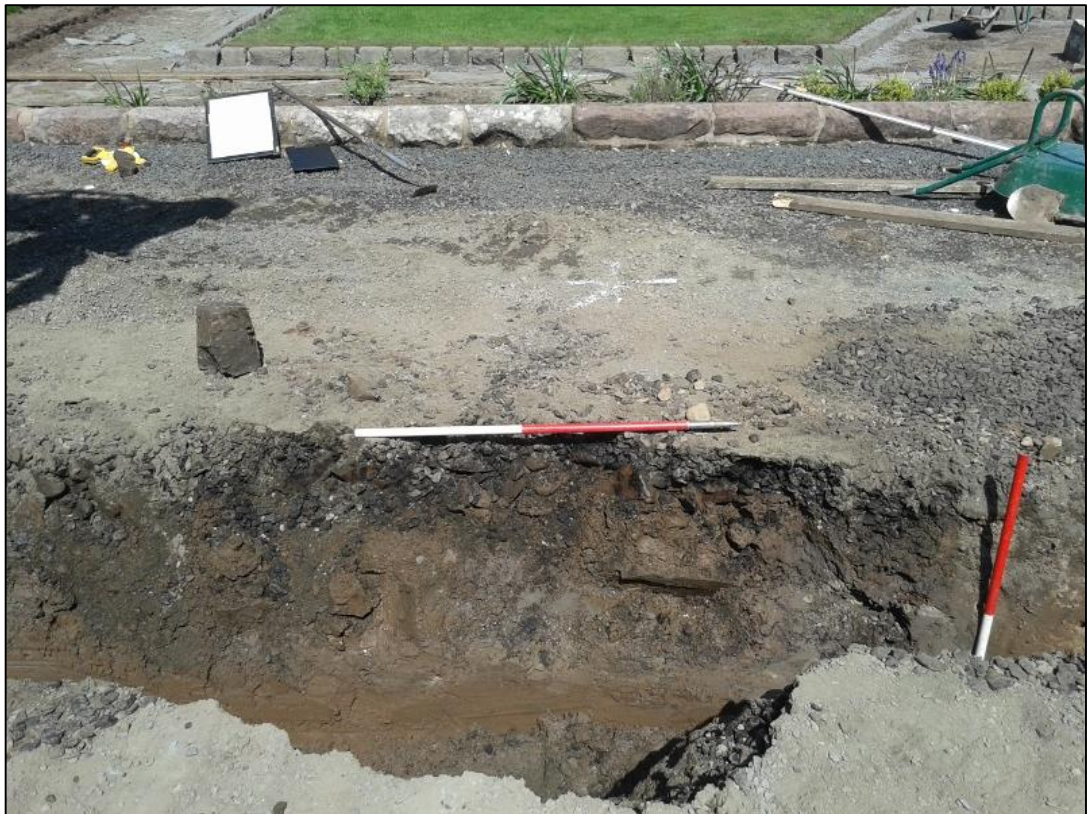
Figure 11: South facing section at western end of T4 showing stone foundation [008].
