Caledonian Cheese Effluent Pipeline, Dumfries & Galloway: Archaeological Mitigation

Data Structure Report

issued 23rd January 2015

on behalf of Caledonian Cheese Company

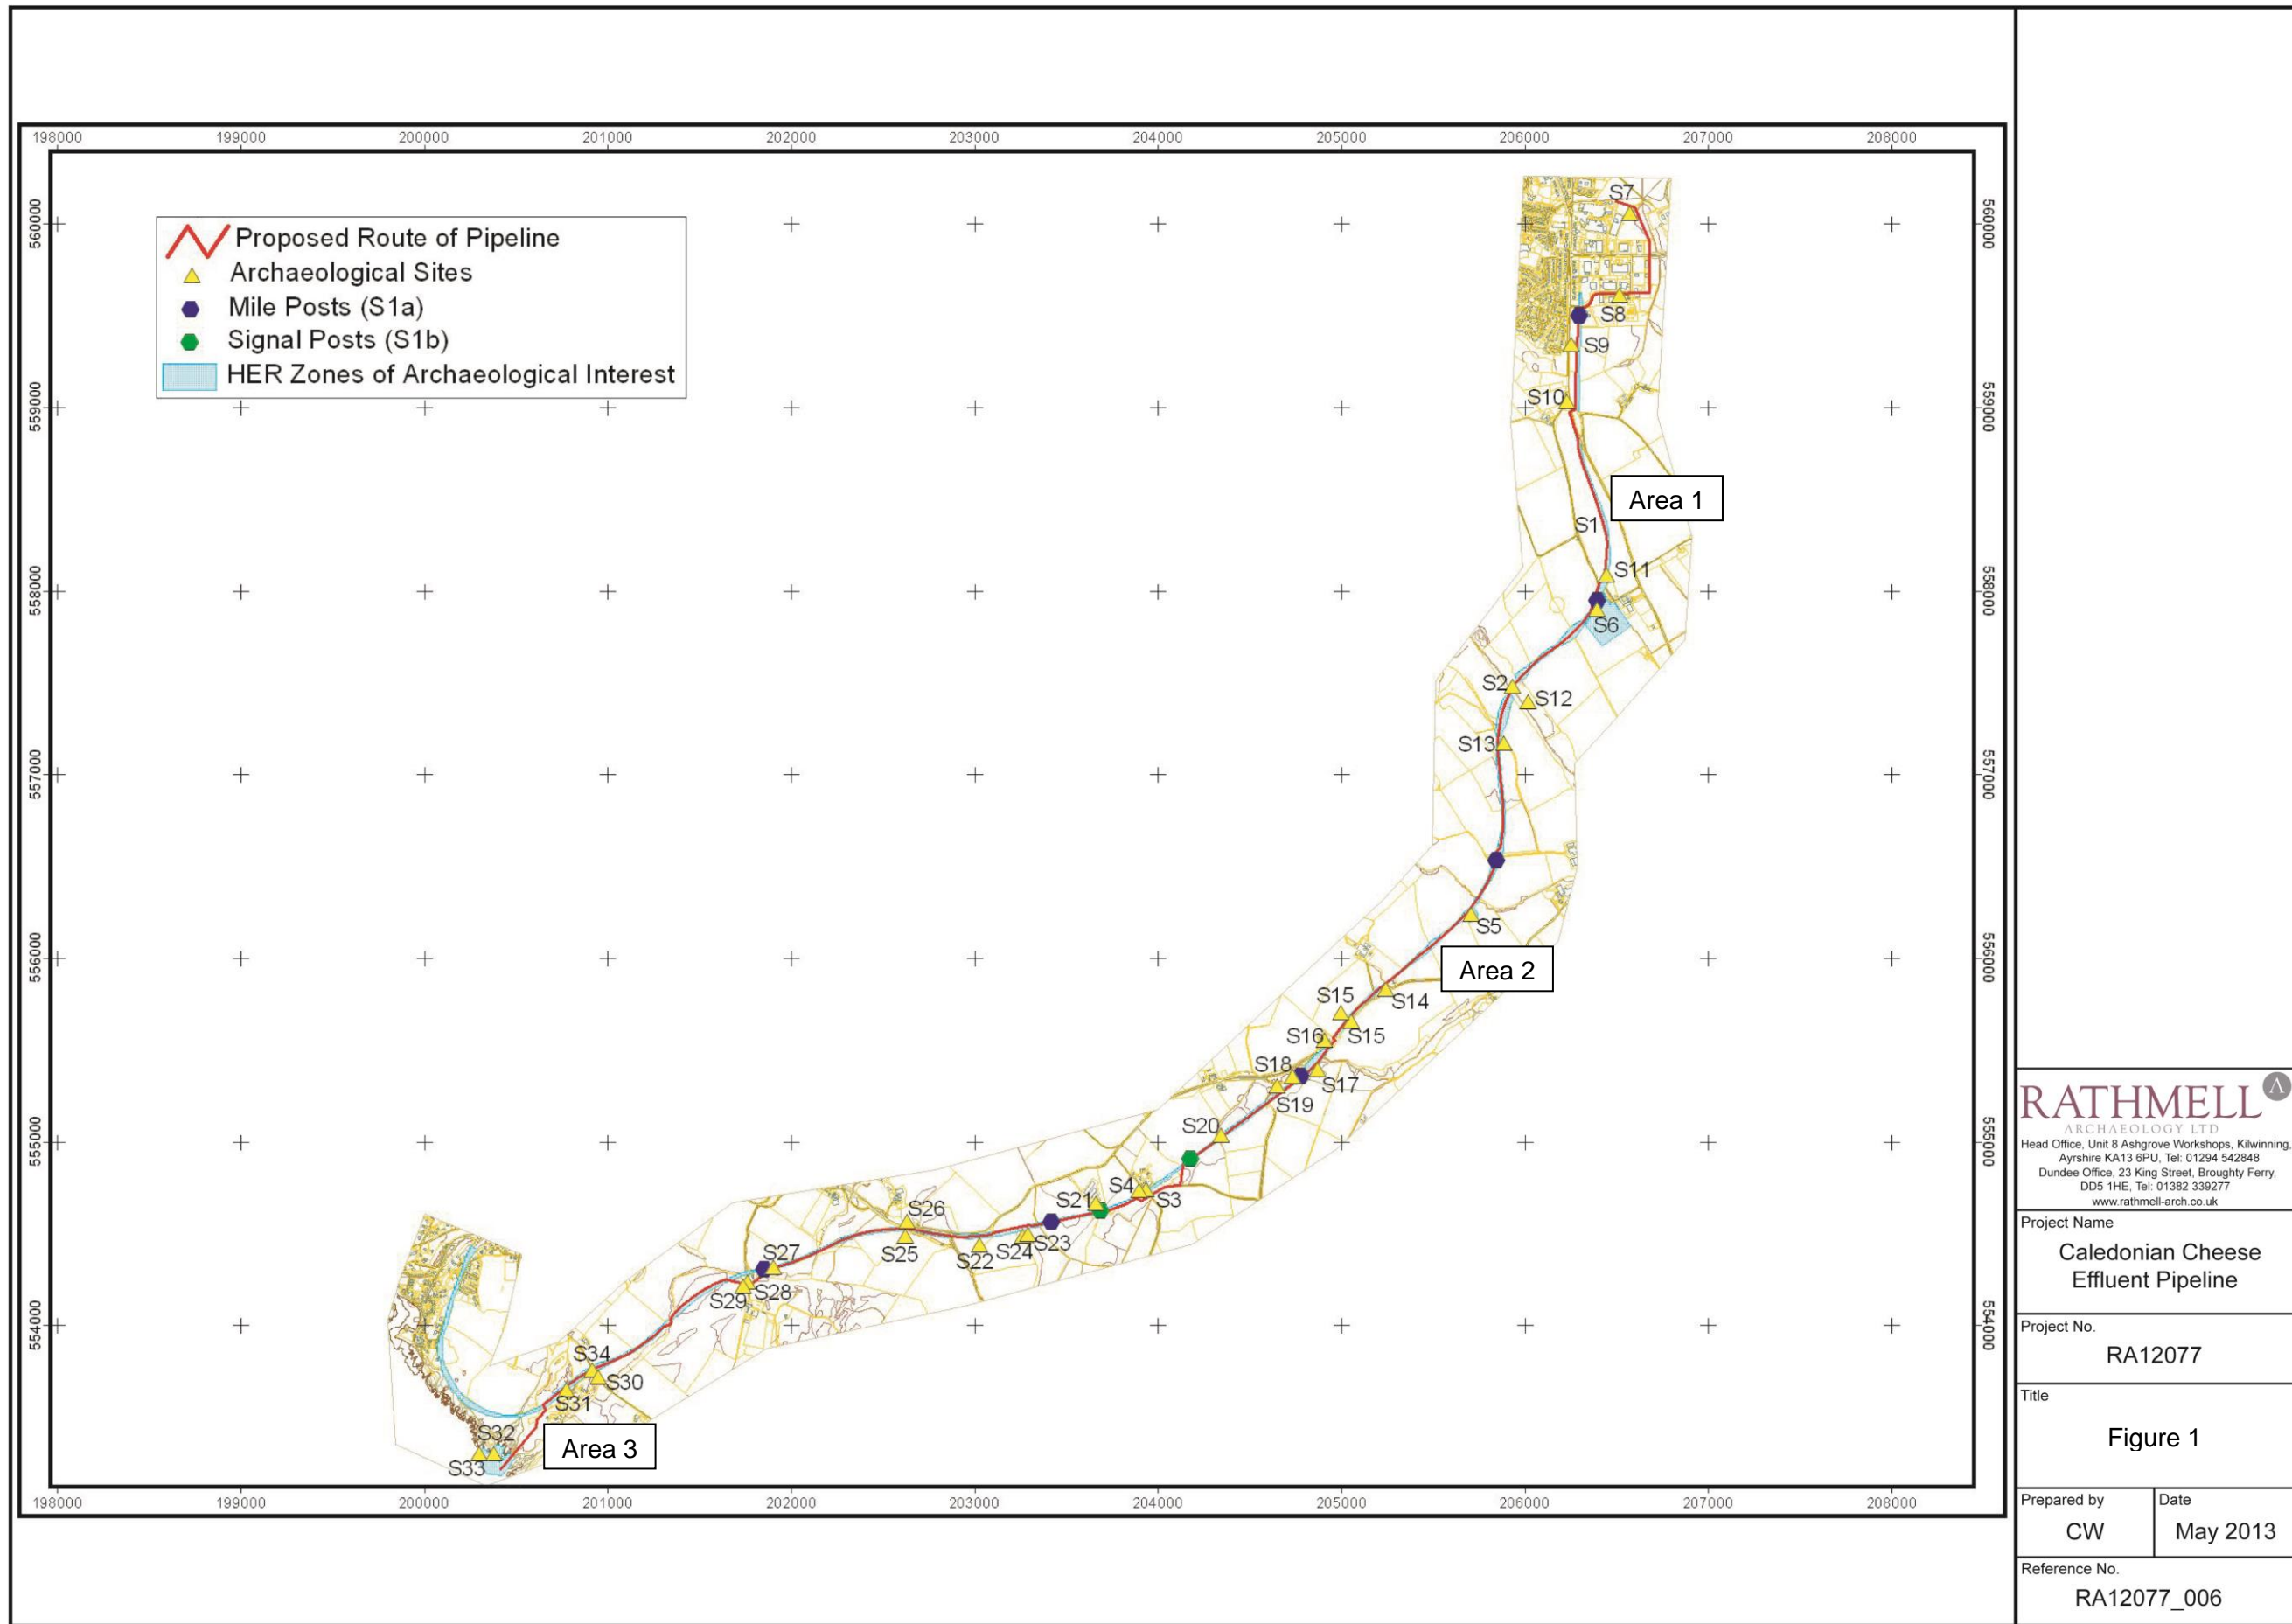
Title
Figure 1

Figure 1: Overview Map of Archaeological Sites (extracted from Williamson 2013) with the three monitoring areas labelled

10. Based on the findings of the desk-based assessment (Williamson 2013), only three areas were identified which required archaeological monitoring (Figure 1). As laid out in the Written Scheme of Investigation (Williamson 2014, 5-6), these areas were:

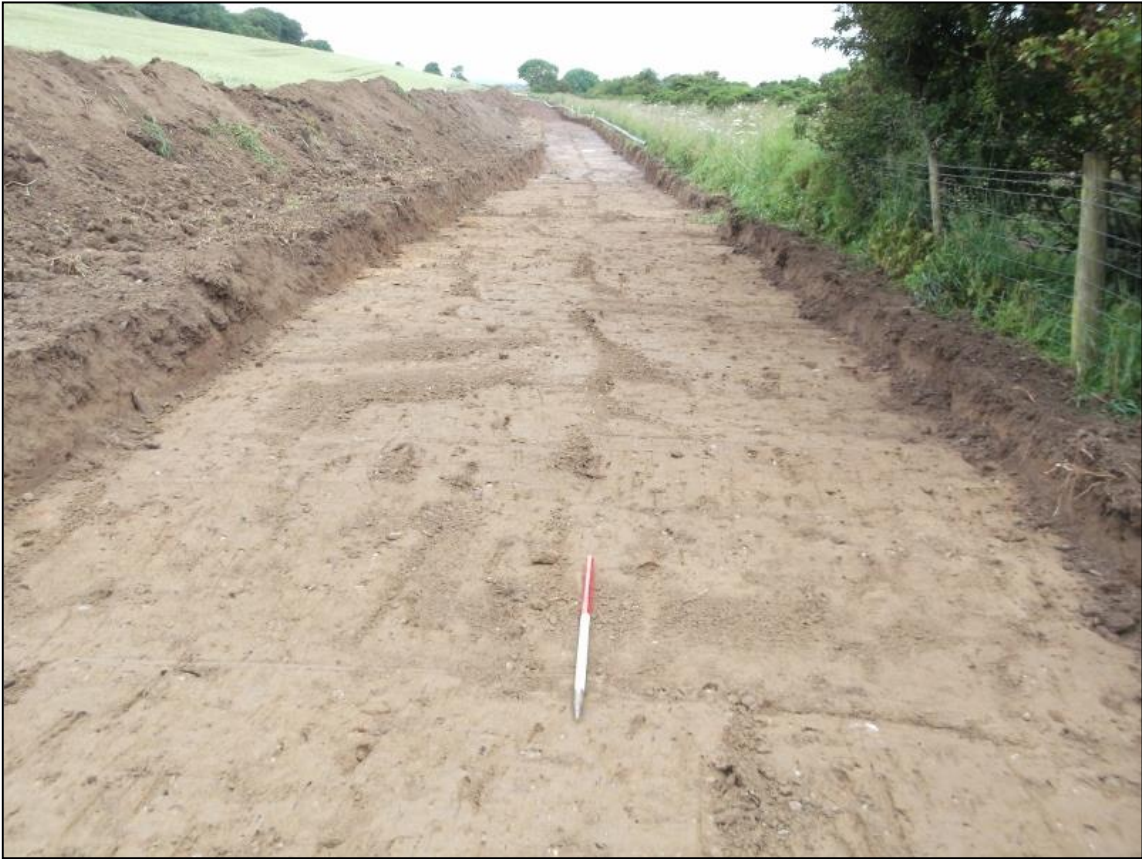
Figure 3a: Sample shot of northern stripped section in Area 1 from the southwest

16. The northern section, running roughly north-north-west to south-south-east, measured approximately 900m in length and 4 to 6m wide (Figure 3a), totalling a minimum area approximately 3600m² in size. The southern section, running roughly north-north-east to south-south-west, measured approximately 133m in length and 4m wide, totalling an area approximately 532m² in size.

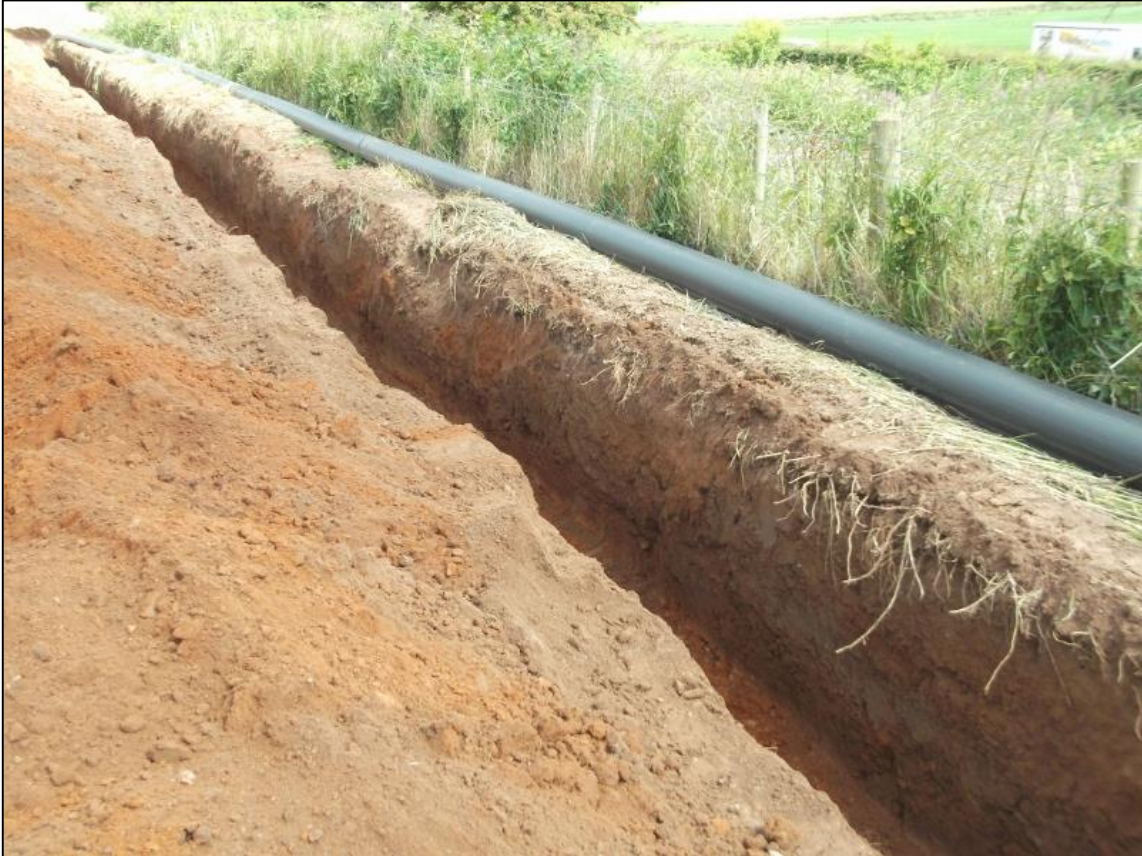
Figure 3b: Shot of pipe trench in northern section in Area 1 from the southwest

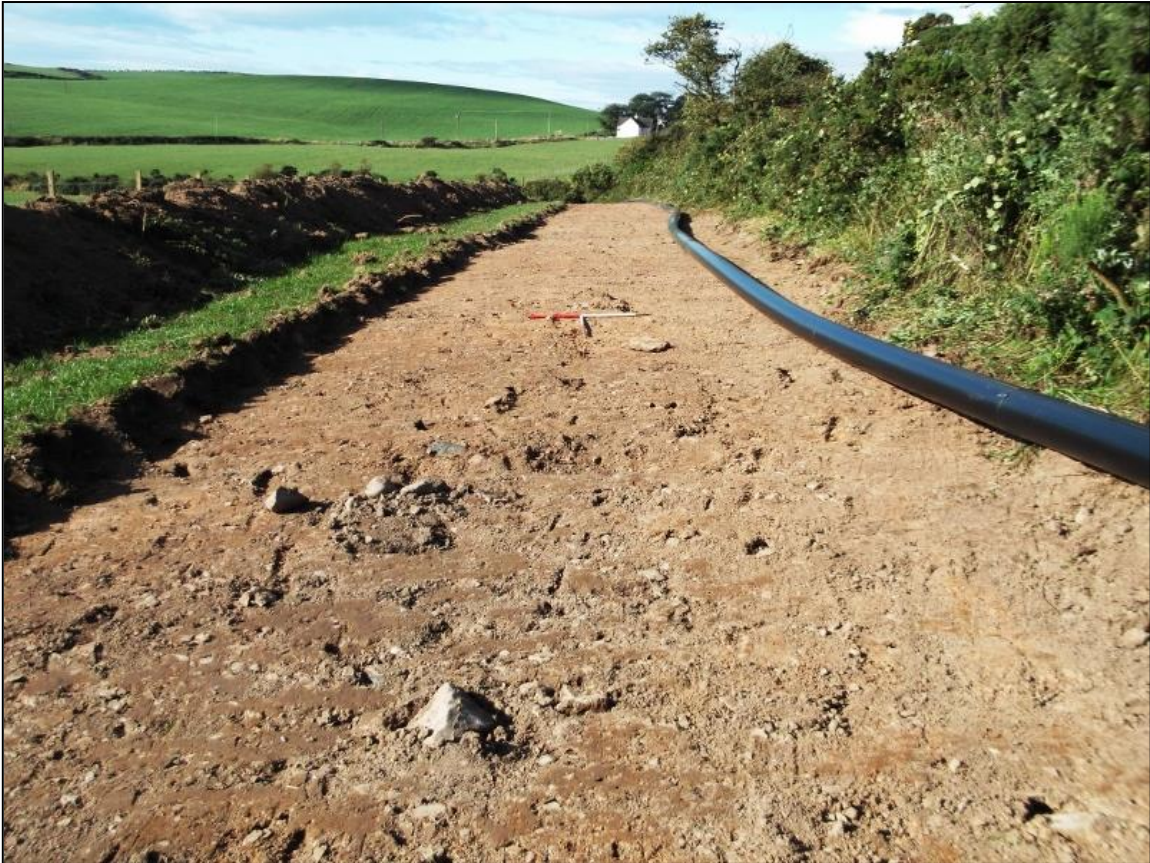
Figure 5a: Sample shot of northeastern stripped section in Area 2 from the northeast

30. The works removed the topsoil to reveal natural subsoil underlying it. The natural subsoil across the whole area consisted of (016), a mid- to dark orange silt with frequent stone inclusions (Figure 5a).

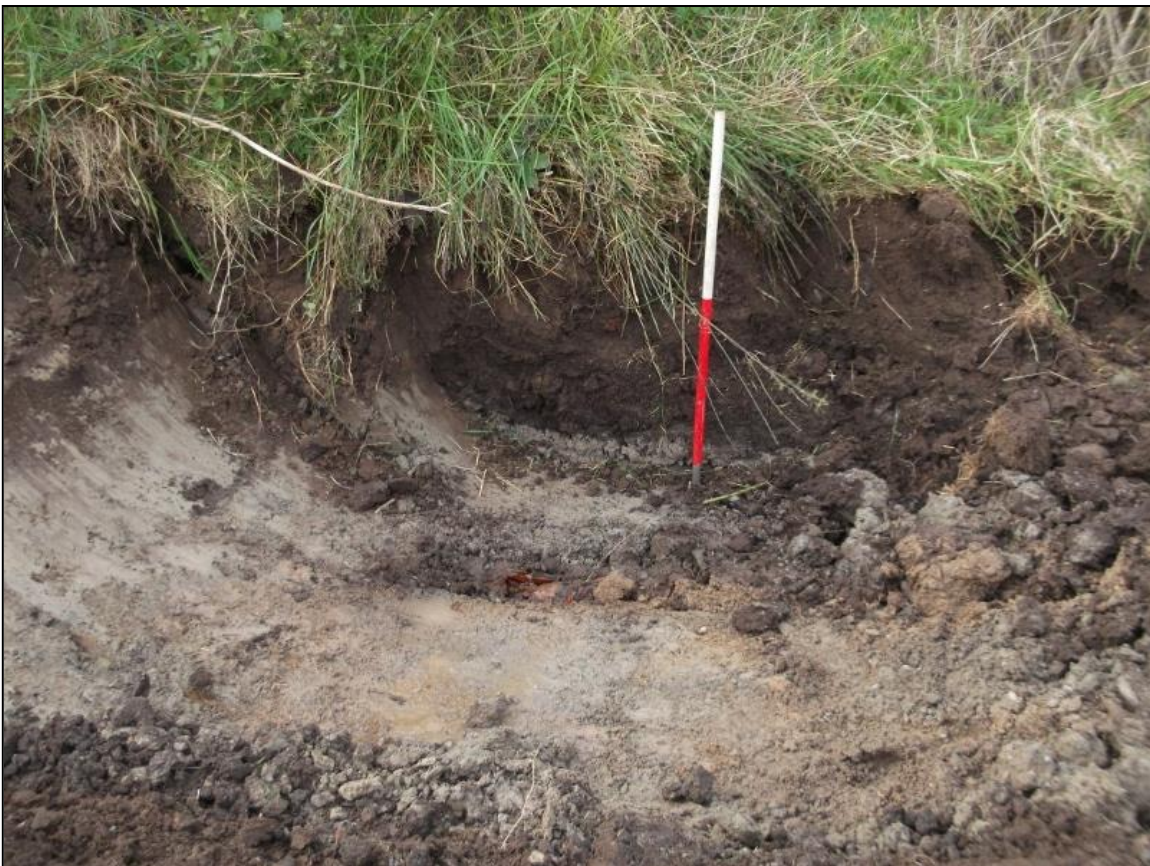
Figure 5b: Southeast facing section through [025] showing field drain at base

34. Approximately 95m from the southern end of the northeast section, sat large cut [025]. When excavated, a number of field drains were revealed at its base (Figure 5b); it appears that it was originally dug for the purpose of their insertion. As exposed, [025] measured 30m by 5.5m although it continued outwith the edges of the stripped area. Its maximum depth was 800mm and it was filled by (026) which comprised a mix of topsoil, grey and orange clay and moderately compact grey gravel. It sat in a natural dip in the surrounding landscape, at a point where water was likely prone to collecting, causing the need for the insertion of a number of field drains.

46. Indeed, the complex of field drains sitting within large cut [025] show that some amount of effort was expended in trying to maintain the ground for agricultural use. It also implies that some areas were prone to waterlogging, something also suggested by the presence of peat (017) elsewhere.

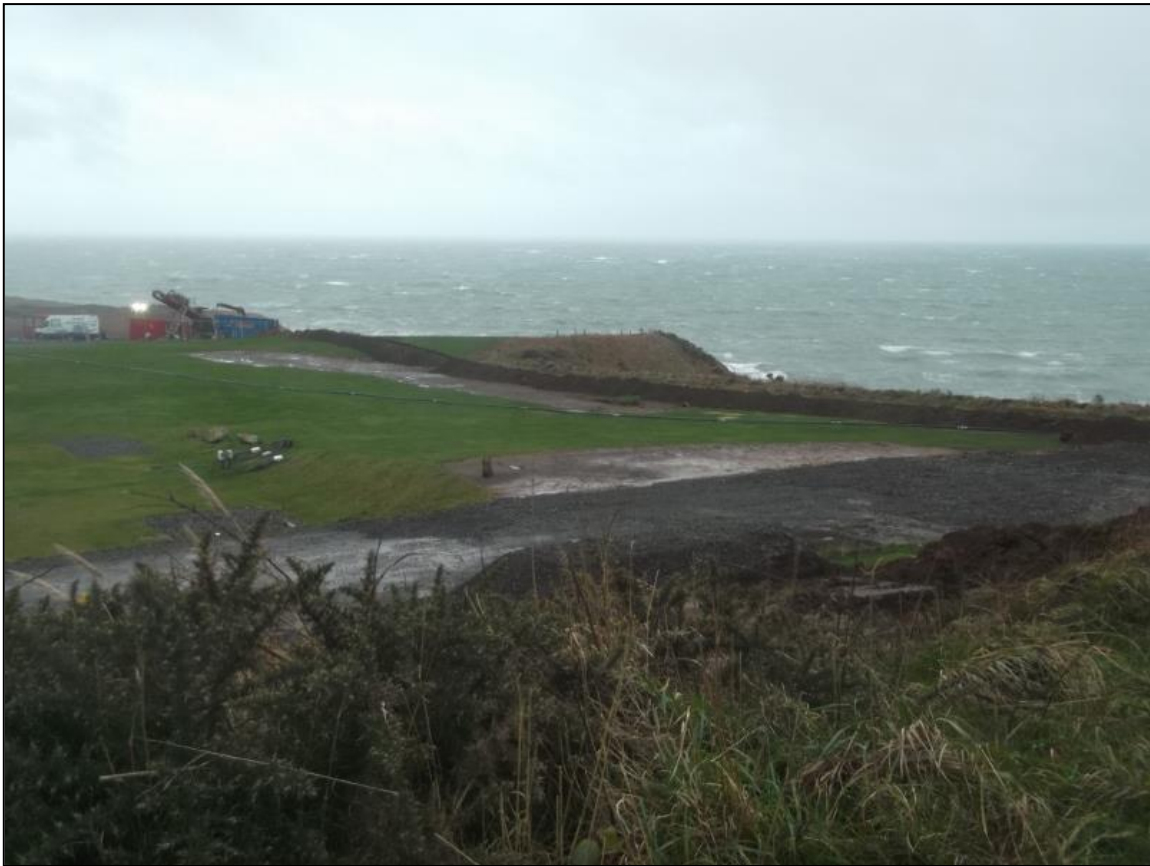
Figure 7a: General shot of Area 3 from the northeast

36. The section of the route in Area 3 ran from the edge of the railway embankment across an open grassed area close to coastal cliff line, at the edge of a caravan park (Figures 6 and 7a). Some of the area had been landscaped as part of the caravan park, with a gravelled roadway crossing the line of the route near to its northern end. The stripped area did not cross this roadway but instead left a gap across it, splitting the stripped area into two sections. As nothing significant appeared elsewhere in this area, and due to the disturbance likely caused by the landscaping carried out when the roadway was created, this gap was left unmonitored. This decision was agreed with the Dumfries & Galloway Archaeology Service.

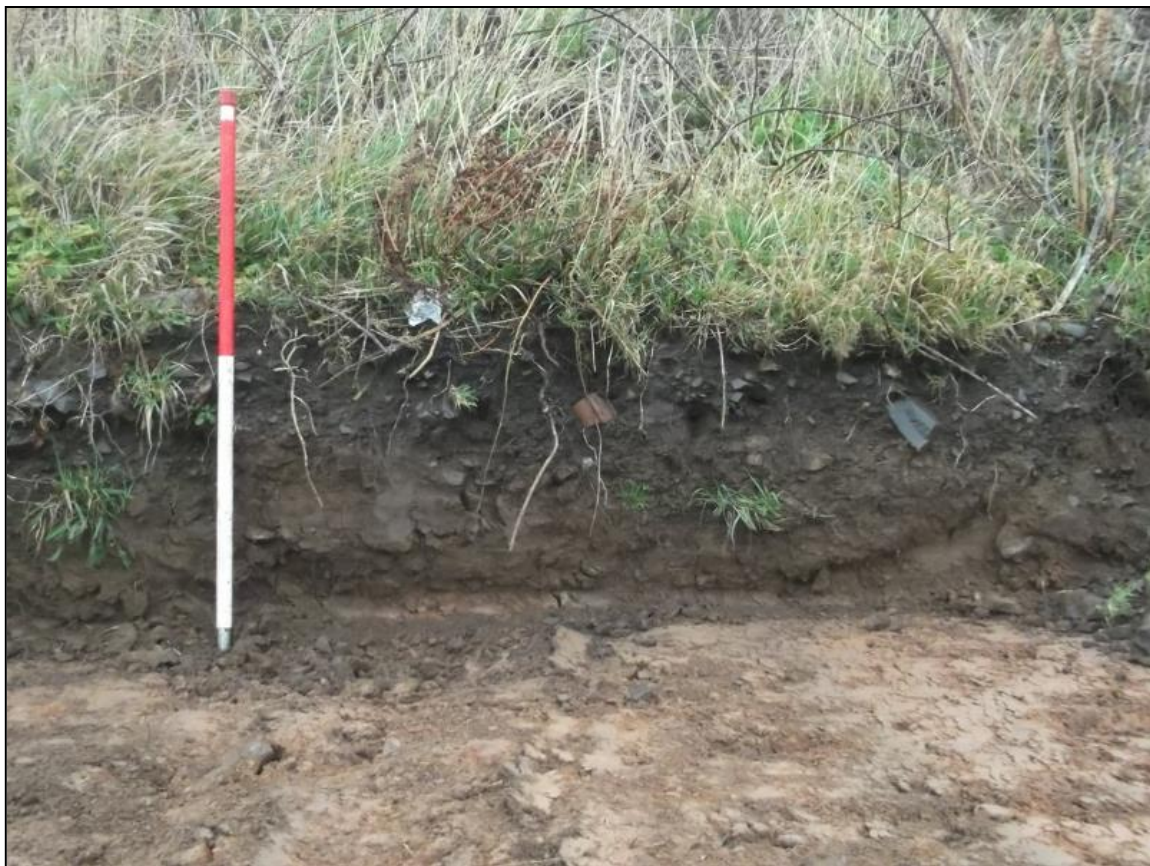
41. The only other deposit recorded within either stripped area in Area 3 was (031). This consisted of a compact dark brown clayey silt with frequent roots, very frequent small-medium sized angular stones and frequent modern inclusions, such as fragments of red tile field drain. It was revealed in section overlying the topsoil (027) (Figure 7b) along the full length of the northwestern side of the northern stripped area, and measured between 150 to 350mm thick (thickest at the northeastern end). This deposit represented the base of the embankment along the edge of the railway line which sat slightly further to the northwest, and which the stripped area cut slightly into.

Figure 7b: Southeast facing section of northern section in Area 3 showing deposit (031) overlying topsoil (027)

47. Some of the features uncovered did appear to be related to the railway line itself. In Area 3, one of the stripped areas cut slightly into the base of the adjacent railway embankment which sat upon higher ground. The section of this area revealed the composition of the railway embankment as having been built up with what appeared to be a mixture of topsoil and gravel (031), which had been laid over the top of the existing topsoil. Deposit (004) in Area 1 also showed an area of built up material which ran along the fenceline flanking the edge of the railway, which was also likely to have been built up or deposited during the railway's construction.
