Lade Street Car Park, Largs, North Ayrshire: Archaeological Monitoring

Data Structure Report

issued 3rd February 2015

on behalf of North Ayrshire Council

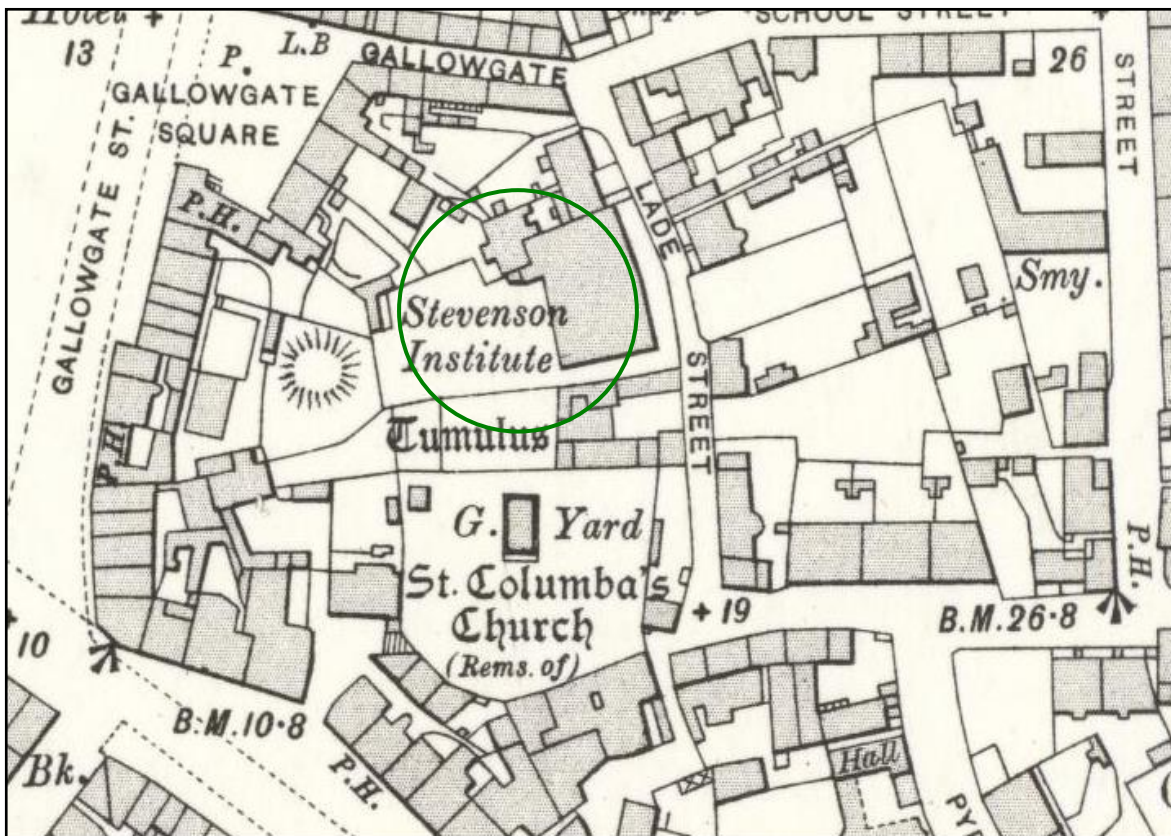
Figure 1b: 1909 revised Ordnance Survey. The green circle denotes the development area (Published 1911)

7. Further to the west of Lade Street and beyond the boundary of the now demolished Stevenson Institute a tumulus is recorded on the 6-inch 1st edition (1857) and 6-inch 2nd edition (1911) Ordnance Surveys (Figures 1a and 1b). The mound measures some 75ft by 27ft and is 15ft high. It was partly excavated in 1873 by Dr J S Phene who recorded the presence of human bone (some of which was partly and some wholly calcined), burnt clay, oak charcoal, and bright green flakes, supposed to be of copper or bronze, which was probably 'remnants of armour'. Human teeth were also found. Dr Phene concluded that this was the burial place of the Norsemen killed during the Battle of Largs in 1263. Its situation, near the old Largs parish church, is consistent with the account given in the Norse saga that the dead were interred at the church. The local tradition is that the mound, which is called the Gallowhill, was used for executions, and it is more than likely that it was so used in later centuries.

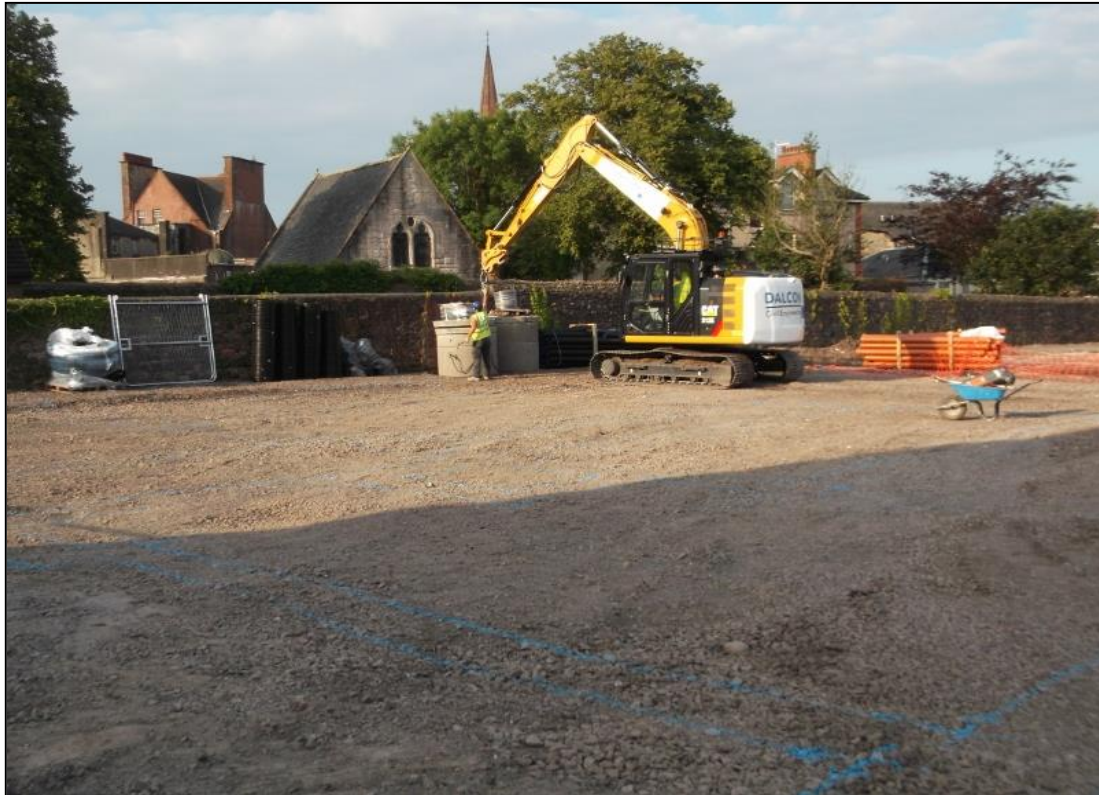
20. The upper level throughout the site was formed by a modern hard core layer (003) which consisted of stone/gravel (type 1 granular sub base) (Figure 3a). The layer (003) had a thickness range throughout the site of 150-400mm. This hard core layer overlay (004), which consisted of a mix of recent modern backfill and demolition debris. This demolition debris was found throughout the site. The layer was a moderately compacted, grey, coarse deposit with rubble and demolition debris. It had a thickness range throughout the site of 200-600mm. The rubble and demolition debris (004) overlay the original topsoil (001) within the site, which most likely formed the original ground level around the now demolished Stevenson Institute buildings. This topsoil layer comprised a moderately compacted, dark brown silt with modern brown ceramic service pipes (*in situ* and fragmented), modern pottery sherds, and angular stone inclusions. Some of these inclusions may have been intrusive coming from the demolition debris (004) which overlay it. The average thickness of the topsoil throughout the site was 600mm, although the thickness was significantly reduced in areas where the demolition debris (004) was present, indicating that areas of the topsoil had been partially or totally removed during previous works, mainly in the southern or south western parts of the site.

Figure 3a: General shot of footprint of flats painted on surface layer (003), from the northeast

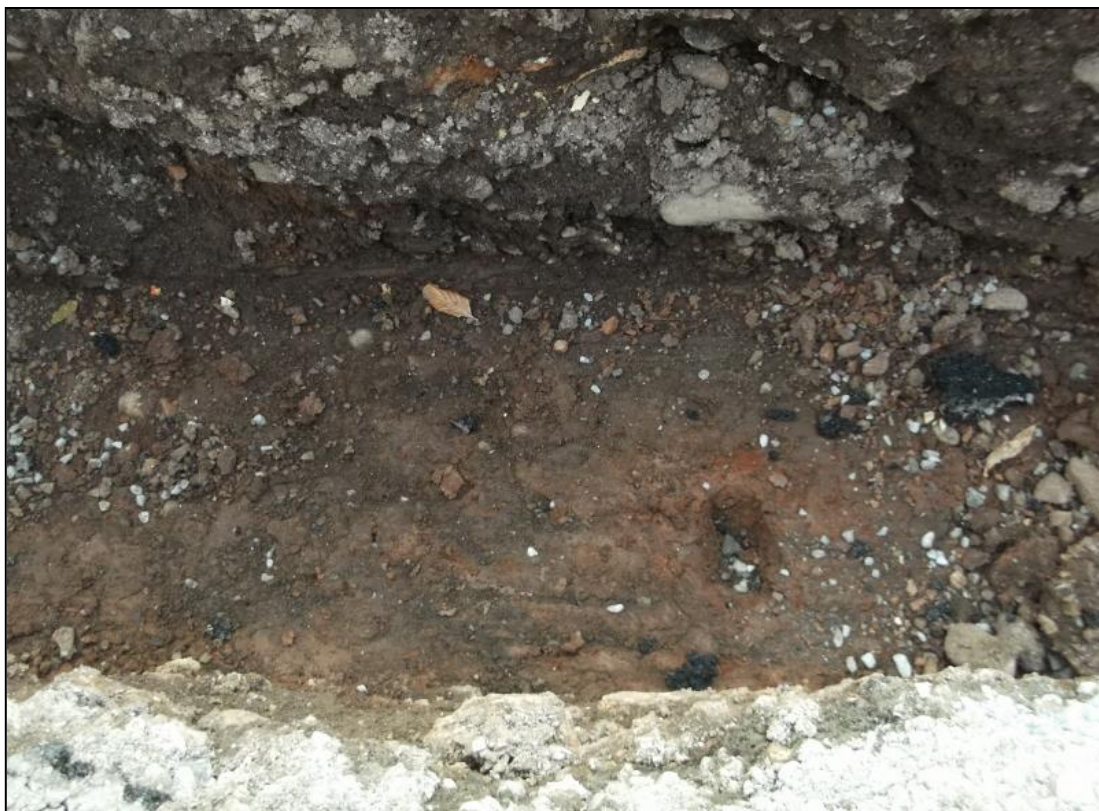
22. The main naturally occurring subsoil identified throughout the site, (002) (see Figure 3b), was located beneath the original topsoil (001), and comprised a loose to moderately compacted, mid orange/brown sand with gravel inclusions. The average, observable, thickness of the layer throughout the site was 600mm. Two other natural subsoils were identified within the foundation trenches for the flats and the service trenches surrounding them (Trenches 1-4 and 6-7). The first of these soils, (006), was a moderately compacted, light brown/orange clay with occasional gravel inclusions and underlay the topsoil (001). The second of these soils, (011), was a firmly compacted, mid orange/pink sand which underlay layer (010).

Figure 3b: Natural subsoil (002) within the west-southwest foundation trench for the flats, from the south

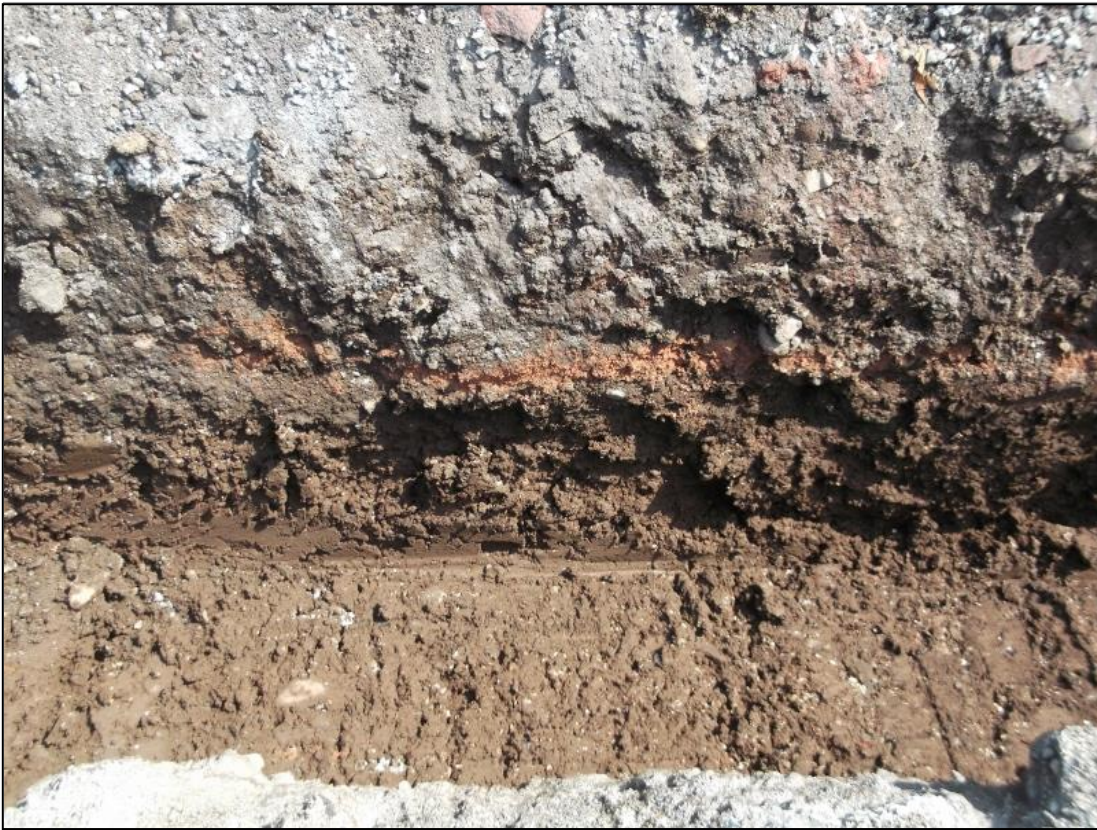
Figure 4a: Layer (005) showing shell fragments within the east-northeast foundation trench for the flats, from the west

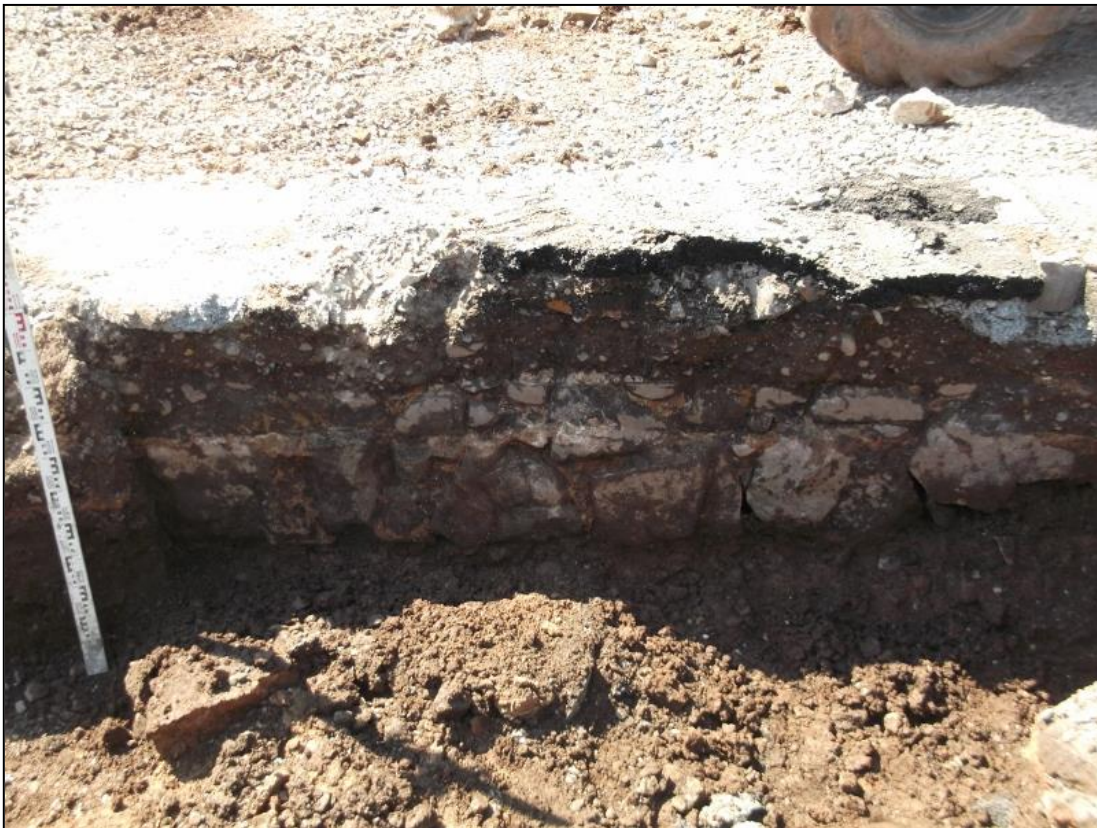
23. The remains of the foundations (007) for the now demolished Stevenson Institute were identified (Figure 4b), alongside the original topsoil (001). The remains were located in the eastern end of the site within the foundation trenches for the flats. The foundations consisted of a large stretch of wall on a north-south orientation. This wall measured approximately c.600mm high, c.0.5m thick and c.20m long. The components of the wall comprised squared-off sub-angular stones which were approximately 400mm by 400mm in size. In between these larger stones were a number of smaller stones and a mortar bond.

Figure 4b: View of the surviving foundations of the Stevenson Institute (007) lying under layer (004), from the east

28. Structural remains (007) identified within the foundation trenches for the flats were most likely part of the eastern foundation wall of the Stevenson Institute which had been demolished in 2012 (Klemen, P 2012). Two subsurface features were also identified during the works which were cut into the original topsoil level (001) that was associated with the Stevenson Institute. The first of these features was most likely a soak-away pit [008] associated with the carpark at Lade Street. The second feature seemed to be a large deep pit [013], most likely a test pit, which had been excavated presumably to locate old services associated with the Stevenson institute, either as it was being demolished or during the construction of the later carpark.

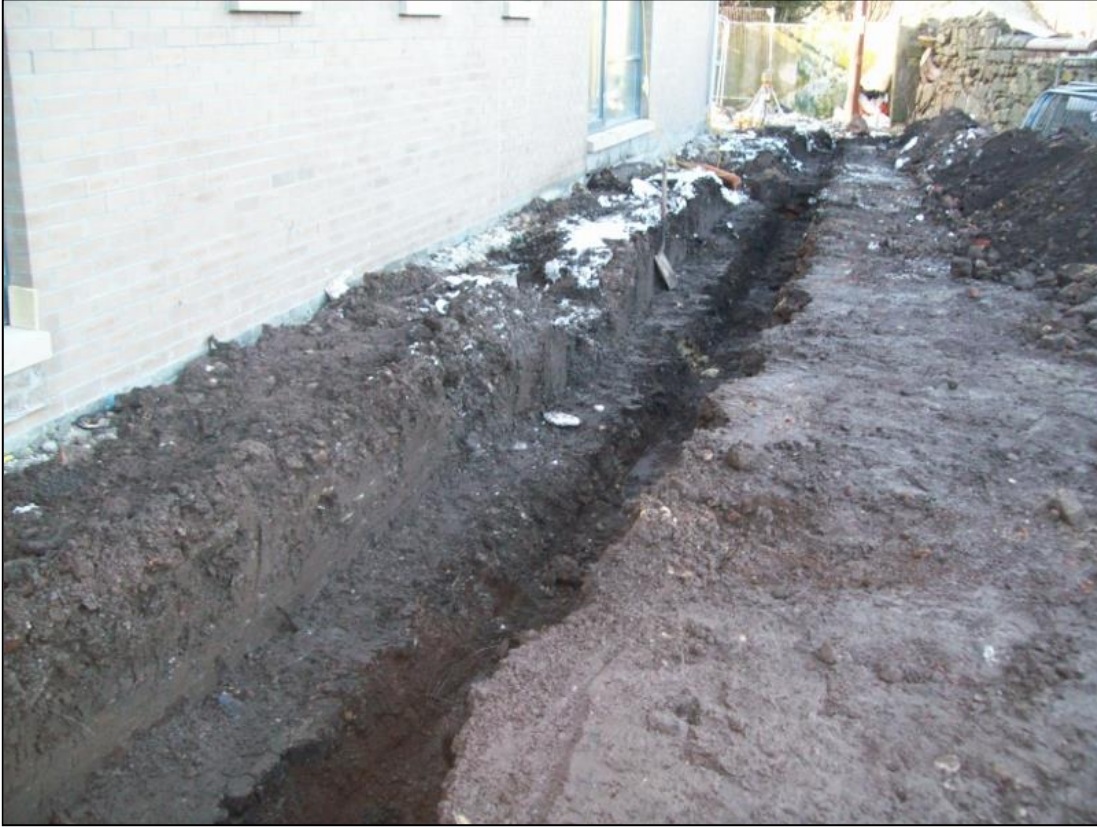
Figure 5a: Post-excavation view of Trench 5 which was situated close to the day-care centre, from the east

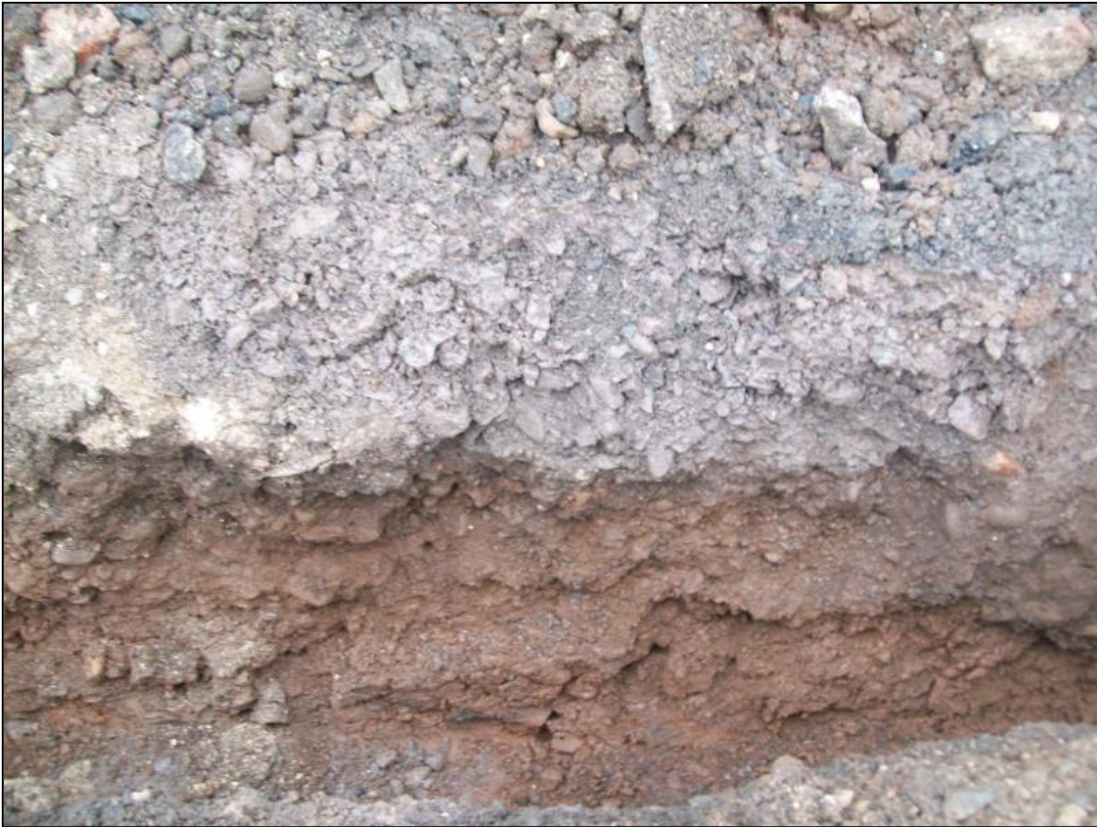
Figure 5b: North facing section of Trench 4 which was situated close to the flats, from the north
