Larkhall CGA: Archaeological Monitoring

Data Structure Report

by Michael Briggs and Alan Matthews
issued 30th September 2014
on behalf of Johnson Poole and Bloomer

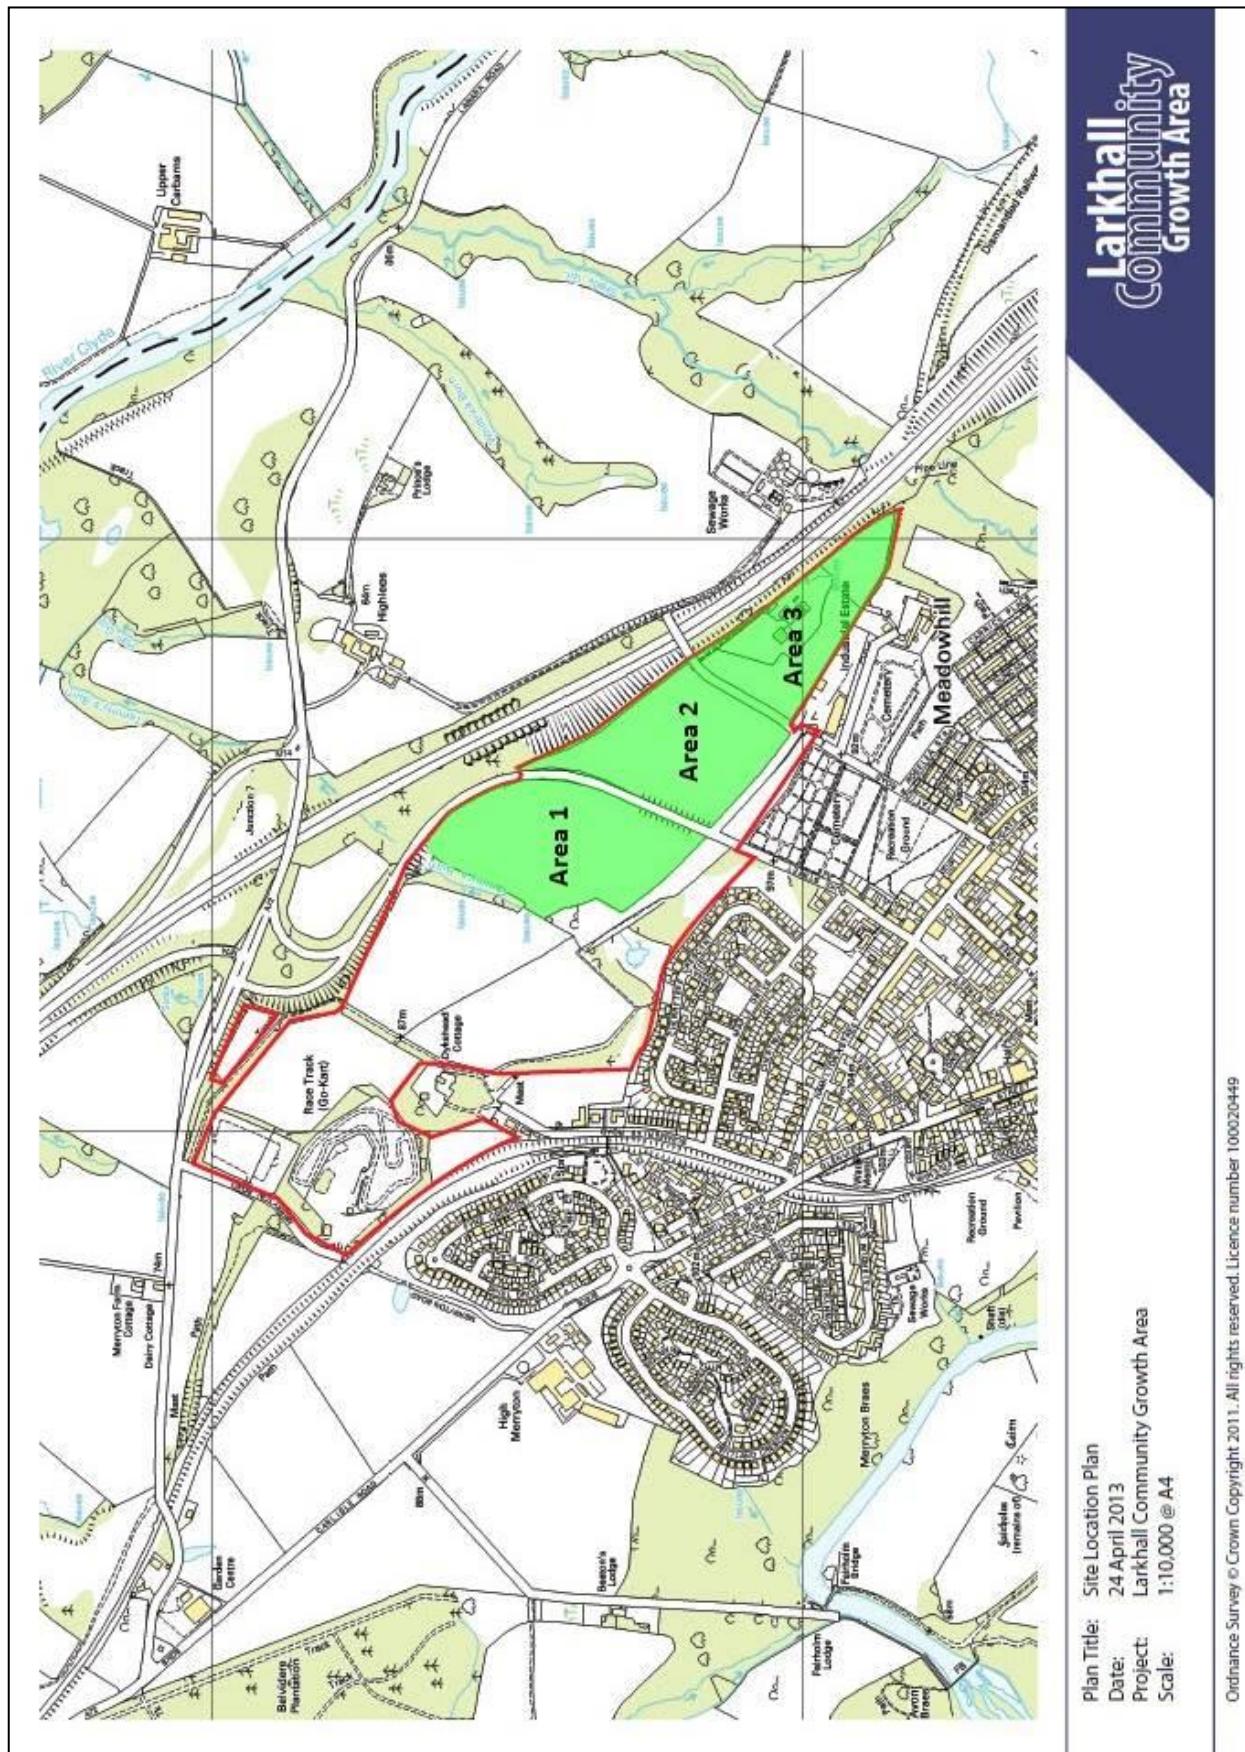
Figure 1 - Plan of proposed development area (Area of current works shown in green)

4. The proposed development area is located on the north-eastern periphery of Larkhall between the existing town and the M74. The land is predominantly arable farmland and includes a private property (Tileworks Cottage and associated outbuildings (Figure 2)) at the eastern extremity. The site investigation work, and therefore the archaeological monitoring works described here, took place over three parcels of land in the south-eastern half of the proposed development area. This area is shown in green on Figure 1.

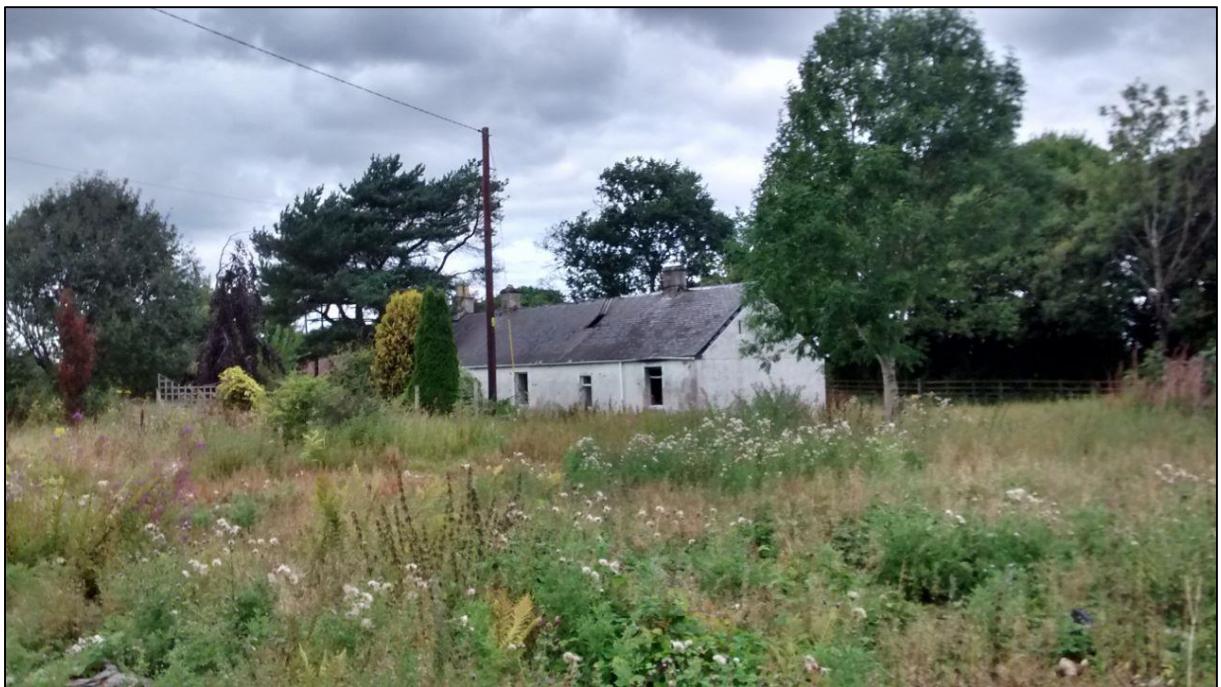
Figure 2 - General shot of rear of Tileworks Cottage, from S

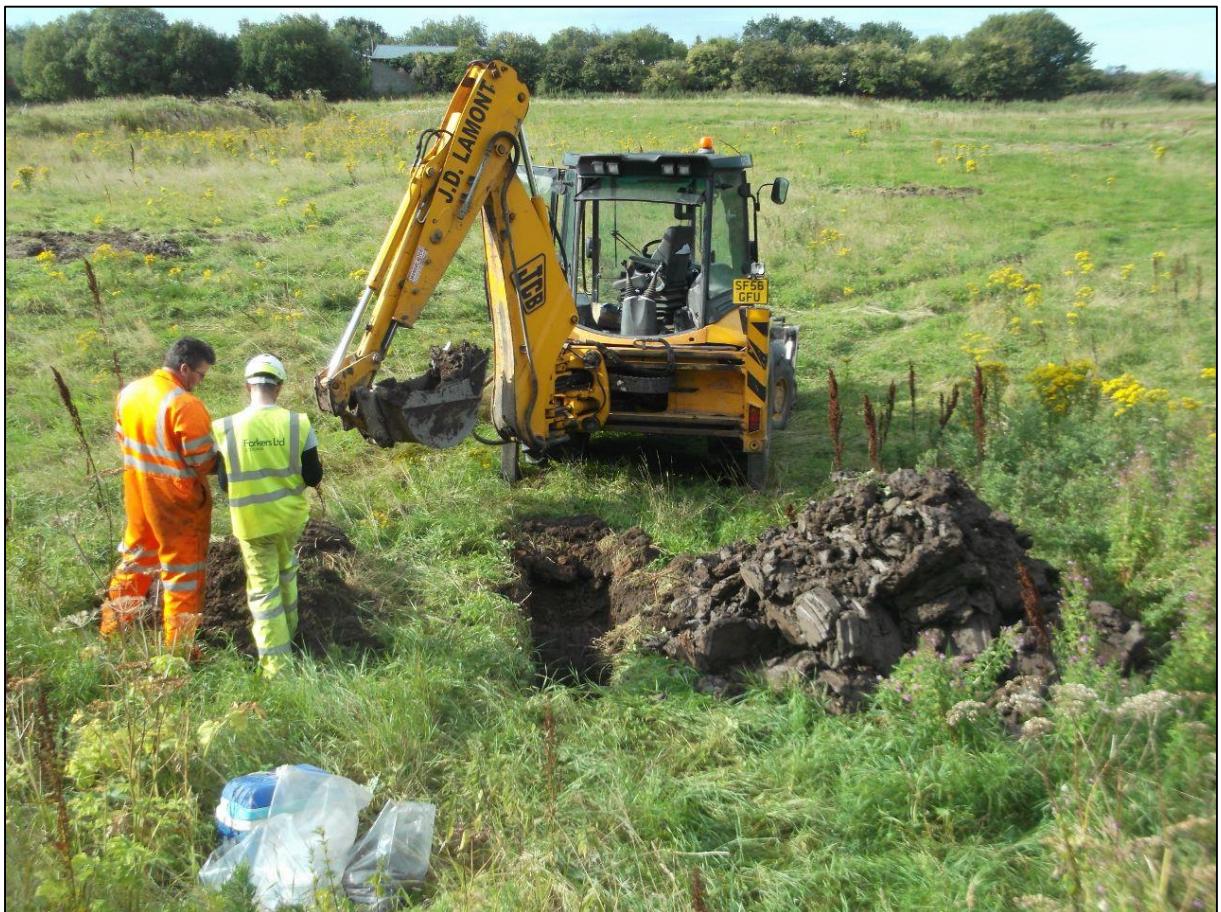
Test Pits
13. The test pits and trenches were excavated through turf and topsoil (001) (Figure 3), which was a loosely compacted, mid brown silt with frequent inclusions of coal, rootlets and small stones. There was also a significant quantity of modern ceramic and glass throughout the topsoil over all three areas, evenly distributed due to the frequent ploughing of this soil. (001) measured between 300 to 500mm thick.

Figure 3 - Working shot from NE of a test pit under excavation

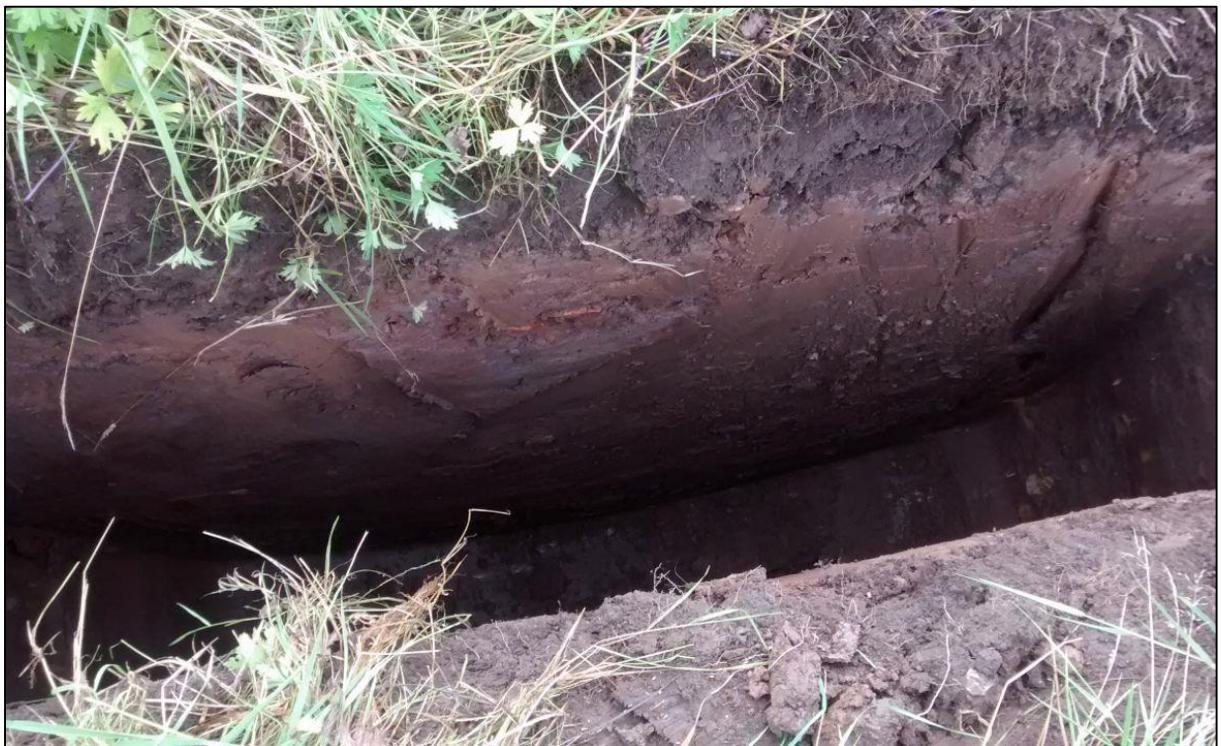
Figure 4 - Base of test pit 197

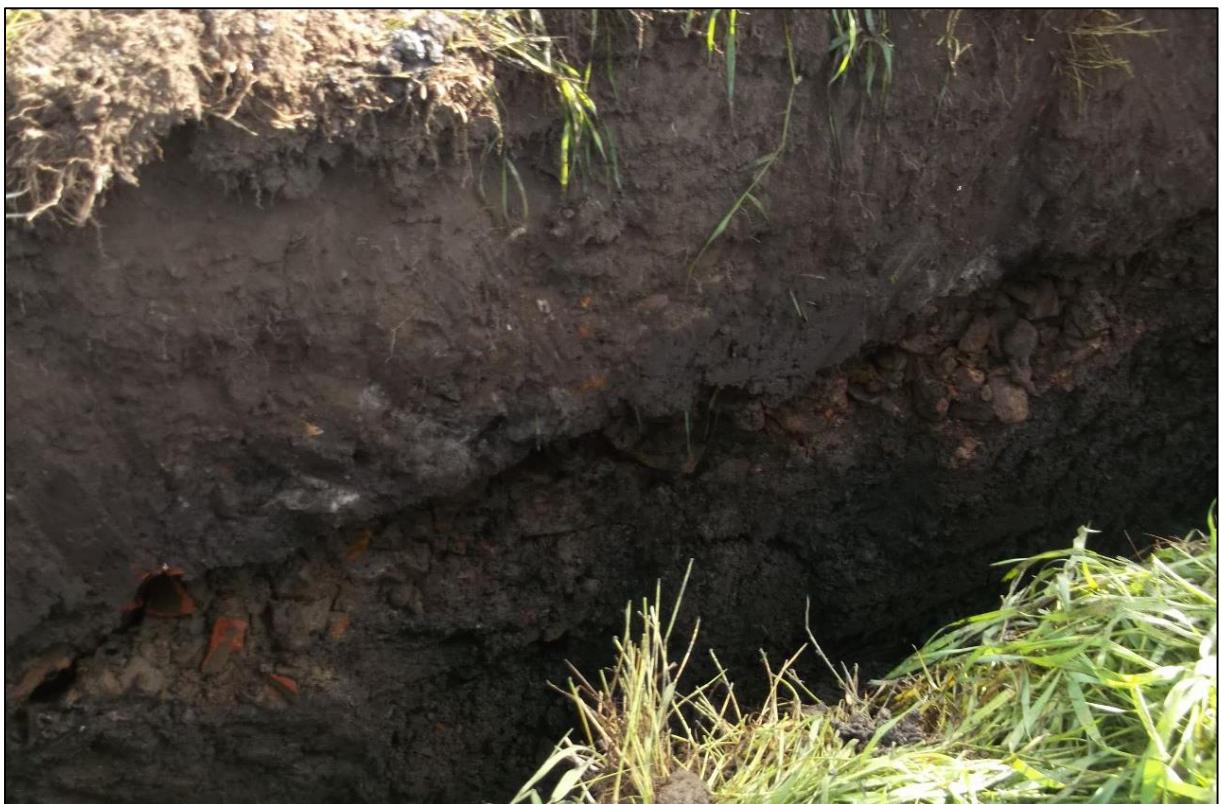
Figure 5 - Cobble backfill (008) of mine shaft (007) under (001), from W

007	Area 2	Cut	Large pit cut of former coal mineshaft. About 9m by 3.5m and filled with 001 at the edges and 008 in the middle. Unknown depth.	Cut of mine shaft
008	Area 2	Fill	Cobble backfill in the middle of mine shaft 007. Small to medium sub-rounded stones.	Cobble backfill of 007 mine shaft
009	Area 3	Deposit	Mixed re-deposited clay containing section of asbestos pipe – not fully revealed as trial pit abandoned on discovery of asbestos.	Disturbed ground in area of former clay pit for former brick and tile works in the area
010	Area 1	Feature	Red tile field drain. Measured approximately 100mm in diameter. Mainly orientated N-S. Sat at a depth of approximately 600 to 800mm below the ground surface.	Field drain

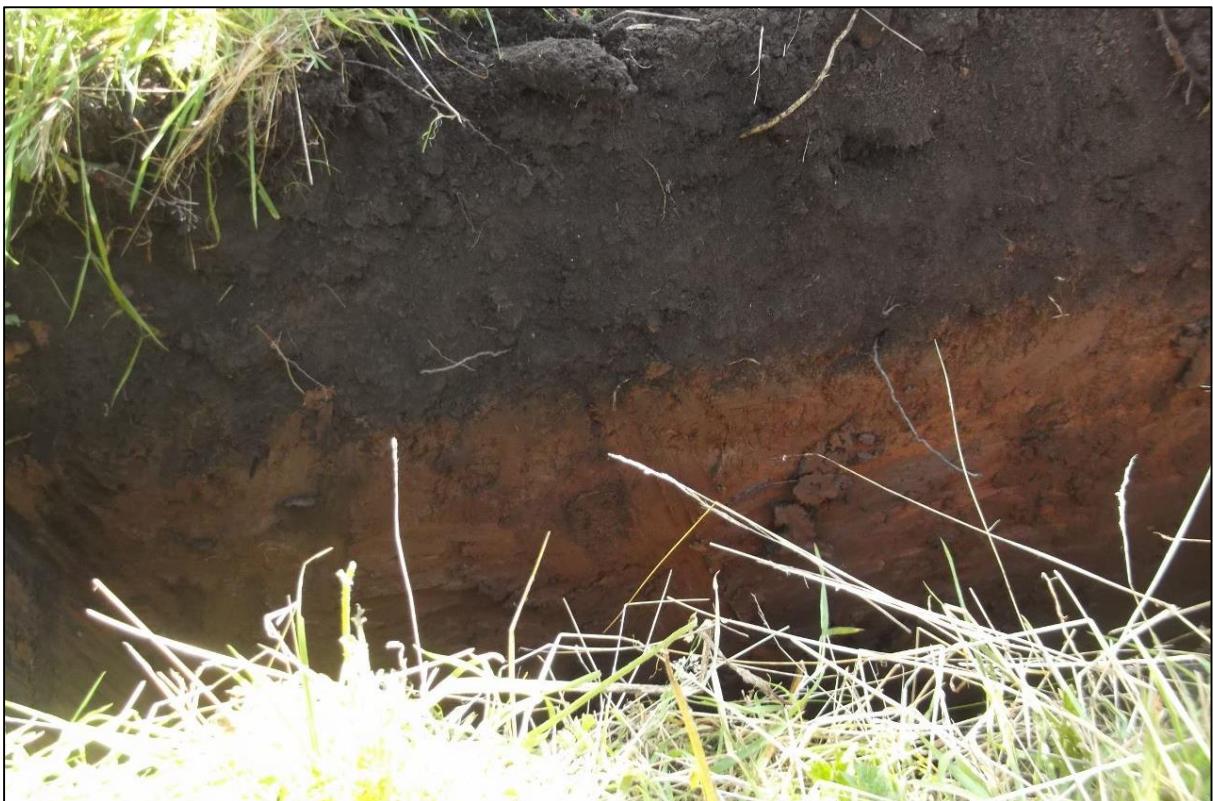
14. Some pits were excavated through a different topsoil (006) (Figure 6), which was found at the south end of all three areas. This was a very loose, dark brown-black silt with many modern inclusions such as large fragments of pottery and complete glass bottles. This layer was 400 to 700mm thick and the very high density of modern artefacts within it suggests they were deposited intentionally.

Figure 6 - NW facing section of 258, with (006), from NW

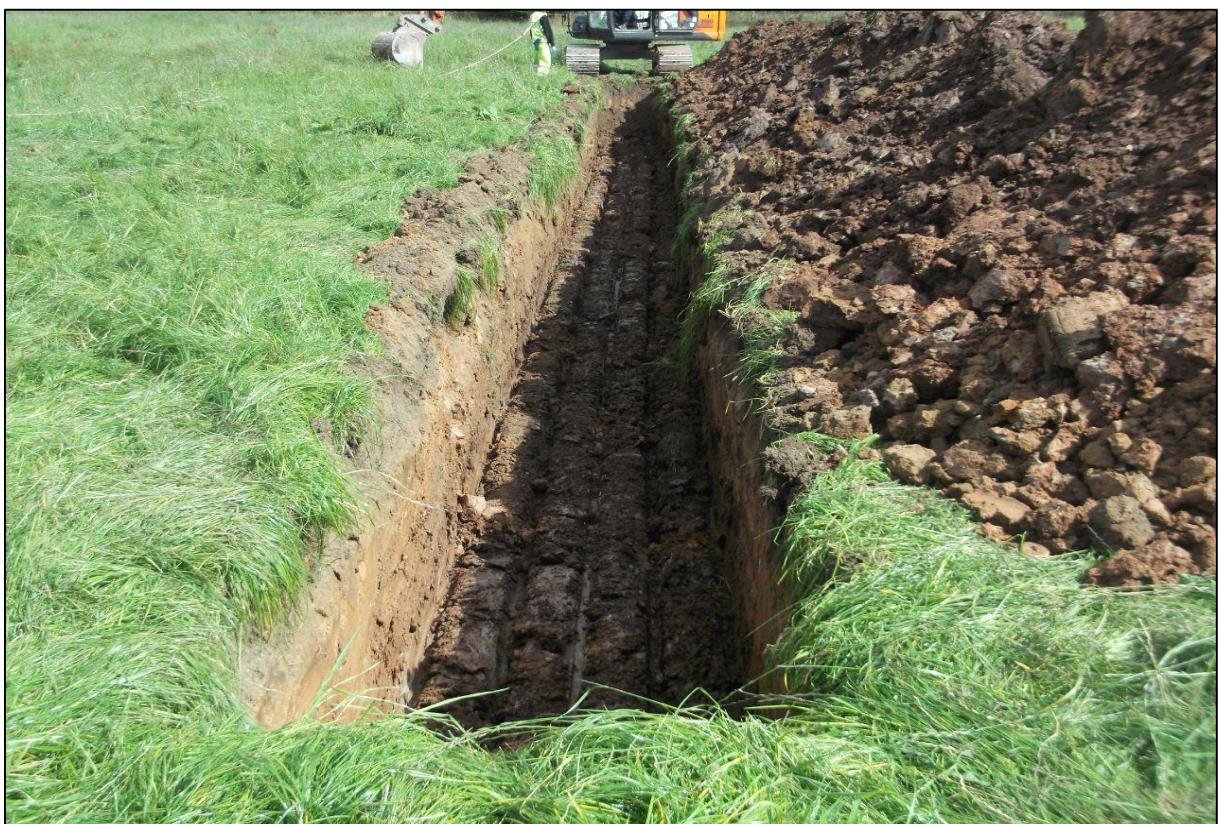
19. At the east end of Area 2, five trenches measuring 30m in length were dug in search of a mine shaft that was indicated to be in the area (Figure 7). A further two trenches measuring 15m in length were dug through it once it had been discovered. These trenches revealed that a mine shaft [007] was present that measured approximately 9m by 3.5m in area. This was filled with a cobble backfill (008) (Figure 5) in the centre where the main shaft was, with topsoil (001) infilled around the edges. The cobble backfill (008) of the main shaft measured approximately 3.5m by 3.5m in area. This feature was judged too unsafe to continue with detailed and specific investigation, and the trenches were stopped at a depth of 2m.

Figure 7 - Large trench B for mine shaft, from SW

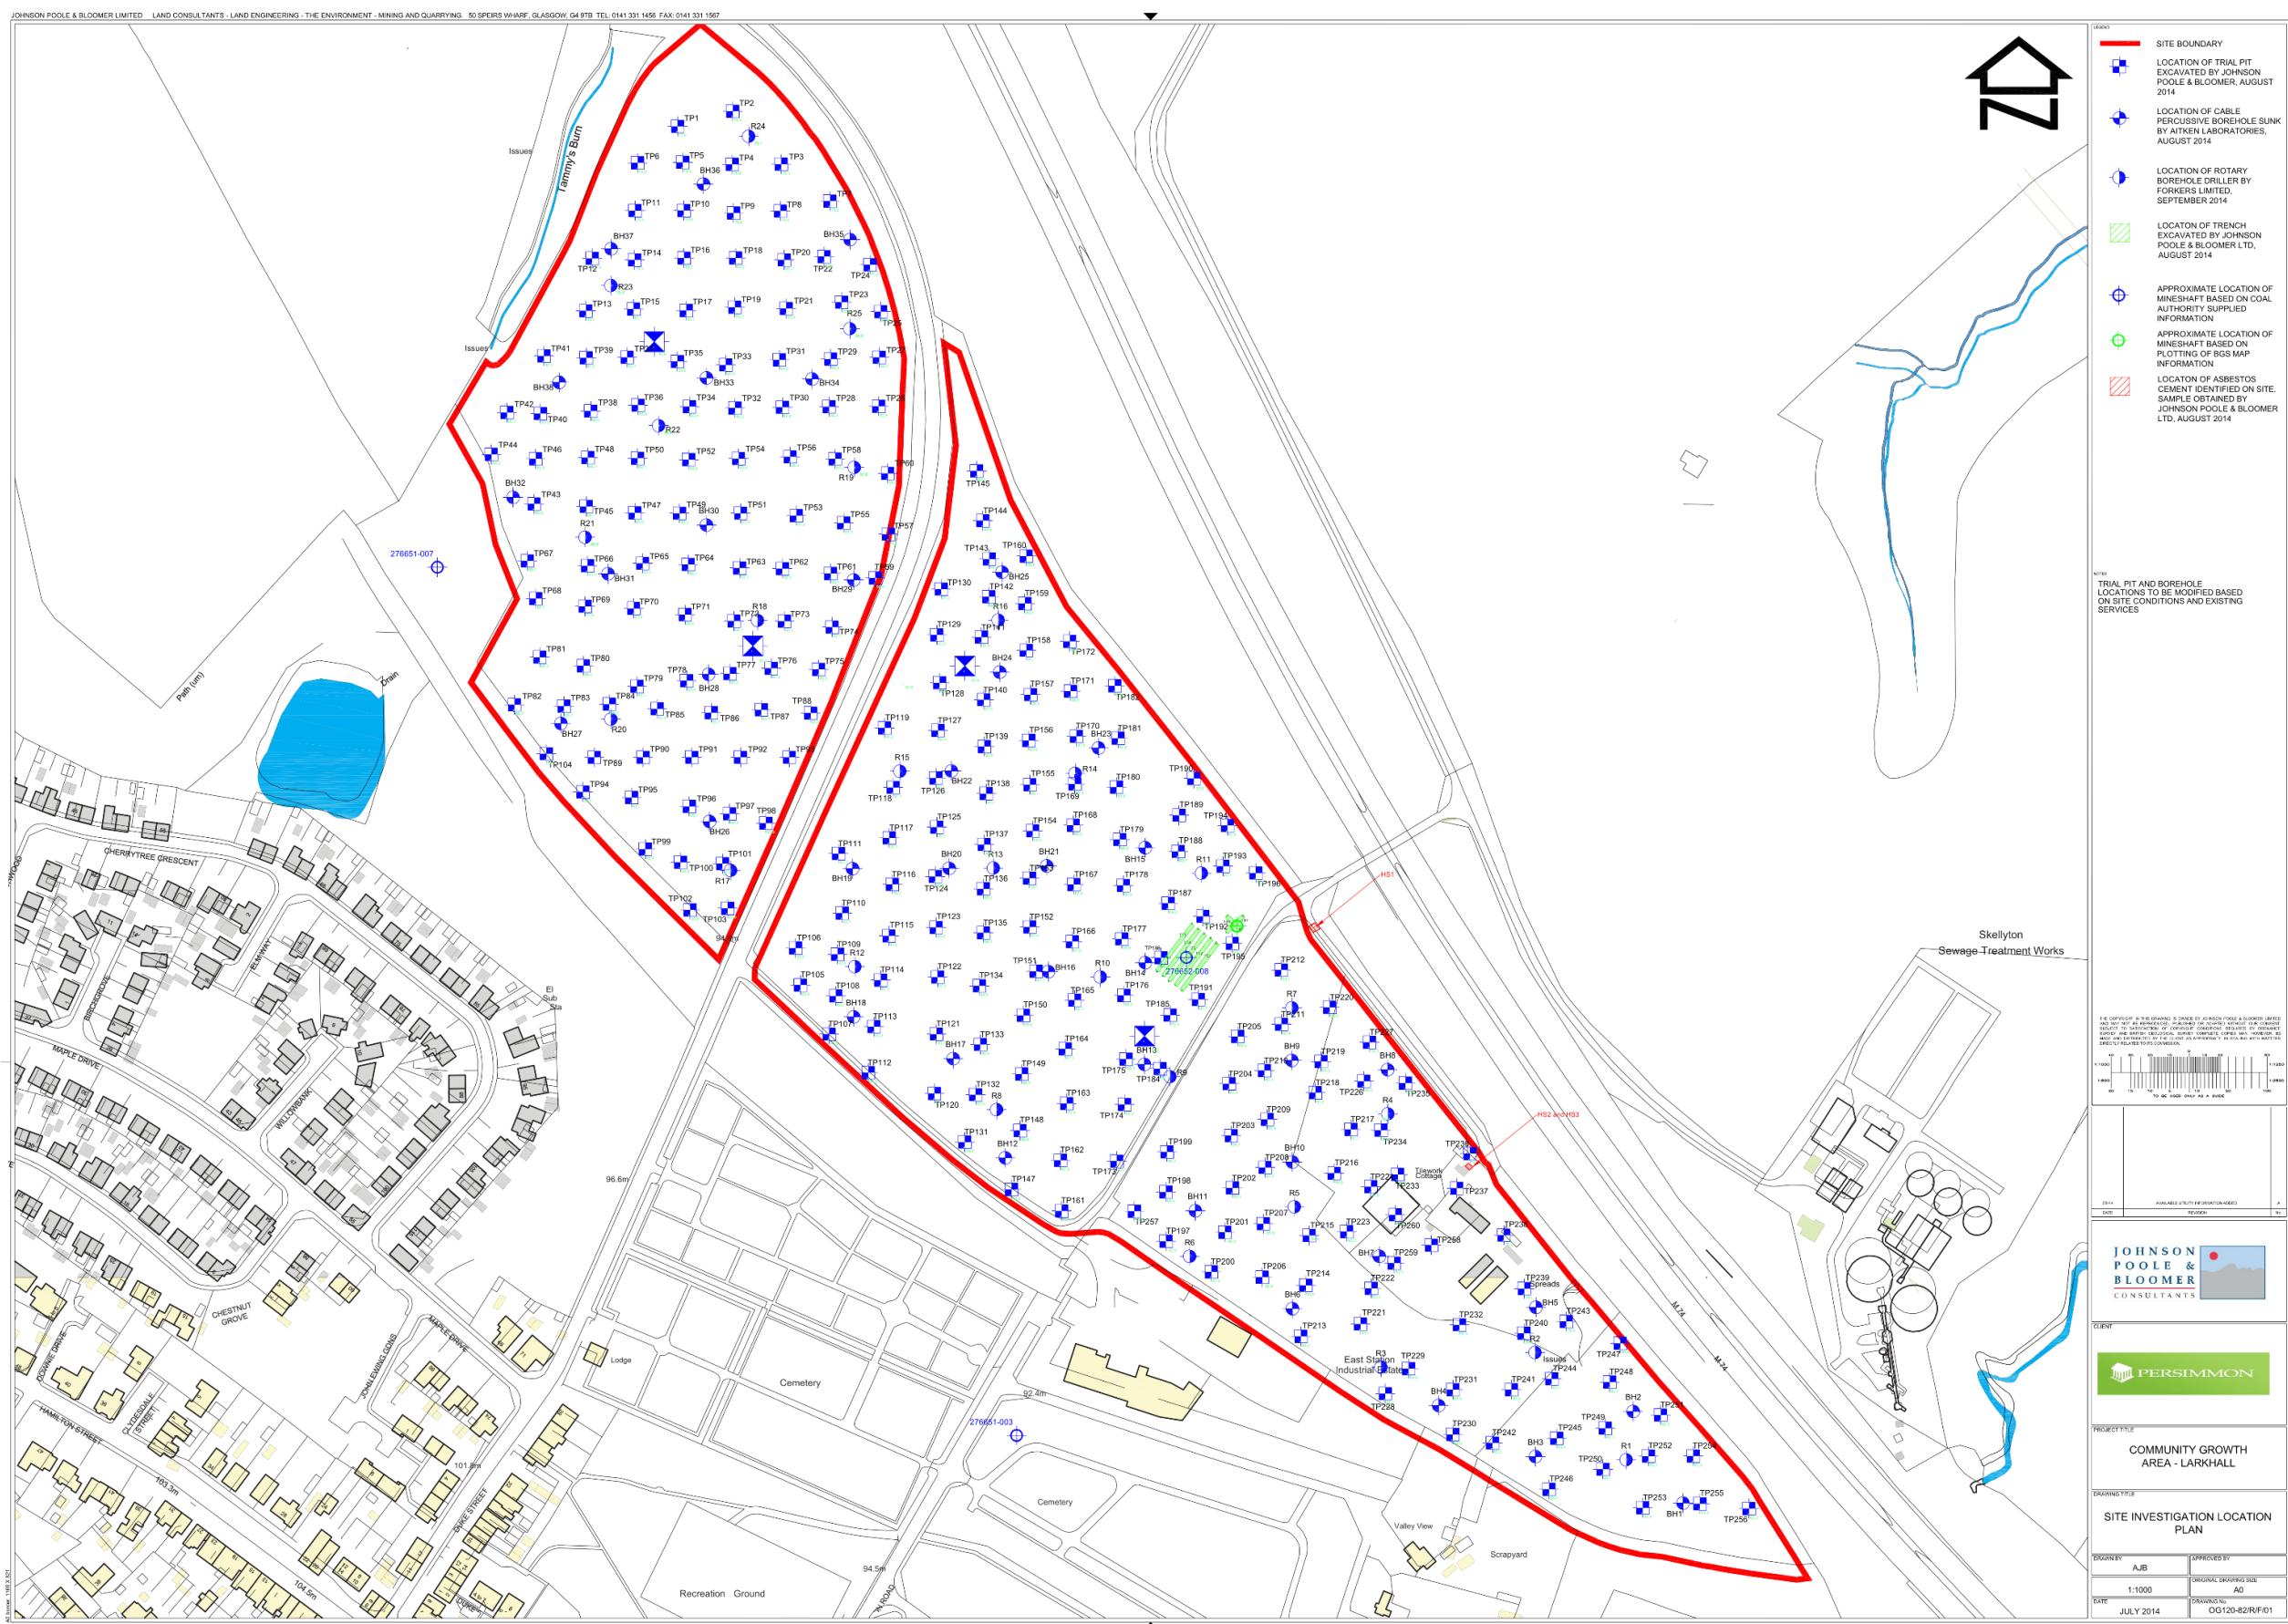
8. The archaeological works comprised the monitoring of test pits, larger trenches and soak-away pits over the three areas (Figure 8):
 - ❖ the test pits typically measured 3m by 0.5m and were dug to a depth of between 2m and 4m. These were spaced roughly 25m apart in a grid formation;

Within this appendix a standardised set of data pertaining to the test pits, trenches and soak aways is presented; Figure 8 at the start of this appendix illustrates the location of each excavation.
