# **Kiln Court, East Road, Irvine: Archaeological Mitigation**

## **Data Structure Report**

issued 18<sup>th</sup> September 2014

on behalf of North Ayrshire Council

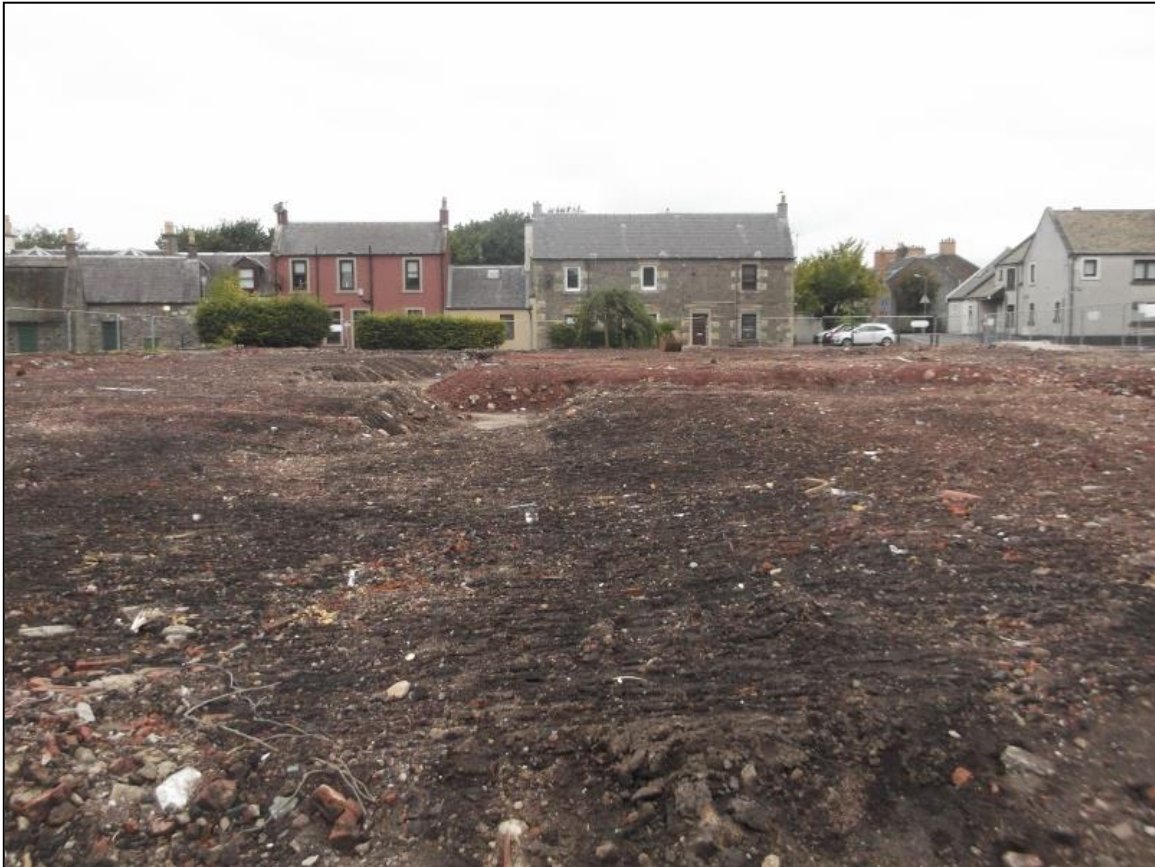
Figure 2a: General pre-excavation shot of the site from the southeast

7. Prior to the evaluation, the building had been demolished but the foundations had been left *in situ*. The area had been covered by demolition material from the recent works so that the top of the foundations were not visible (Figure 2a). Across the site, the concrete slab which formed the base of the service duct had been left exposed (Figure 2b), and this was avoided when deciding the placement of the trenches.

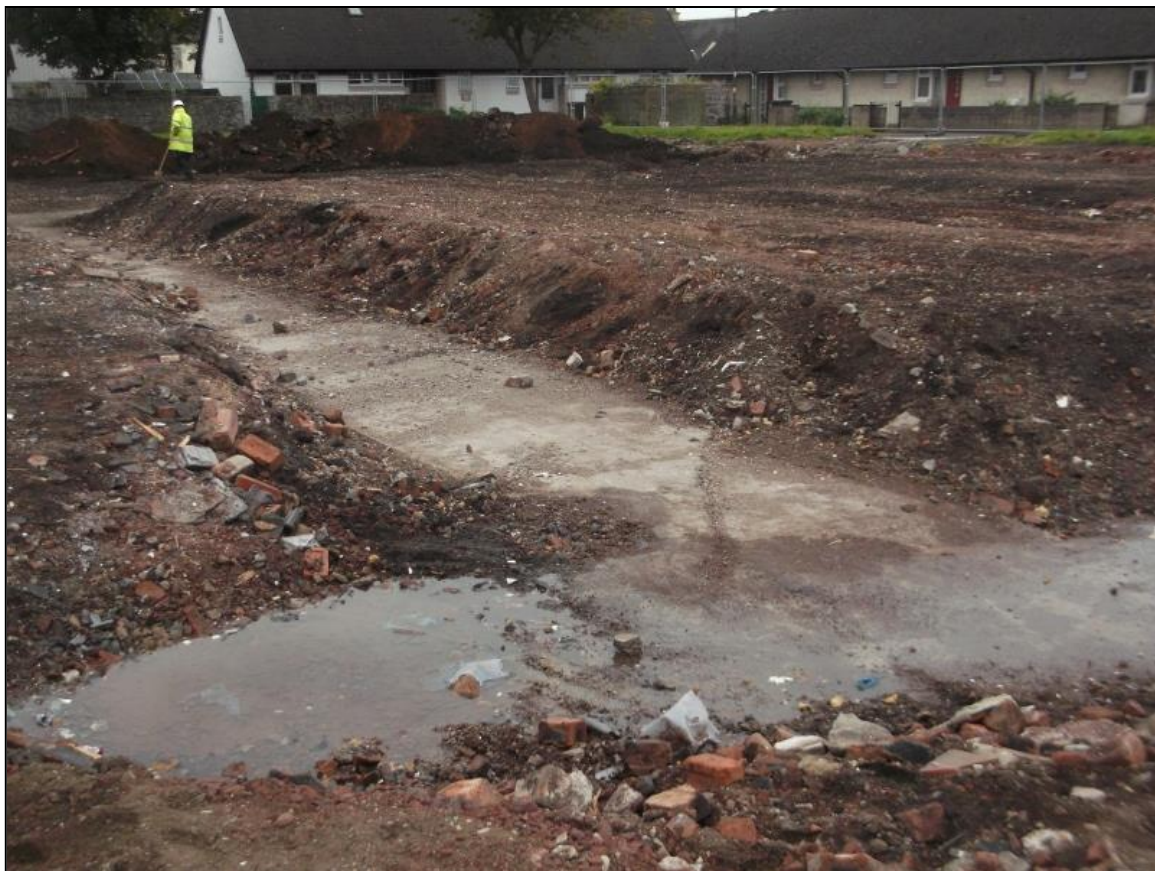
Figure 2b: Shot showing the exposed concrete base of the service duct from the northwest

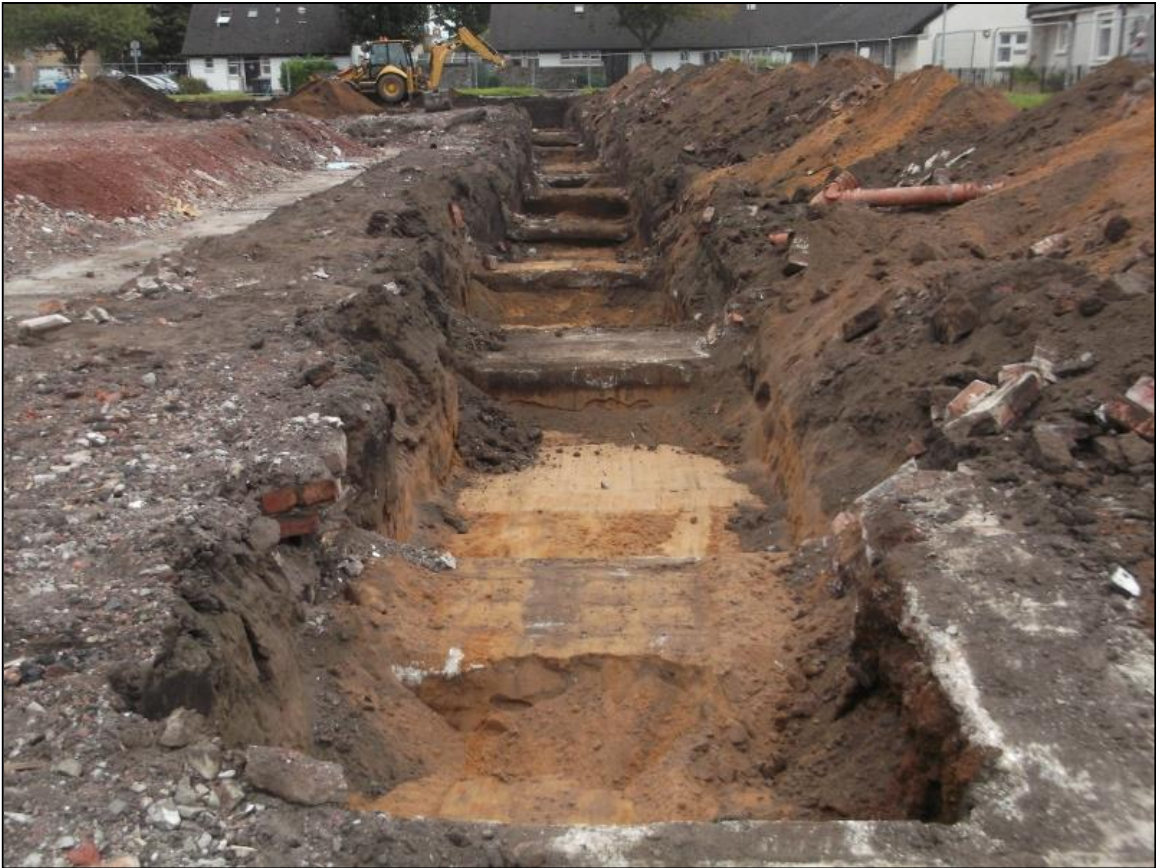
Figure 3a: Trench 2 from the northwest showing *in situ* concrete foundations

9. The foundations for the demolished building which remained *in situ* were exposed at frequent points throughout the trenching (Figure 3a). Surviving brick foundations were removed by the machine, but concrete foundations were left in place. Not only would their removal would have been difficult for the machine, it is also likely that their initial construction would have caused much disturbance to the underlying subsoil, removing any possibility for the survival of features.

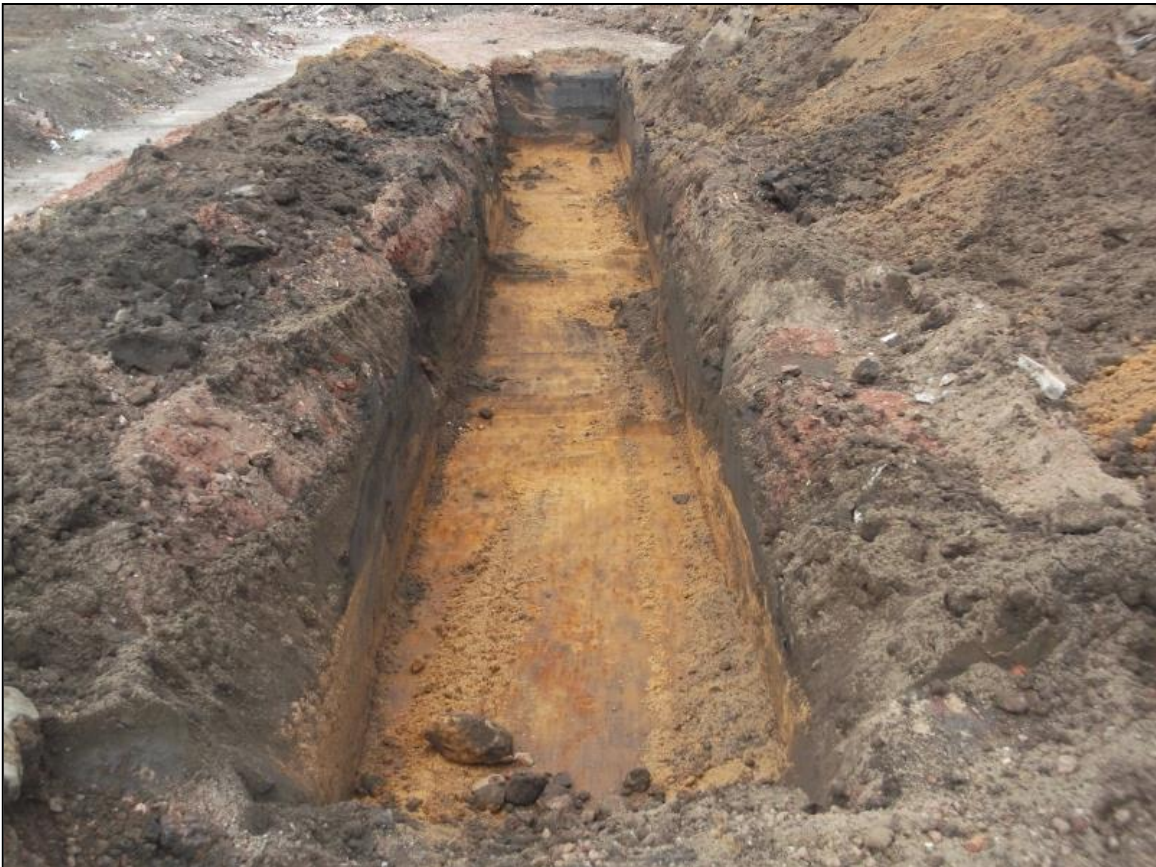
Figure 3b: Trench 6 from the southeast located within area of internal courtyard

15. Underlying this sat natural subsoil (003) which comprised a loose to moderately compact dark orange/yellow silty sand (slightly mottled) (Figure 3b). This was the natural subsoil present across the whole site.

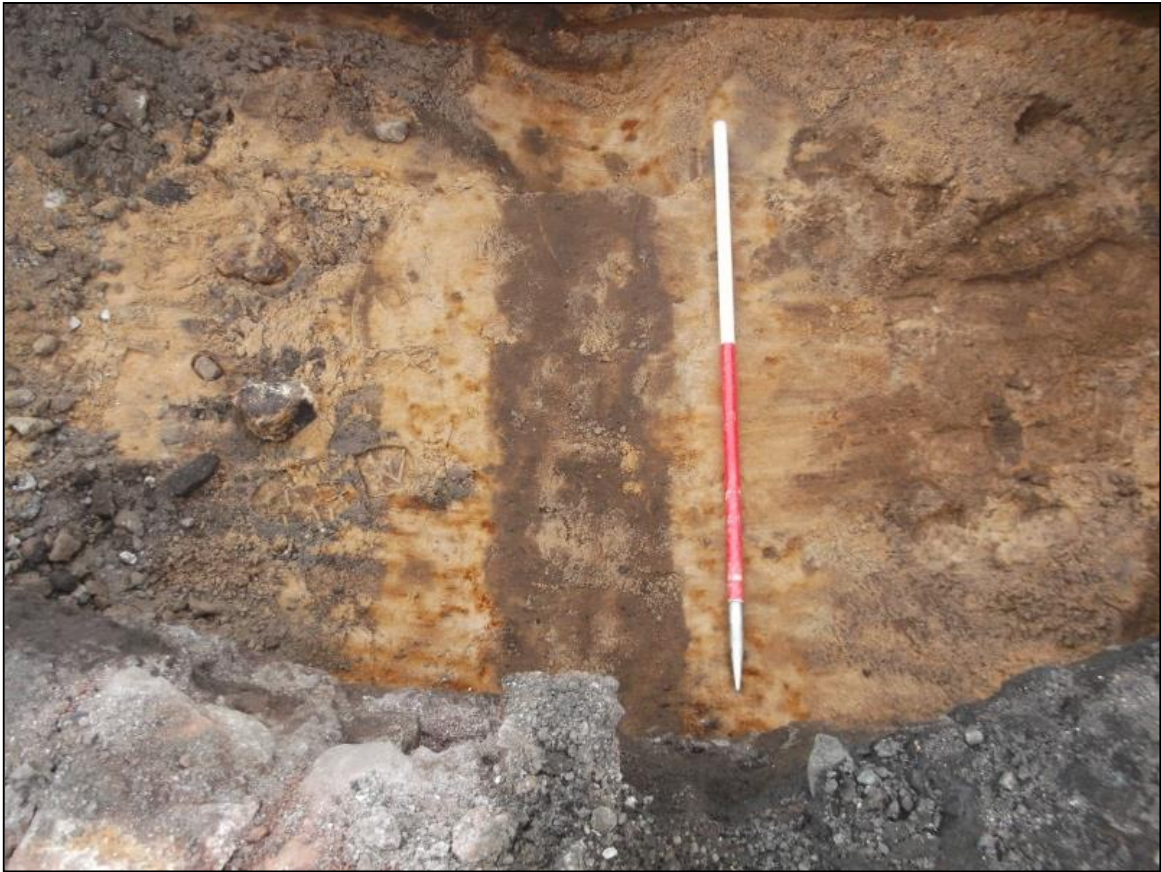
17. Only two features were exposed which had the potential to be significant.
18. In Trench 2, linear feature [004] was present which was orientated NE-SW and extended beyond the limits of the trench in both directions. It measured 0.3m wide and 100mm deep, with gradual sloping sides and a rounded base (Figure 4a). It was filled by topsoil (002), which also overlay it. No artefacts were recovered from its fill.

Figure 4a: Feature [004] from the northeast

23. As described previously, two features were recorded during the works: [004] and (005). The nature of linear feature [004] suggests that it is likely to be modern in date. It had a very regular shape and contained a topsoil fill with no artefacts. There were no other features still remaining in the surrounding area, and the fact that (004) was also fairly insubstantial in size points to it being unlikely as part of a structural feature. It is possible that it is the truncated remains of an old service track leading to the houses which sat to the southwest.

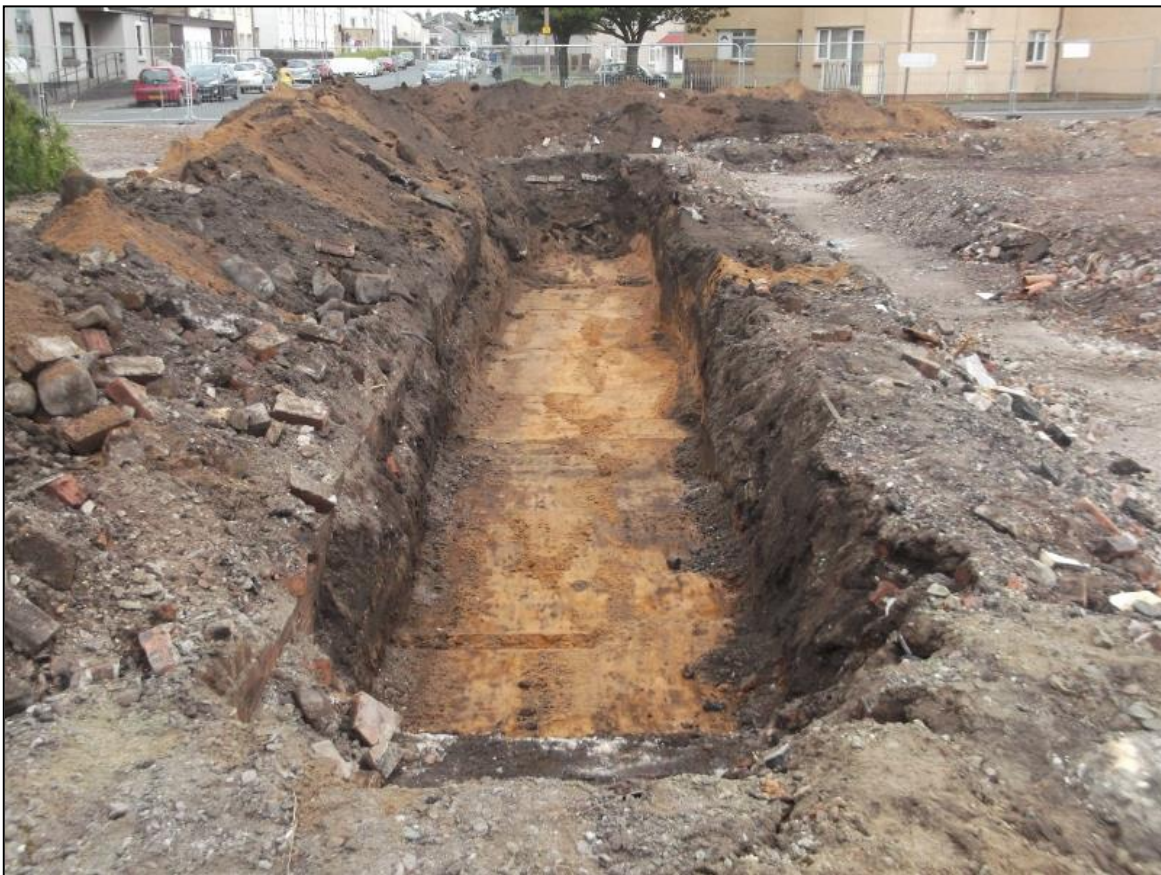
19. In Trench 9, an area of disturbance (005) was recorded which ran for most of the length of the trench orientated SW-NE (Figure 4b). Roughly linear in plan, its sides and base were irregular in shape, and it measured up to 0.7m wide and 200mm deep. It was filled by disturbed and darkened natural subsoil. No artefacts were recovered, although what appeared to possibly be a tiny fragment of brick was spotted within the fill. The irregular nature of the sides and base suggests that it is more likely to represent an area of disturbance than a cut feature.

Figure 4b: Trench 9 from the southwest showing feature (005) running along the left hand side

24. (005) was quite irregular in shape and contained what appeared to be re-deposited natural subsoil. What appeared to be a tiny fragment of brick was visible within its fill, and it ran adjacent to a foundation which ran along the side of Trench 9, so it could potentially represent an area of modern disturbance related to the construction. However, its irregular shape and subsoil-like fill suggests that it could also possibly represent the site of an old hedgerow. Looking at the 1<sup>st</sup> edition Ordnance Survey dating to 1860, the line of a boundary is visible in this area which runs on a similar alignment, and it is possible that this is the remains of that boundary.
