Culzean Castle, Outfall: Archaeological Monitoring

Data Structure Report

issued 27th March 2014

on behalf of The National Trust for Scotland

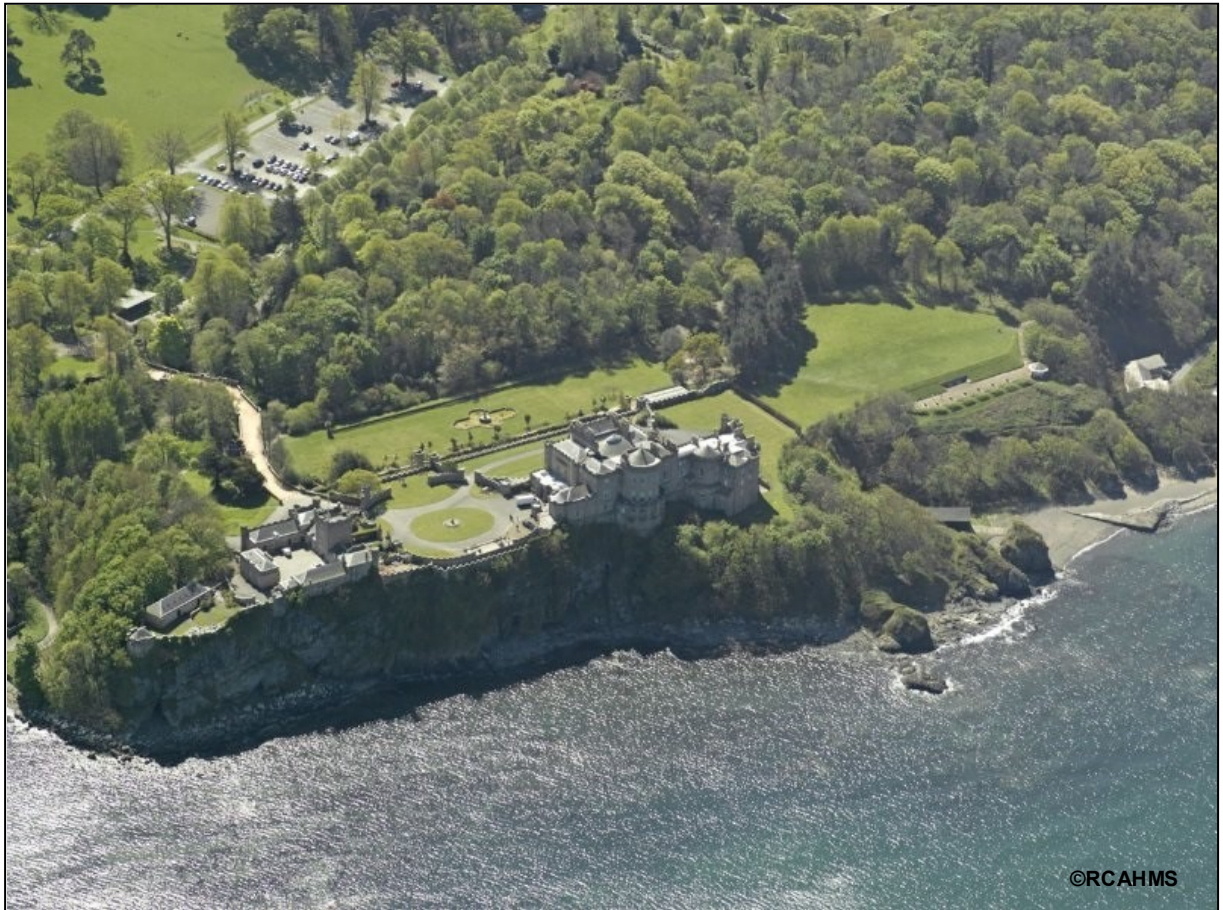
Figure 2a: Culzean Castle

9. The archaeological monitoring work was carried out immediately to the north-west of Culzean Castle (Figure 2a) on a steep bank (Figure 2b). Test pits were being excavated by structural engineers to determine the suitability of each location for a concrete pad. The concrete pads are intended to support a waste outflow pipe. Therefore, the location of each test pit was determined by the engineers on site and based on a previous examination of the area (Figure 5).

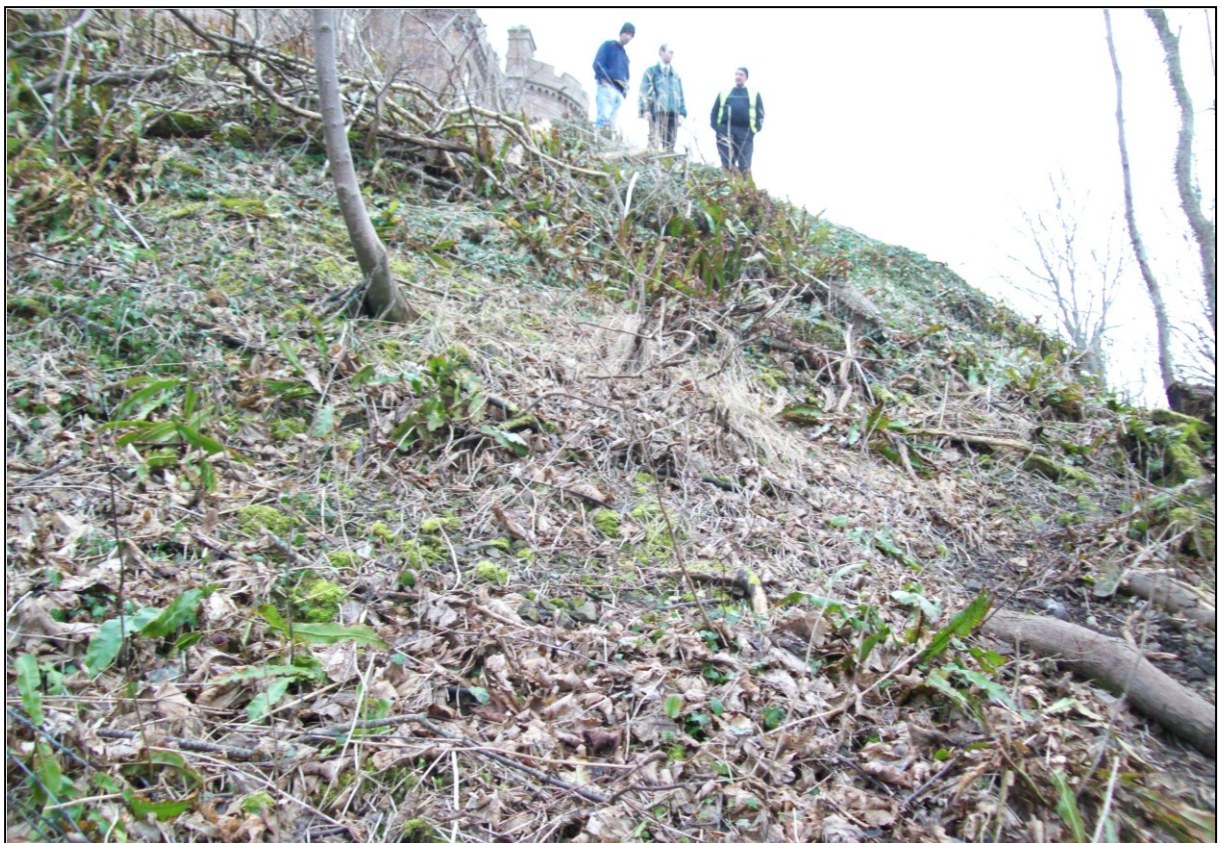
Figure 2b: Looking up slope from the test pits

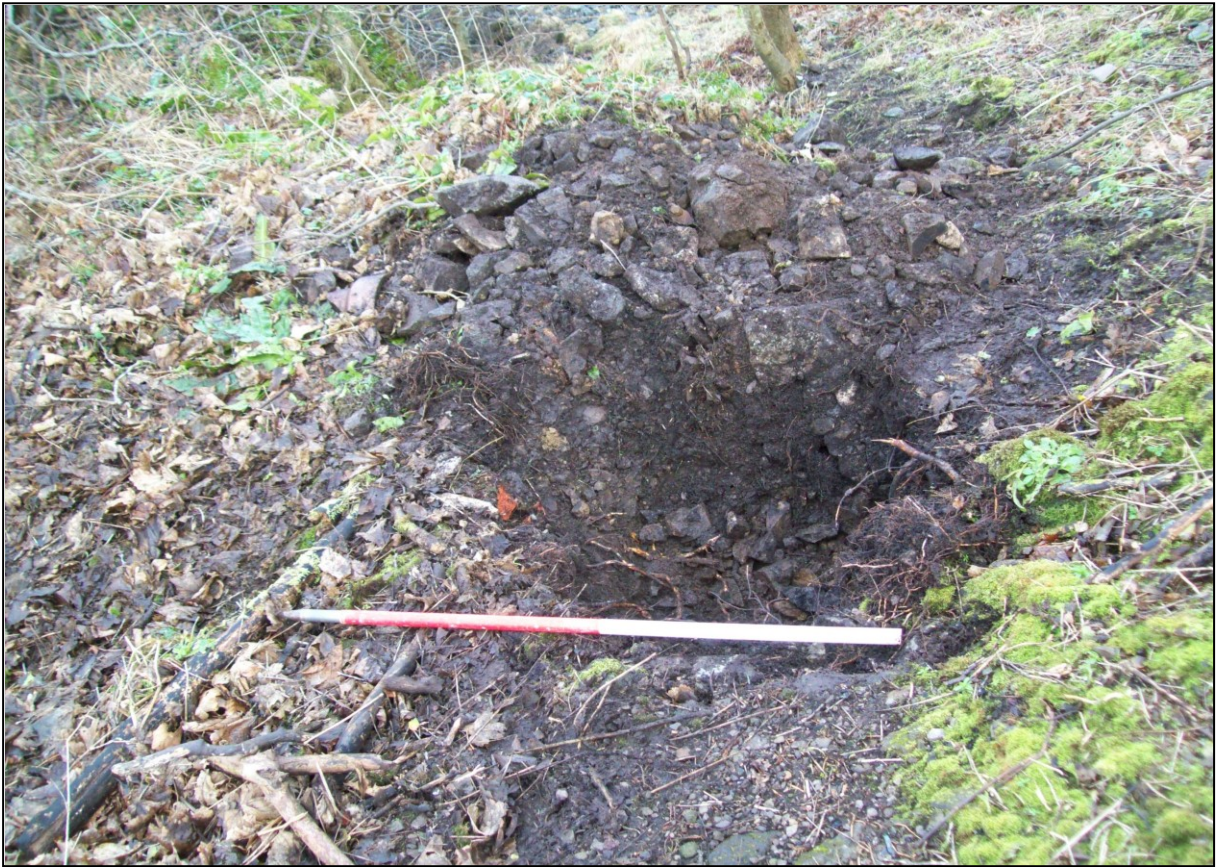
Figure 3a: TP1

10. Test pit 1 (TP1) (Figure 3a) measured 0.95m north-west by south-east and 1m south-west by north-east. Due to the natural slope of the landscape it was excavated to a depth of 0.58m at the north-east end and 0.74m at the south-west end. The topsoil (1001) was about 40mm thick and composed of grass and moss with some shallow sandy soil. Deposit (1002) contained angular fragments of stone in a sandy soil matrix. Included within this context were some small fragments of building debris. TP1 had brown sandy silt at the base (1003).

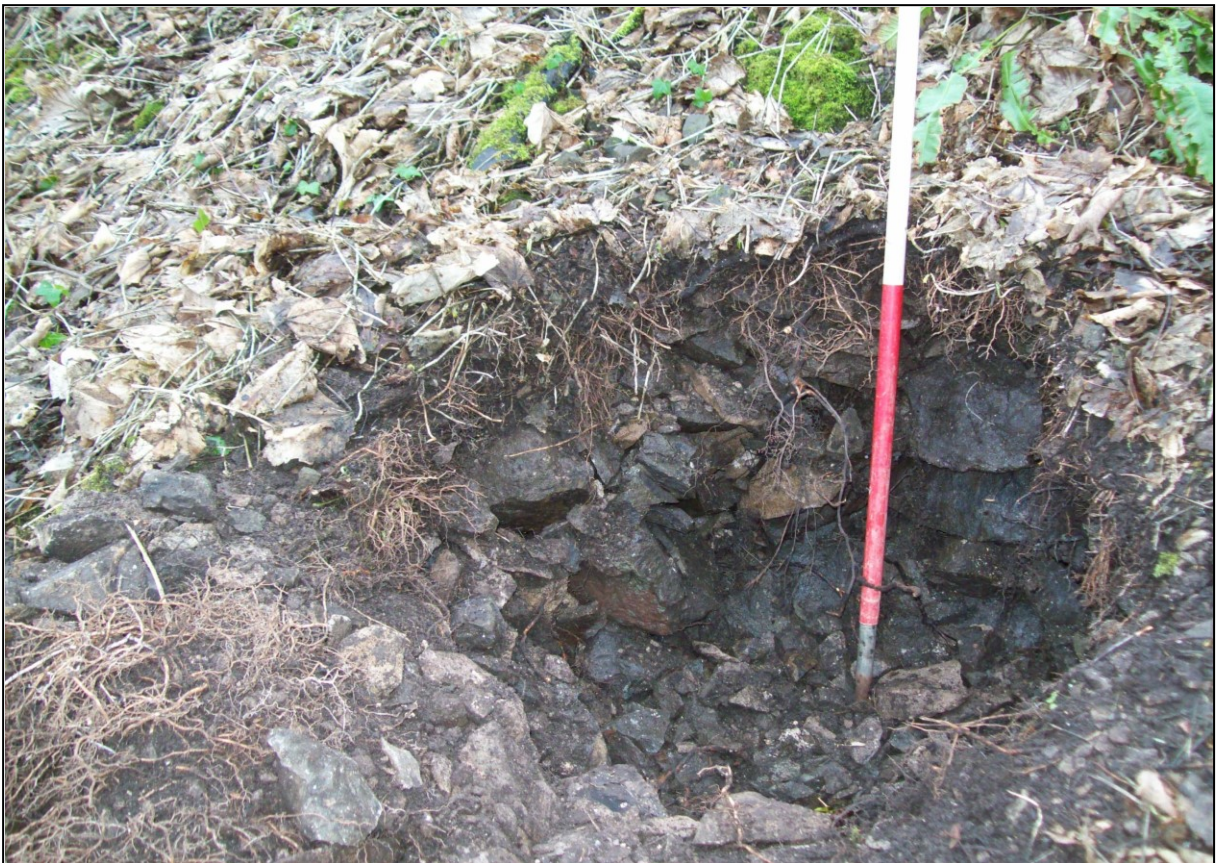
Figure 3b TP2

11. Test pit 2 (TP2) (Figure 3b) measured 0.8m north-east by south-west and 0.9m south-east by north-west. Again, due to the natural slope of the landscape it was excavated to a depth of 0.75m at the south-west end and 0.6m at the north-east end. The deposits uncovered were very similar to those observed in TP1. Approximately 60mm of topsoil (2001) of similar character to (1001) was present. Deposit (2002) was mainly composed of angular stones similar to (1002) but with less of the sandy matrix and no building material present. TP2 had bedrock (2003) at the base.

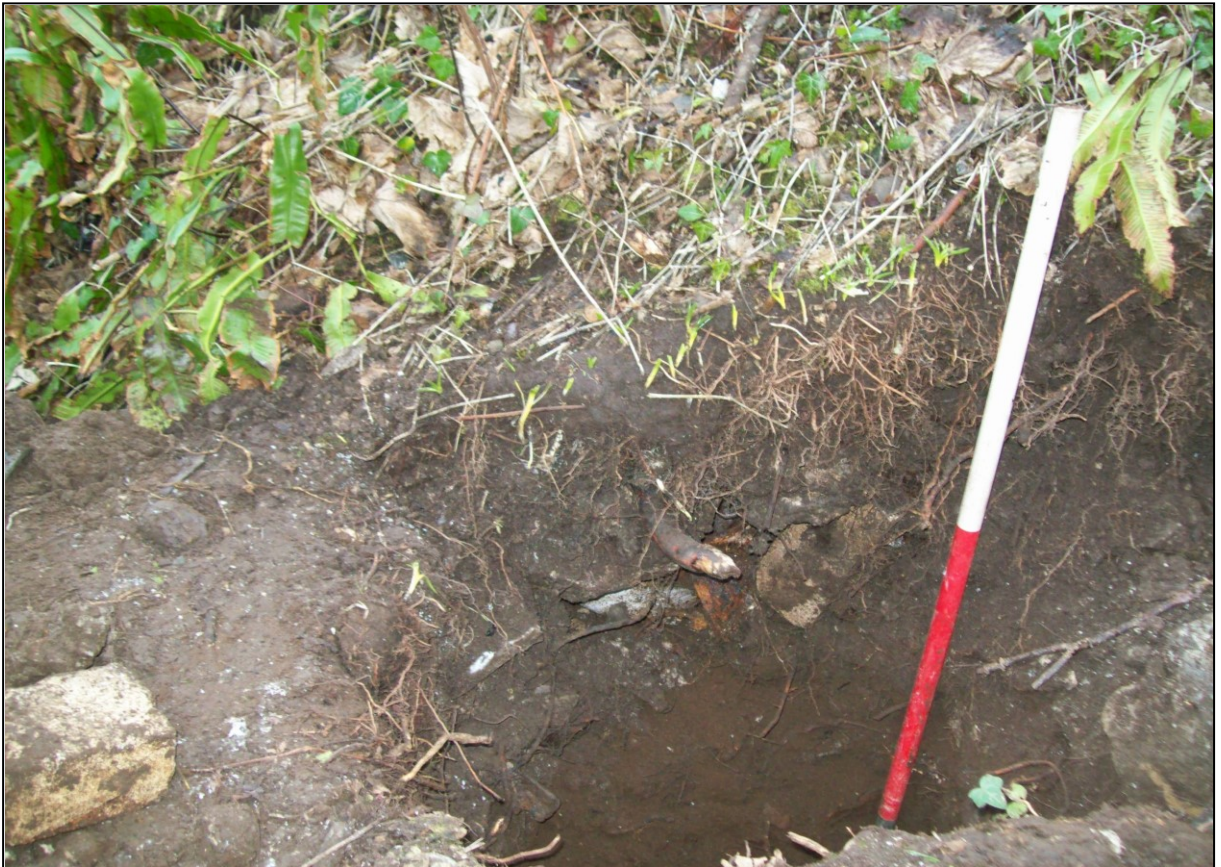
Figure 4a: TP3

12. Test pit 3 (TP3) (Figure 4a) measured 0.8m north by south and 0.65m east by west. TP3 was excavated to a depth of 0.78m. The sediments observed in TP3 were similar to those described above, the upper half of the test pit was composed of topsoil (3001) and the lower half was composed of a mid-brown silty subsoil (3002). A quantity of building material was recovered from (3001) including window glass, fragments of iron fence posts, and pieces of slate. Also recovered from (3001) was bed springs. Three architectural fragments were also recovered measuring approximately 280mm by 350mm (Figure 4b).

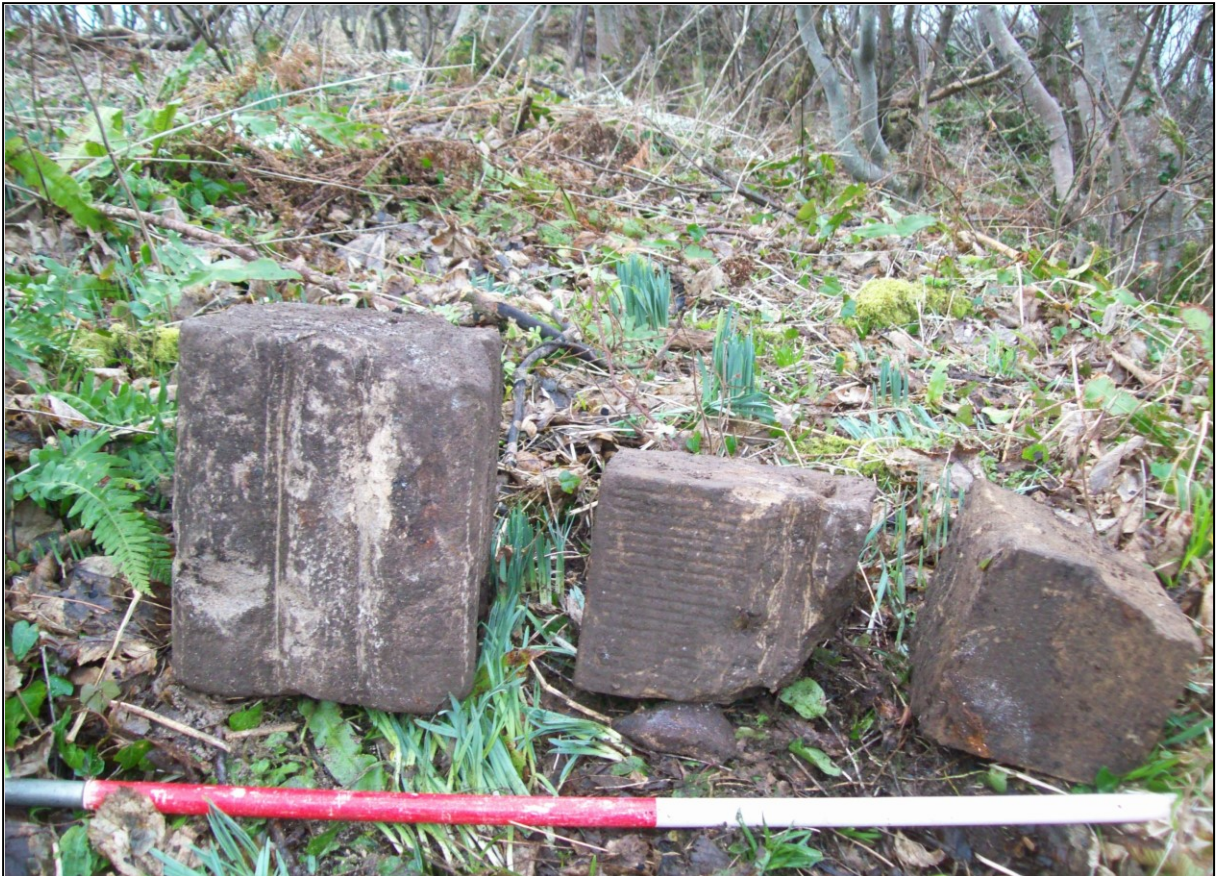
Figure 4b: Architectural fragments recovered from TP3

15. Those architectural fragments which were uncovered from TP3 were assessed to be sandstone quoins and probably of late 18th or early 19th century date. Given the frequency of refurbishment which has taken place to the Castle and its surrounding walls and structures, it is not surprising that these larger fragments would have been discarded here along with other building debris. In this case their presence in the test pits in an unsecure context is of no archaeological significance.
