Ochertyre, Blair Drummond: Archaeological Mitigation

Data Structure Report

issued 12th June 2014

RATHMELL  
ARCHAEOLOGY LTD

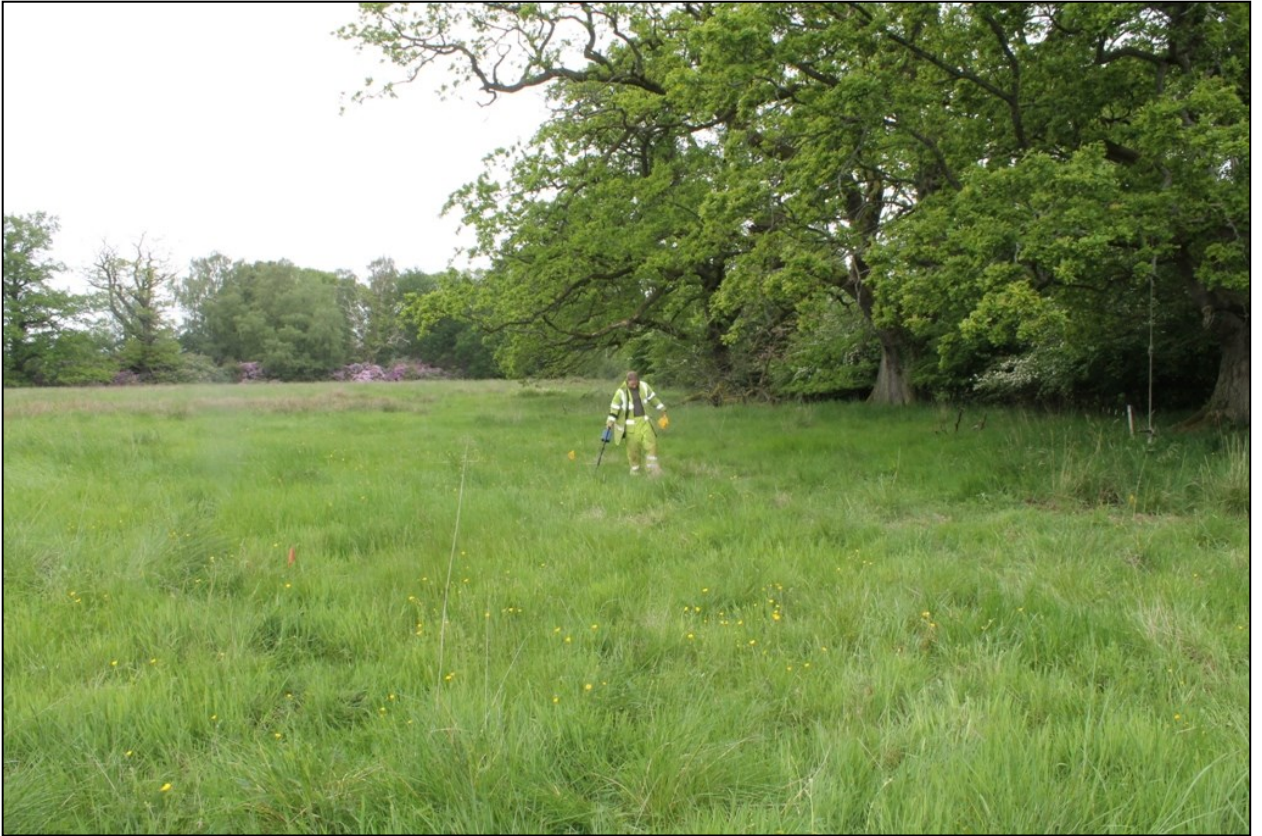
Figure 3a: Metal detecting areas of reasonable potential.

16. A metal detecting survey was also undertaken by the onsite archaeological team in accordance with the terms of the Method Statement (Rees 2013) using a Musketeer Advantage Pro (Minelab) using an 8 inch search coil. Transects were surveyed north-south at intervals of a metre which ensured 100% coverage of that area of reasonable potential located within the development area (Figure 3a).

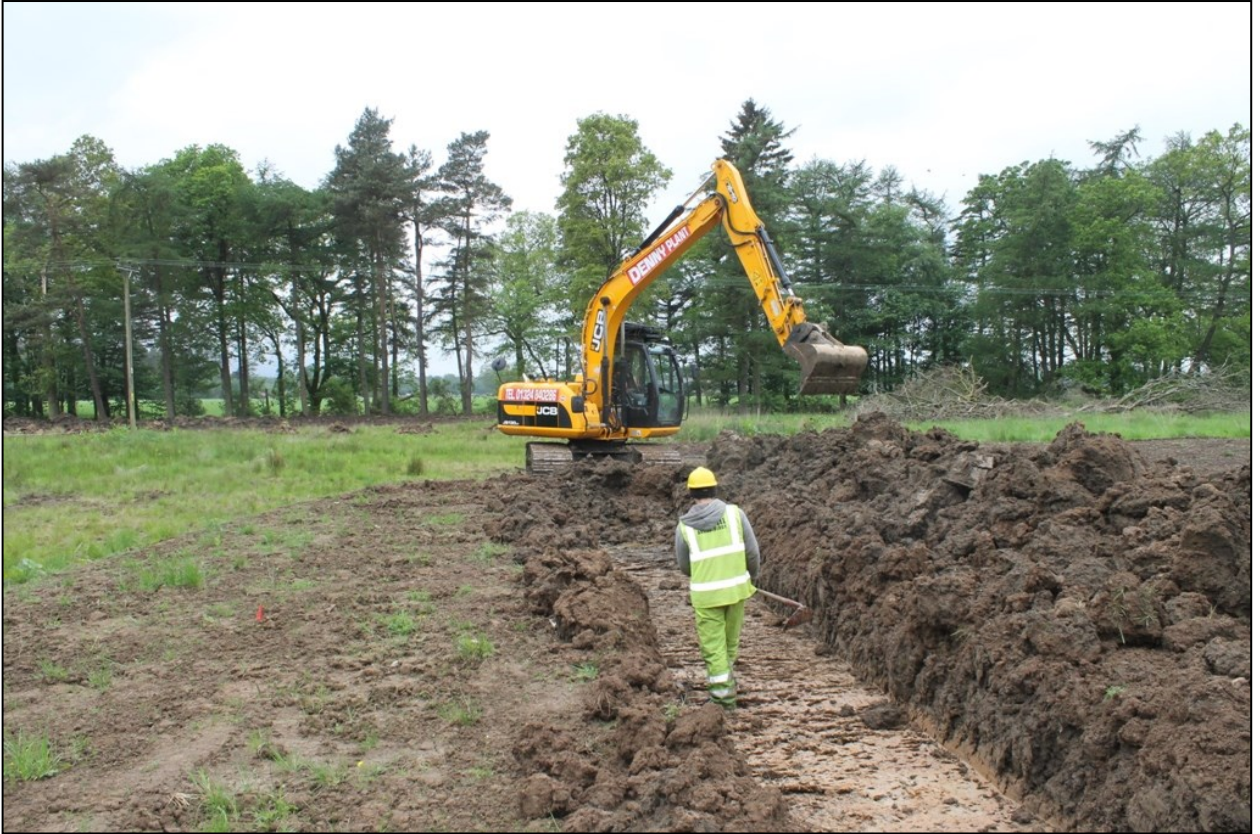
Figure 4a: Excavating trenches.

19. In all, 9 evaluation trenches were excavated using a 360° tracked 13 ton mechanical excavator with a toothless 2m ditching bucket (Figure 4a). The details of the trenches may be found in Appendix 1 within this document. Included below is a synthesis of the findings and interpretation from these trenches.

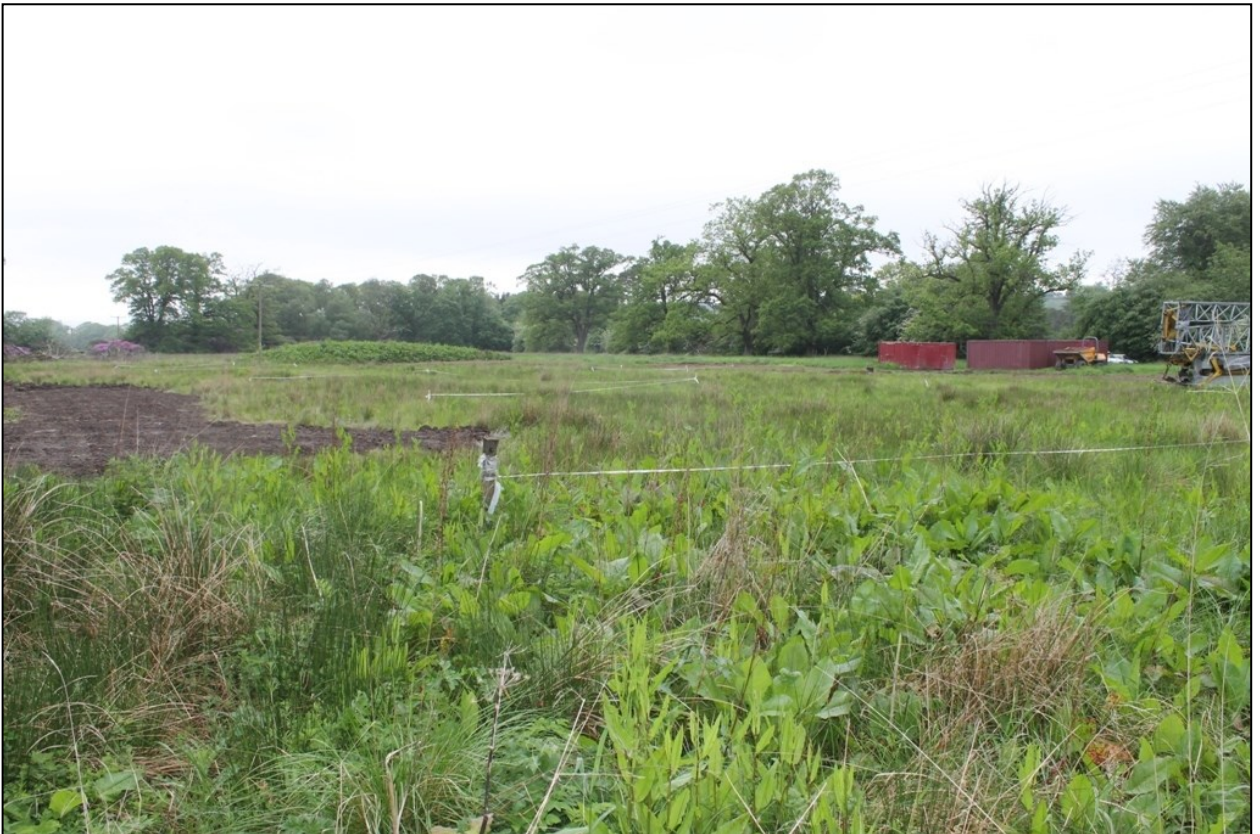
Figure 4b: Depicting the development site with vegetation cover synonymous with the brownfield nature of site.

20. At the time of the works, the development site was covered with areas of vegetation consistent with its brownfield character (Figure 4b). Some areas of the site also showed obvious signs of waterlogging, and indeed, the trenching works revealed a predominantly clay subsoil which would not allow for much natural drainage of the area (Figure 5a). It was clear that a large area of the site had been affected by previous use for industrial farming activities with evidence of hardstanding present.

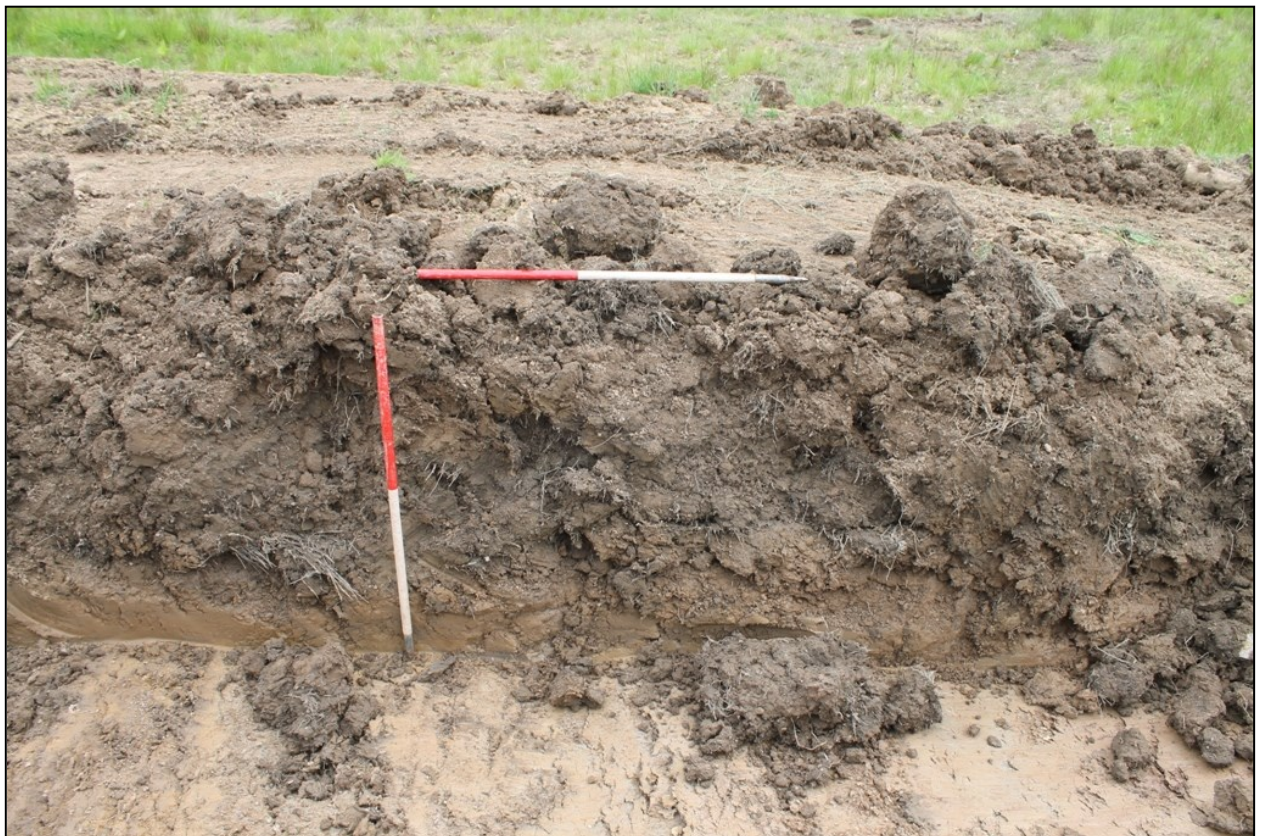
Figure 5b: West end of trench 3 demonstrating depth of overburden.

21. The trenches were excavated through turf and topsoil (001) which was a moderately compacted mid brown to light grey humic clay with frequent rootlets, measuring between 230mm and 270mm on average in depth across the site. There were two trenches (3 and 4) which had significantly deeper topsoil at the west and north-west ends respectively (Figure 5b). The depth of overburden, that included the topsoil, was due to the residue of spoil from bunding that had been removed prior to the evaluation commencing. Throughout (001) were modern inclusions of brick, tile and aggregate representing waste from previous activities and structures reflecting the nature of the development area as a brownfield site.

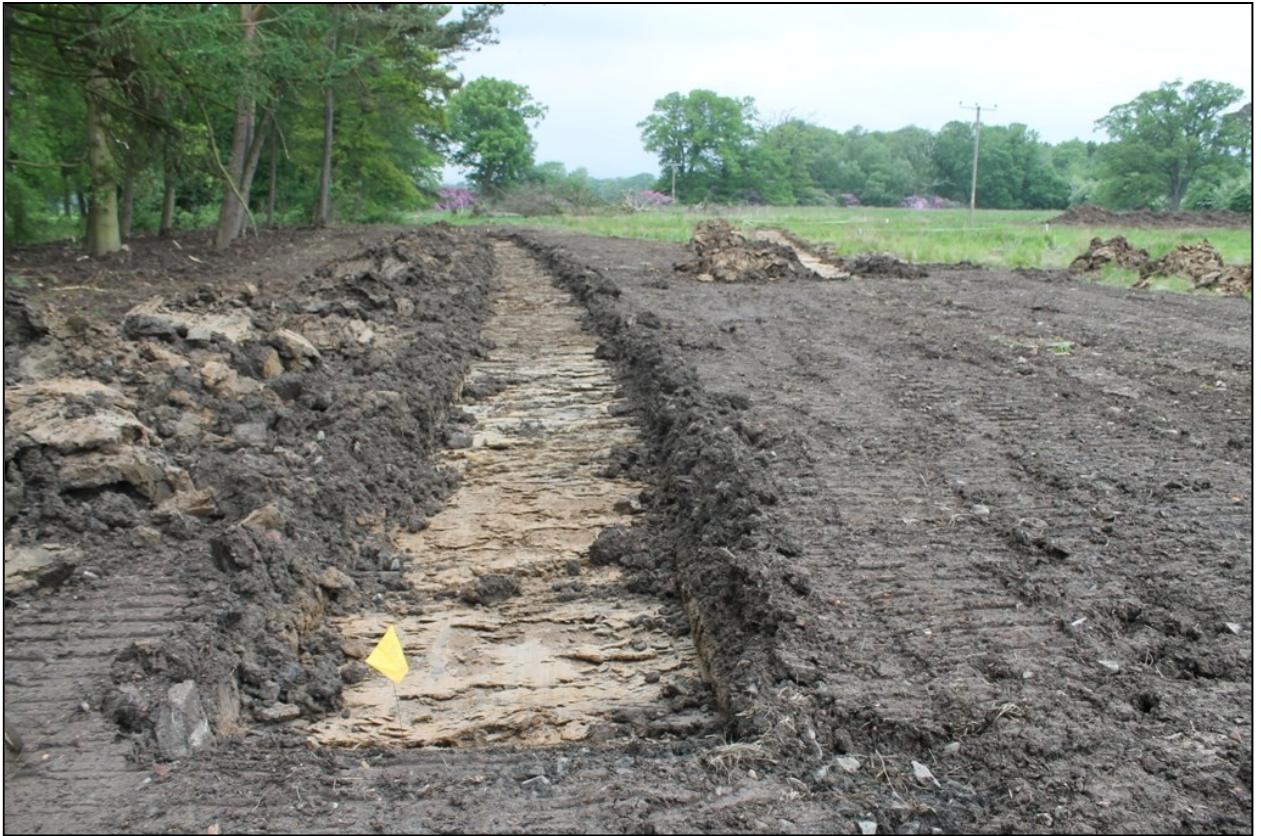
Figure 6a: Trench 9 demonstrating subsoil (002).

22. Underlying this was natural subsoil which predominantly consisted of a compact clay (002) and (004). Subsoil (002), which was present across the majority of the trenches, was light yellow orange in colour with areas of light grey mottling with the presence of frequent rootlets in areas (Figure 6a). Context (004) was a compacted mid brown orange colour with frequent rootlets throughout (Figure 6b).

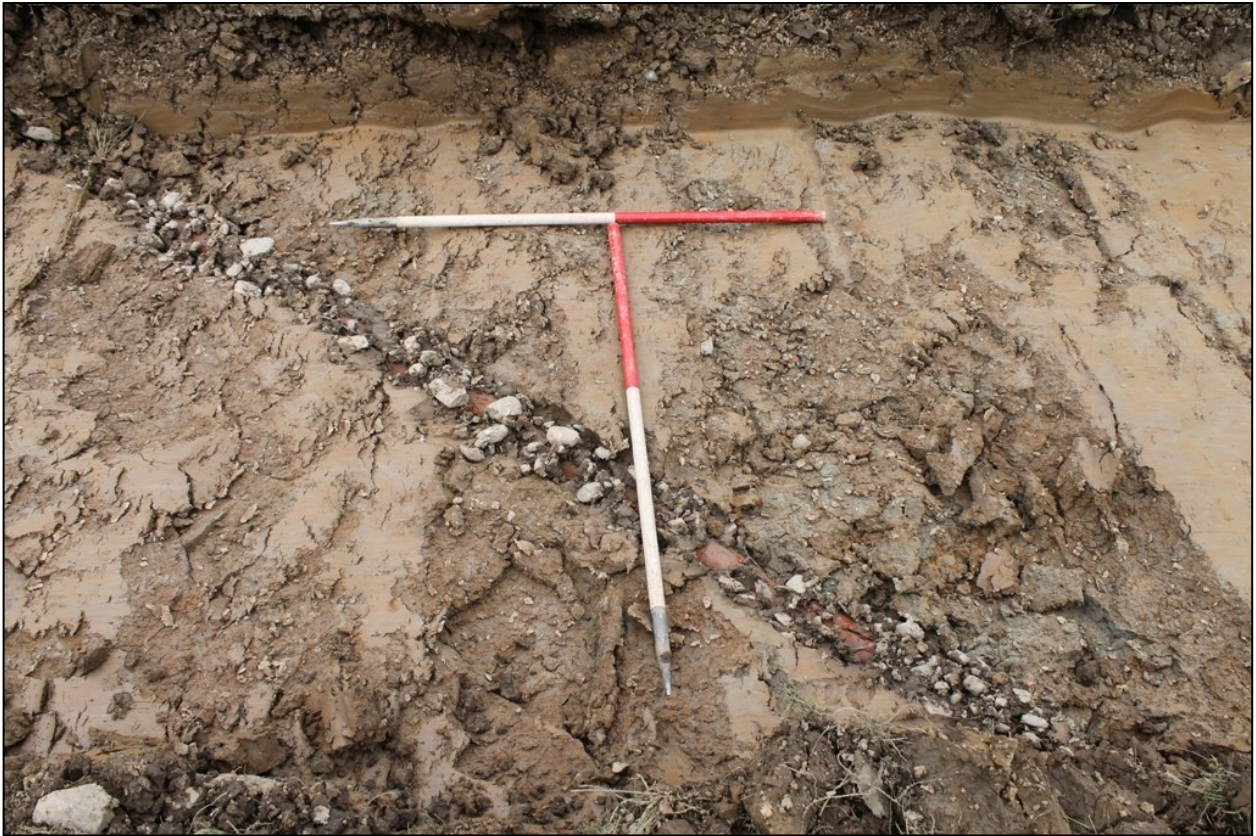
Figure 7a: Red ceramic field drain [003].

23. A number of red tile field drains [003] were also present measuring 100mm in diameter and surrounded by rounded stone packing (Figure 7a). These were present spread out across the entire site. Only one rubble drain [005], 150mm in diameter, was recorded during the works and what are suggested to be the 'scars' from where drains have been removed. Whether these 'scars' were previously rubble or ceramic field drains is unknown. The presence of both rubble and red tile drains indicates that the site has potentially seen more than one phase of attempts to improve the drainage of the ground.

29. The main type of archaeological feature present were field drains and which were uncovered in a number of the trenches in the form of red tile drains with packing stones covering them [003] and one rubble field drain [005]. The presence of two types of field drain suggests that there has possibly been more than one phase of attempting to improve the drainage of the ground and this may potentially be linked to the area as a mink farm. Indeed the predominantly clay nature of the subsoil alongside the presence of waterlogged areas still visible within some areas of the site.

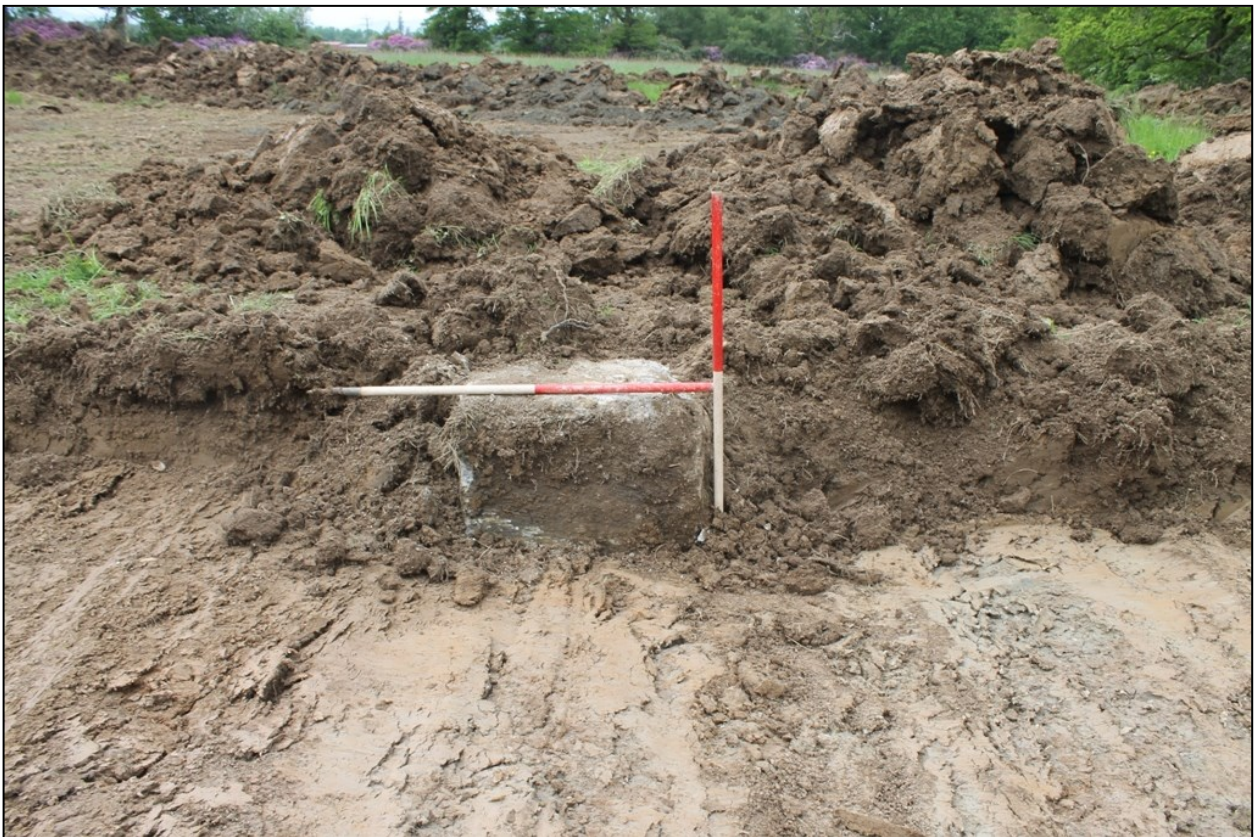
Figure 7b: Concrete base/plinth [006]

24. Only two other sets of archaeological features [006] and [007] were exposed and appeared to be modern in date. These were represented by two square concrete features [006] with exposed dimensions of 720mm by 540mm by 480mm (Figure 7b).

31. The concrete features [006] would seem to suggest their use as load bearing bases for above ground structures and have been left *in-situ* due to their size and situation well within the topsoil and cut into the subsoil.

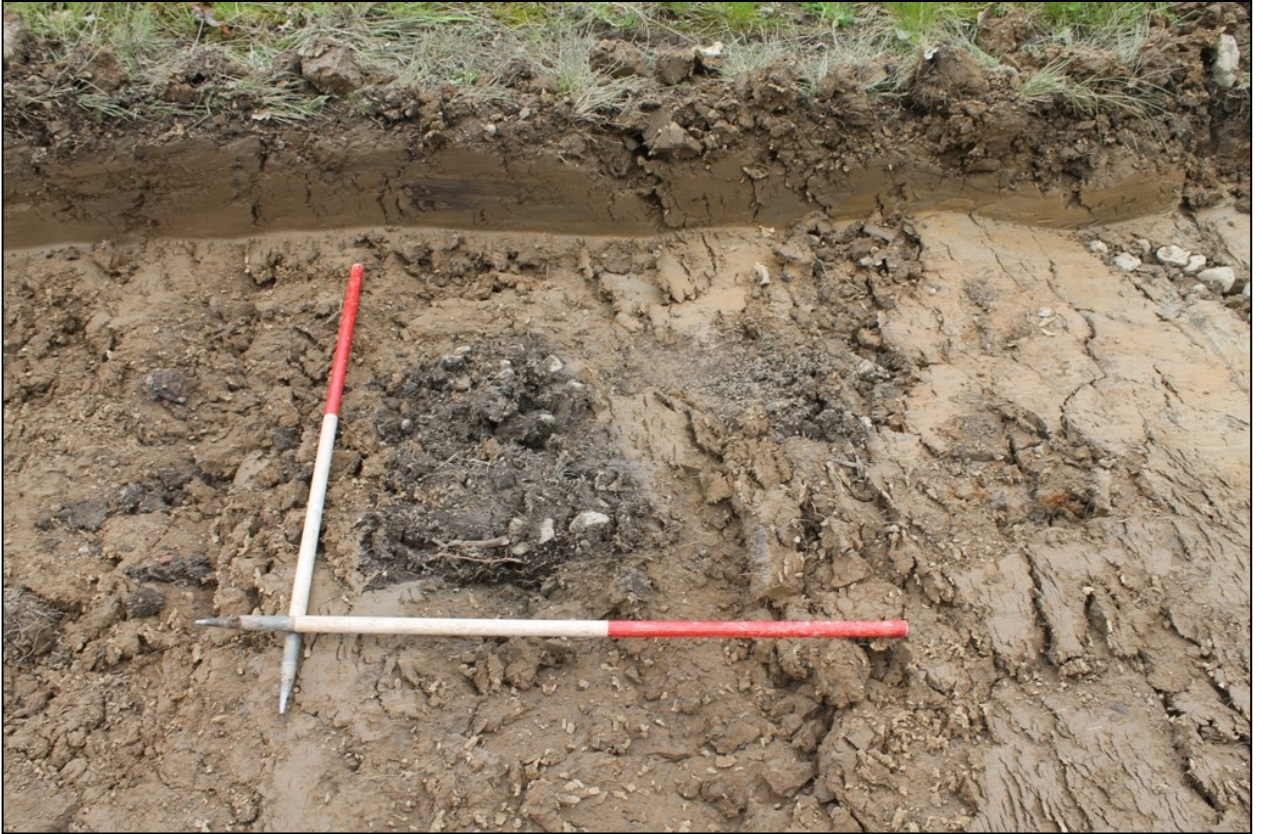
Figure 8a: Feature [007] with fill (001).

24. Features [007] were square in shape with dimensions of 500mm by 600mm with (001) forming the fill (Figure 8a). In trenches 1 and 2 features [007] form a discrete alignment suggesting that they possibly have been associated with each other (Figure 8b).
25. No other archaeological features were uncovered on site and the only artefacts observed, were fragments of modern material (glass, aggregate, brick, tile) within the topsoil (001).

32. The shape and size of features [007] along with the discrete alignment that they form in trenches 1 and 2 would further support their function as the foundation cuts for structural features. The fill would indicate that they have been removed and then the resulting hole filled in with (001).
