# Monitoring and Excavation of Test Pits

- In response to the need to redesign the foundations for the proposed development the SI works were extended to include excavation of several test pits in order to evaluate the sediments on site at greater depth. The location of these test pits was agreed with James Barr on behalf of Northern Marine Management with Rathmell Archaeology Ltd. The test pits were located on site by the engineer, Angus Souter. BACTEC bomb disposal were also present on site.

- 2. The Forth-Clyde Canal exists immediately to the south of the development area and is a scheduled monument protected under the Ancient Monuments and Archaeological Areas Act 1979. WoSAS identified the abandoned line of the canal as potentially of archaeological interest and requested an archaeological watching brief on all ground breaking work on site. The excavation of these test pits provides an additional opportunity to assess the archaeological potential of the development area and locate the remains of the abandoned line of the canal. The monitoring work was carried out on the 29<sup>th</sup> of November 2013 by Alan Matthews of Rathmell Archaeology Ltd.

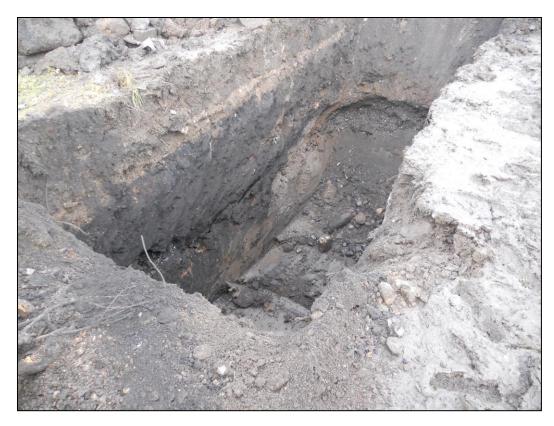
Figure 3: TP5 (extended) from the S

- 7. The extension of TP5 was intended to find the interface between the clay backfill and the natural sand subsoil. This wasn't possible due to the constraints of excavating such a large trench to a depth of more then 5m and the risk of flooding as we approached TP4. TP4 had flooded to a depth of about 0.5m at the base. In addition, a small amount of natural sand was recovered from the base of TP2. This suggested that the deposit of clay, which has been identified as backfilling the canal may only be roughly 1m deep.
