Auchmannoch House, Sorn: Archaeological Mitigation

Data Structure Report

issued 10th November 2014

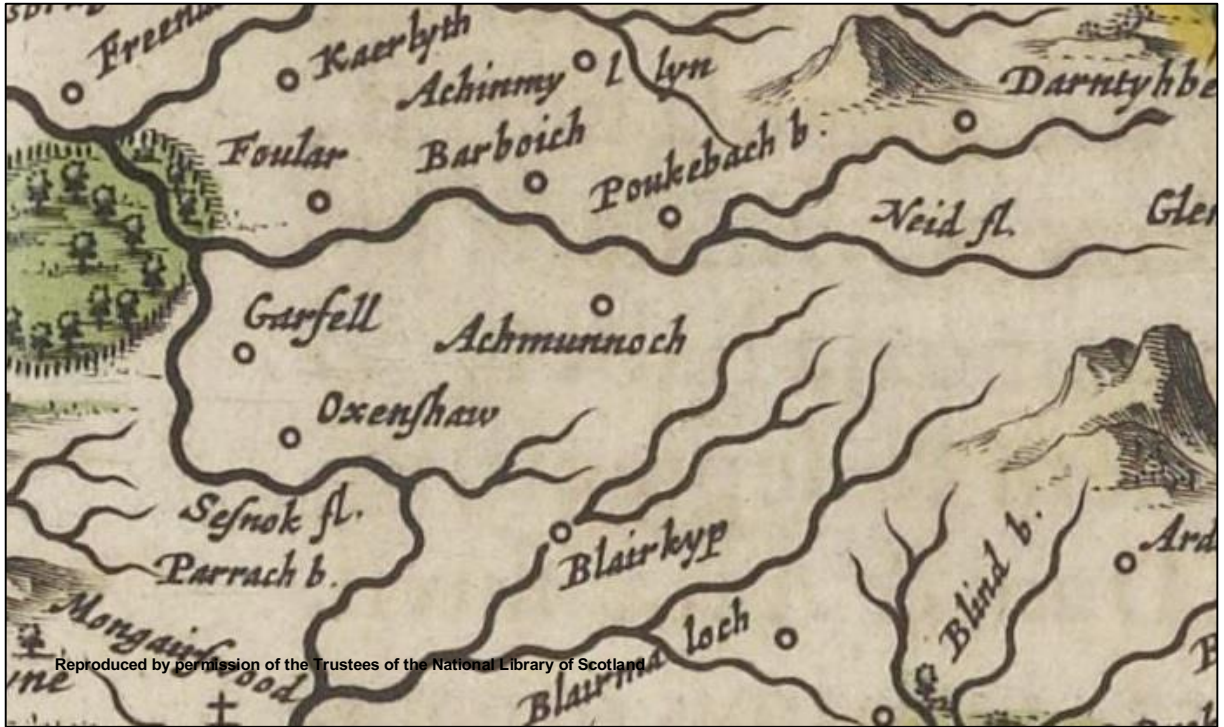
Figure 1a: Extract from Blaeu's Map of 1654

7. Blaeu's map of 1654 features the place name of 'Achmunnoch,' but there is no indication at this time that the site marks anything more than a farmsteading (Figure 1a). Blaeu typically shows fortified dwellings in a more grandiose manner: in this case, there is no indication of a tower-house, and no sign of a fence or pale which might indicate a deer park. From its depiction on the map we can surmise, then, that there was indeed a precursor to the extant Auchmannoch House, but that its origins were comparatively humble.

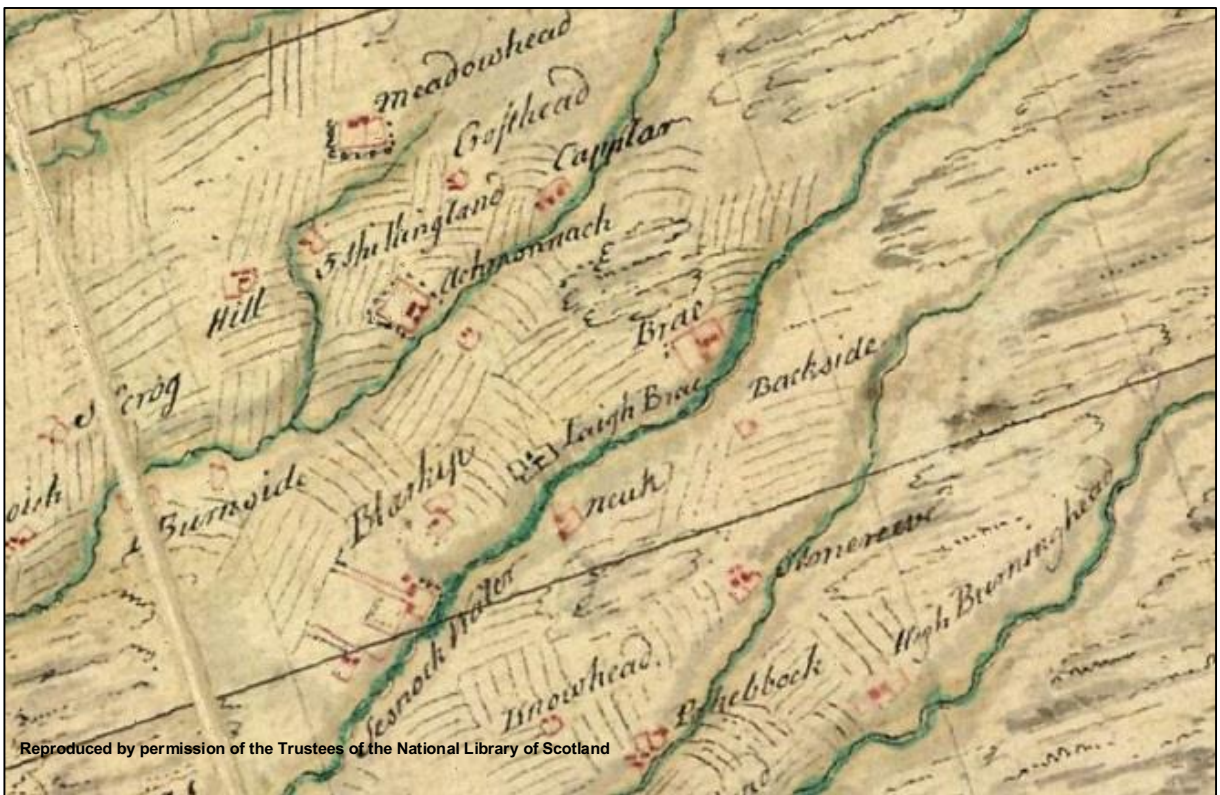
Figure 1b: Extract from Roy's Military Survey of 1752-55

8. By the mid-18th century, when Roy's Military Survey of Scotland, a transformation in the fortunes of Auchmannoch is evidenced, and indeed, this tallies well with the presence of the datestone marked '1724.' Roy's map shows a large building and what appear to be two flanking ancillary structures arranged around a central space, perhaps a courtyard (Figure 1b). The building itself is located within an enclosure, flanked on the northwest, southwest and northeast sides by trees, perhaps forming a shelter belt. Beyond the immediate vicinity of the house, the landscape is dominated by cultivated fields, with no evidence of a designed landscape or parkland present, the impression given being one of a prosperous farmsteading with no evidence of gentrification apparent at this time.

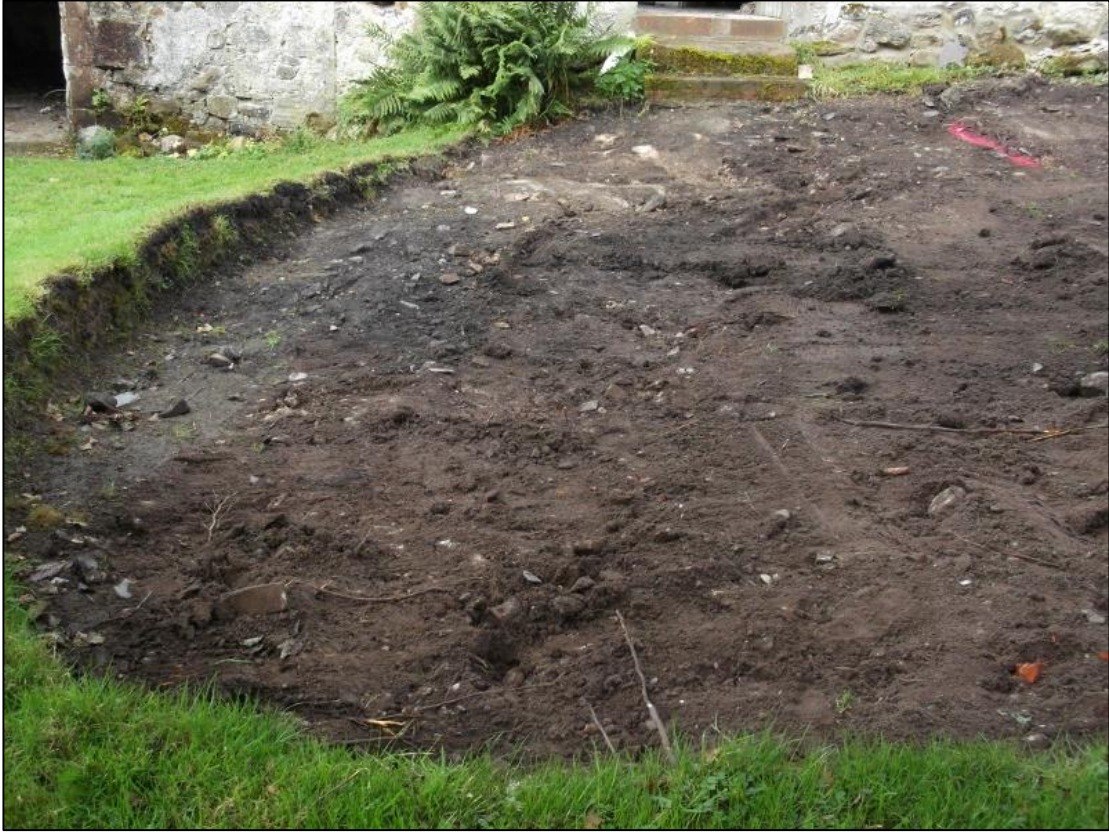
20. Across a small portion right at the southwest end of the access track, ground reduction ceased prior to the level of the subsoil being reached. The resulting surface (105) was modern in character, and comprised a black, ashy layer (Figure 4a) measuring roughly 10 x 5m in extent, which was rich in finds including broken slates, sherds of white glazed white earthenware and red tile field drain, and fragmentary bricks.

Figure 4a: Deposit of Made Ground (105) at W Side of Turning Circle

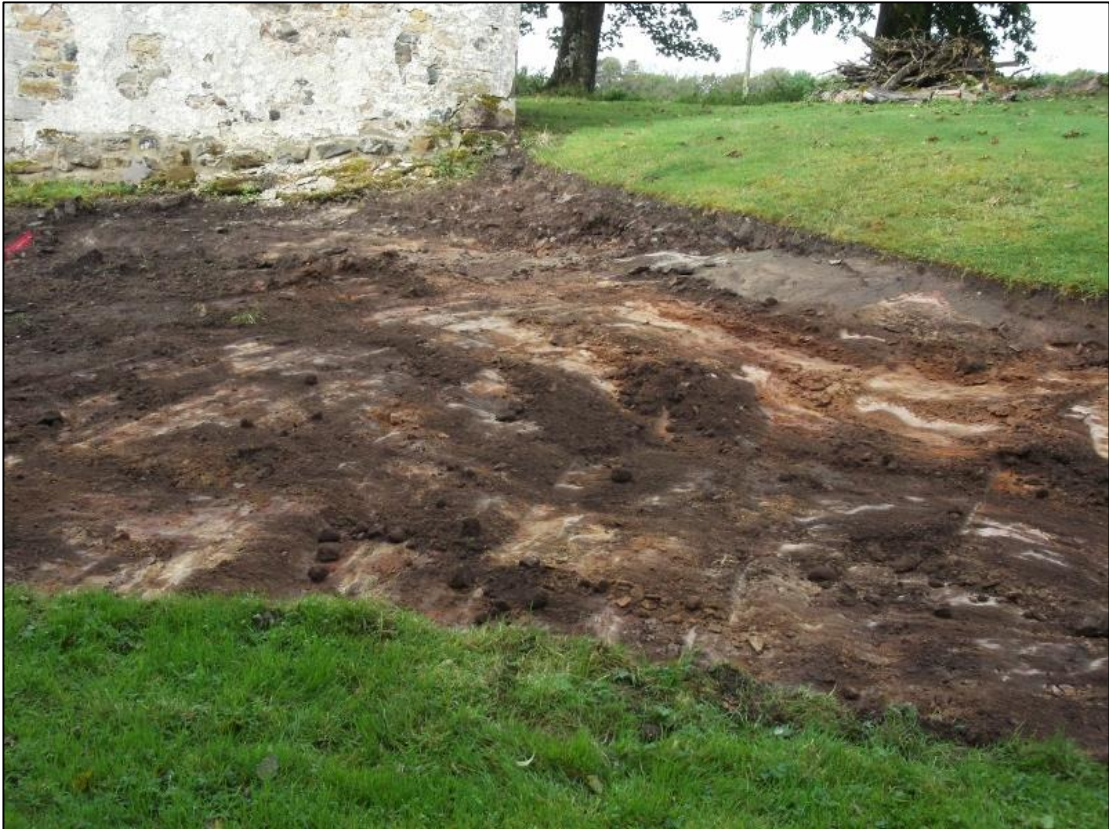
21. Further to the east, the level of the bedrock (102) began to rise, and over much of the eastern portion of the turning circle, excavation reduced the ground level down to the bedrock, which lay just below the modern ground level along the north edge of the excavated area (Figures 4b and 5b). Topsoil (101) directly overlay bedrock (102) in this area: here, the uneven surface of the bedrock resulted in a number of discoloured patches which resembled potential features. A number of these were investigated, but all were of shallow depth (up to 0.08m deep) with no formal edges and a fill which was clearly identical in character to the topsoil, with frequent finds of glazed white earthenware present.

Figure 4b: Remnants of Topsoil (101) adhere to Bedrock (102) at E side of Turning Circle

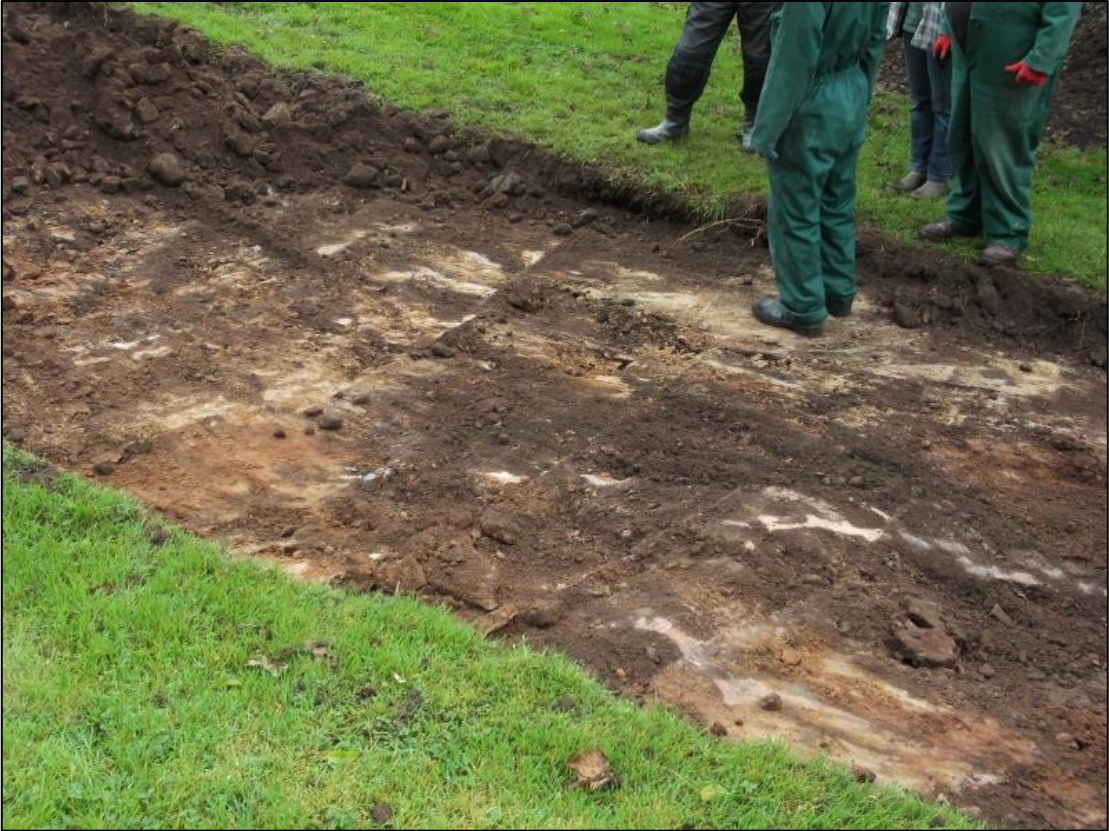
22. Where the turning circle narrowed to form the northeastern end of the access track, an intervening layer was identified, overlying bedrock (102) and underlying topsoil (101). This was a stony layer (103), which comprised a deposit of small stones (averaging 0.04 by 0.04m in size) within a dark brown sandy silt matrix (Figure 5a). The depth of this layer varied between 0.04m and 0.08m deep, depending on the depth of the underlying bedrock. At the northeast end of the access track, (103) underlay a black, ashy layer (104) which was identical to (105): exposed over an area measuring roughly 7 x 5m in extent, this deposit was not excavated to its full depth, but it revealed numerous finds of modern material, including bricks, slates, sherds of field drain and glazed white earthenware. Some larger pieces of mortared rubble were also identified in this area, and left *in situ*.

Figure 5a: Access Road, W End: Bedrock (102) with remains of Metalled Layer (103) overlying

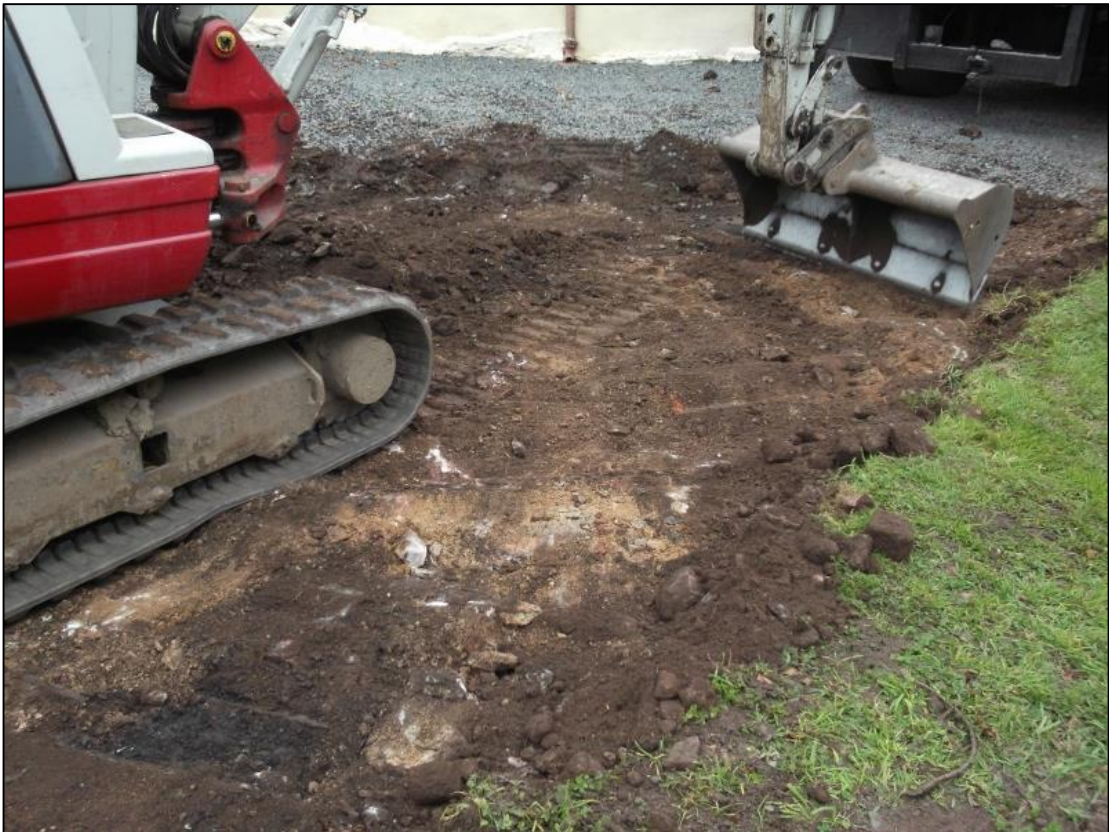
Figure 5b: Demolition layer (105) still *in situ* at end of ground reduction works

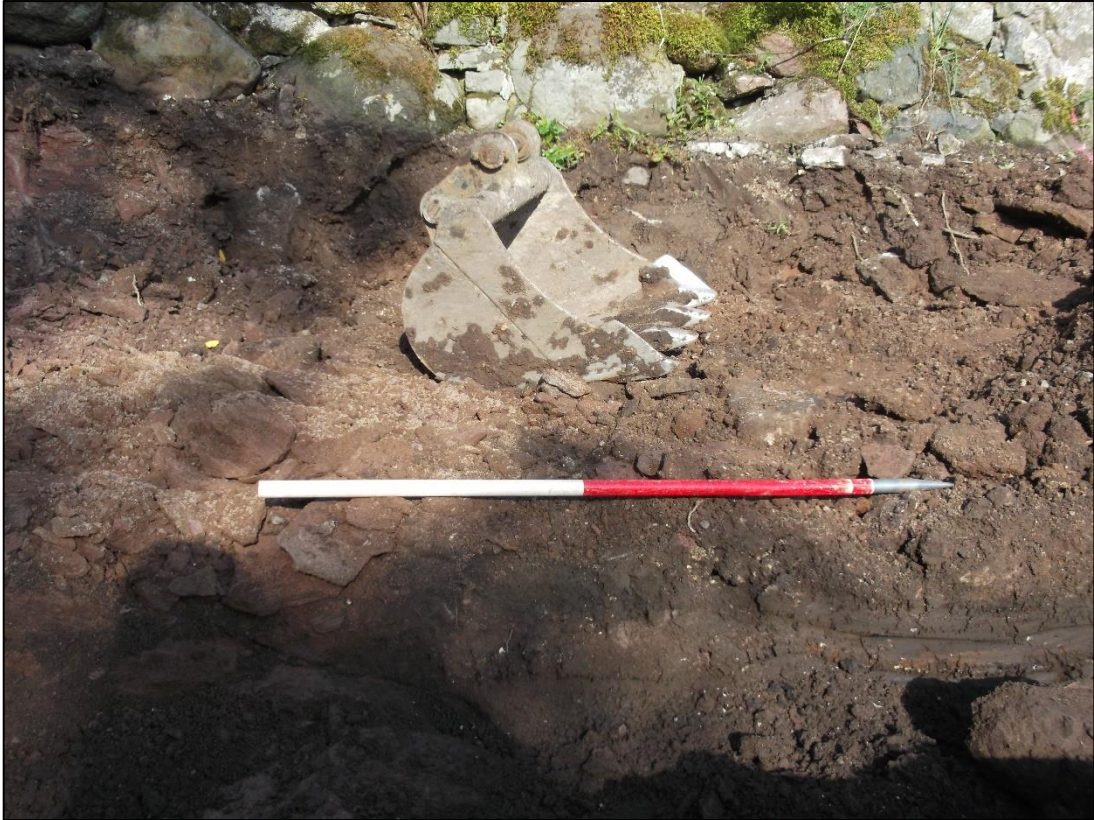
27. Two layers were identified between bedrock (202) and the uppermost horizon (201). The uppermost, (204), comprised a compact, greyish-black silty clay measuring 0.4m deep (Figure 6a) with frequent flecks of lime mortar, coal and charcoal, which unfortunately produced no ceramics which might assist in its dating. At its base was a layer of angular stones (205) surrounded in a similar coal/lime rich matrix. Both layers formed a feature that was linear on plan, extending across the entire 3m width of the trench from northwest to southeast and measuring a maximum width of 1.7m. Together, both layers formed the fill of a feature which was roughly u-shaped in section, and reached a maximum depth of 0.4m.

28. Deposits (204) and (205) were limited to the central portion of the excavated area, with the level of the bedrock rising again at the SE side of the trench. That (204) and (205) represented some kind of infill was evident, but it was the date and function of the 'feature' that they were infilling that remained open to question. No clear evidence of a cut in the bedrock, and it seemed likely, following the full reduction of the site to its excavated level, deposits (204) and (205) appeared more likely to be infilling a hollow or dip in the bedrock, rather than a cut feature such as a drain or earlier foundation trench.

Figure 6a: Deposit (204) Revealed in SW-Facing Section of SW Foundation Trench

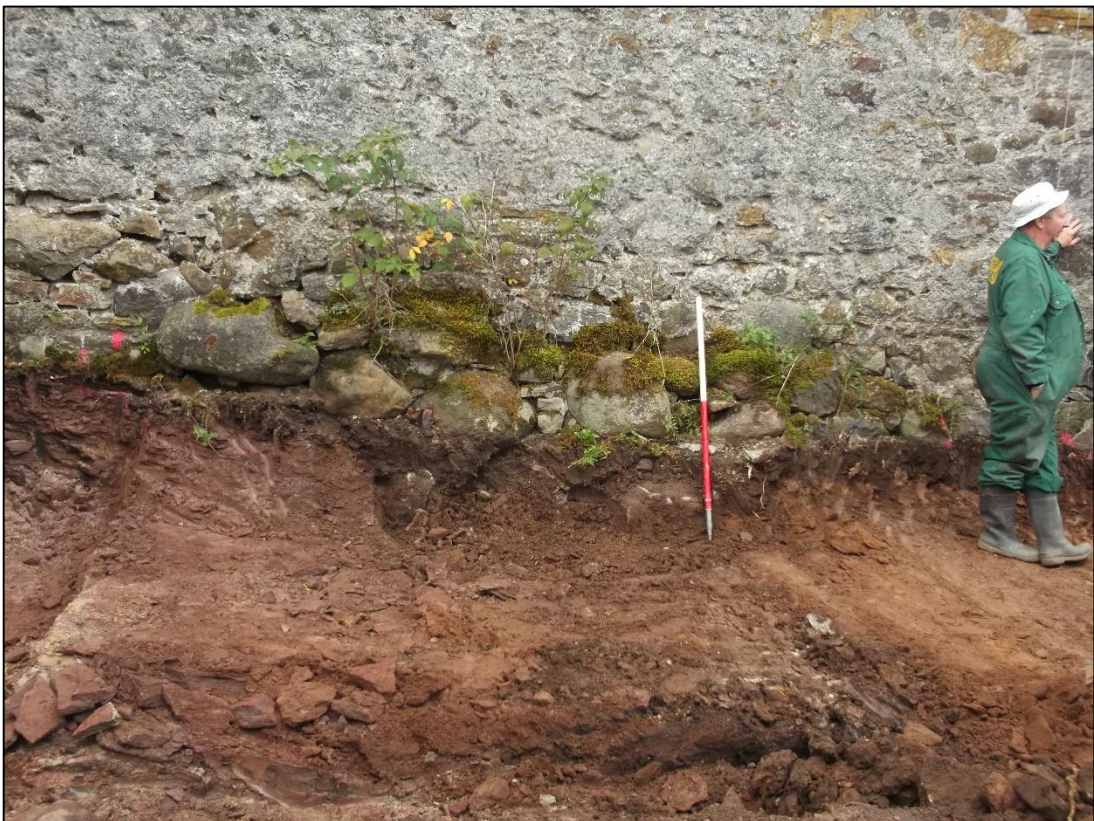
29. One final observation to note was the presence of a lime- and coal-rich grey-black layer, similar in character to that identified in the section of the foundation trench, underlying the foundations of the extant gable end wall of the barn building (Figure 6b).

35. It is layers (204) and (205) which showed the greatest evidence of having some antiquity, and which are also potentially of greatest interest. They pre-dated layer (201) (and therefore most probably (105)), and the presence of a similar deposit directly underlying the southwest gable wall of the extant west barn building means that their origins must predate the mid-19th century.

Figure 6b: Post-Excavation View of SW Gable Wall, revealing Bedrock (202) and Deposit (204) Underlying Base of Wall
