Kilhenzie Castle, Maybole, South Ayrshire: Archaeological Mitigation

Data Structure Report

by Claire Williamson
issued 25th August 2014
on behalf of Mr Briggs

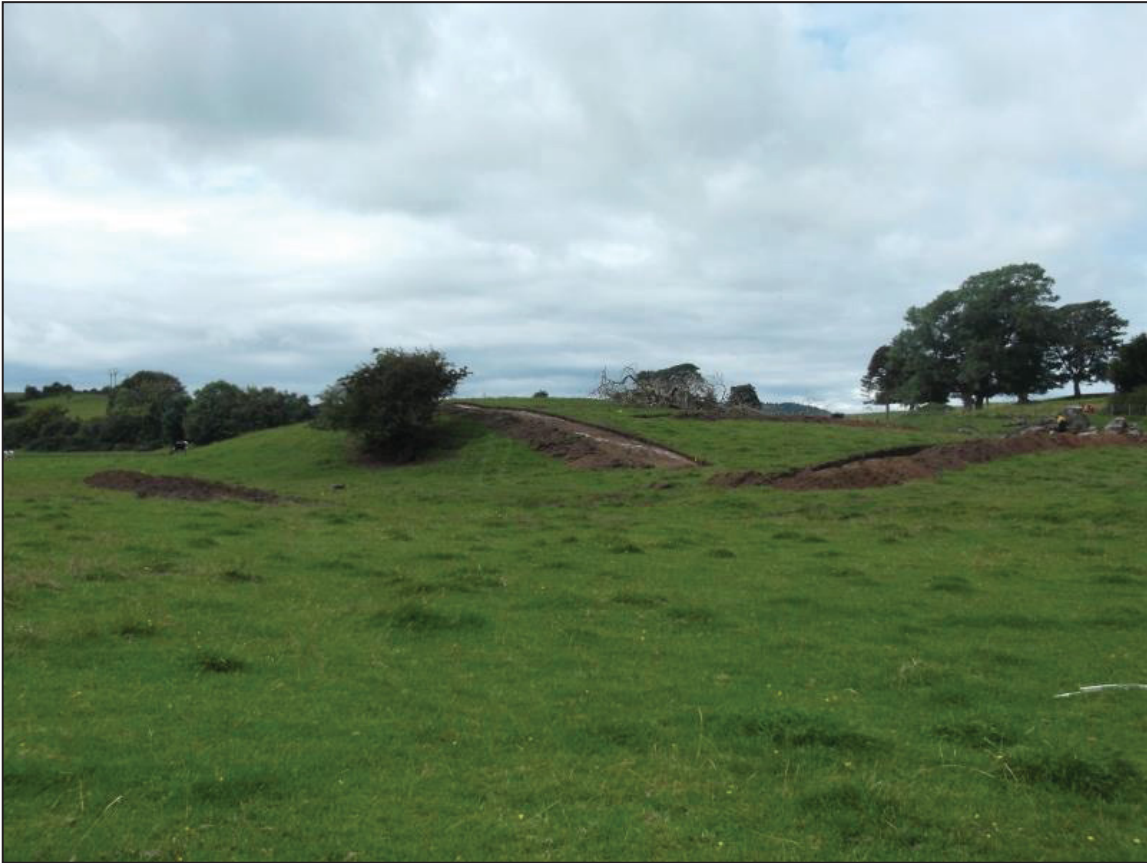
Figure 4a: General shot of site from the southeast

16. The proposed development area was located within open agricultural land currently used for grazing. The western side rose to form a mound with a steep slope along its southern side (Figure 4a). At its southern end, south of this slope, a section of heavily waterlogged ground crossed the area WSW-ENE, perhaps the result of a broken field drain.

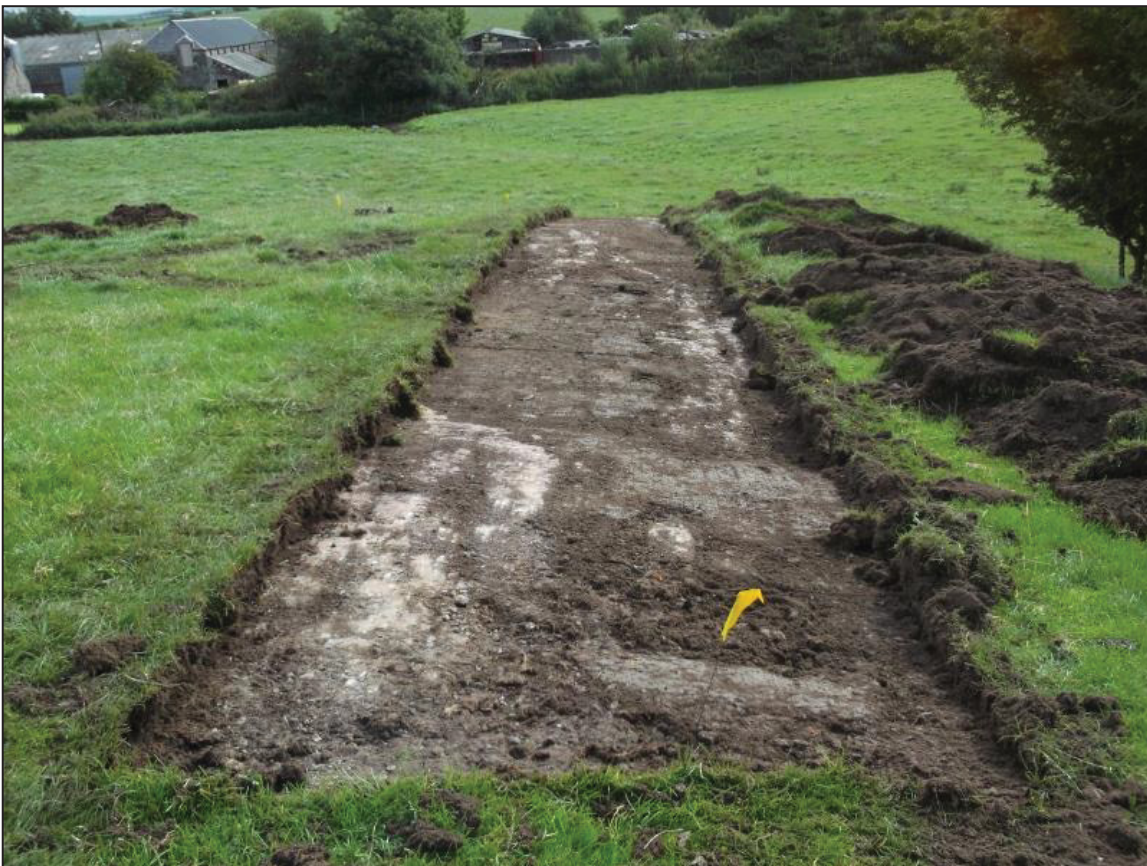
Figure 4b: Trench 4 from the east showing bedrock (003)

22. At the centre of the site across the top of the mounded area (as shown within Trenches 2, 3 and 4), the natural subsoil consisted predominantly of a very compact pale white/brown bedrock (003) which sat just below the topsoil (Figure 4b). Where bedrock was not exposed in these trenches, Trench 2 revealed a moderately compact mid orange brown gravel in a silty clay matrix (004) to be the natural subsoil in its northwestern half, while Trench 4 revealed a small area of quite compact mid orange brown silty clay with occasional small stone inclusions (002) at its eastern end.

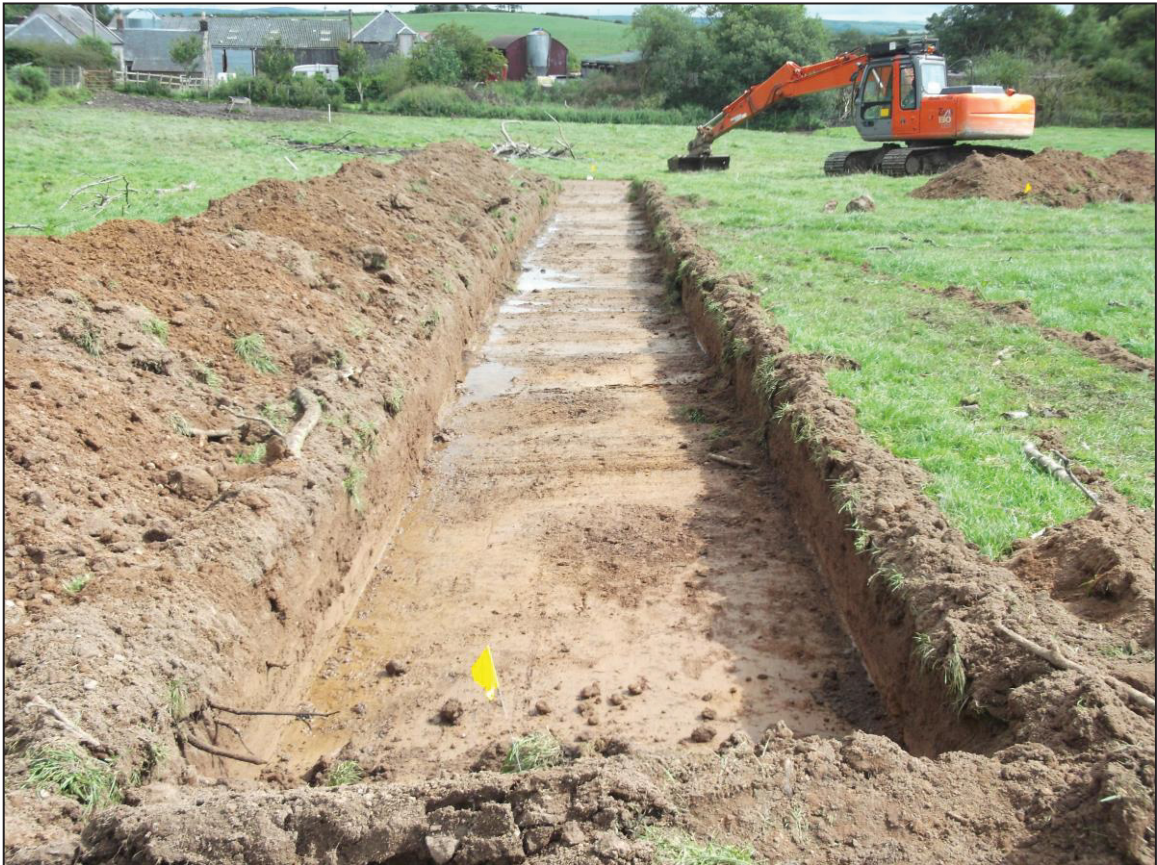
Figure 5a: Trench 1 from the west showing clay subsoil (005)

23. Trenches 1 and 5, which ran along the northern and southern ends of the area respectively, and did not cross the top of the mounded area, revealed the natural subsoil to be a compact pale grey (with some orange patches) silty clay with occasional small and medium sized stone inclusions (005) (Figure 5a). As already mentioned the southern end of the site was heavily waterlogged and, indeed, the presence of a clay subsoil in this area would not allow for much natural drainage of this ground.

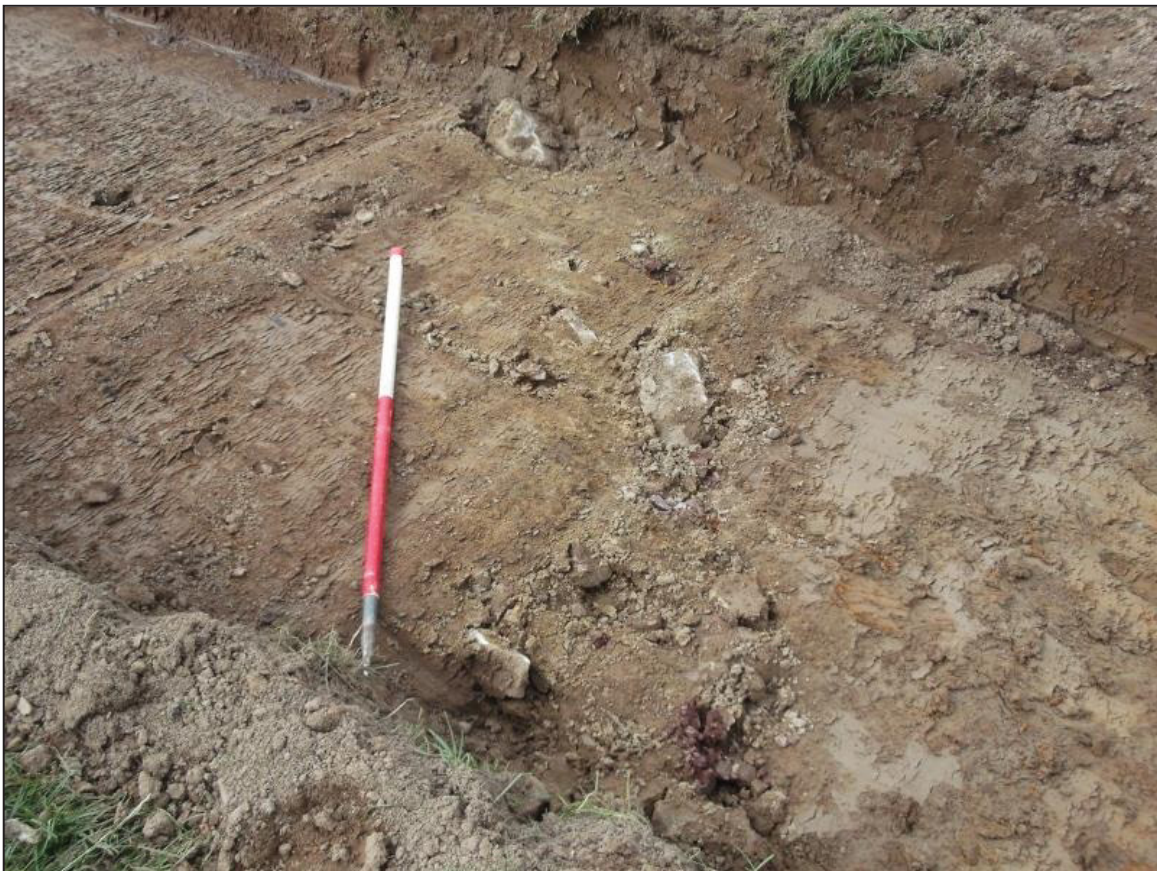
Figure 5b: Rubble drain (006) in Trench 1 from the southeast

24. It is also within this clay subsoil (005), that two field drains were uncovered. (006) consisted of a rubble drain orientated NW-SE near to the eastern end of Trench 1 (Figure 5b). It consisted of angular and sub-angular sandstones measuring an average size of 100mm by 140mm by 100mm and sat within a linear cut measuring 0.4m wide. (007) was a red tile drain orientated SW-NE and located roughly in the centre of Trench 5. The drain measured approximately 0.1m in diameter and sat approximately 400mm below the upper surface of the natural subsoil, within a linear cut measuring 0.35 to 0.4m wide.
