**Whitecrook Quarry, Glenluce:  
Archaeological Evaluation**

Data Structure Report

by Alan Matthews and Amanda Gow

issued 30<sup>th</sup> March 2006

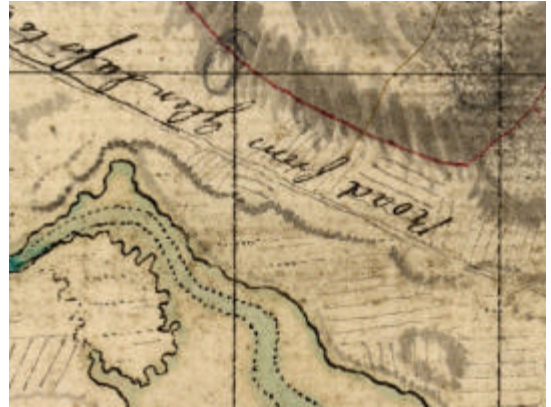
Figure 1b: Roy 1747-55

- 3.2.6 None of the mapping consulted appears to illustrate the enclosure (NMRS NX15NE75) to the south of the application area. The cultivation remains noted (NMRS NX15NE76) may relate to the unenclosed arable fields depicted on the Roy map (Figure 1b).

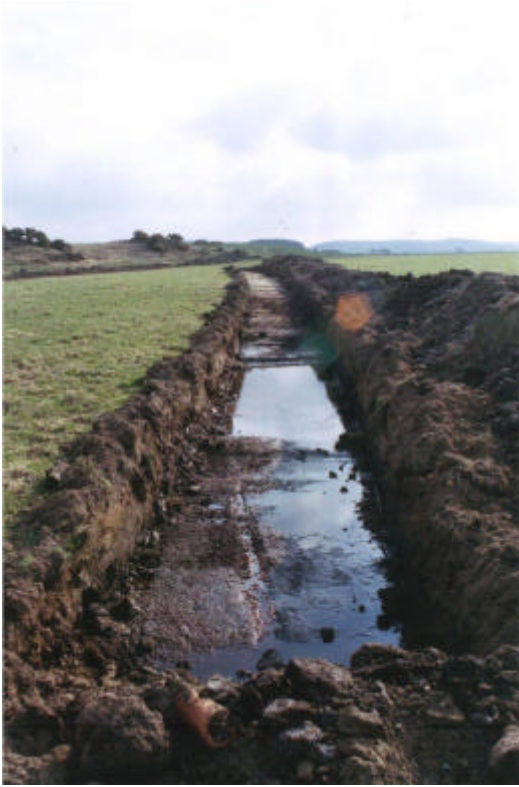
Figure 3a: Trench 10

- 4.2 *The lower ground*
- 4.2.1 Only three of the trenches (4, 8 and 10) contained field drains. These trenches were located at the base of a slope in a waterlogged area which therefore required additional drainage. However, the majority of the drains were located in the trenches in the lower western area (4 and 10), which was more waterlogged than the lower eastern area. All the other trenches were located on higher ground at the top of the slope and therefore had adequate natural drainage. The drains were principally red ceramic drains, although there were very occasional rubble and plastic drains.

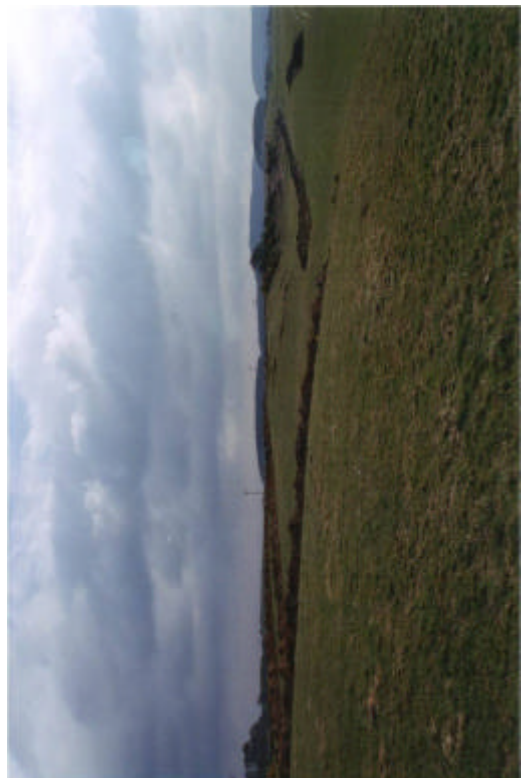
Figure 3d: Western raised and lower Ground, with break of slope

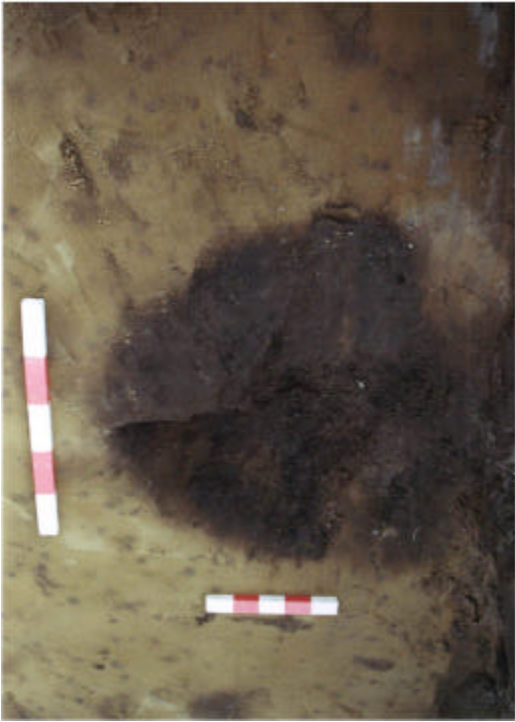
Figure 4a: Feature [016]

- 4.3.2 The putative pits [012], [013] and [015] to [018] were roughly circular in shape, except pit [005] which was of a sub-rectangular shape in plan and measured 900mm by 900mm. This pit may also represent a possible large posthole sunk within larger sub-rectangular feature, as suggested by the slightly paler fill noted in the larger feature. The circular pits varied between 260mm and 520mm diameter. All the pits were filled with [001] comparable material which often included small flecks of wood charcoal and occasionally contained small flecks of what appears to be shale.

- 6.4 Consequently it is our recommendation that the appropriate mitigation for the pit and posthole complex is monitoring of all the ground breaking works above the top break of slope in the western field (predominantly Phases 1 to 2) outwith the nineteenth century sandpit. This monitoring would comprise:

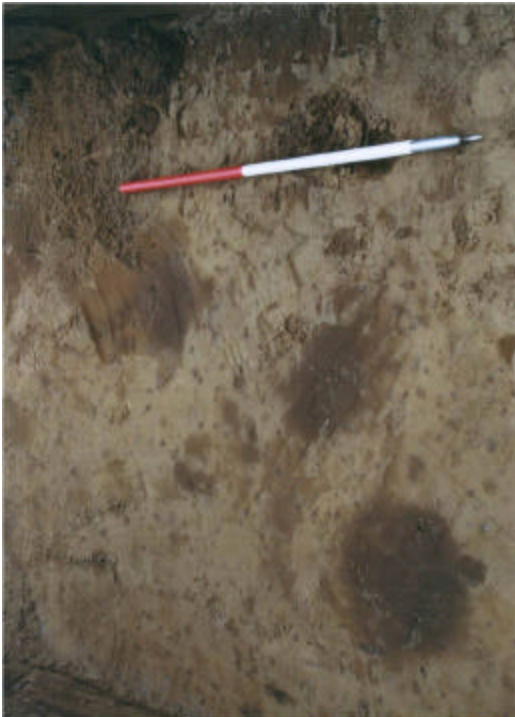
Figure 4c: Features [008], [009], [010]

- 5.1.3 Six truncated posthole features [006] to [011] were also identified. The close proximity of these features to the pits may suggest an associated period of use. The rough arc-shaped arrangement of the visible postholes suggests that these possibly formed part of small structure or enclosure.
