# **Ballochmyle Inn, Mauchline: Archaeological Watching Brief**

Data Structure Report

issued 7th November 2014

on behalf of Armour Veterinary Practice

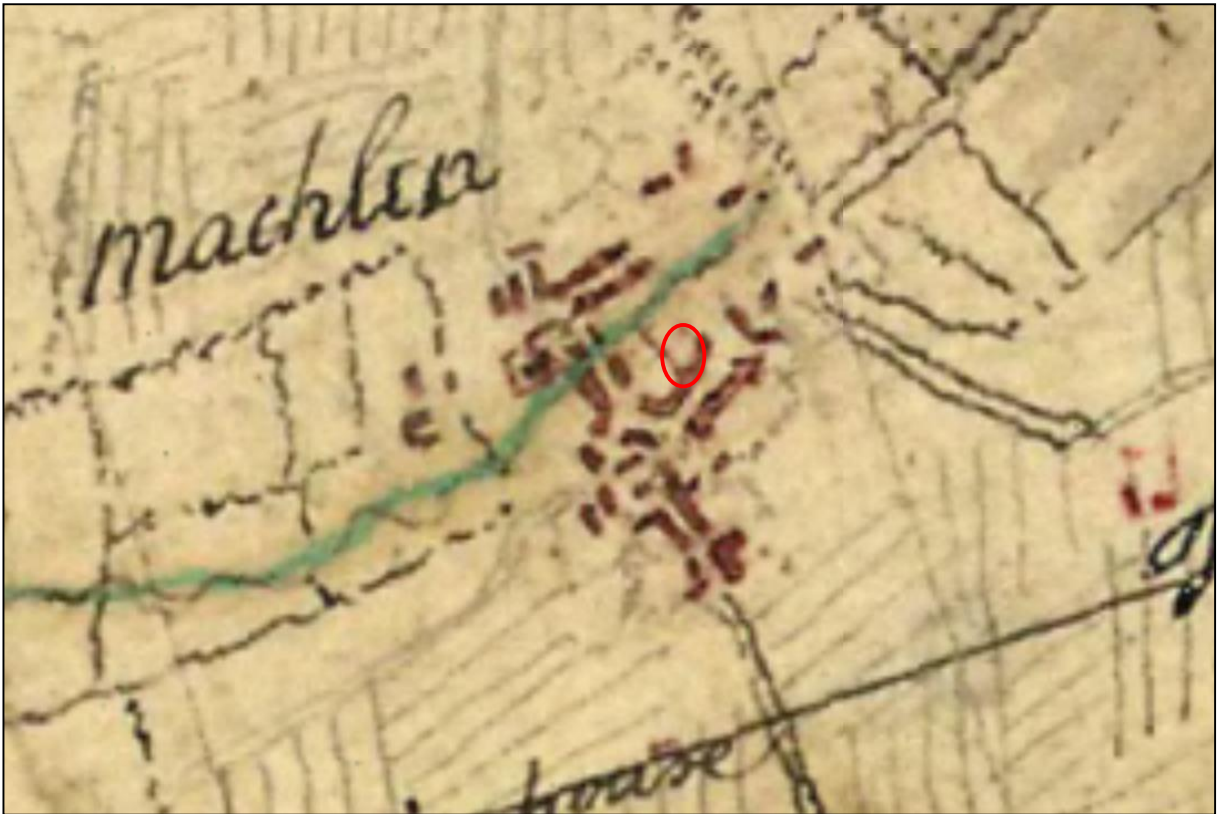
Figure 1a: Roy's Military Survey (Lowlands 1752-55)

7. The best illustration of this is from Roy's Military Survey of Scotland 1752-55 (see Figure 1a) showing Machlin (sic) aligned on a single north-south street with a number of lesser thoroughfares converging on the centre, near the present church (WoSASPIN 7263). The most built-up of these roads leads eastwards on or close to the line of the modern High Street. The greater part of the settlement is shown to lie south of the Mauchline Burn, but a second well built-up street lies on the north side of the burn on or near the alignment of the modern Burnside.

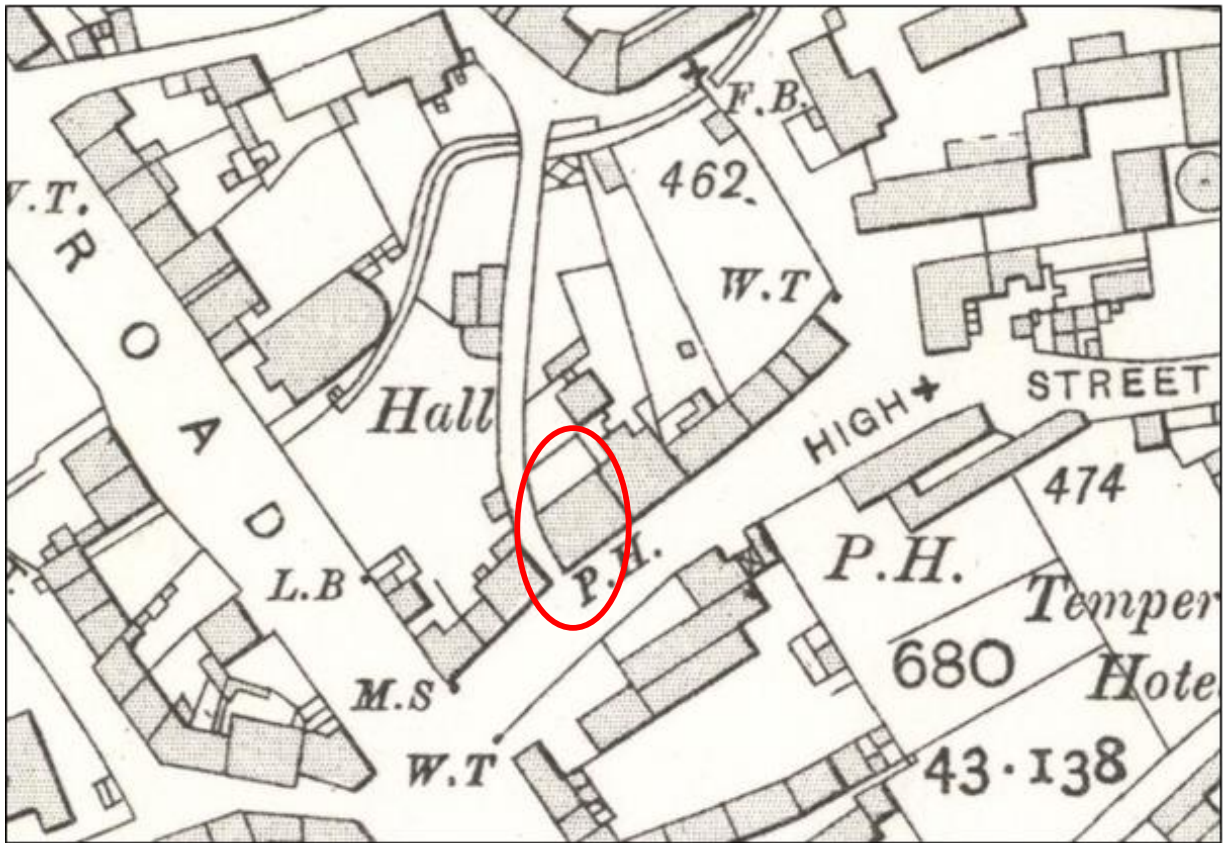
Figure 2a: 3rd edition Ordnance Survey (1909)

10. The outbuildings remain in the 3<sup>rd</sup> edition of 1909 (see Figure 2a), with what appears to be an unroofed yard abutting the rear of the main building. This is the first point that No 5 High Street is identified as a Public House, remaining in use as such until very recent times (known in recent years as the 'Ballochmyle Inn').

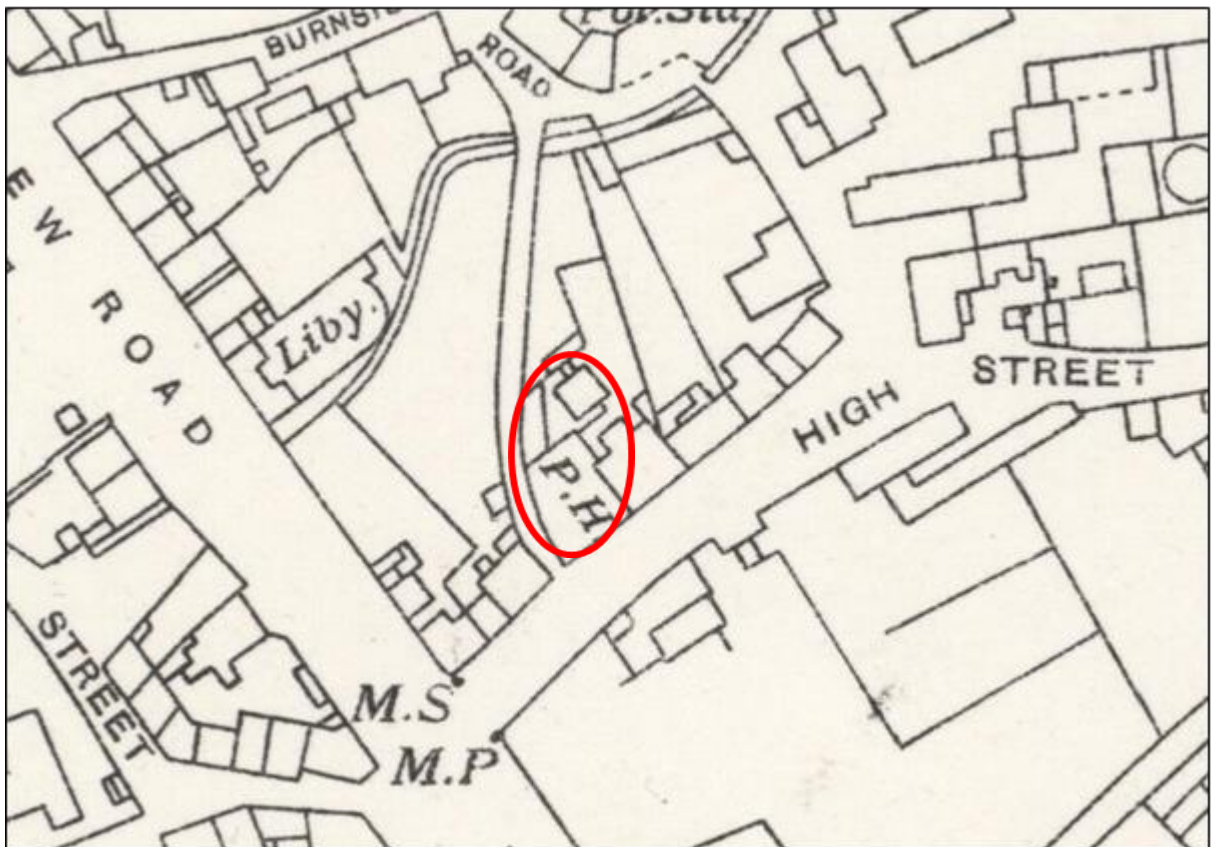
Figure 2b: 4th edition Ordnance Survey (1945)

11. By 1945, the 4<sup>th</sup> edition Ordnance Survey map shows the Public House to have been extended to the rear (see Figure 2b) through the addition of a rectangular structure flanking the vennel along its western edge. The extant Ballochmyle Inn has the superficial appearance of a modified single storey cottage, the extensive sequential changes to this property between the mid-19<sup>th</sup> and mid-20<sup>th</sup> century showing a much more complex history of demolition, reconstruction and remodelling.

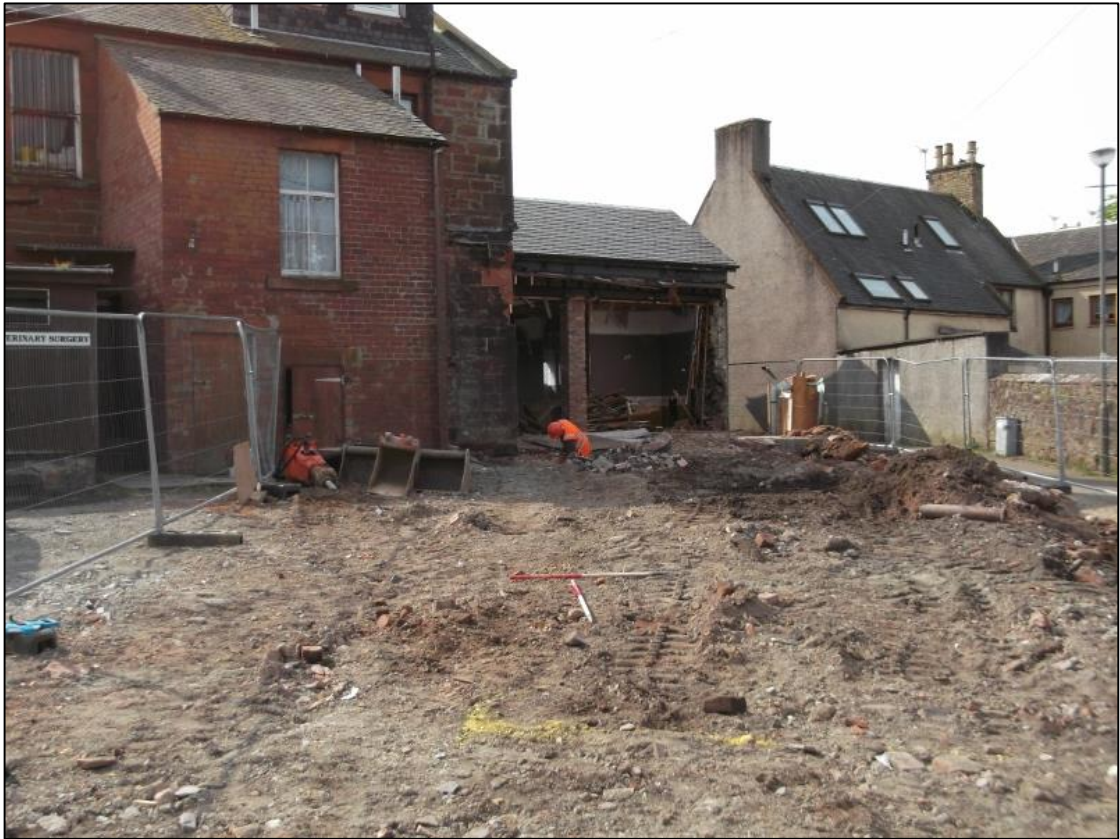
Figure 4: View of the development before excavation from the SW.

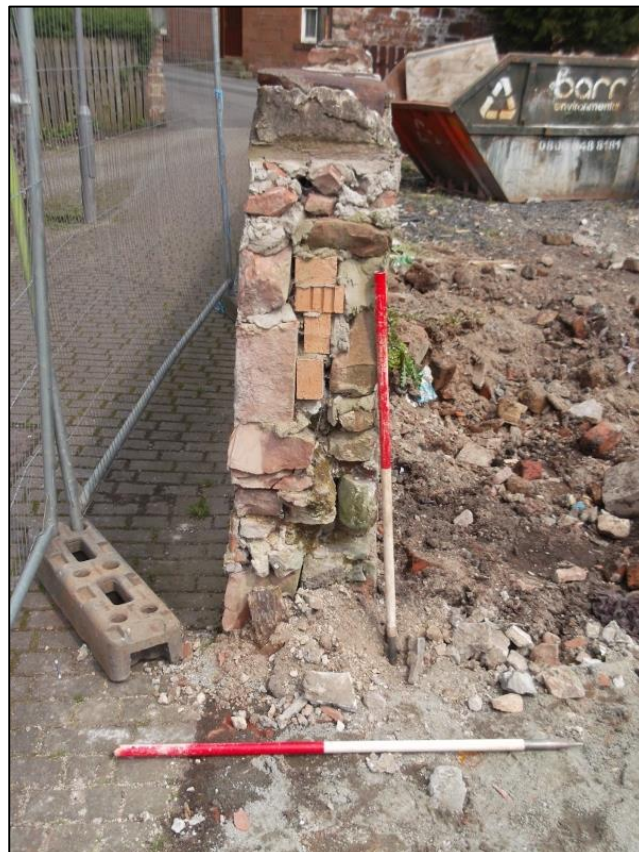
Figure 5: View of the remains of the enclosing 19<sup>th</sup> boundary wall from the SSW.

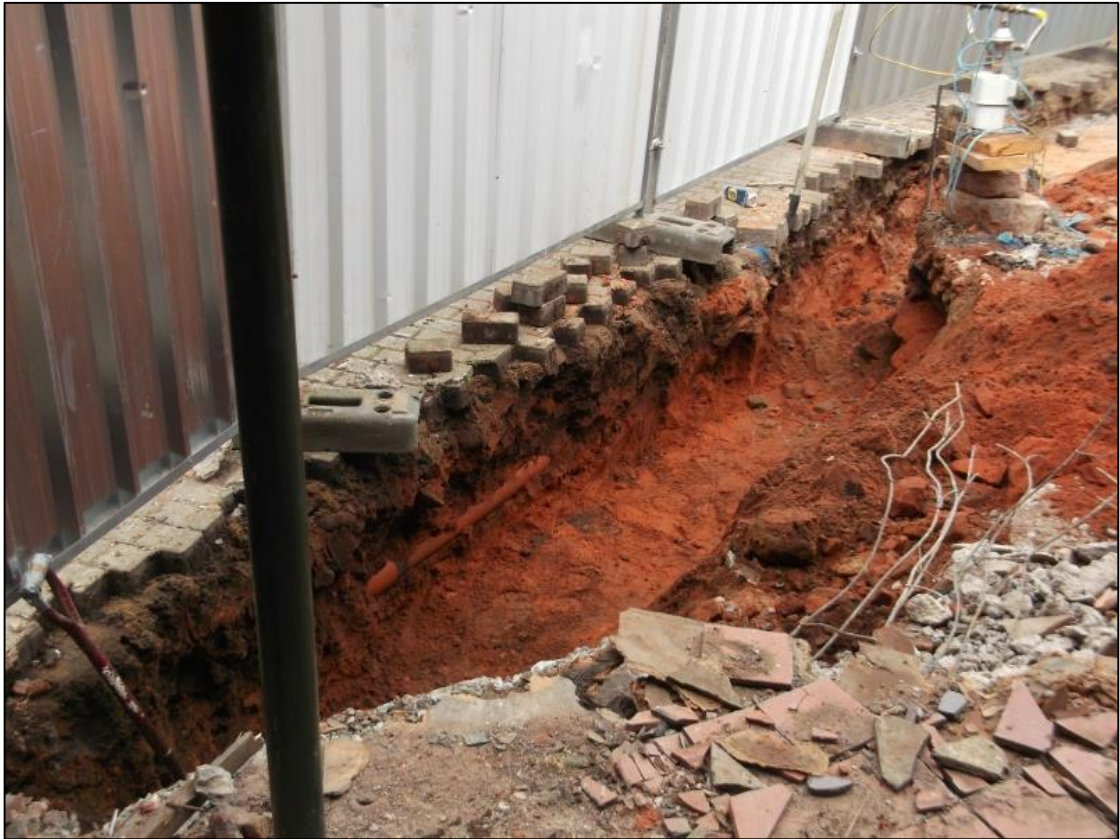
16. Excavations centred on the extension which ran back from the northern elevation of the retained inn building. The foundations defining the external wall of its western elevation ran north for approximately 16m from from the retained inn building before changing orientation to run northeast for a further 10m. The extension measured approximately 6m in width: the external wall of its eastern elevation ran north for a distance of approximately 14m before changing orientation and running back a further 10m to the northeast. The outer foundations varied in width between 0.75m and 1m and had a depth ranging between 0.9m and 1.3m.

Figure 6: View of the western part of the outer foundation trench from the SSE.

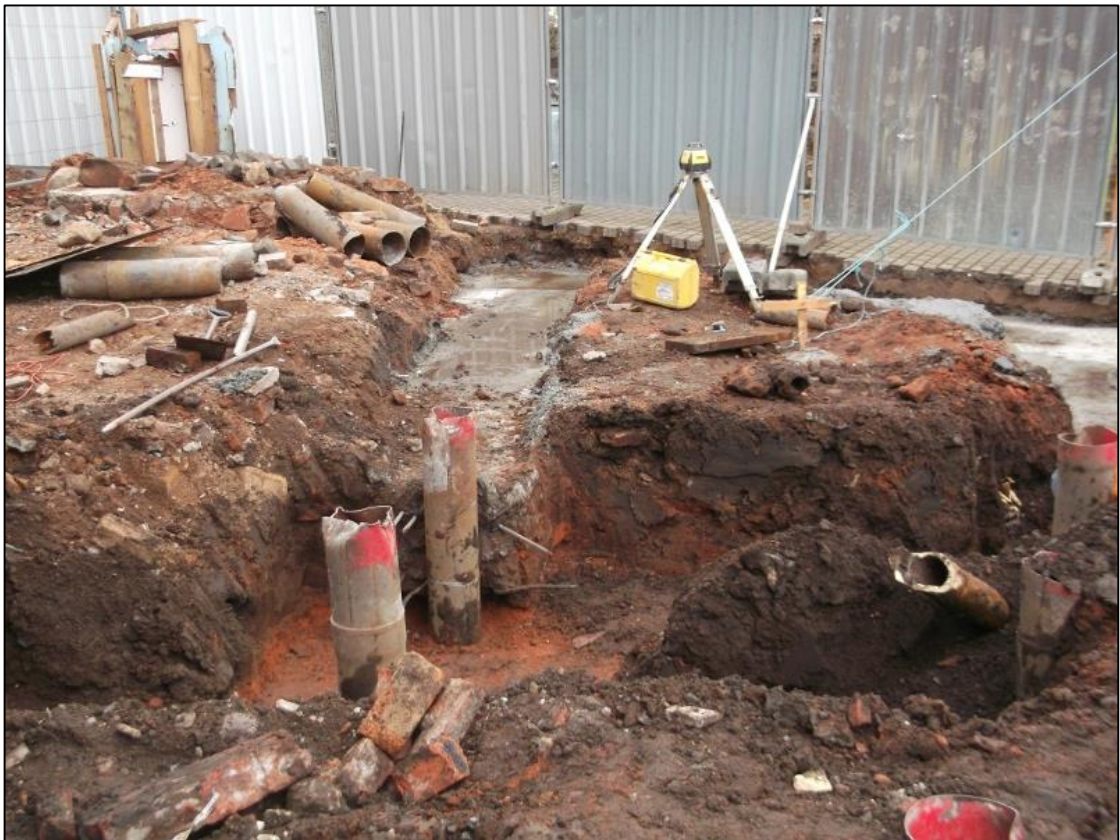
17. In addition to the external walls, there were a series of four foundations for internal walls dug within the northern (NE-SW-aligned) part of the extension. Three of these were orientated in a northwest-southeast direction, while the fourth was aligned northeast-southwest. In the southern (N-S aligned) part of the extension, a further three internal foundations were present: two aligned north-south and the third east west orientated. The internal foundations ranged in width between 0.59m-0.75m and in depth between 0.89m-1.32m.

Figure 7: View of the internal foundation in the northern part of the development area from the E.
