**Thirstone Quarry Extension Phase 3a, South
Lanarkshire:
Archaeological Evaluation**

Data Structure Report

issued 20th November 2014

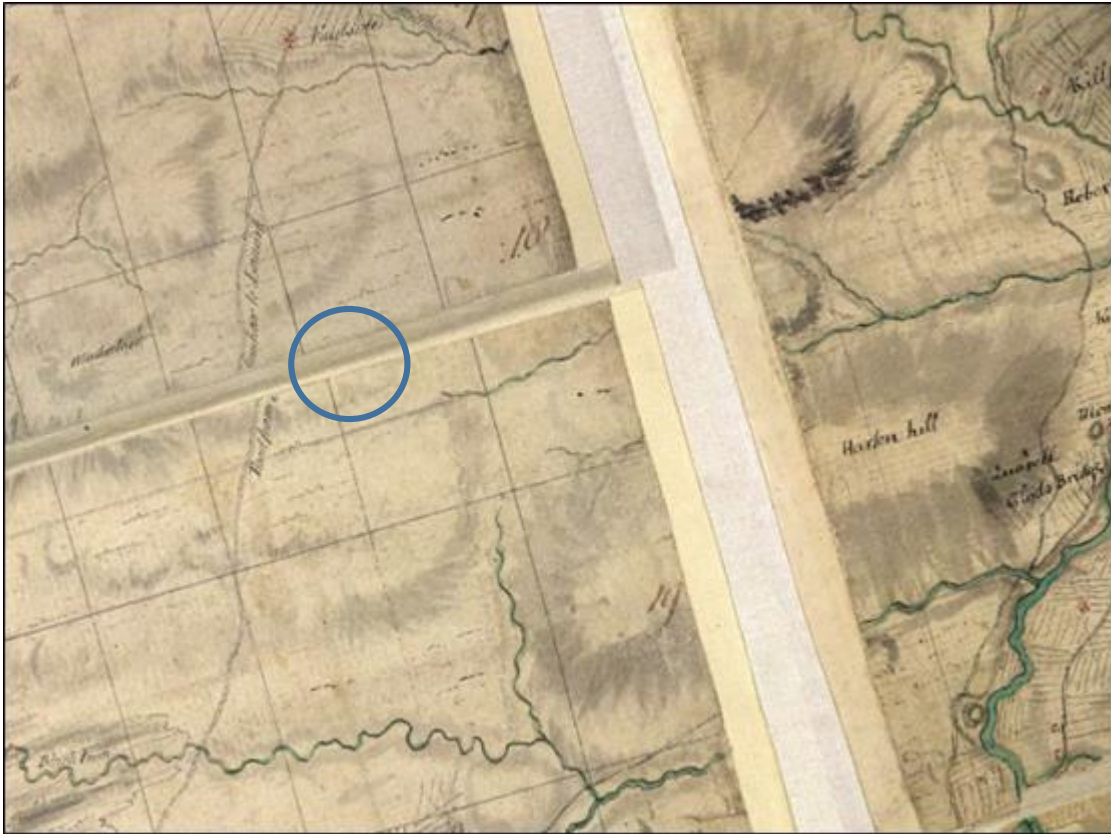
Figure 1a: Roy's Military Survey 1747-55

7. A review of historic mapping also failed to locate any additional sites of archaeological interest. When mapped in the mid-18th century as part of Roy's Military Survey of Scotland (1747-55) the proposed extraction area is marked as unused hill ground (see Figure 1a) lying to the east of the Sanquhar to Lanark road as it runs north from Crawfordjohn.

13. The topography across the development area was characterised by a north-south orientated ridge occupying the western portion of the site and a low hill occupying the east. Both features were very steeply sloping in places (Figure 1a). A small farm road (010) crossed the southern extent of the site, cutting through the north-south ridge and hugging the contours of the hill on its south side. Another smaller farm track (009) crossed Trenches 4, 10, 11-14 and 17 in a northwest-southeast direction, eventually joining the farm road.

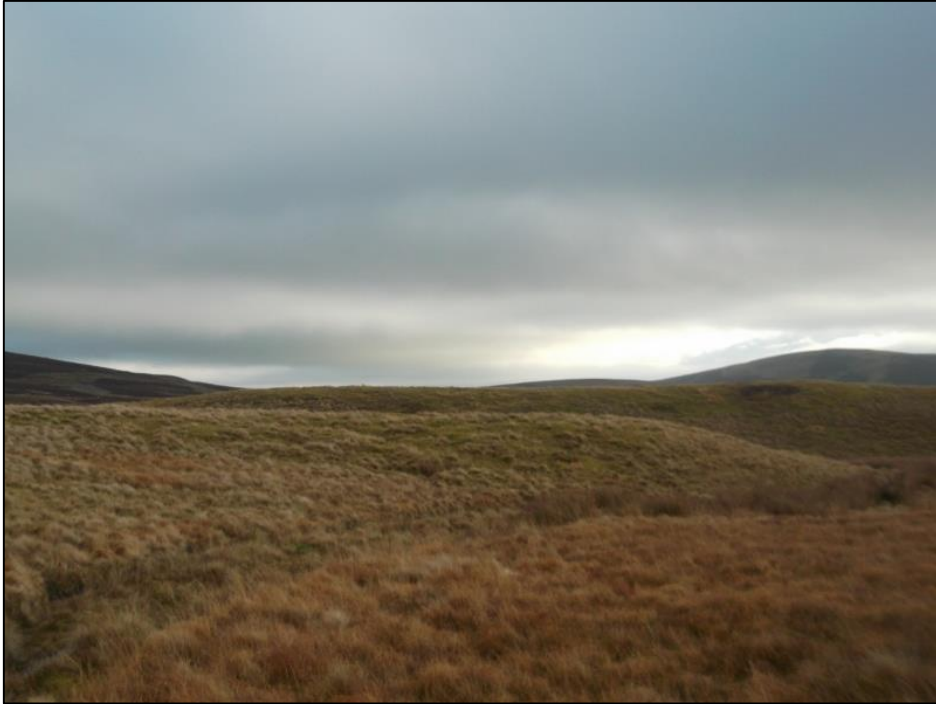
Figure 3a: View of the site before excavation. From the SW.

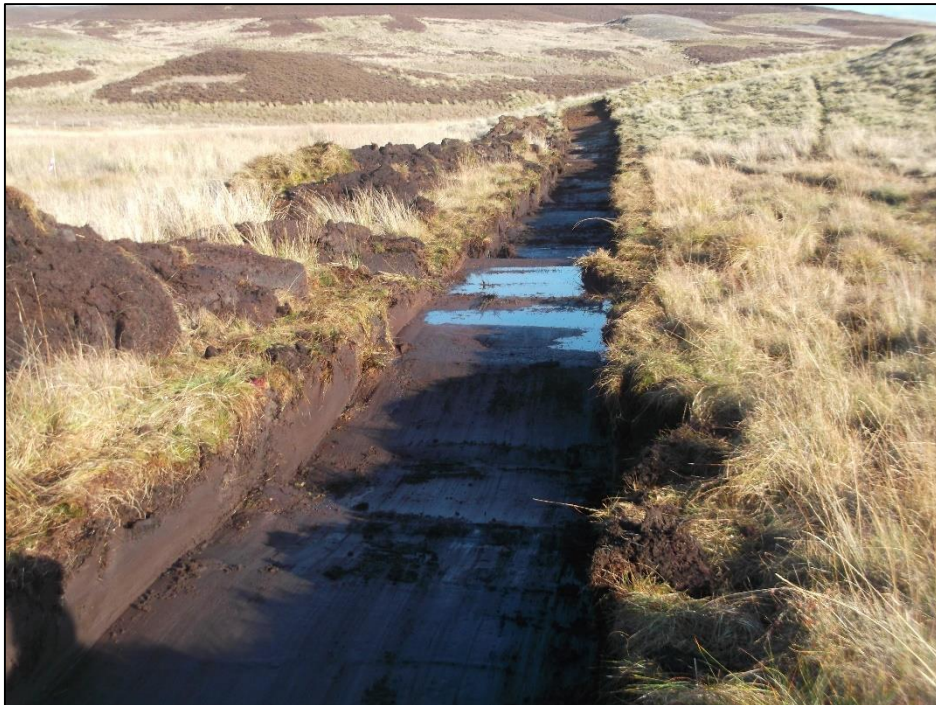
Figure 3b: Post excavation view of Trench 4 from the W.

4	ENE-WSW	2m by 39.39m 78.78m ²	0.21 – 0.68m	Subsoil (002) consisted of moderately compacted light brown/yellow silty clay with moderate inclusions of small to medium sub-rounded stones. Natural clay layer (005) consisted of moderate to firmly compacted light to mid grey clay with occasional patches of sand within its make-up. There were several small fragments and one large piece of naturally occurring wood found	Modern NW-SE running farm track (009).	None	None

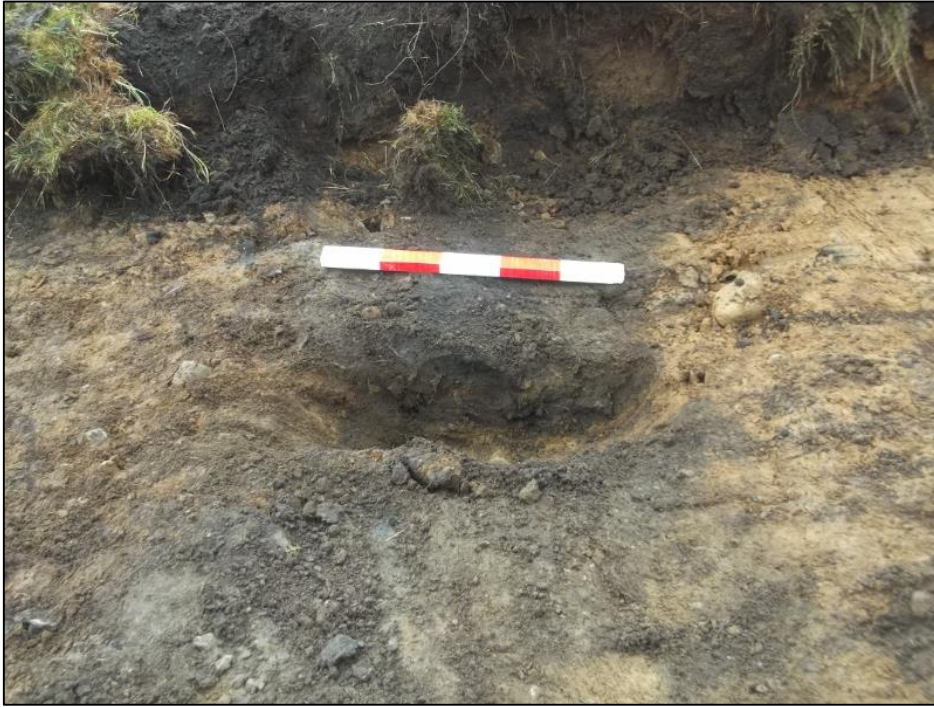
Figure 4a: View of animal burrow [007] within Trench 8. From the W.

17. Two features were identified during the excavation. One had natural origins; the remains of a recent burrow was identified within Trench 5. The burrow's cut, [007], was linear on plan and measured 0.5m wide by 0.17m deep. It had an approximate orientation of E-W. The fill (008) within the burrow consisted of loosely compacted (friable) mid brown sandy silt with inclusions of small to medium sub angled stones. The other feature was modern, characterised by an area of wheel ruts and trampling associated with the farm track (010). The track itself measured between 3-4m wide, while the material within the rutting and trampling consisted of a mixed layer of topsoil and subsoil. No significant archaeology was identified within any of the 19 excavated trenches.

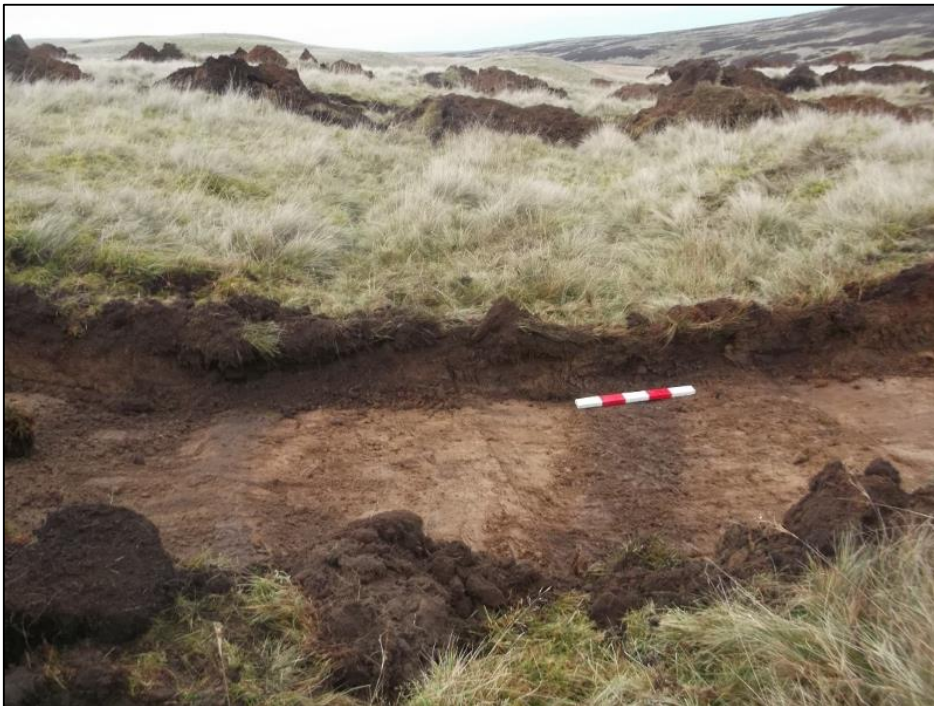
Figure 4b: View of wheel ruts from the farm track (010) within Trench 14. From the NE.

Context No.	Area/ Trench	Type	Description	Interpretation
009	T4, T11, T12, T13, T14 & T17	Deposit	An approximately NW-SE orientated track which joined the main E-W farm road to the immediate S of the development area. The track was only single track and had a width of c.3-4m. There was no deliberate surface within the track though wheel ruts were visible where it was excavated through in the test trenches. An interface layer (mix of (001) and (002)) caused by long-term vehicle usage and animal traffic was observed, especially within the wheel ruts. This material consisted of mid brown/yellow silty clay with inclusions of small to medium stones.	Farm track. Most likely recent and still in use.
010	None	Road	An approximately E-W orientated single track road which lay to the immediate S of the development area. The road did not appear to have a manmade surface but comprised instead a rough track which was rutted by modern vehicles and trampled by livestock. The road was approximately 4-5m wide.	Modern farm road/rough track.
