# Cartland Mains, Lanark: Archaeological Evaluation

Data Structure Report

by Liam McKinstry & Claire Williamson issued 14<sup>th</sup> April 2015 on behalf of Mr & Mrs A Wilson

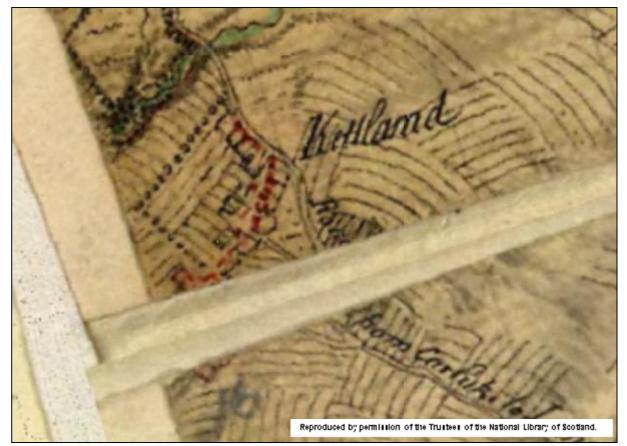
Figure 1a: Roy's Military Survey (1752-55)

- 8. The earliest available pre-Ordnance Survey map which shows detail, Roy's Military Survey in 1747-55, depicts a moderate sized settlement identified as 'Kettland' (Figure 1a); an earlier linguistic variation on Cartland. The settlement is seen to extend along a central axial road, branching from the western side of the Carluke to Lanark road, surrounded by a system of rig and furrow fields.

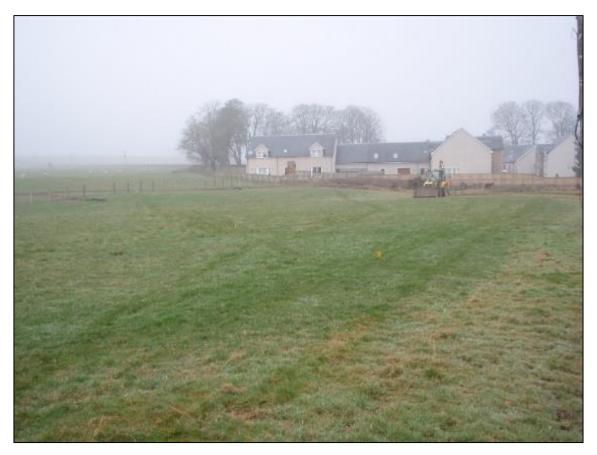
- 17. The trenches were excavated through turf and topsoil (001) (Figure 3a) which comprised a mid- to dark grey silty clay with moderate to occasional small stone inclusions, and occasional fragments of modern brick. Natural subsoil was encountered at depths of between 300 to 520mm below the top of the current ground surface.

Figure 3a: General shot of development area from the north

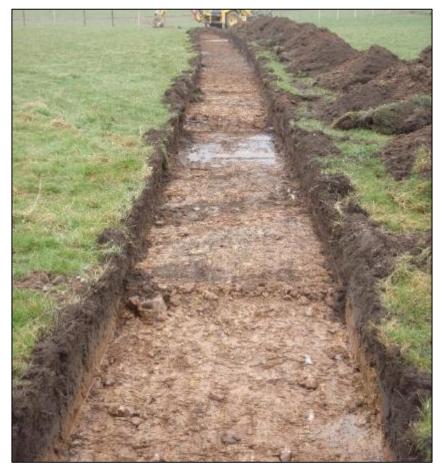
- 18. The subsoil across the site consisted of clayey silts (002), (005) and (006). These varied slightly in colour and in their inclusions. (002), which was present in all four of the trenches, was mid- to light yellow/orange brown in colour and contained moderate to frequent small stone inclusions (Figure 3b). (005) and (006) were both light to mid-grey brown in colour and, while (005) had no inclusions other than occasional flecks of manganese, (006) had occasional small inclusions of degraded stone.

Figure 3b: Trench 1 from the northwest showing natural subsoil (002) in the foreground

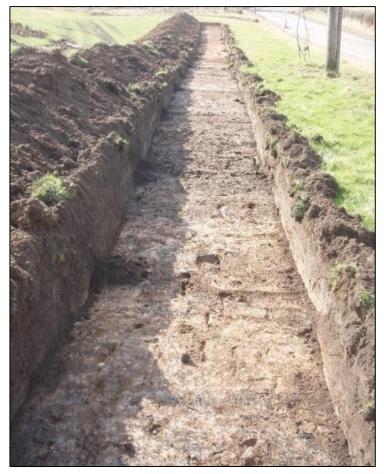
Figure 4a: Trench 3 from the north-north-east

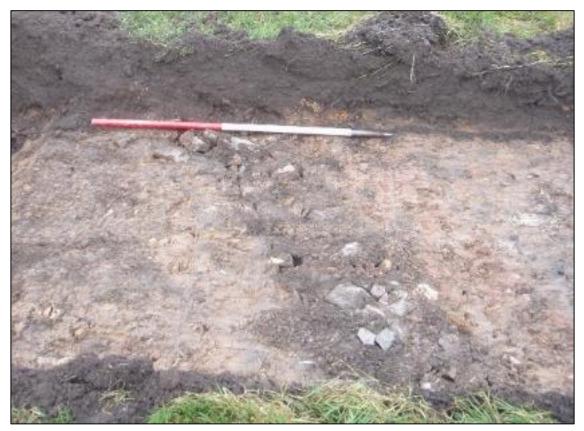
- 20. Rubble field drains were revealed in Trenches 1, 3 and 4 showing that they were present at least within the northern and western ends of the development area. In Trench 1, drain (003) was revealed orientated north to south (Figure 4b). It contained small to medium sized sub-angular stones mixed with grey clayey silt, and measured 0.3m wide and 190mm deep. Drains (008) and (011) were revealed in Trenches 3 and 4 respectively and were of

a similar character. They were both orientated southwest to northeast, and both contained a mid-grey stone fill. They measured 0.3m wide and 210 to 230mm deep.

Figure 4b: Rubble drain (003) in Trench 1 from the northeast
