# Barony Churchyard Wall, West Kilbride: Archaeological Mitigation

Data Structure Report

on behalf of North Ayrshire Council

**RATHMELL**    
ARCHAEOLOGY LTD

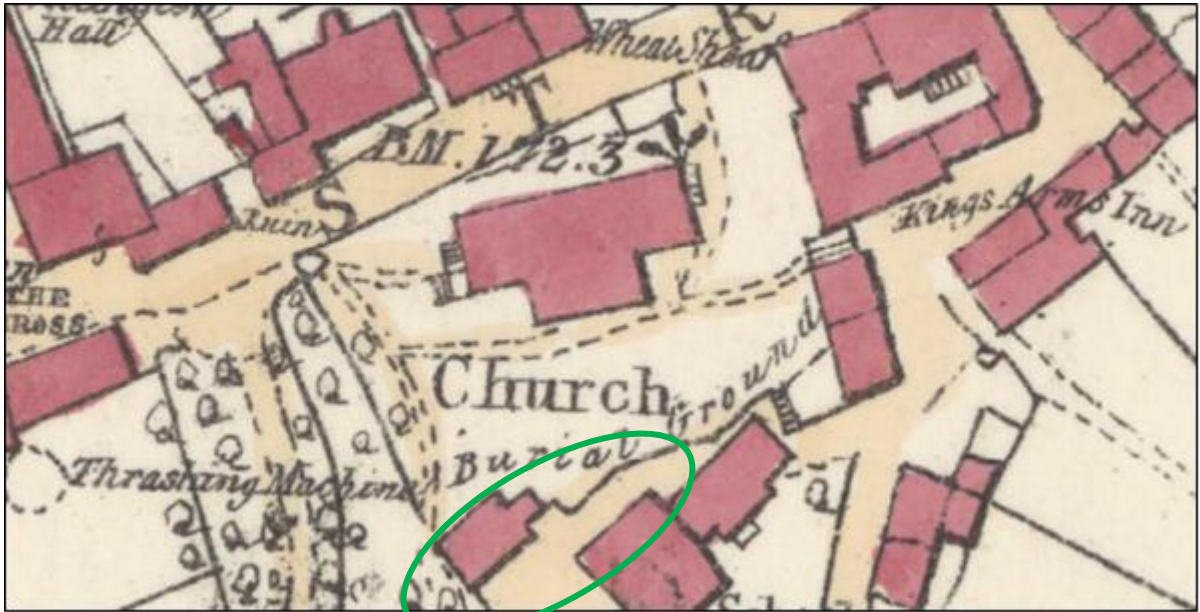
Figure 1: 1855-58 1<sup>st</sup> edition Ordnance Survey

5. Of note on the 1st Ordnance Survey (Figure 1) is an arcing path through the pre-Barony Church graveyard which suggests that it was not significantly different in height to the solum for the house. Hence, the extent to which the current churchyard has been built up following the construction of the 1870s Barony Church may be as much as 2m.

14. The line of the wall covered by Phases (i) and (ii) matched the northern boundary of a structure depicted on the 1855-8 Ordnance Survey (see Figure 1). The original burial ground surface is inferred to have lain at a comparable level to the base of the Phase (i) wall.

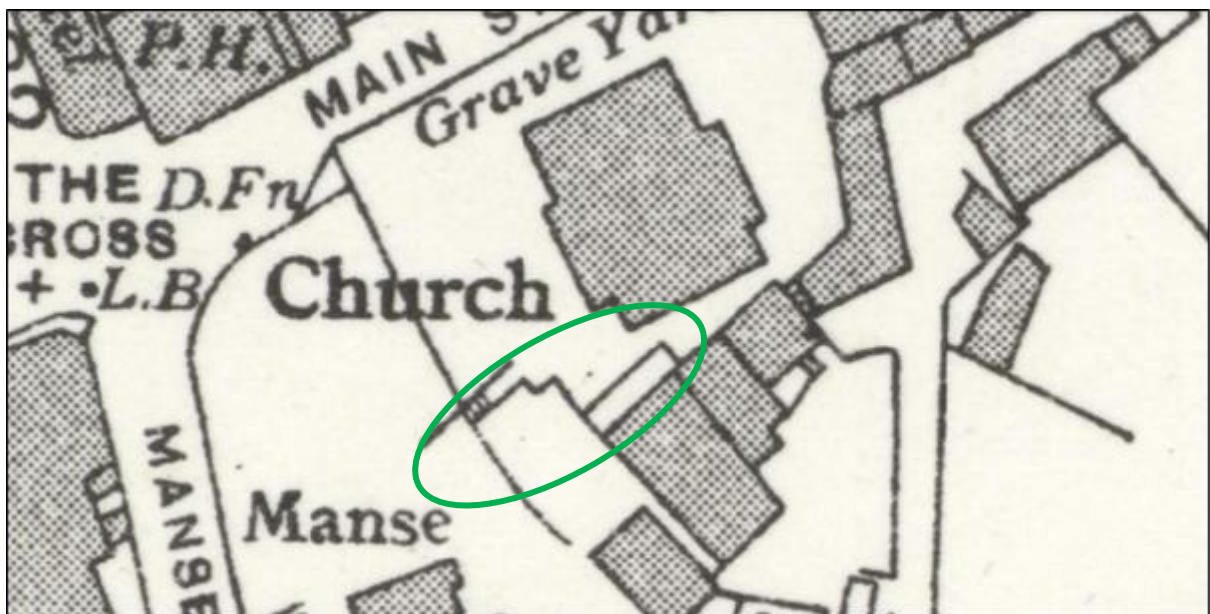
Figure 2: 1938-40 4th edition Ordnance Survey

6. There appears to be a realignment of the western boundary of the churchyard running down to the western gable of the structure under consideration between the 2nd (1895-6) and 3rd (1909-1910) editions of the Ordnance Survey. This is associated with the appearance of a short pend running up the first half of the northern wall of the structure. Our structure has been demolished by the 4th (1938-40) edition Ordnance Survey at which time this pend is still depicted, but is shown with stairs climbing into the churchyard.

7. A reasonable inference would be that at some point between 1895 and 1909 the southwest corner of the churchyard is raised in height but that to sustain access to the northern wall of our structure a short pend is inserted. After the demolition of our structure, between 1909 and 1938, this pend is retained and reused as a stair into the churchyard – providing a direct route to the Manse gardens. More recently than 1938 this stair has been filled in.

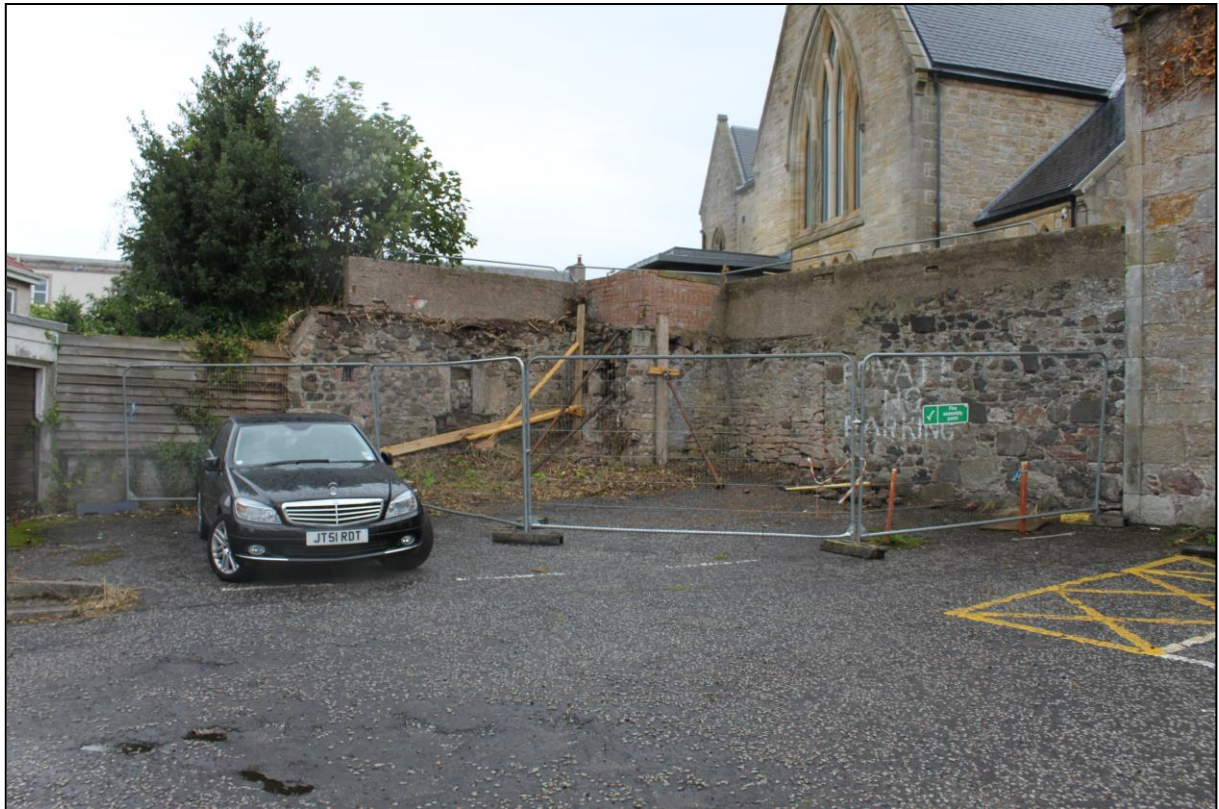
Figure 3: At time of Initial Site Inspection

11. An initial site visit was carried out by Rathmell Archaeology Ltd on 12<sup>th</sup> August 2014 (Figure 3), which involved the inspection and recording of the retaining wall at the rear (southwest) side of the churchyard where it was failing.

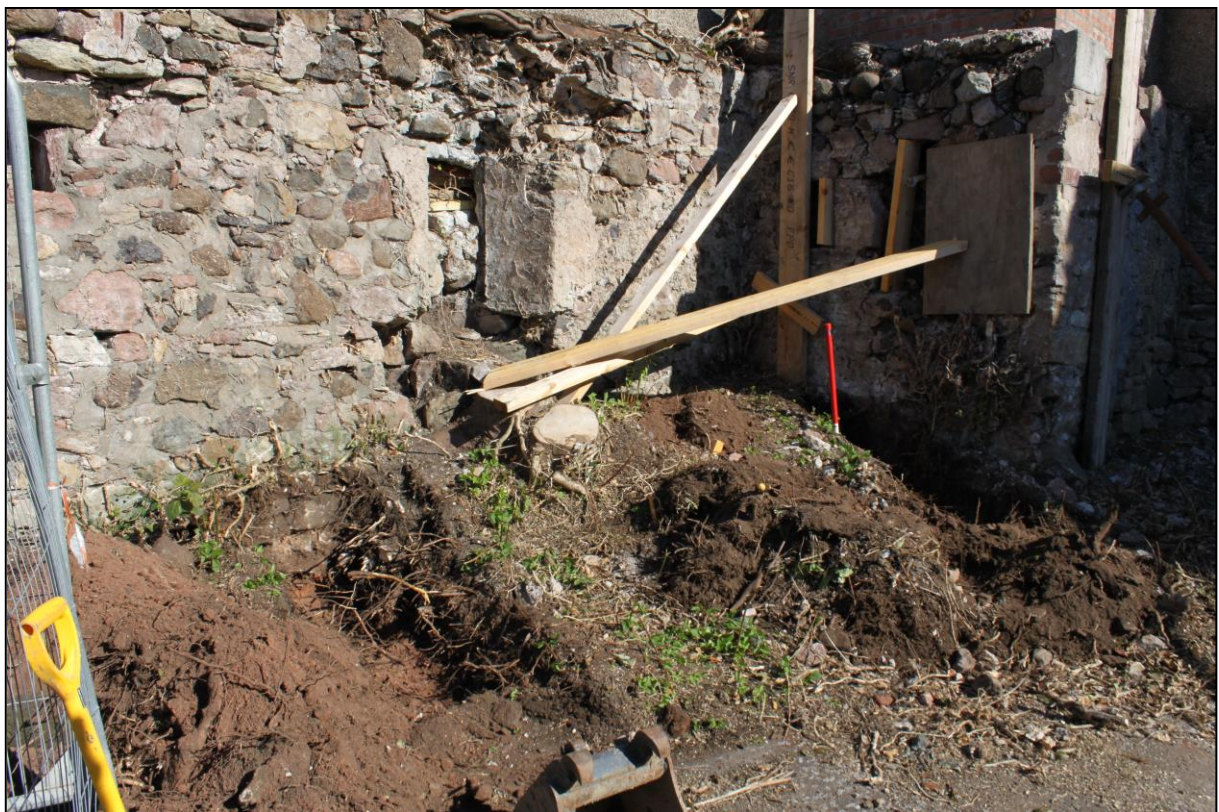
Figure 4: Detail of wall at time of Initial Site Inspection

12. This inspection identified three separate phases of wall construction (excluding the brick superstructure above). The relevant stretch of the retaining wall ran from southwest to southeast and formed an inverted 'w' shape when viewed on modern mapping (Figure 4):

- ❖ Phase (i) comprised the stretch of wall which formed the southwest arm of the 'w' and the western portion of the central 'v'. This clearly comprised the relict remains of a structure, which must have predated the raising of the ground level within the churches;

- ❖ Phase (ii) abuts Phase (i) on the west side, and formed the eastern portion of the central 'v' and continued on into the southeast arm of the 'w,' where it extended over roughly a third of its extent; and

- ❖ Phase (iii) extended along the remaining length of the southeast arm of the 'w' before abutting an upstanding 19<sup>th</sup> century building.
13. Based on inspection, Phases (ii) and (iii) clearly represented different episodes of building, although there was insufficient information from the site inspection to establish the relationship between the two.

- ❖ Phase (i) appears to have been the surviving north wall of the structure that predated 1855 and may be 18th century in origin, behind which was an infilled 20th century stair that reused a very early 20th century pend (i.e. there is another retaining wall further north);

- ❖ Phase (ii) was on the line of the east gable but the character of this wall was such that we interpreted this as an irregular rebuild after the loss of the structure (i.e. post 1938); and

- ❖ Phase (iii) was a retaining / boundary wall depicted on the 1896 Ordnance Survey hence mid to late 19<sup>th</sup> century in origin.
15. The site inspection highlighted that should the Phase (i) wall be failing this may relate to the infilling of the stair/pend to the immediate north. During the site inspection it was also commented that an infilled stair had been used as an ossuary for previously excavated burials during archaeological works.

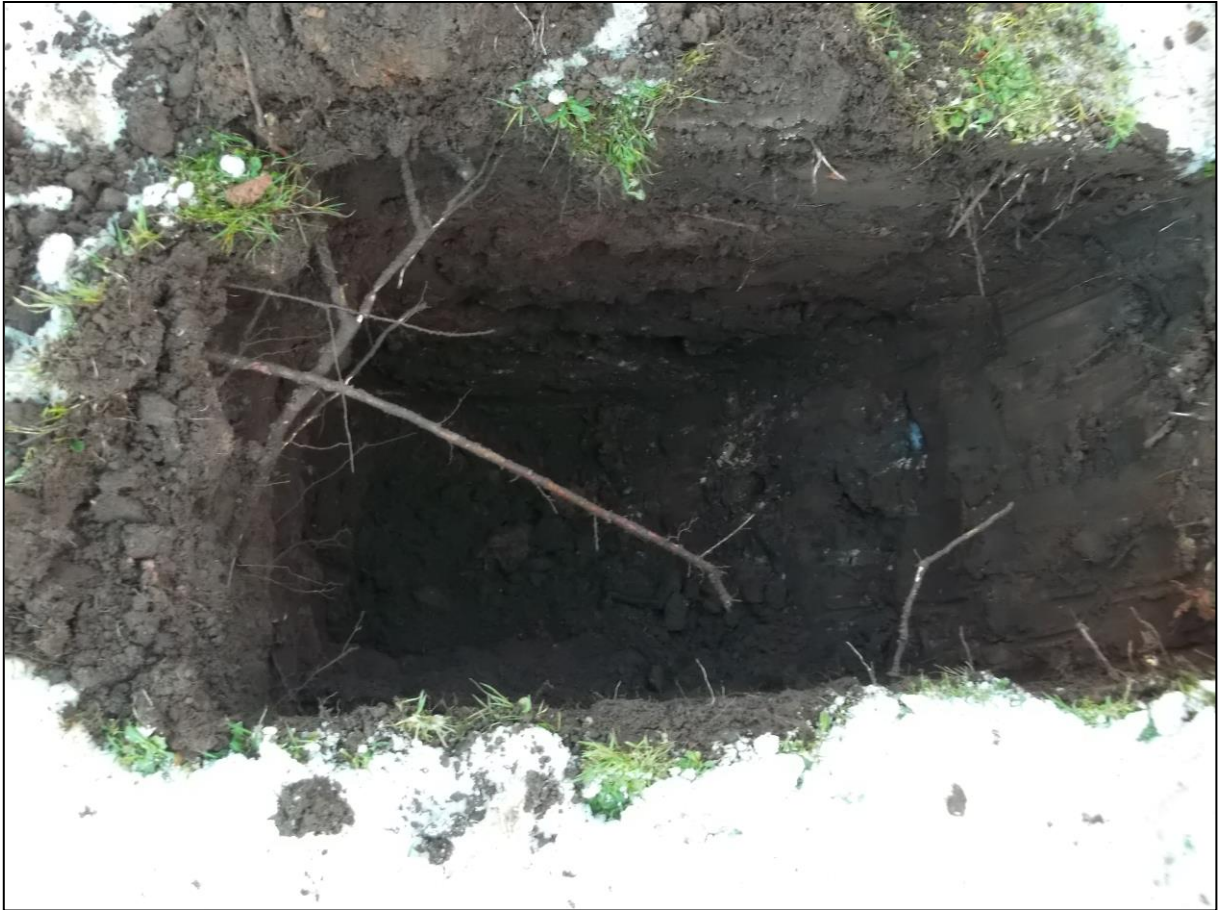
Figure 5: Test pit during monitoring 19<sup>th</sup> January 2015

18. On the 19<sup>th</sup> and the 20<sup>th</sup> January 2015 a total of seven test pits were excavated at roughly 1m intervals along the northern face of the easternmost wall. The aim of these test pits was similar to those excavated on the 26<sup>th</sup> August 2014, to examine the exposed sediments (Figure 5) and assess the potential for significant archaeological material and human remains in the area. Each of the seven test pits was excavated through dark brown sandy silt with many roots (001) and into red-brown sandy clay (002) interpreted as redeposited subsoil. Disarticulated human remains were recovered from four of the seven test pits. (001) also contained some structural material in the form of fragments of slate, mortar and sandstone.

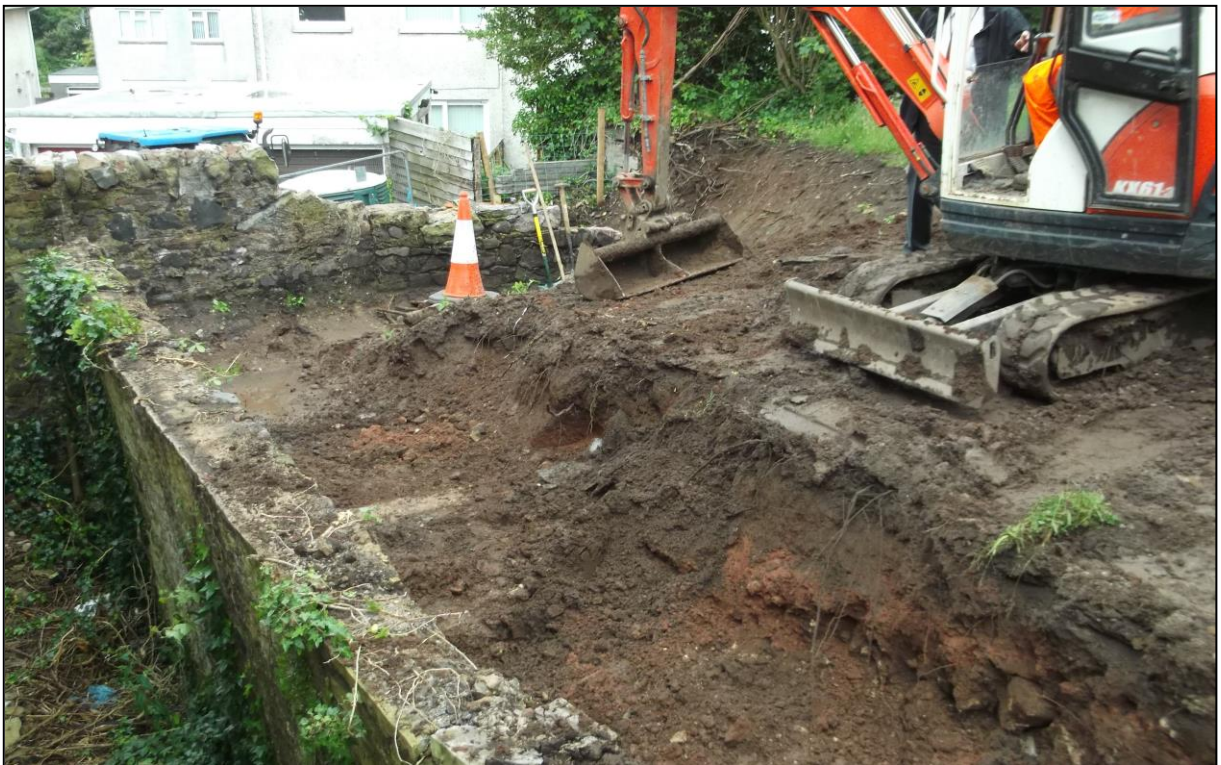
Figure 6: Monitored excavation revealing (501)

22. Archaeological monitoring was undertaken on the 7<sup>th</sup>, 8<sup>th</sup> and 9<sup>th</sup> July 2015 supporting reduction of the ground behind the retaining wall facing onto the enclosed valley. This attendance was initiated by the exposure of bone by contractors on the 6<sup>th</sup> July 2015. This bone was demonstrated to be disarticulated and so was removed and retained. Further stripping was then undertaken under archaeological supervision – the stripping forming the first terrace level - that revealed the upper edge of a possible lair against the boundary wall (501). From here the stripping continued to the north-west revealing a headstone which lay horizontally under the turf (500).

23. Further excavation in the area of wall (501) revealed that there was no matching parallel wall which might indicate the marker for a lair or crypt. In fact (501) (Figure 7) ran perpendicular to the main retaining wall at a height where there was a horizontal break in that wall. Hence, Wall (501) matched the height of the main retaining wall (at the break) before it had been heightened. This may indicate that wall (501) was intended as an enclosure wall. Further excavation formed a lower terrace that revealed dark brown shallow soil (506) beneath a mass of mortar (505). Orange-red subsoil was exposed further to the north-west (507). Some lenses of (507) were redeposited higher in the exposed sediments.

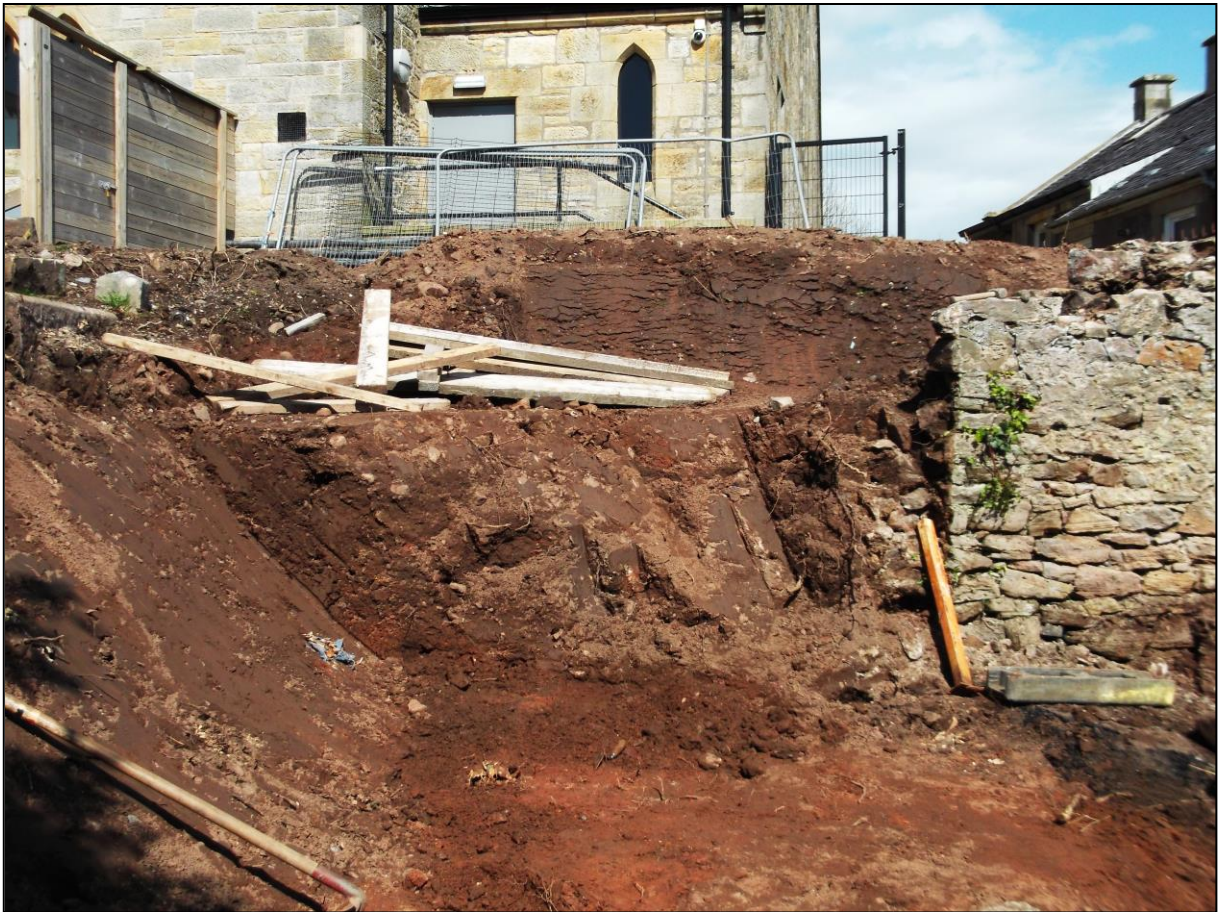
Figure 8: Location of Grave #1, 11<sup>th</sup> May 2015

4. At the base of the graded slope, on the level, a distinct grave cut was noted orientated west-southwest to east-northeast entering the exposed subsoil surface with cranial fragments at the west-southwest end. These cranial fragments (as loose) were recovered – this has all the markers of an *in situ* grave.

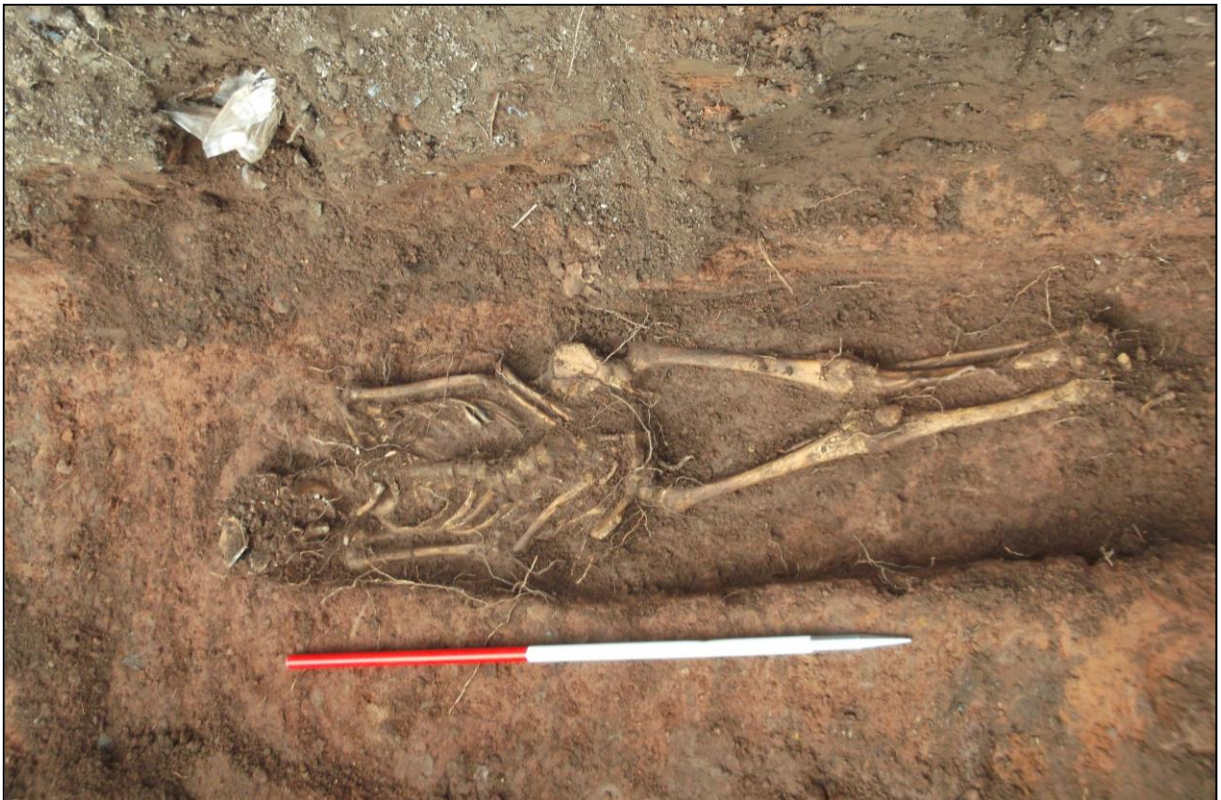
Figure 9: Grave #1

28. Grave #1 (Figure 9) was a complete inhumation and aligned roughly east to west, with the head pointing to the west. The skeleton was lying prone with hands laid upon the pelvis. There was no evidence of a coffin however some artefacts were recovered from the gravel fill. These included a shroud pin, indicating that the remains had been buried in a shroud, and fragment of transfer painted ceramic. Grave #5 (Figure 10) was similarly aligned roughly west to east. The skeleton was lying prone with hands folded on the pelvis. Some green staining was evident as there had been in Grave #1 but no shroud pin was recovered. Again, there was no evidence of a coffin so most likely a shroud burial.

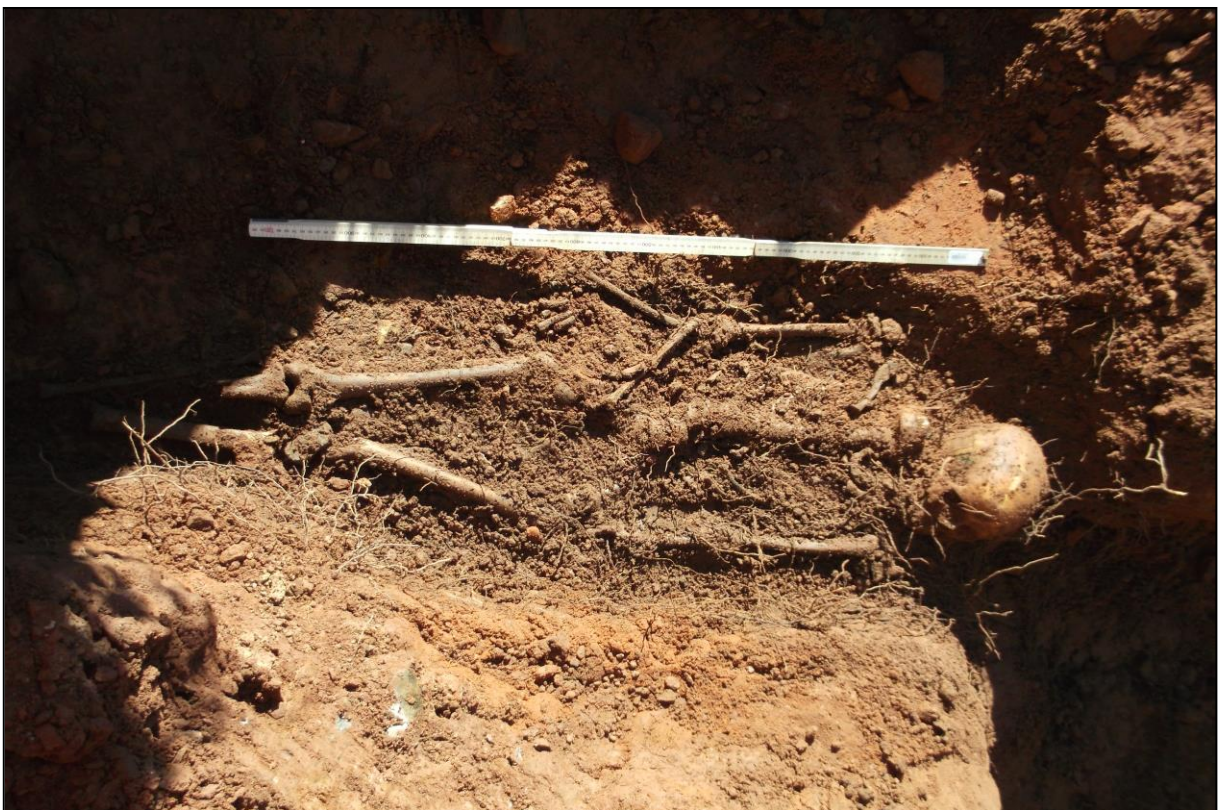
Figure 11: Grave #6

30. The skeleton in Grave #6 (Figure 11) was of noticeably shorter stature than those found in Graves #1 and #5. The grave was similarly orientated west to east, with the head pointing west. No artefacts were recovered from the fill. However green staining on the skull indicated that this may have been a shroud burial with a bronze shroud pin. Grave #6 must have had its head very tight to the wall of the now removed house. As necessitated by the works Grave #6 was also exposed, excavated and removed.
