**GlaxoSmithKline Wind Turbines, Irvine,
North Ayrshire – Turbine 4:
Archaeological Mitigation**

Data Structure Report

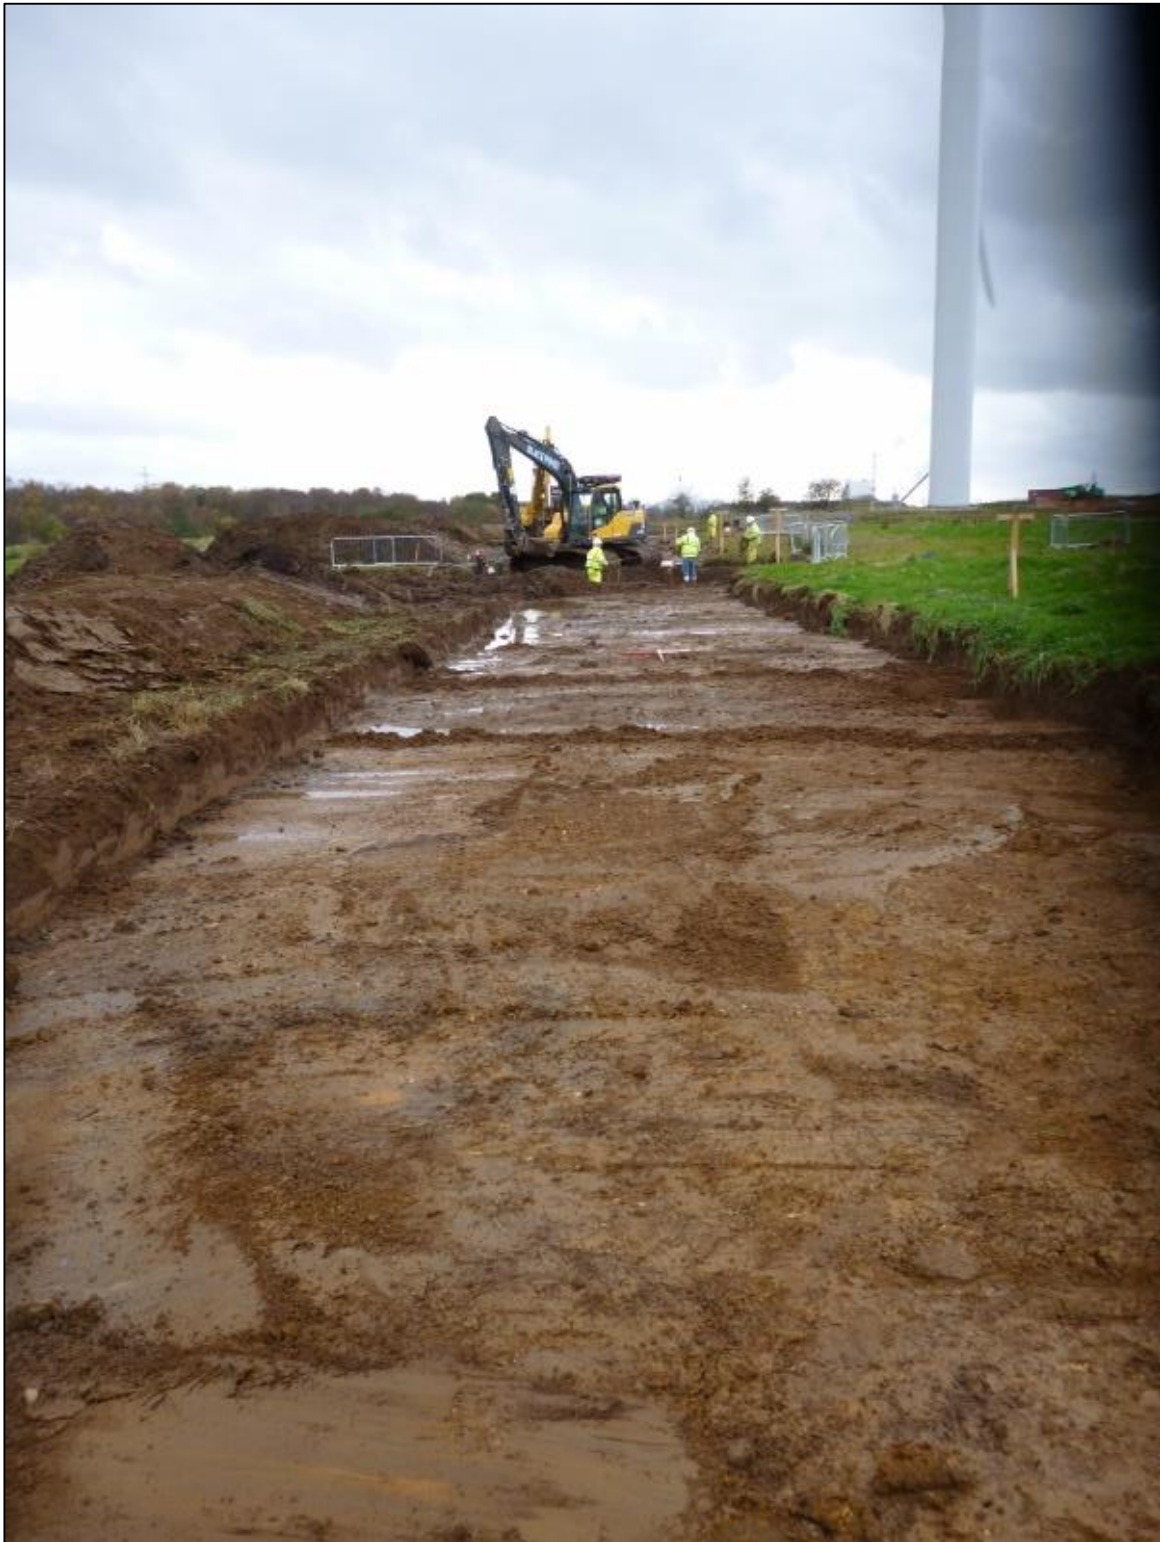
Figure 2: Ground breaking works for Haul Road between Turbines 3 and 4 from the northeast.

17. The topsoil (T1001) within the excavated area was a moderately compacted dark grey brown silty sand with occasional small stone inclusions. There was also evidence of bioturbation throughout in the form of root and animal activity. The topsoil layer had a depth range of 0.1 to 0.6m along the length of the haul road. The naturally occurring subsoil (T1002) consisted of a firmly compacted light orange brown sandy clay with occasional small stone, pebble and grit inclusions. This subsoil extended throughout the entire length of the haul road (see Figure 2).

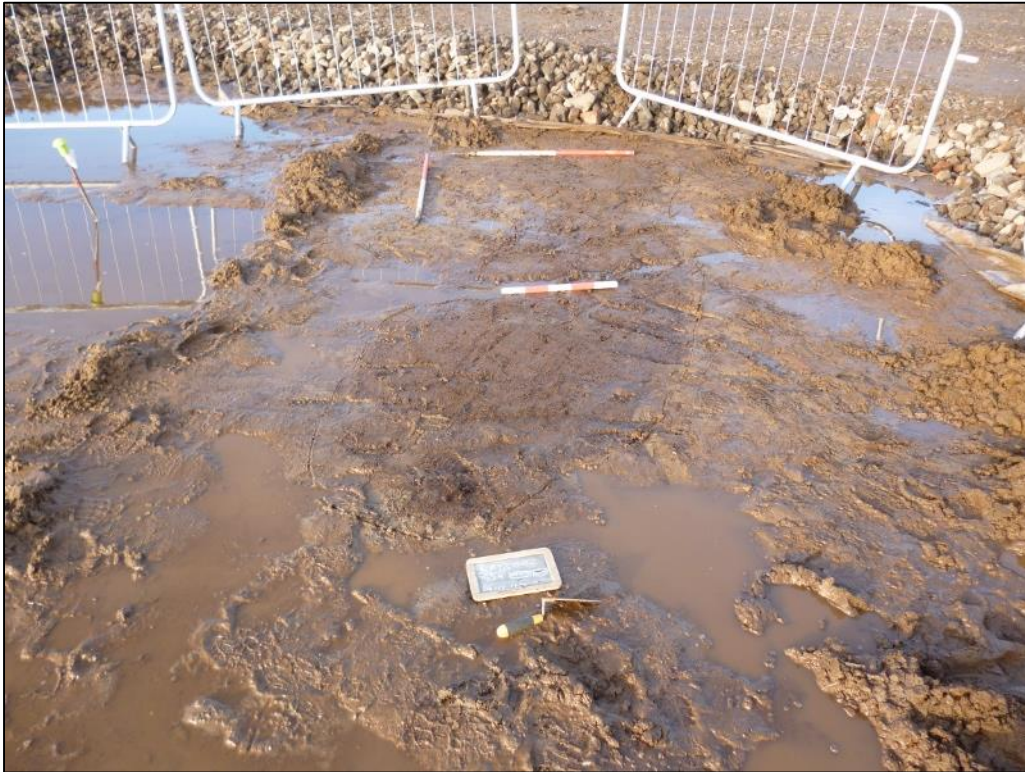
Figure 4a: Pre excavation view of [003], from the east.

20. Three significant features were identified in a cluster within the turning point area. These features consisted of three linear shaped features: [003], [005], and [017]. The first linear feature [003] measured 3.5m by 1.2m and was 0.1m deep (see both Figures 4a and 4b). Its break of slope at the top was gentle with gently sloping sides and a gradual sloping base: slightly irregular to flat. The feature was orientated in a SE-NW direction filled by (004), a moderately compacted dark red-brown silty-clay with charcoal inclusions. The second feature [005] measured 1.9m by 0.9m and was 0.4m deep (see Figure 4c). Its break of slope at the top was gentle with gently sloping sides and a slightly shallow concave base. The feature was orientated in a N-S direction filled by (006), a firmly compacted dark red-grey clay/sandy-silt with occasional charcoal and gritty sand inclusions. The final feature [017] measured 1.54m by 0.49m and was 0.4m deep (see Figure 4d). Its break of slope at the top was sharp with near vertical sides and a near flat base. The feature was orientated in a NW-SE direction filled by (018), a firmly compacted dark brown silty-clay.

26. The three features [003], [005] and [017], excavated within the turning point may represent partial and heavily disturbed structural remains. Two of these features [003] and [005], may form an angle, possibly from a heavily disturbed structure. The last feature [017], was on a different alignment and may relate to a separate structure. It is unclear as to what kind of structure these features would have formed and it is more likely that they form a group of isolated denuded pits. No postholes or stakeholes were found close to the features, which supports this assertion. However the arrangements of features suggests that further features may occur beyond the southern limit of excavation, which may clarify the nature of this feature grouping.
