**Western Link Northern Point of Connection:  
Hunterston to Ardneil Bay;  
Archaeological Watching Brief**  
Data Structure Report

by Jessica Lumb and Katie Sludden  
issued 28<sup>th</sup> November 2014  
on behalf of RSK Environment Ltd

**RATHMELL**    
ARCHAEOLOGY LTD

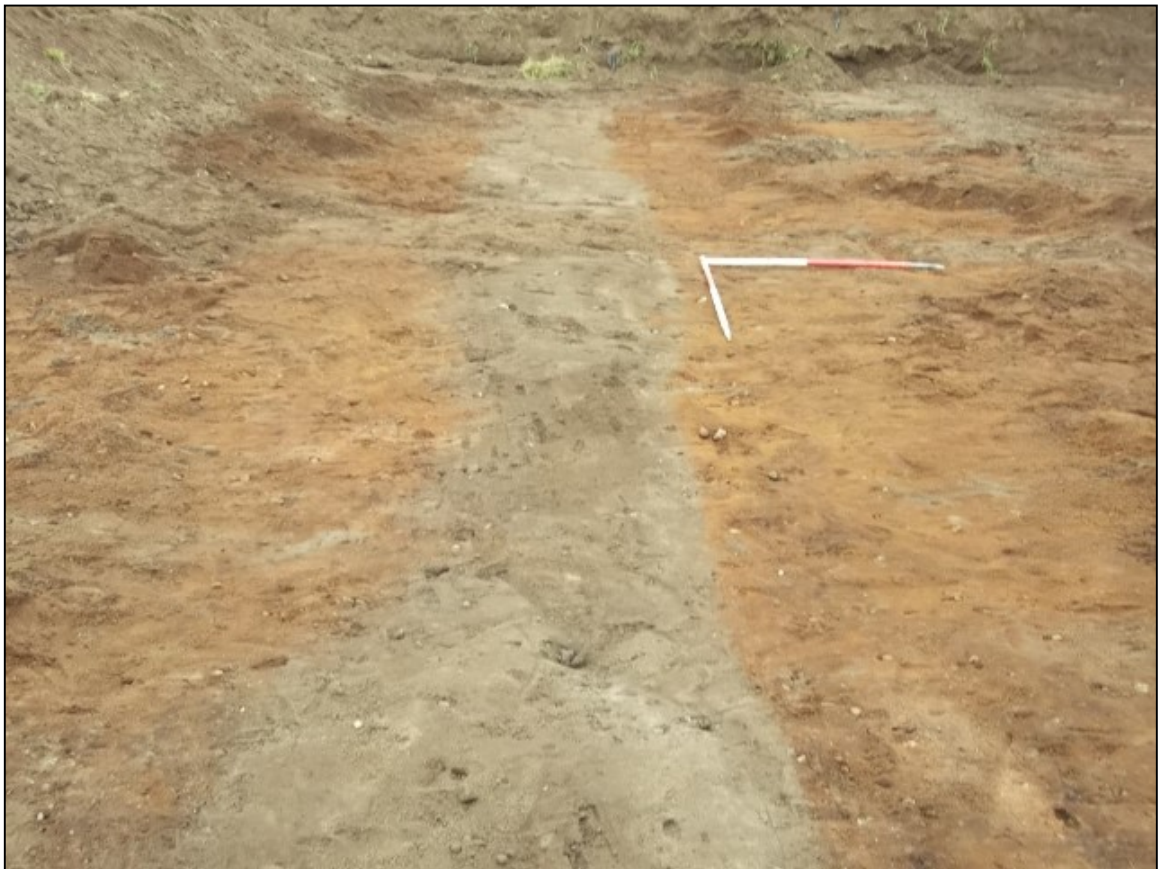
Figure 4b: General Pre-ex shot of [004] plough furrow from the east-southeast.

22. Two plough furrows were recorded during the compound strip: [004] and [006]. Furrow [004] (Figure 4b) was orientated east-south-east to west-north-west running from NS 19011 48593 to NS 19003 48958, measuring 0.8m wide by up to 35m long by 80mm deep. It was filled by a loose light grey sandy silt (003). Furrow [006] was orientated north to south from NS 19032 48582 to NS 19028 48565, measuring 0.8m wide by 17m long by 190mm deep. It was also filled by a loose light grey sandy silt (005).

64. The plough furrows recorded in the compound area suggest a land use of agricultural type during the 19<sup>th</sup> and 20<sup>th</sup> centuries.

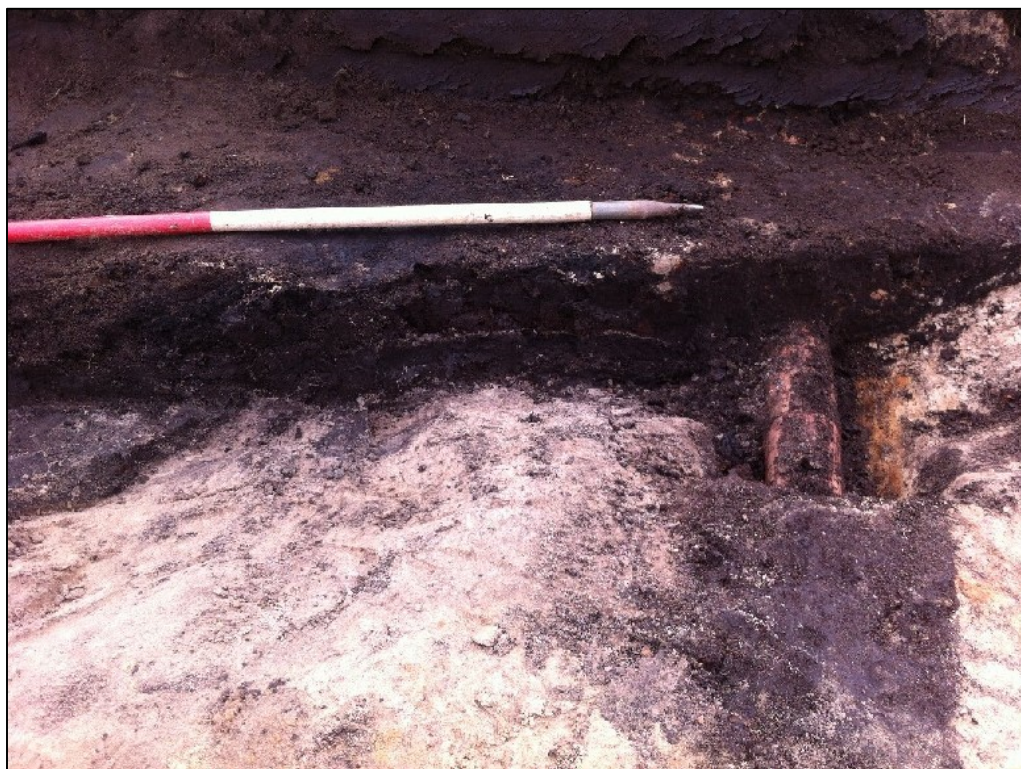
Figure 9a: General section shot of natural hollow [118] and field drain [120].

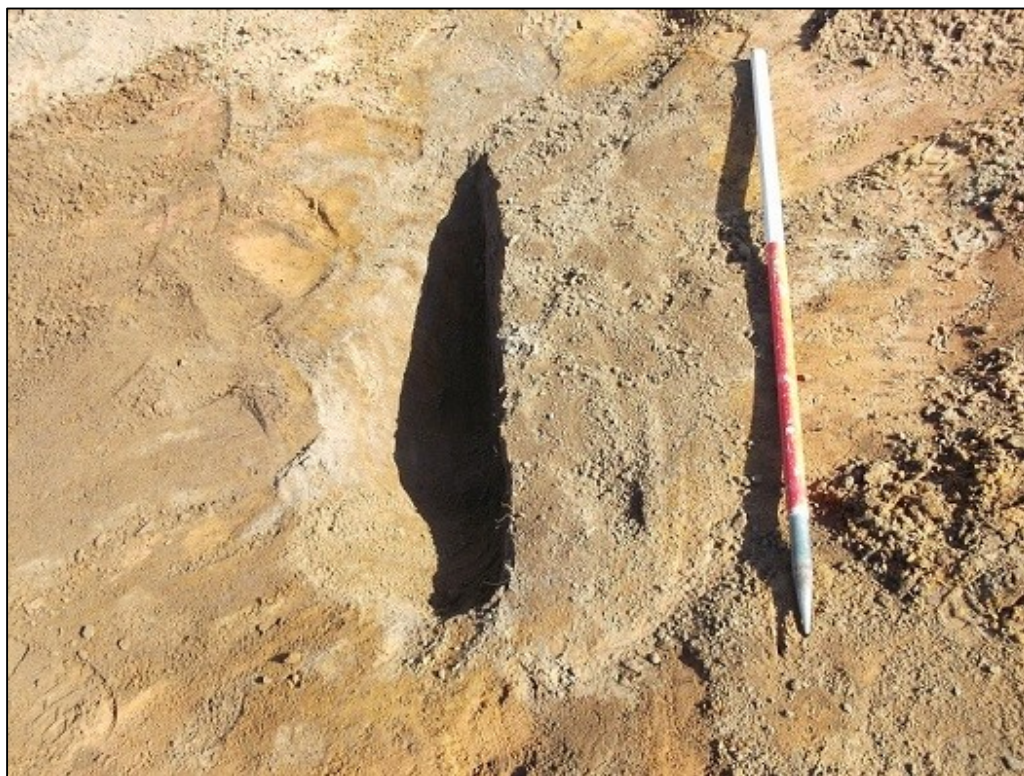
34. Pit [081] (Figure 9b) was sub oval in plan, measuring 1.1m by 750mm by 270mm deep and oriented east-north-east to west-north-west. It was filled with friable mid-brown slightly silty sand (082) with inclusions of fine roots. Pit [081] sat in an isolated position, located at NS 19368 49380 near the northwest base of Croek Hill.

Figure 9b: General post ex shot of pit [081] from the West.

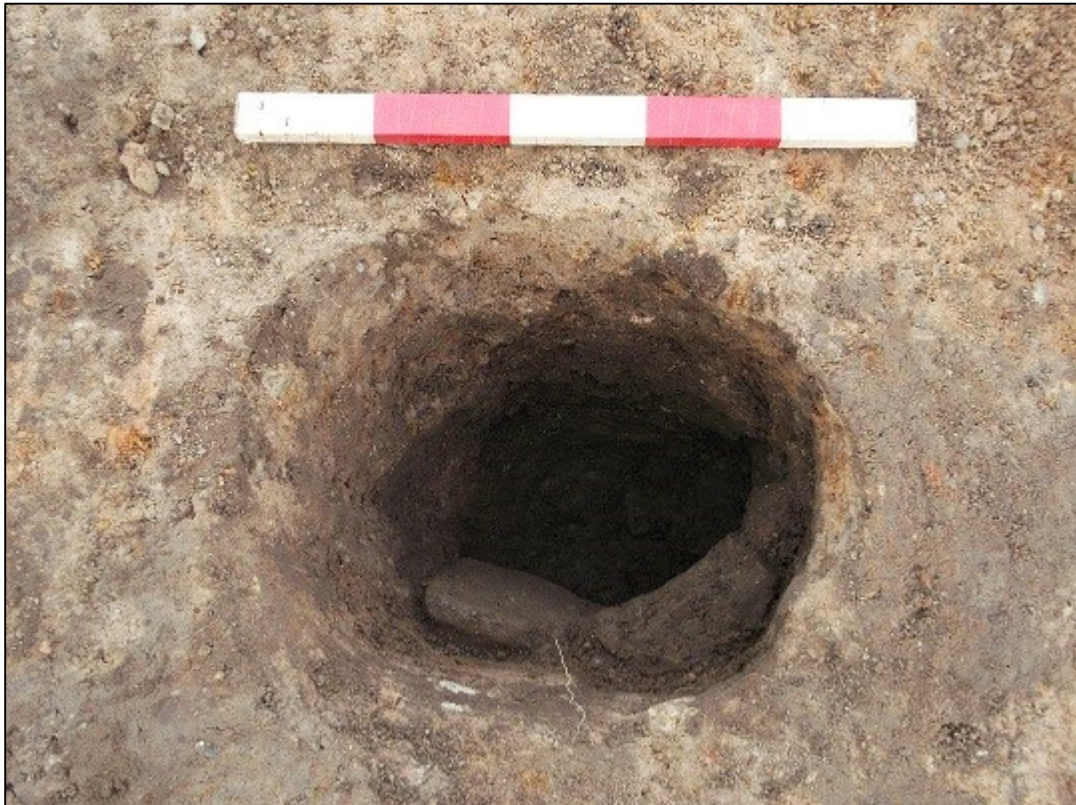
40. Postholes [112] and [114] (Figure 8) were recorded as having a possible relationship due to their similarity in dimensions, fill and inclusions. Posthole [112] was sub circular in plan, measuring 400mm by 350mm by 140mm deep and filled by (113), a moderately compact, dark brown/black silt with substantial inclusions of charcoal, some burnt stone and ash. Posthole [112] also included three stones, interpreted as possible packing for a post (Figure 11a).

Figure 11a: Post ex posthole [112] showing possible packing stones

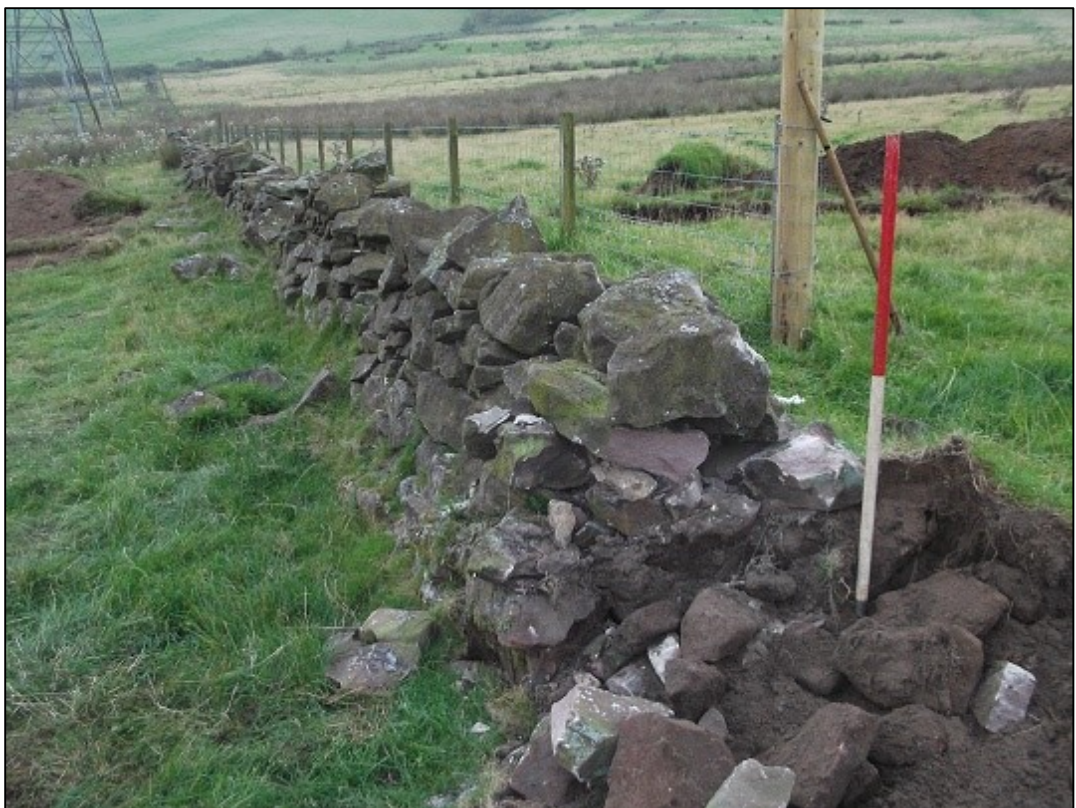
42. Wall (124) was an upstanding dry stone wall, 800mm to 1m high by 400-600mm wide with roughly eight courses of large sub angular light brown/pink sandstone. It was reduced within the wayleave and left in situ to the southwest (Figure 11b).

Figure 11b: Drystone wall (124) left in situ to the Southwest of the wayleave

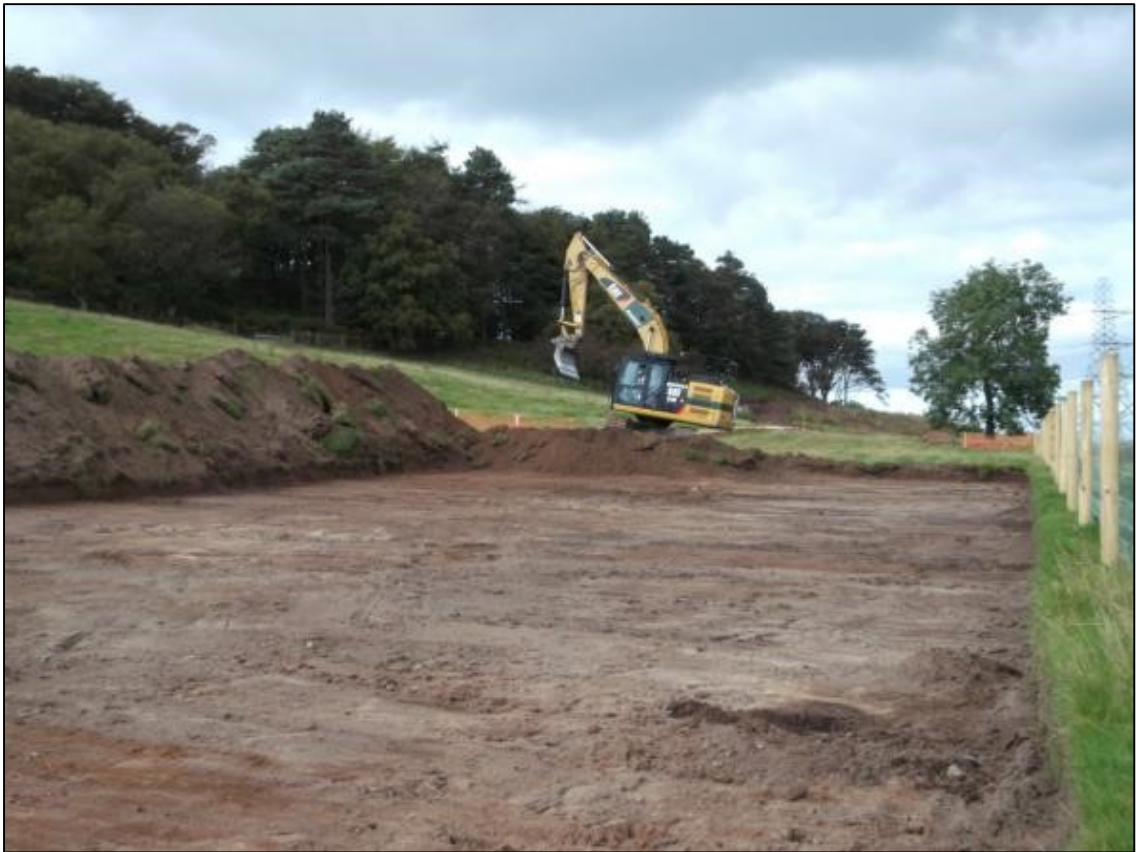
44. Monitoring of works in this area took place between the 24th of September 2014 and the 29<sup>th</sup> of September 2014. This area comprises approximately 350m of the length of the wayleave from NS 50630 18820 to Goldenberry Road (Figure 10). The topsoil (001) was removed in this area with a 13 tonne 360° tracked mechanical excavator (Figures 12a and 12b).

Figure 12a: Reduction of the topsoil (001) in Section 4 looking Northwest toward Goldenberry Hill

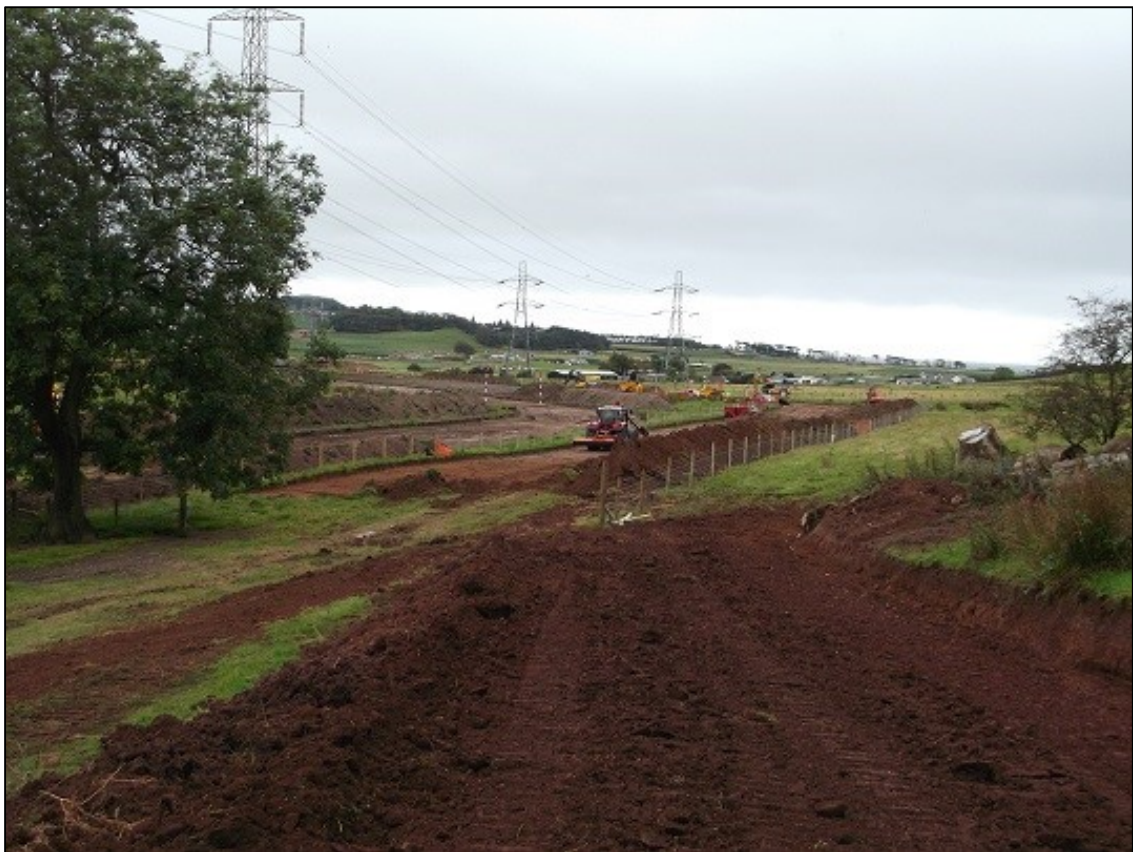
Figure 12b: Overview of section 4 looking East

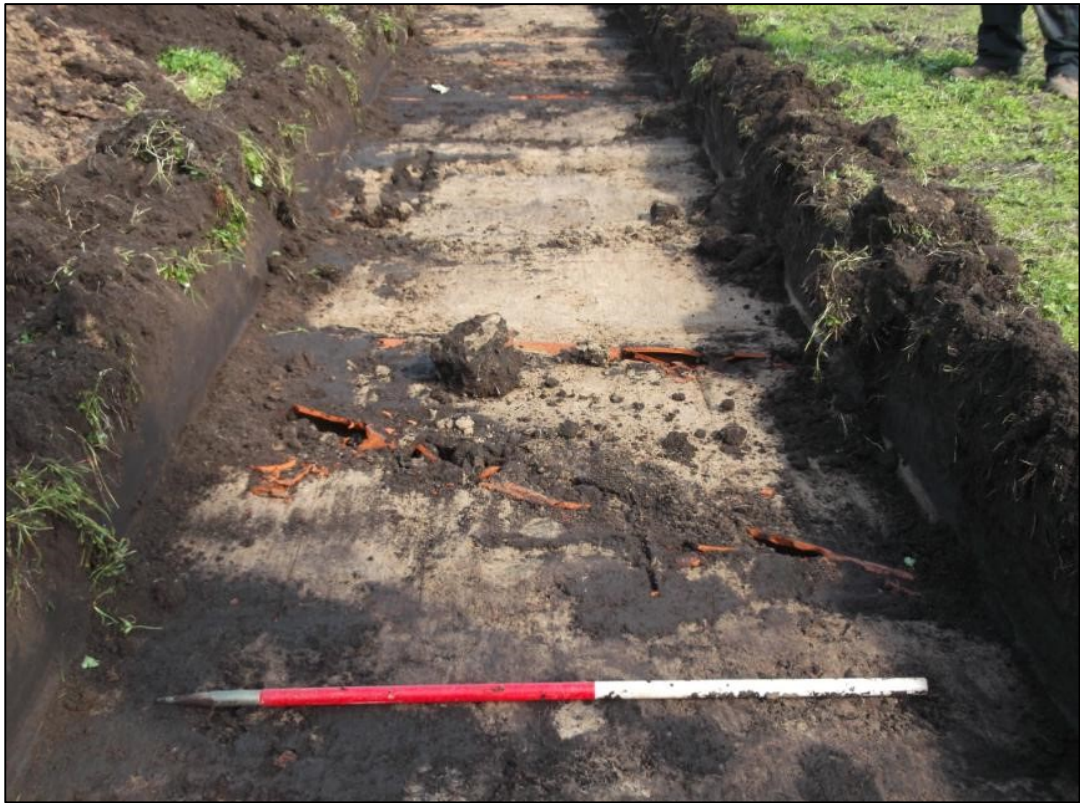
Figure 13a: Field drains [120] in Trench 9; from the South

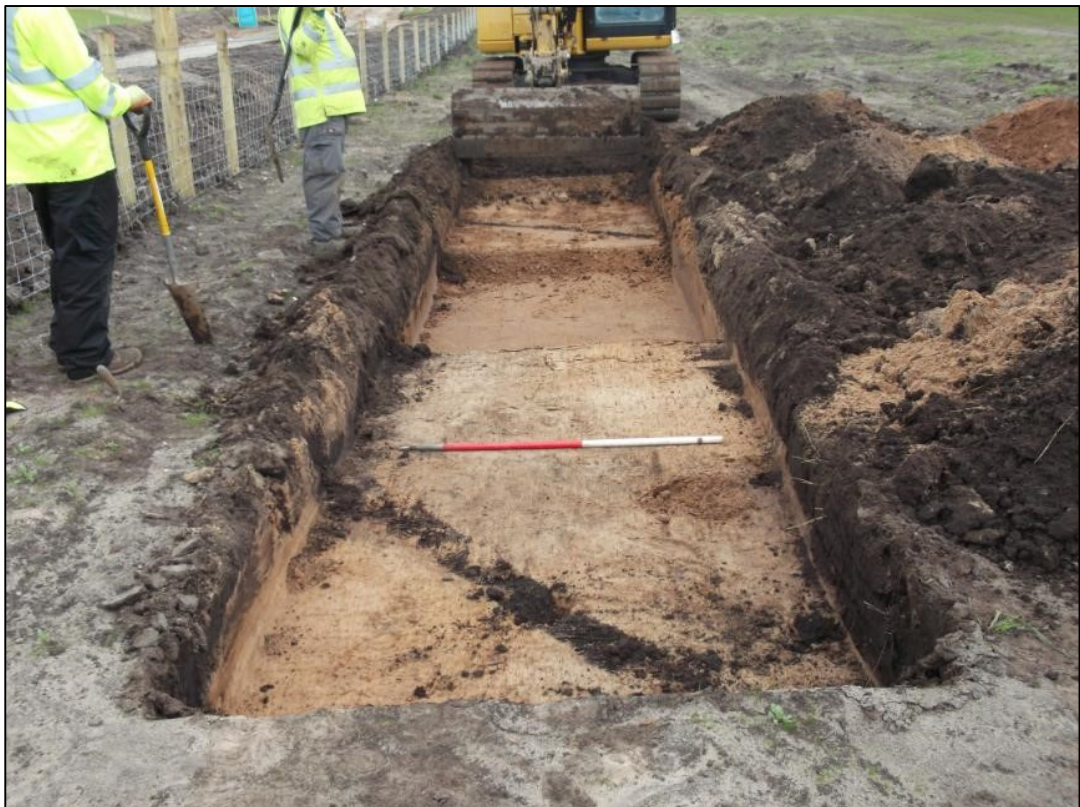
Figure 13b: Trench 10 Field drain [120]; from the South

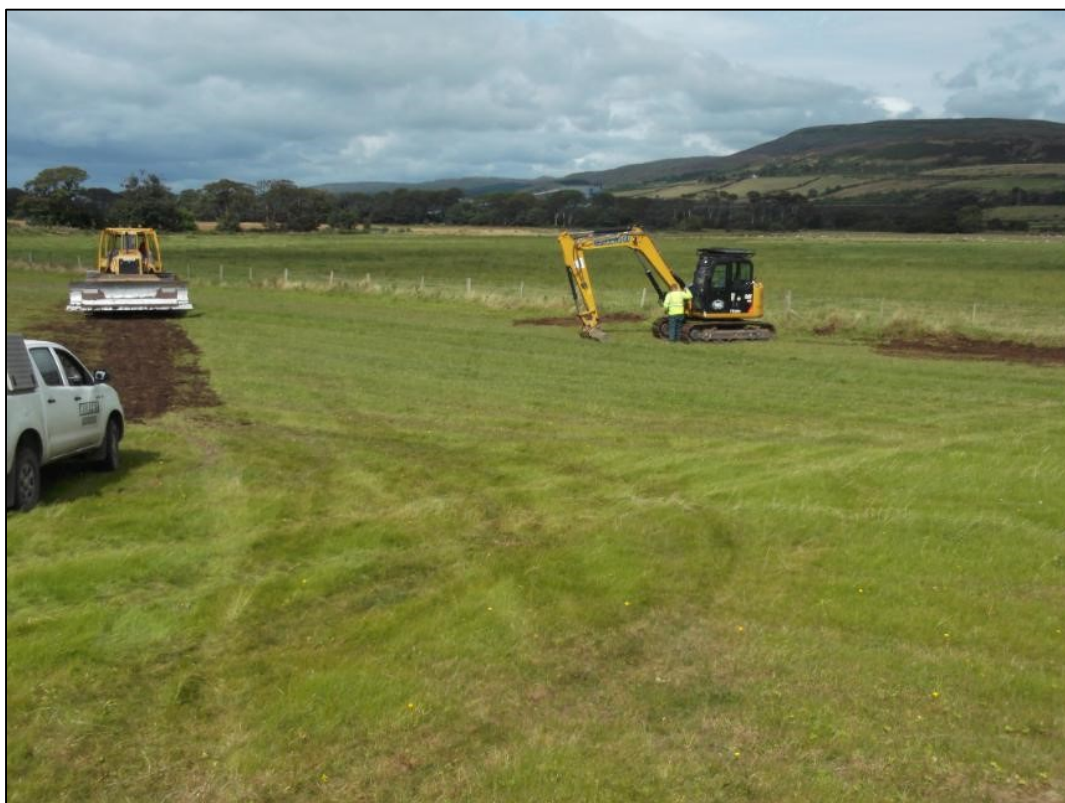
Figure 14a: Trenches 11, 12 and 13 left to right; from the SSW

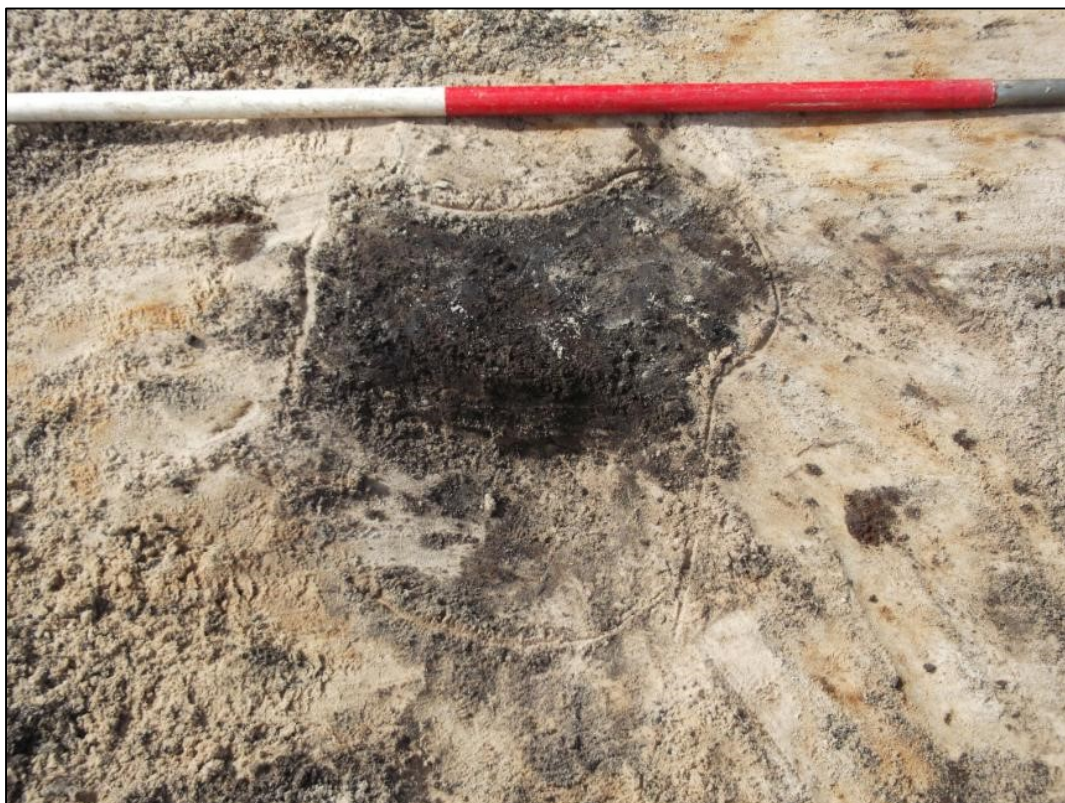
Figure 14b: Natural feature in Trench 11 from the East

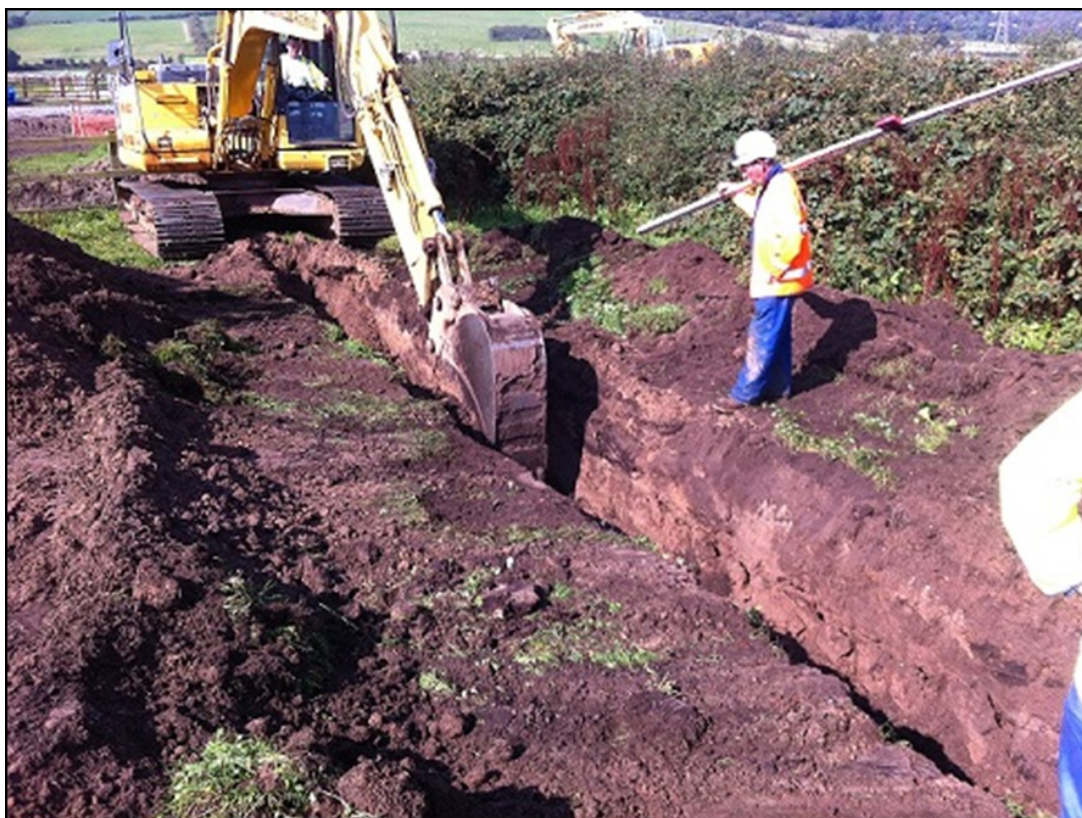
Figure 15a: Off easement trench to the South of Thirdpart Holding Road

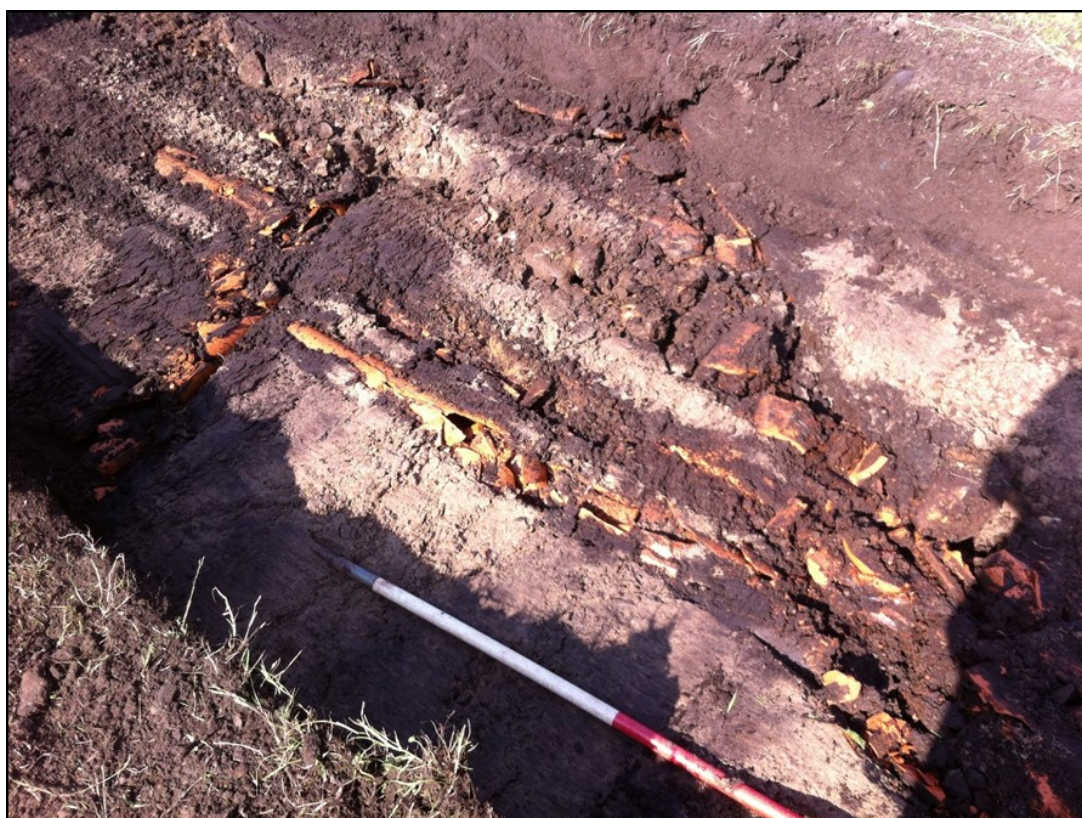
53. The majority of the drainage works were carried out within the wayleave prior to the reduction of the topsoil, however; the drainage channel was also excavated off easement where necessary (Figure 15a). These works did not reveal any deposits or features of archaeological interest (Figure 15b).

Figure 15b: Field drains [120] in drainage trench South of Thirdpart Holding Road
