**Dasher Cottage,
Kippen:
Archaeological Mitigation**

Data Structure Report

by Liam McKinstry

issued 14th June 2016

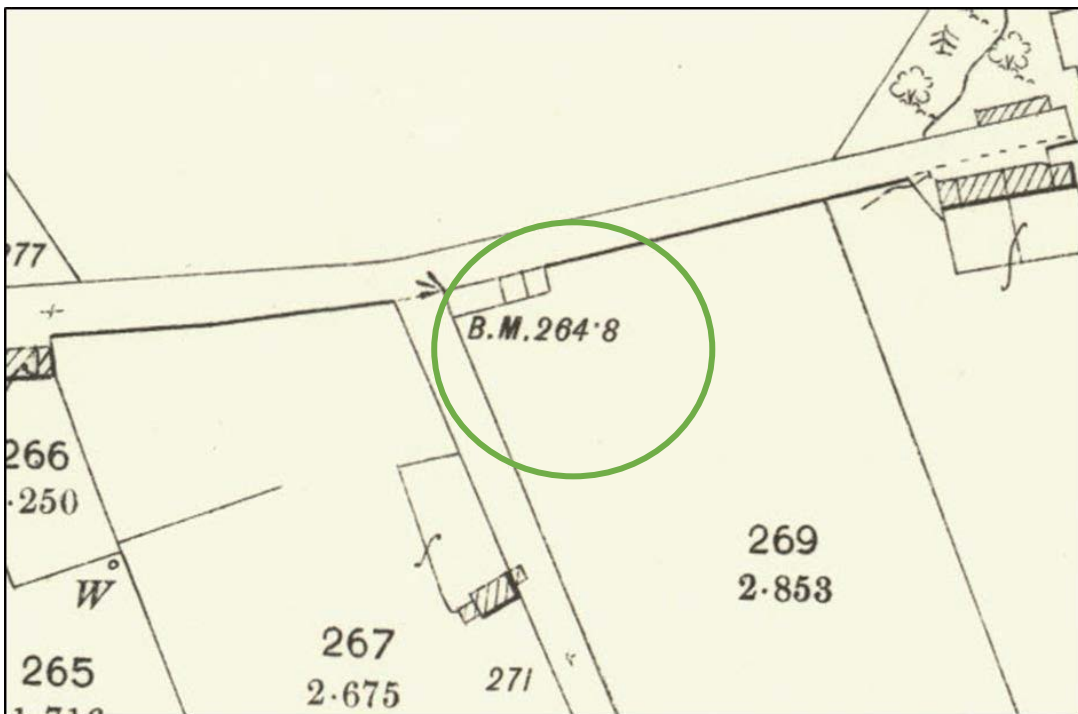
Figure 1b: 2nd edition Ordnance Survey 1897, 25-inch, with cottage circled in green.

5. Superseded mapping can demonstrate the change in land use over time in the development area and the surrounding landscape. However, the principal change in the landscape appears to be the presence in the NW corner of the larger field (within which the development sits) of a cottage adjacent to the minor road to the north. This unnamed cottage is depicted on the 1st edition Ordnance Survey 1865 (Figure 1a) as a structure of two compartments with an enclosure (possibly an unroofed third compartment). The 2nd edition Ordnance Survey 1897 (Figure 1b) continues to depict the structure, but unroofed – hence presumably derelict.

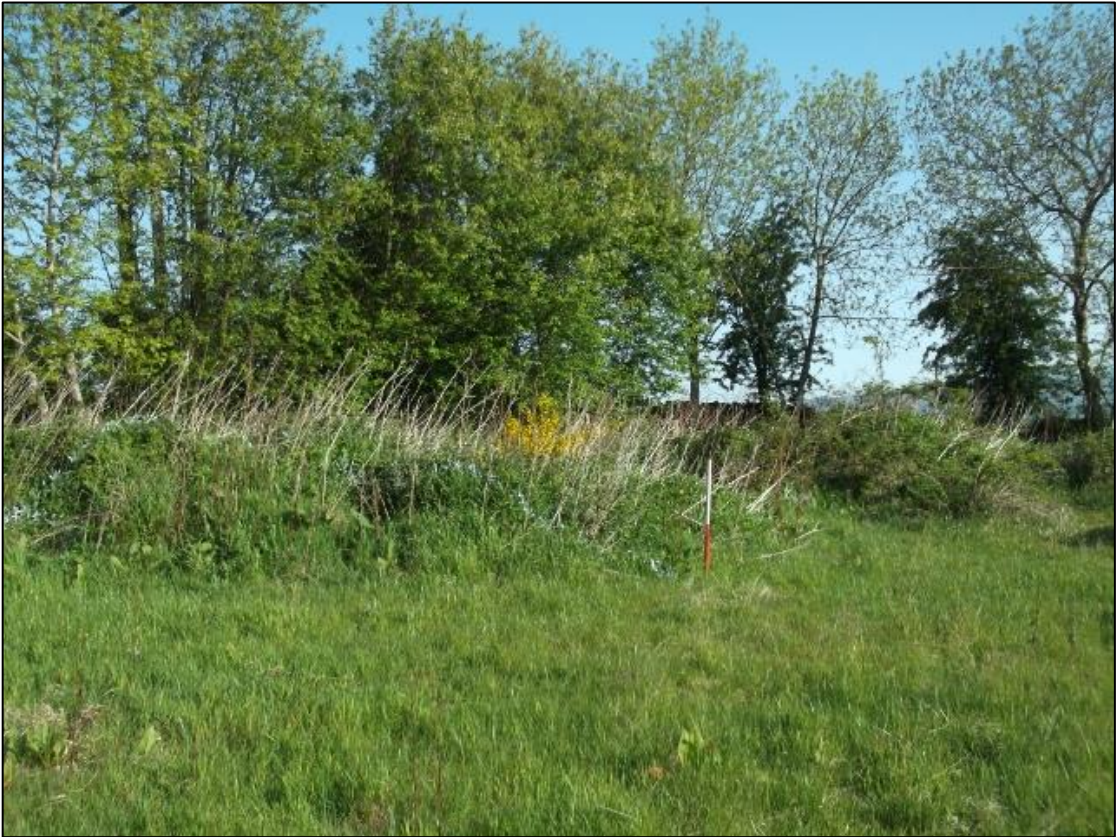
15. The modern bank was orientated in an east to west direction and measured 13.18m long, 0.5-0.32m wide and the height of the bank was between 0.4-0.7m (Figures 2a and 2b).

Figure 2a: View of modern bank (004) and historic building from the SSE

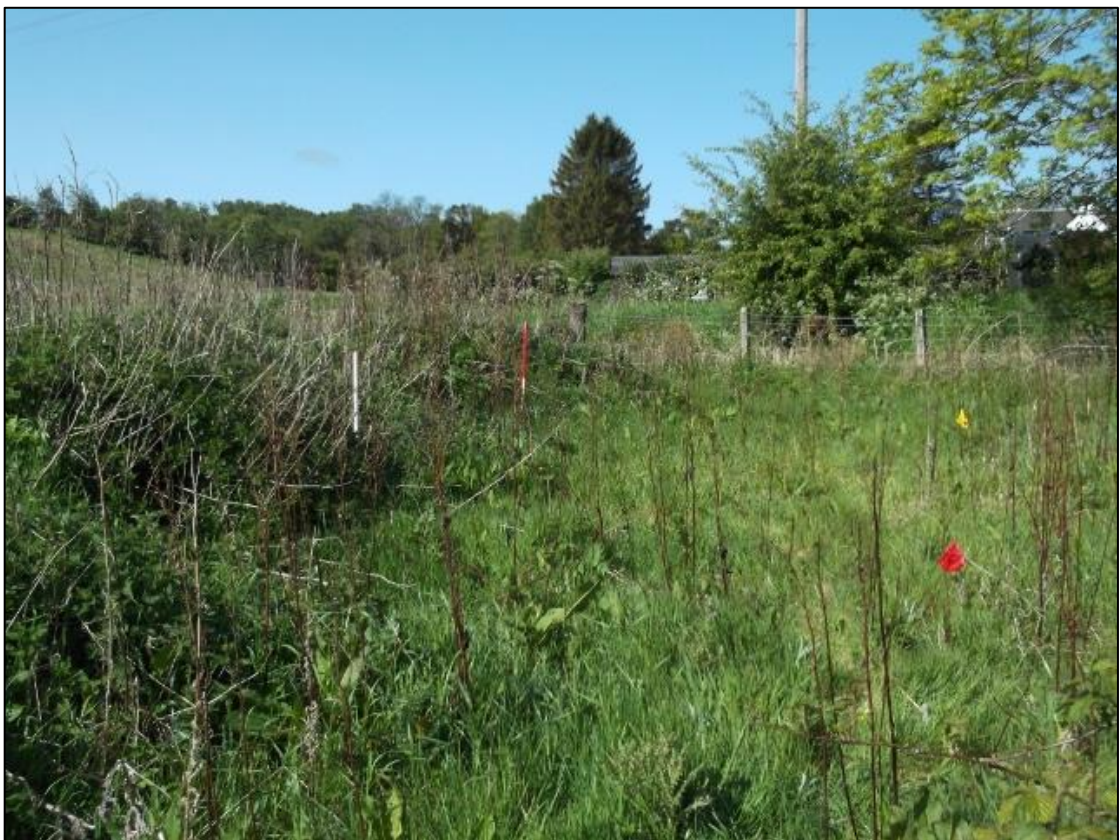
Figure 2b: View of modern bank (004) from the ENE

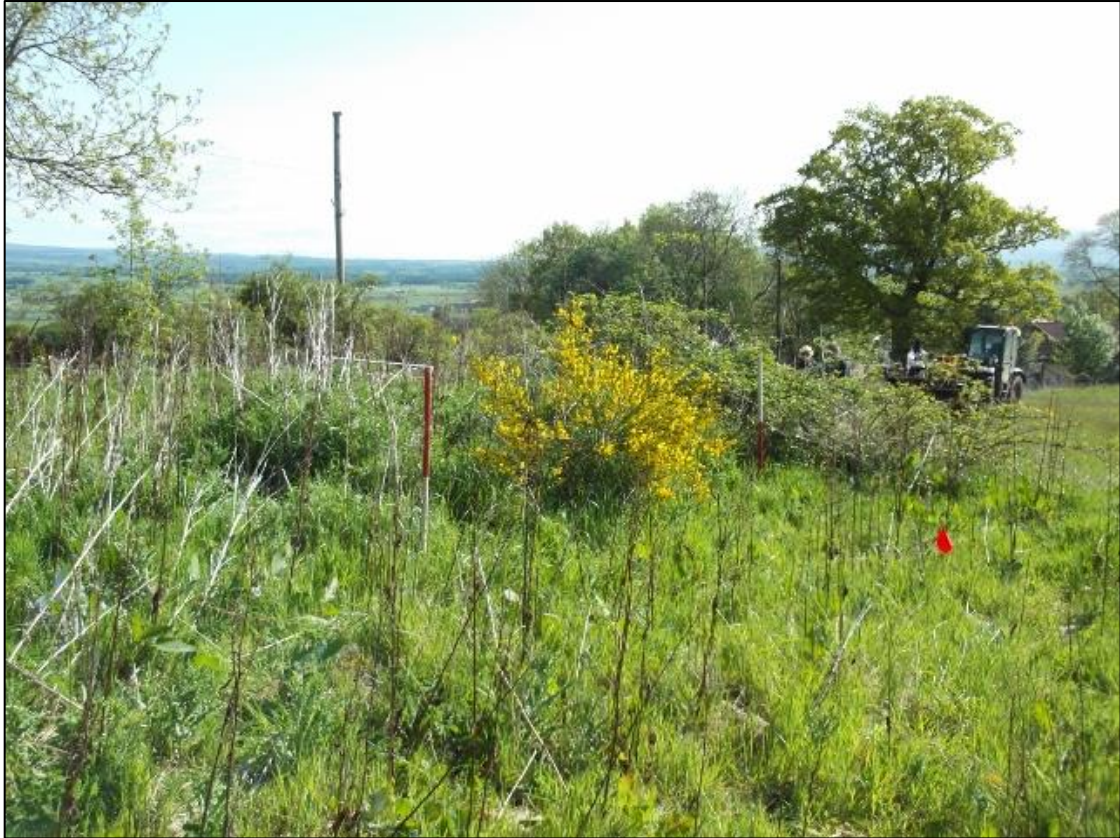
14. The historic building (Figures 2a, 3a and 4b) measured approximately (within the development area) 12.5m from east to west, 11m from north to south and the height of the buildings banks (Figures 3b and 4a) was between 0.4-0.6m. The width of the banks making up the building varied from 1.6m to 3m. The full east to west dimension of the building, including the section within the cordoned off area, would have been 20.9m.

Figure 3a: View of the historic building from the WSW

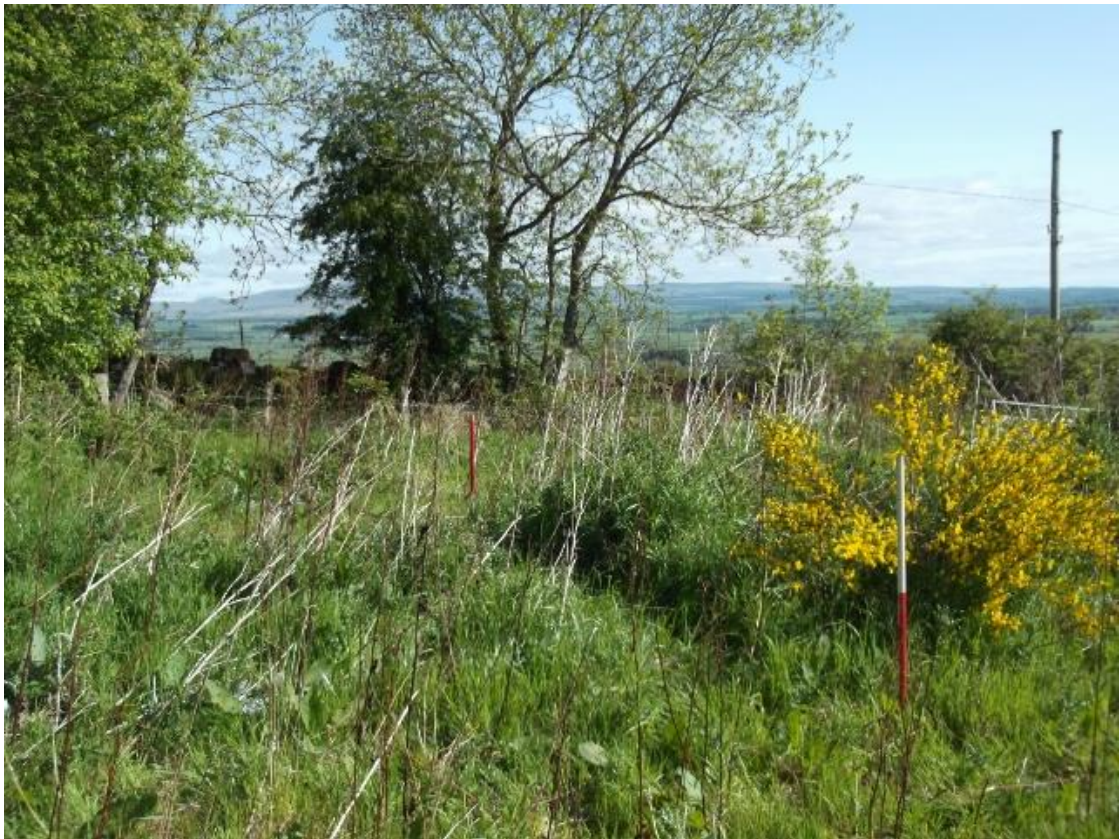
Figure 3b: View of the southern bank of the historic building from the WSW

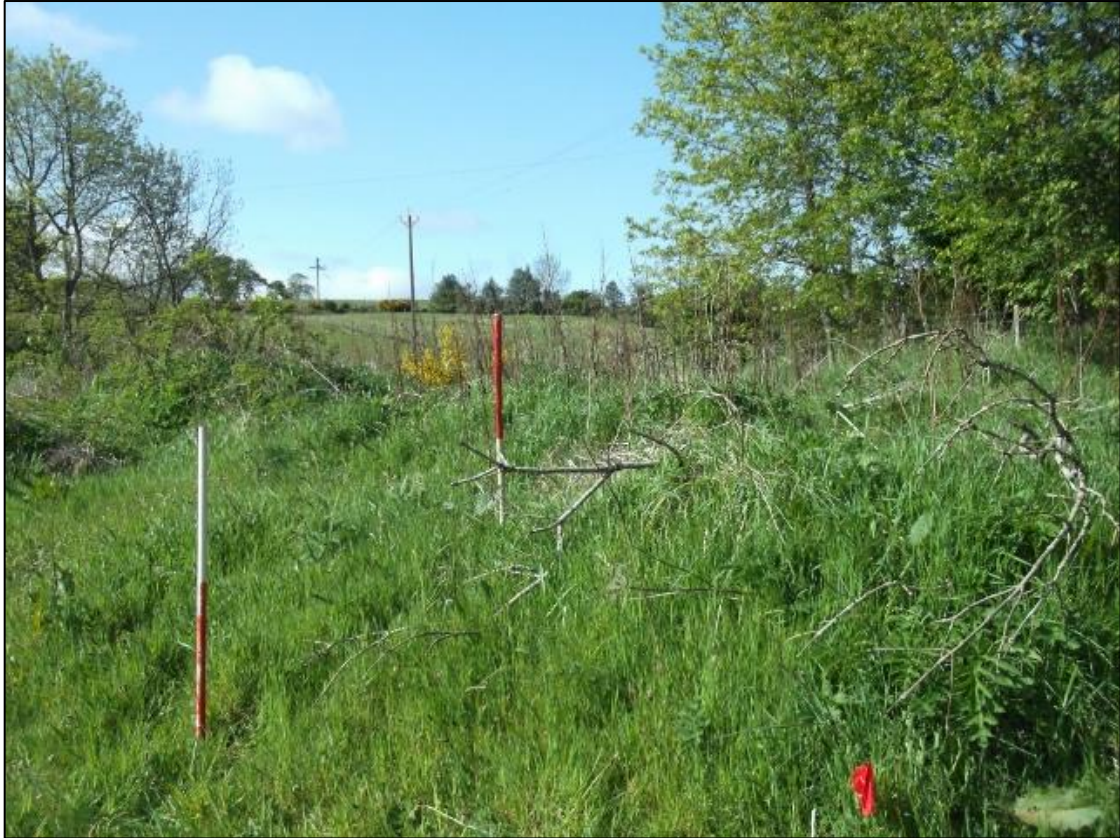
Figure 4a: View of the eastern bank of the historic building from the NE

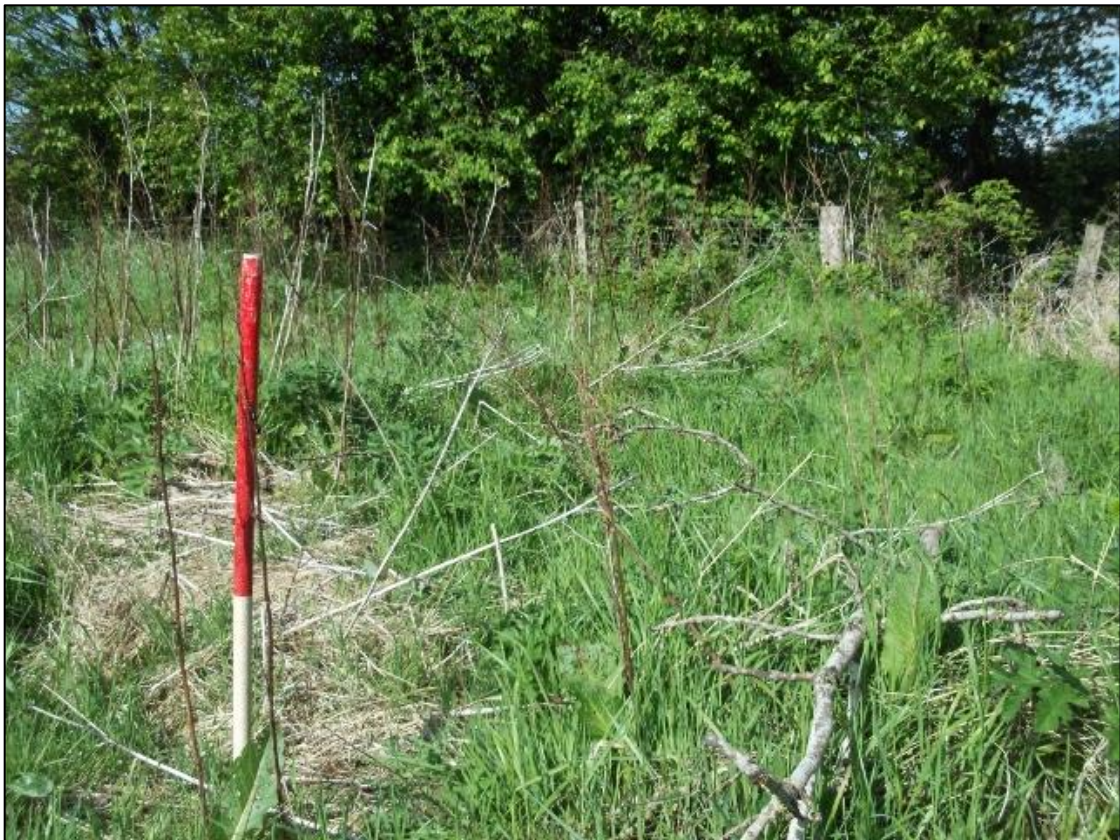
Figure 4b: View of the interior of the historic building with the cordoned area to the rear from the ESE

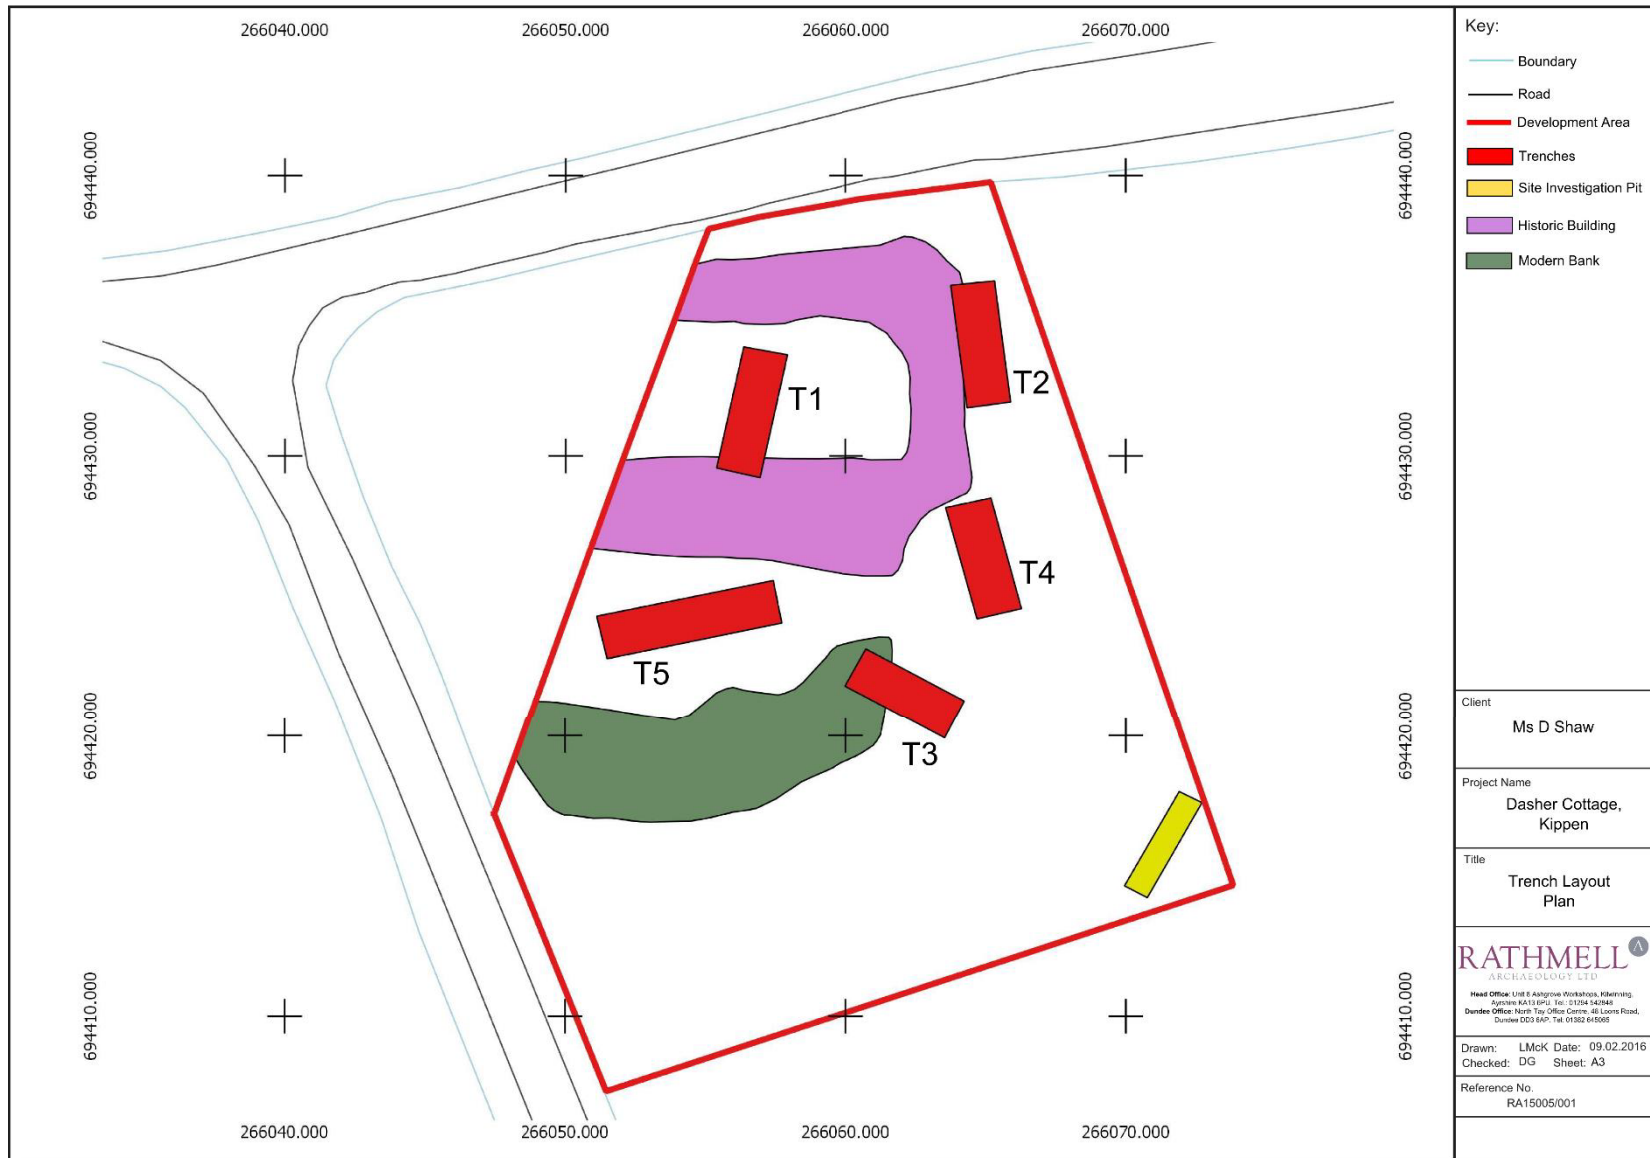
16. In total, 5 evaluation trenches were excavated across the available portion of the development area (Figure 5), using a tracked 360° mechanical excavator with a toothless 1.6m ditching bucket. All of the trenches had to be moved from their intended locations (see table below).
17. A site investigation pit was also excavated (with a 0.6m toothed bucket) within the development area and subject to archaeological supervision.

24. The standing remains of the historic building within the development area (Figure 5) consisted of the eastern part of a rectangular shaped bank, with the other part being within the cordoned off area in the north-western part of the field.

Figure 5: Plan of evaluation trench layout showing the location of the historic building.

31. An archaeologically sensitive area is recognised in the remains of the historic building which survived as a low rectangular shaped bank. This structure appears to have a low level of complexity with no internal or external floor surfaces and minimal material culture. We do not consider this structure to have a significance to warrant its retention, rather an appropriate record should be made during loss. We recommend that any disturbance of this structure by the as the construction works proceed is to be carried out under archaeological supervision to enable an appropriate record of these remains.

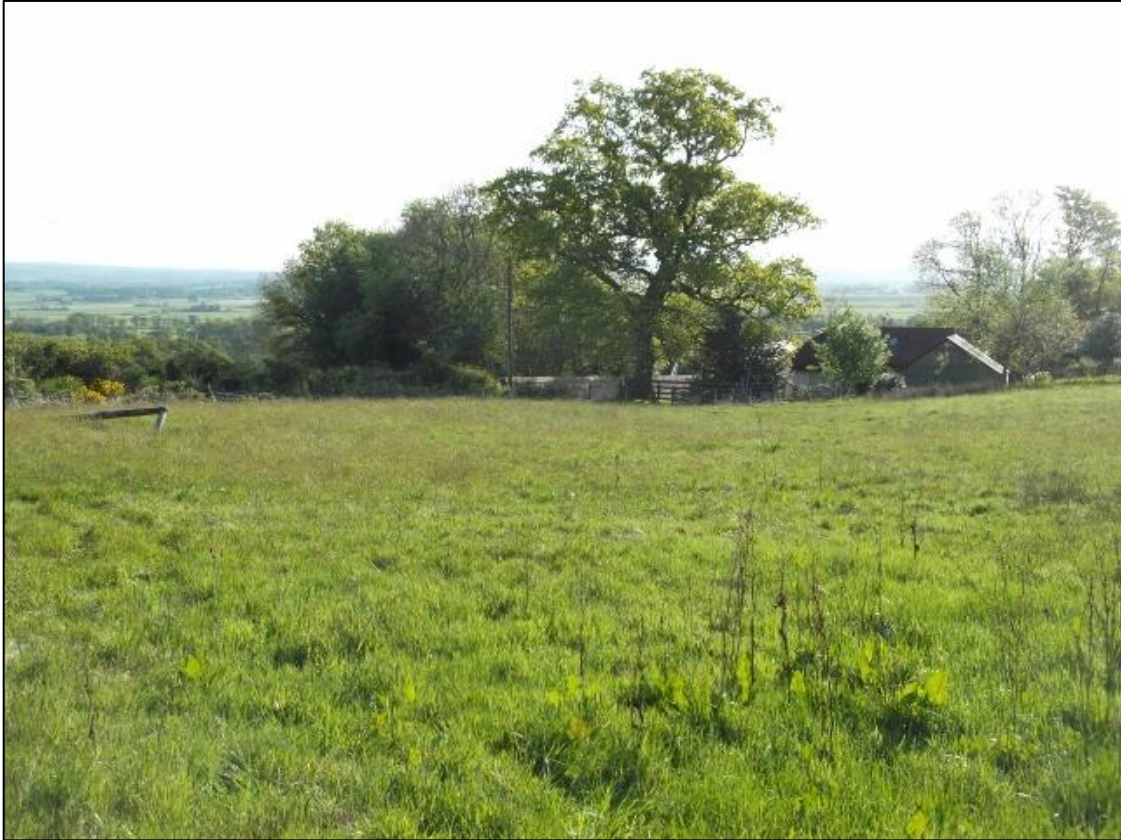
10. The site was located within a rectangular shaped field (Figure 5 and 6a) which was enclosed by a mixture of wire and post fencing and hedgerow. The field dipped down to the S of the development area and rose again further to the S. The historic building was located in the NW corner of the field and could be identified as a low rectilinear shaped bank. To the immediate S of the historic building was a roughly linear shaped bank which ran parallel to the building. Part of the historic building was located within a cordoned off triangle of land in the northwest corner of the field. This cordoned off area contained a number of trees and was overgrown making it difficult to determine the state of preservation of the building remains there.

Figure 6a: Pre excavation view the development area from the WNW

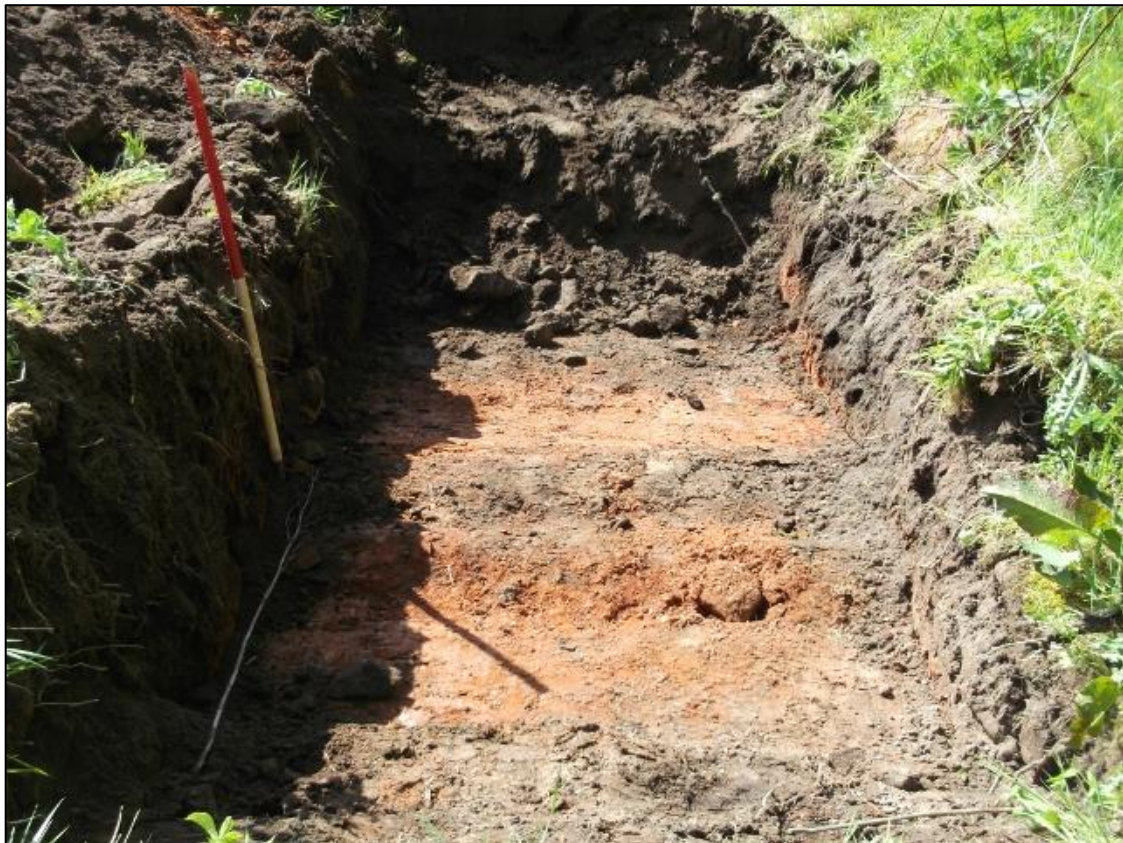
19. The trenches identified a layer, (002), between the topsoil and subsoil which comprised a moderately compacted, mid orange/grey-brown sandy silt with occasional to moderate nineteenth or twentieth century CBM and moderate to frequent small to medium sized stone inclusions (Figures 6b and 7b). The layer had a depth range of 0.3-0.52m.

21. Only two trenches, 1 and 2, were excavated into the historic building and these trenches only clipped the base of the buildings banks in an attempt to assess the banks makeup without drastically cutting into the building (Figure 6b). In both cases the material identified was the layer, (002), which was found in all of the trenches.

Figure 6b: Post excavation view of trench 1 from the N

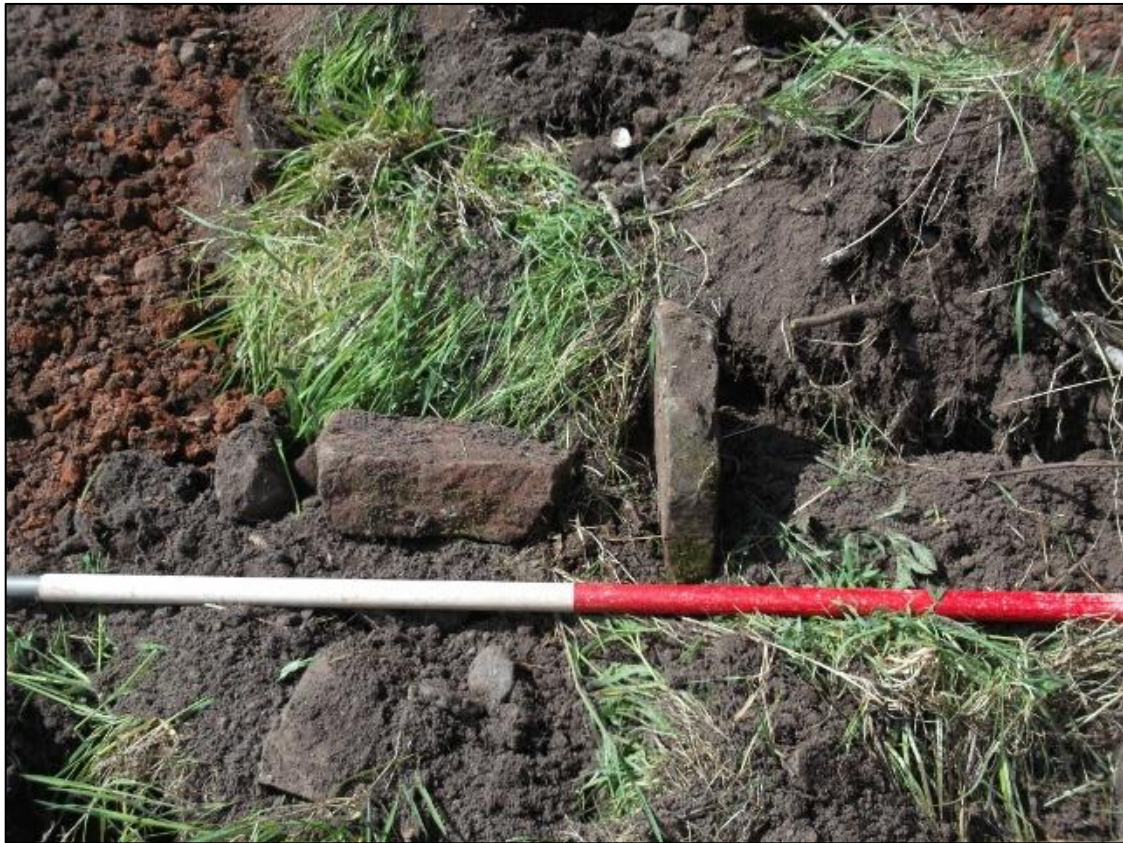
28. Building material identified from within Trench 2 (Figure 7a) it would seem probable that the building was constructed using roughly faced pieces of sandstone, possibly using a drystone method as no mortar was identified within any of the trenches. Trenches 1, 2, 4 and 5, also demonstrated that there was no internal flooring within the building or

Figure 7a: View of building material from trench 2

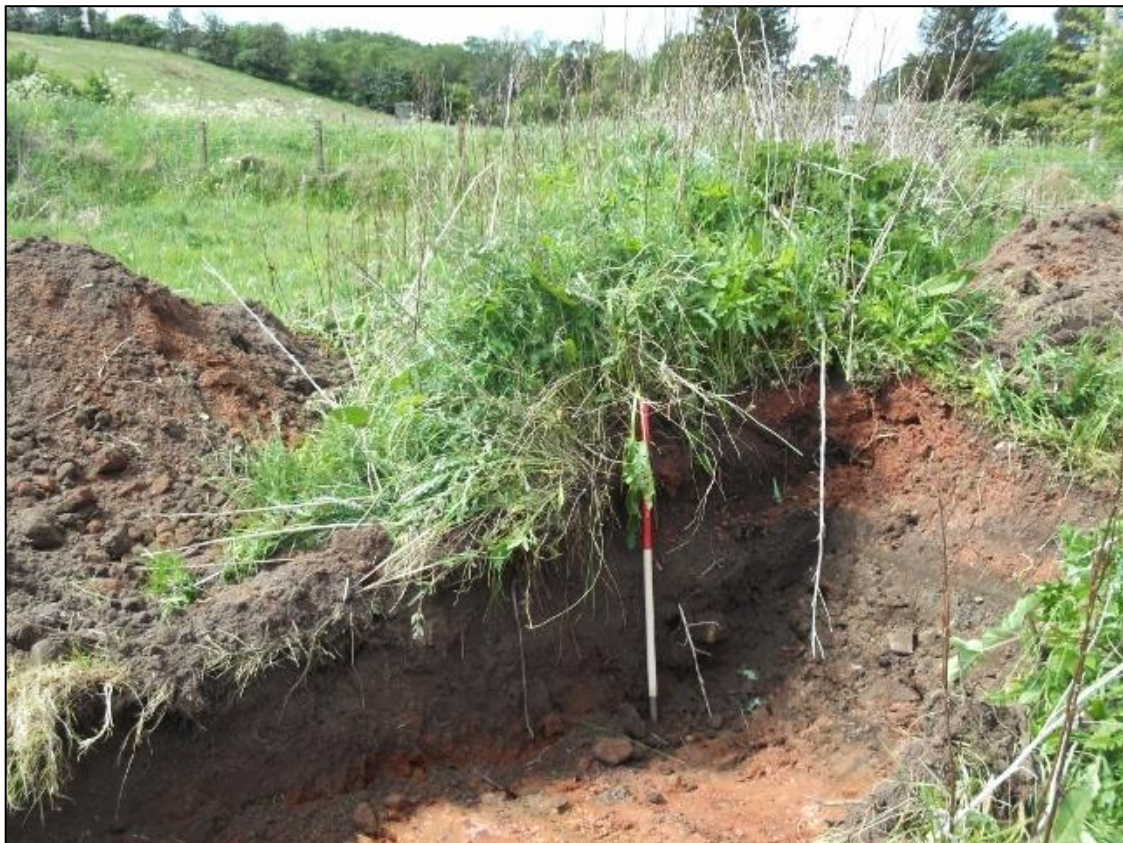
20. Trench 3 (Figure 7b) was excavated through the eastern end of the modern bank, (004). The bank material consisted of loose to moderately compacted, mid to dark grey-brown (with pockets of mid orange-brown) sandy silt with moderate to frequent, small to medium sized stone and occasional nineteenth or twentieth century CBM inclusions. Within Trench 3 the width excavated was 0.4m and its height was 0.42m. The bank also overlay the topsoil layer, (001), suggesting it was a recent deposition.

Figure 7b: Post excavation view of trench 3 showing section through the modern bank. From the NE

29. Trench 3 was placed through the eastern end of the modern bank, (004), to confirm that the feature was modern (pers. comm. D Shaw). The trench showed that the bank material was a mix of topsoil with pockets of what appeared to be natural subsoil. The bank material also overlay the current subsoil surface, (001), which would suggest that the material had indeed been recently deposited (Figure 7b). No obvious excavations could be observed within the development area or in the field as a whole so it seems probable that the material had come from another location.
30. One small sherd of nineteenth or twentieth century pottery was recovered from the demolition layer, (002), within Trench 2.
