11 Kilmarnock Road, Mauchline, East Ayrshire: Archaeological Monitoring

Data Structure Report

issued 13th March 2015

on behalf of Jamieson Blair Ltd

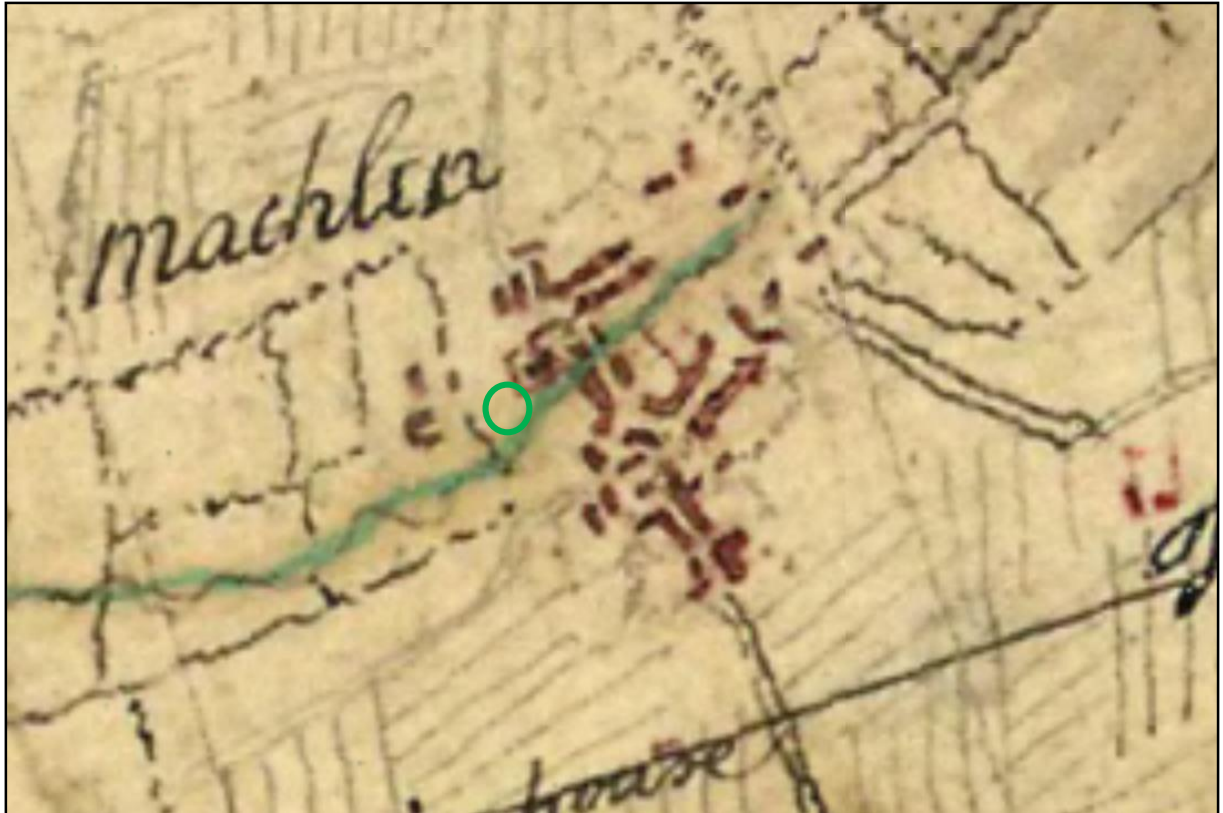
Figure 1a: Roy's Military Survey (Lowlands 1752-55)

9. The best illustration of this is from Roy's Military Survey of Scotland 1752-55 (see Figure 1a) showing Machlin (sic) aligned on a single north-south street with a number of lesser thoroughfares converging on the centre, near the present church (WoSASPIN 7263). The most built-up of these roads leads eastwards on or close to the line of the modern High Street. The greater part of the settlement is shown to lie south of the Mauchline Burn, but a second well built-up street lies on the north side of the burn on or near the alignment of the modern Burnside.

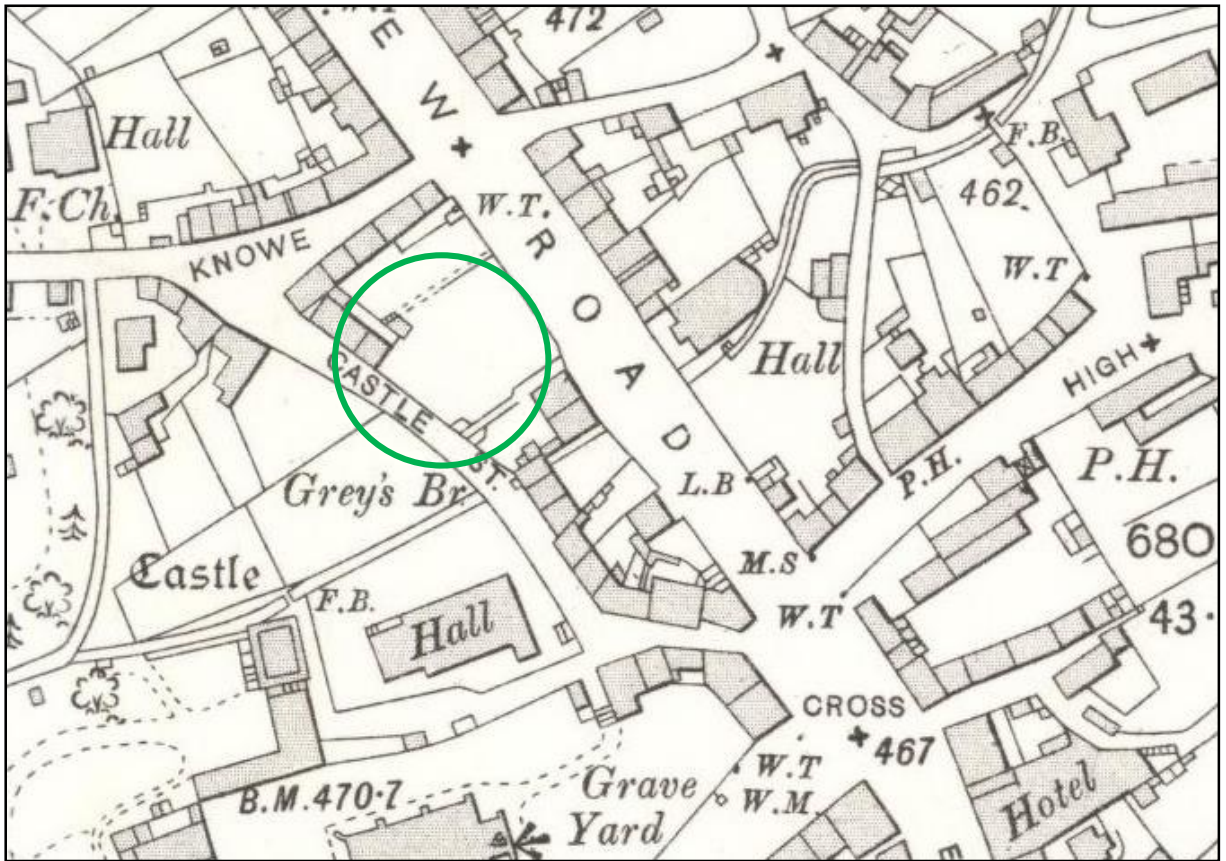
Figure 2a: 3rd edition Ordnance Survey (1909)

11. The development area remains an open plot in the 3rd edition of 1909 (see Figure 2a), there is little change by 1945, the 4th edition Ordnance Survey, (see Figure 2b). The continuity of this frontage between the mid 18th and the present suggests the potential for the development area to overlie much older buildings. Beyond this, there is the potential for evidence of ancillary activity from the medieval and post-medieval period. Such earlier activity is likely to have been compromised to a degree by the later 19th and 20th century structures.

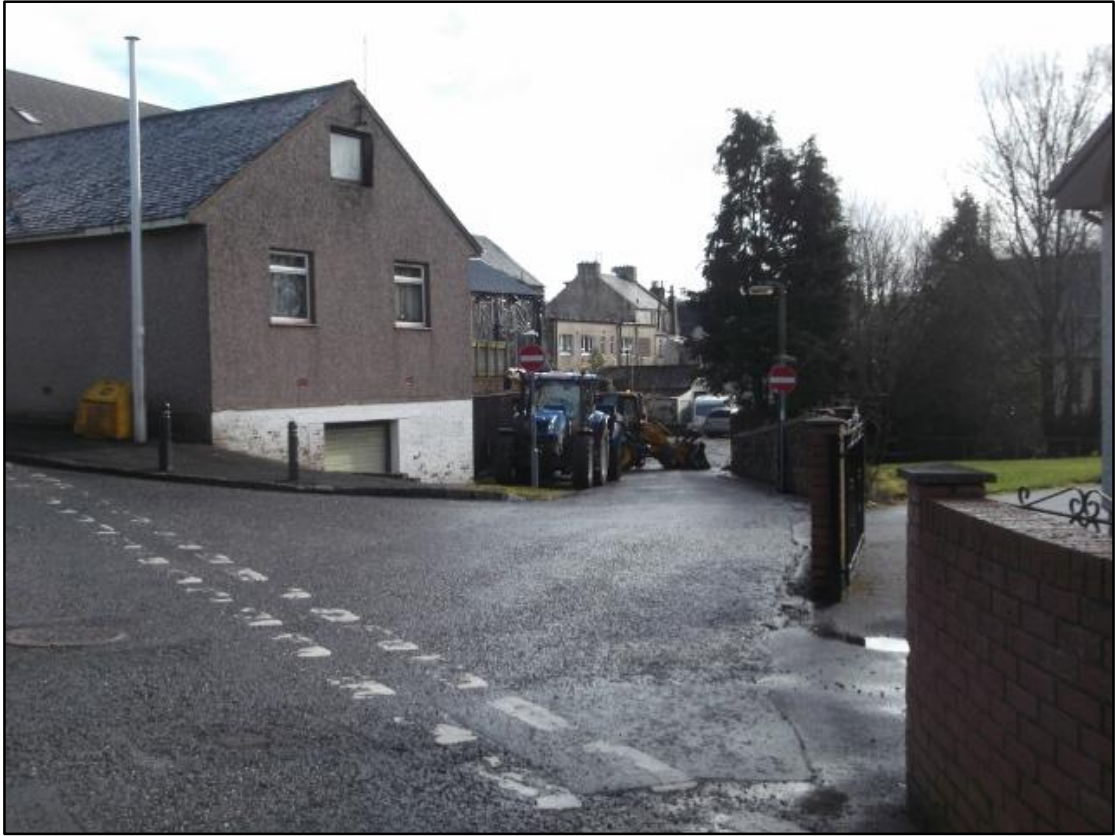
Figure 5a: Site Location, looking onto Castle Street (from WNW)

13. It is important to note at this stage that a height difference of approximately 3m exists between the level of Kilmarnock Road and the level of Castle Street (Castle Street being at the lower level). This seems to have occurred to account for a general sloping of this part of the town from the north (Figure 5a).

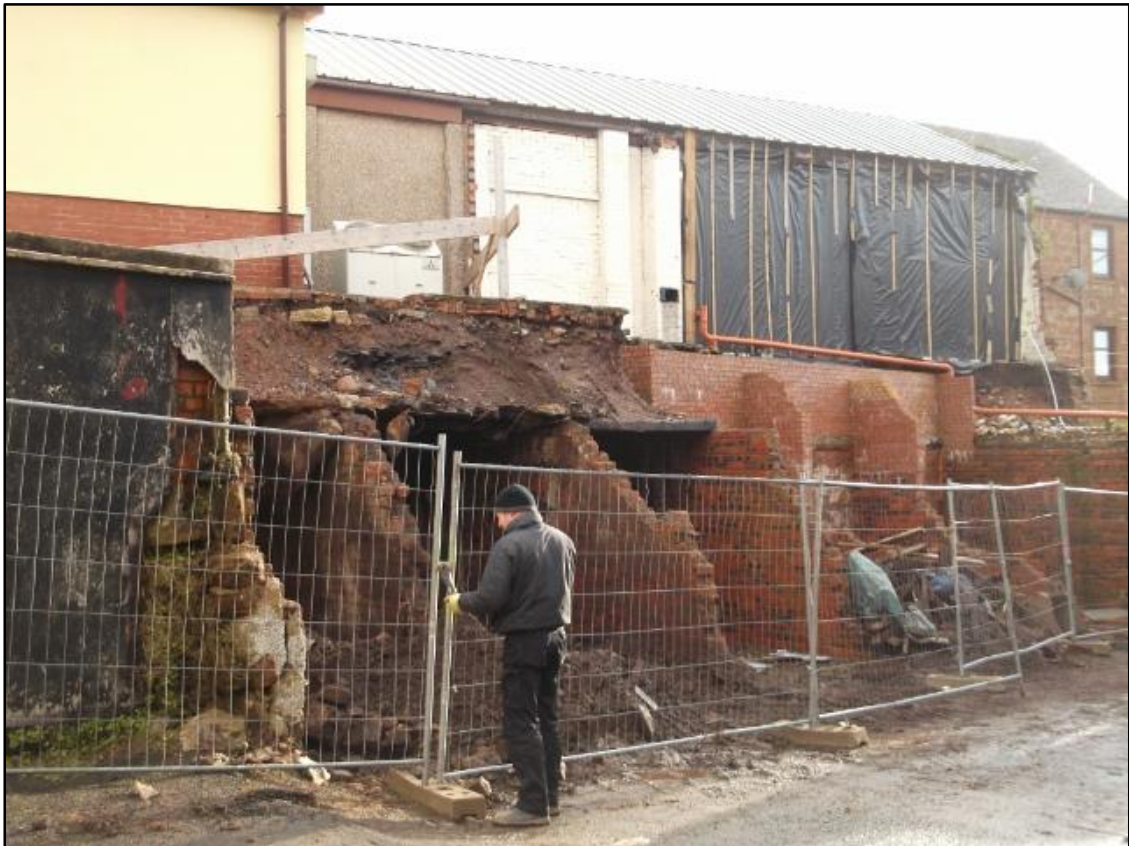
Figure 5b: Lock-ups, and rear of existing building (from W)

12. The archaeological mitigation works took place on Wednesday 4th March 2015, and consisted of the monitoring of the excavation of 6 foundation pits. The excavations were carried out using a JCB 3CX. The development site is located at 11 Kilmarnock Road, and consisted of two areas. Firstly, an existing building at the north-east side of the development (facing Kilmarnock Road) required a new roof. The second area was located to the rear of this building (to the south-west), looking onto Castle Street; it was in this area that the monitoring works took place (Figure 3, Figure 5b).

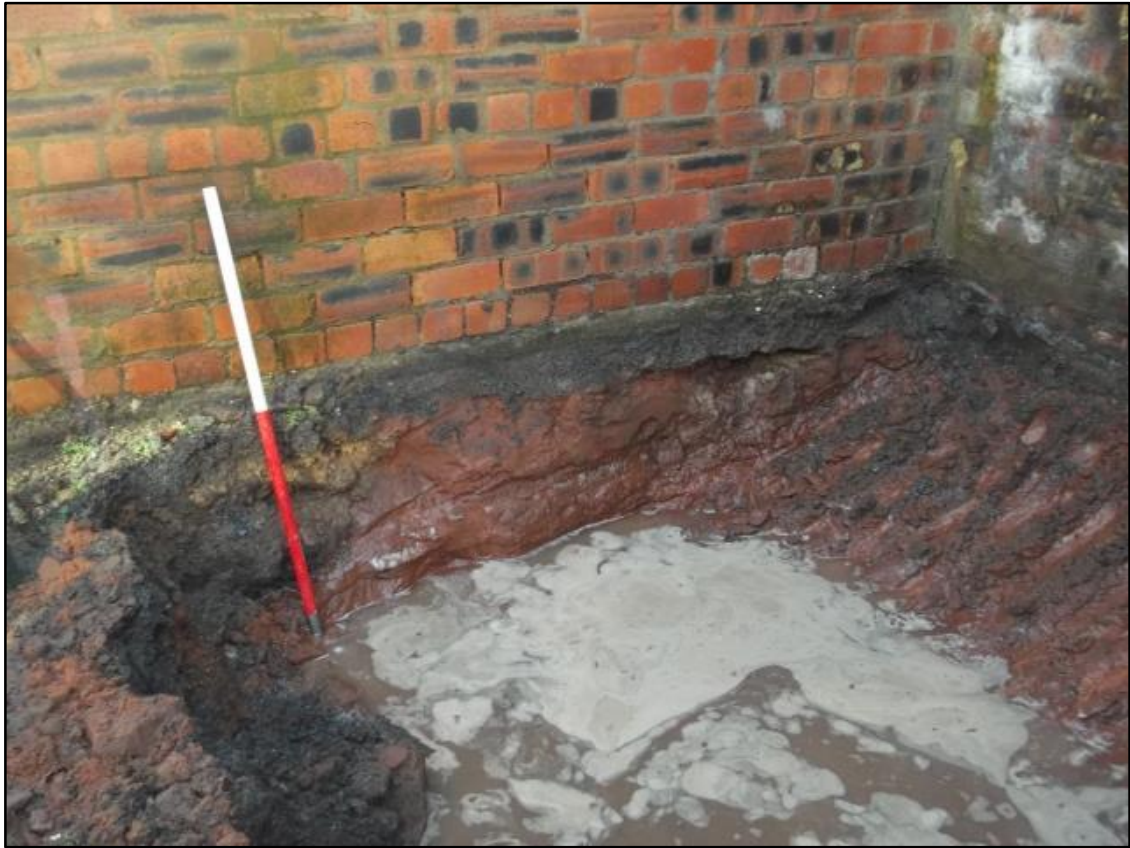
Figure 6a: South-east facing section, Foundation Pit 1 (from SE)

20. Below this, within 4 of the 6 pits (pits 2 to 4 and 6), the excavation came down immediately onto bedrock (002), which was excavated to varying depths. One of the pits (pit 1) showed a similar situation over most of its extent, with 0.1m of (001) overlying bedrock (002). However, at the western corner, two further deposits were also exposed prior to the excavation encountering bedrock (Figure 6a).

21. These were deposits (003) and (004), which occurred in an area measuring 0.4m by 0.45m on plan. A deposit of (001) 0.1m thick was found above 0.3m thickness of deposits (003) and (004), with bedrock encountered at a depth of 0.4m below the top of the current ground level. Both (003) and (004) look to be levelling an area of natural slope within the bedrock. Deposit (003) consisted of yellow, coarse silty sand and measured 0.1m maximum thickness, with no visible inclusions. Deposit (004) consisted of brown silty, coarse sand again, with fragments of bedrock; the deposit measured 0.2m maximum thickness.
