**Tolbooth Grange, Kilmaurs,  
East Ayrshire:  
Archaeological Mitigation**

Data Structure Report

issued 14<sup>th</sup> December 2015

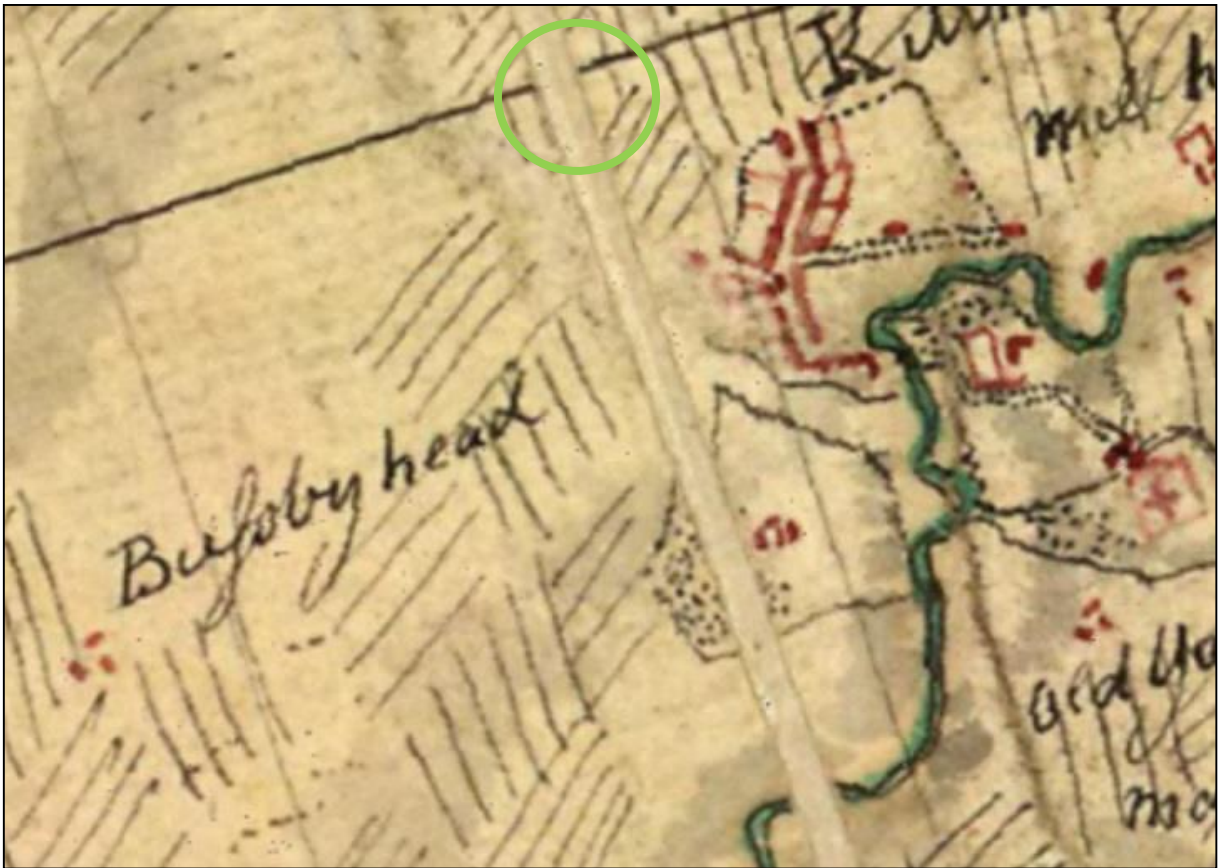
Figure 1a: Roy's Military Survey of 1752-55

6. Superseded mapping gives very little indication of the archaeological potential for the development area but does show the progress of urban and agricultural development in the immediate surrounding area. Roy's Military Survey of 1752-55 (Figure 1a) shows the development area as improved agricultural land to the west of the village of Kilmaurs (shown as Killmarse). The village is recognisable as the shape of the main street reflects the shape of the modern A735. The farmstead of Busbyhead is shown to the south-west, a place name which is still in use (as Busbiehead) today.

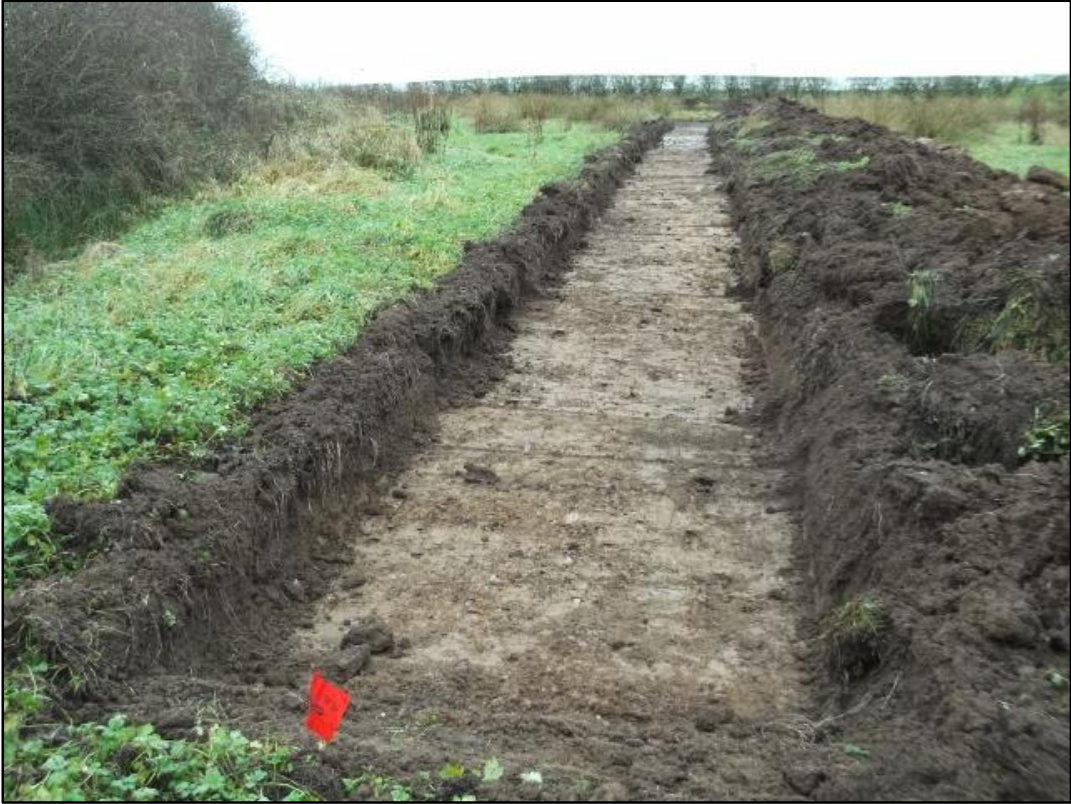
Figure 4a: Trench 4 from the North East

22. A series of linear features [004] were recorded within Trenches 3, 4, 5, 6, 7 and 8. These were aligned north-east to south-west; except in Trench 8, where they ran north-west to south-east. They varied in width from 2 to 3.5m and were approximately 6m apart, measured from each centre line. The features were shallow, generally measuring 50mm in depth, and filled with a mid-brown silty clay deposit containing occasional small sub-rounded and sub-angular stones and frequent coal pieces.

28. The linear features identified in Trenches 3, 4, 5, 6, 7 and 8, given their form and regularity within the trenches, are most likely to have resulted from agricultural works, specifically, ploughing. The furrows appear straight and narrow in form, suggestive of 'straight rig and grooving' which is attributed to the Improvement phase of arable agriculture in Scotland (18<sup>th</sup> century AD onwards) (Barber 2001, p18). Due to a lack of datable artefacts, the date of these features cannot be clarified with more certainty, but it seems possible these represent plough furrows of a reasonably modern date (Barber 2001).

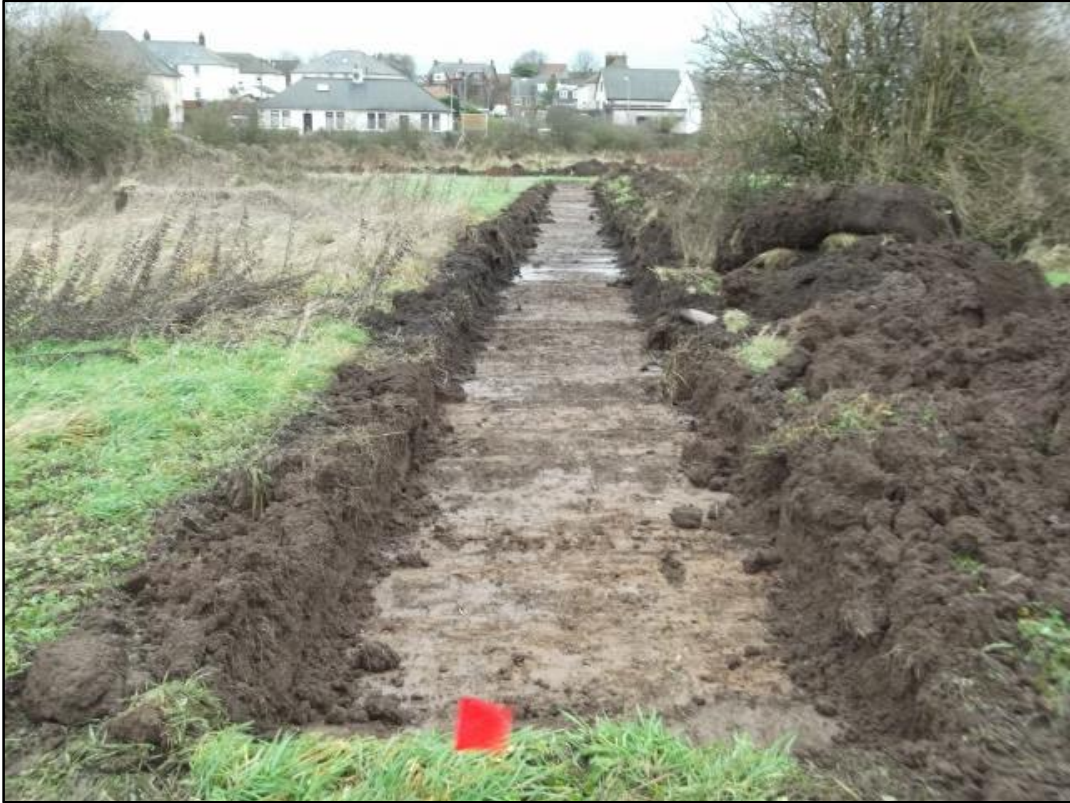
Figure 5a: Trench 16 from the South

24. A deposit of material, (010), was recorded within Trench 16, located between +10m and +19.4m. The deposit measured 250mm in thickness, and consisted of a mixture of crushed bitumen, crushed red brick fragments, glass shards, modern redware pottery sherds and small to medium sub-rounded and sub-angular stones. Stratigraphically, this was found to sit immediately below topsoil (001), and above natural subsoil (003), and was not noted within any other trenches.
