Limonds Wynd, Newton-upon-Ayr: Archaeological Monitoring

Data Structure Report

issued 15th June 2016

on behalf of Ayrshire Housing

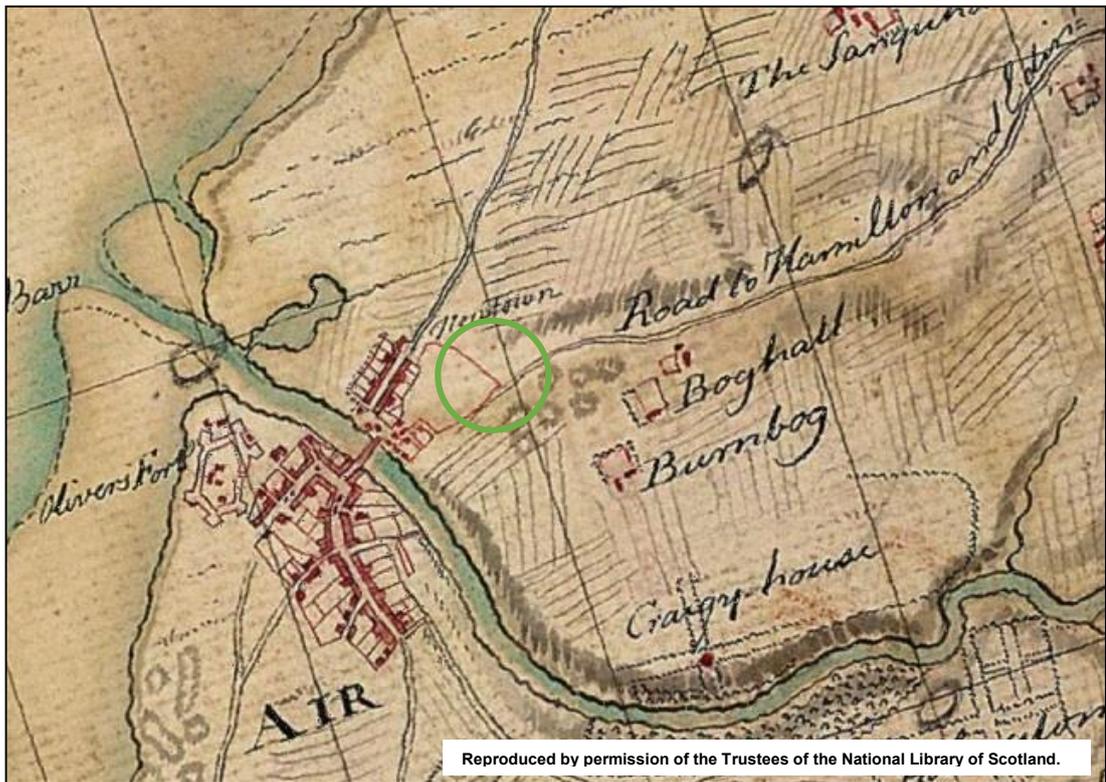
Figure 1a: Extract from Roy's Military Survey of Scotland (1752-5)

9. There are no specific known heritage assets within the development area. Roy's Military Survey of 1752-55 (Figure 1a) shows the town of Ayr (spelt 'Air') on the south of the river and with the High Street and Main Street already present. Ayr Citadel, built by Cromwell, is shown just to the west of the town and labelled 'Oliver's Fort'. Over what is now the Auld Brig and to the north of the river is the 'Newtown', which at this time comprises a single street on a roughly NNE-SSW axis which is lined on both sides by long burgage plots featuring continuous street frontages directly overlooking the street. To the south and south west, there are additional structures laid out in a less formal fashion, with an enclosed area lying to the north-east.

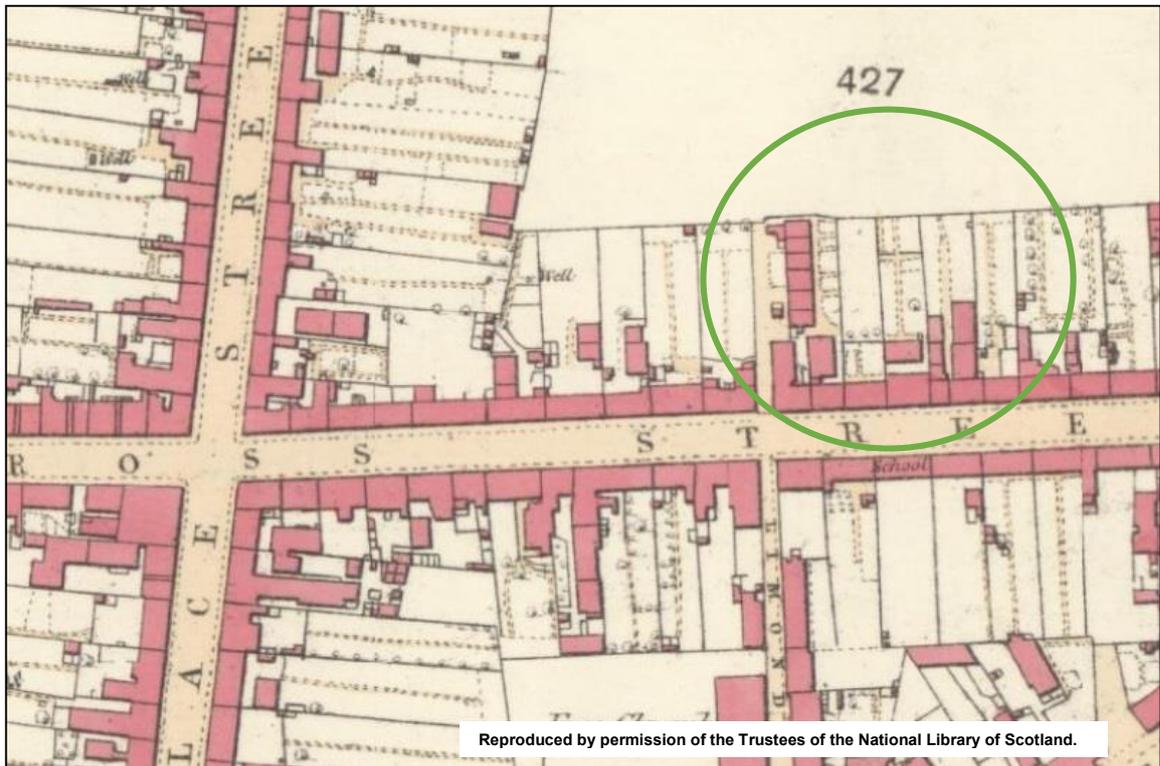
Figure 1b: Extract from the Ordnance Survey 1st edition Town Plan of Ayr

11. From these modest beginnings, the burgh appears to have been subject to steady expansion throughout the late 18th and on into the 19th century. This is attested through comparison between Roy's map and later 1st edition Ordnance Survey mapping of the area. The 25-inch Town Plan published in 1860 (Figure 1b), shows the presence of King Street (A719) (there marked as 'Cross Street'). Building plots have been laid out along both sides of Cross Street, with the development area located immediately to the east of a lane running back from Cross Street and terminating at the open (?agricultural) ground to the rear: though unnamed, this lane may represent the north end of Limonds Wynd, which continues south of Cross Street and may predate the creation of Cross Street, though this is by no means certain.

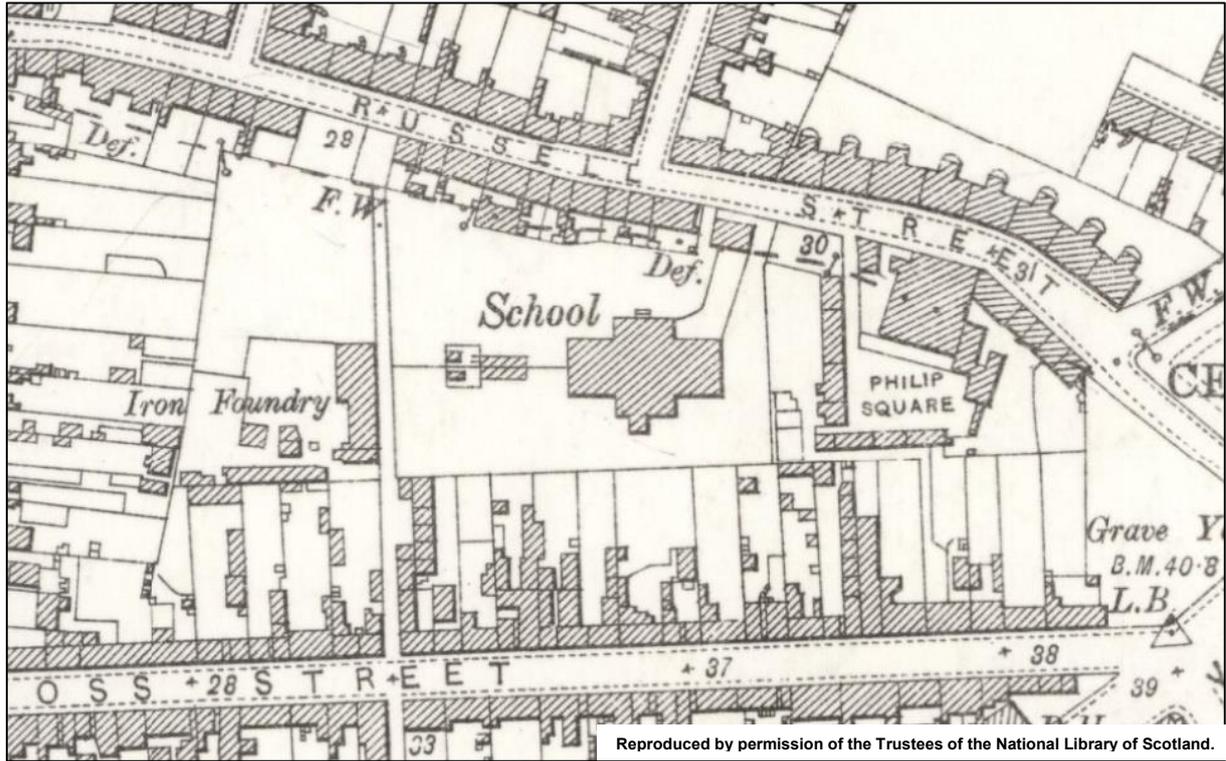
Figure 2a: Extract from the 2nd edition Ordnance Survey map of 1895

13. The 2nd edition Ordnance Survey map of 1895 depicts the first appearance of the school building, occupying an expanse of land lying to the rear of ten building plots extending eastwards from Limonds Wynd (Figure 2a). In addition to the school building itself, there are several ancillary structures, located on either side of a wall which subdivides the school grounds, presumably along gender lines. There is also a rectangular structure, perhaps a janitor's house, at the entrance. The 2nd edition map also shows substantial development to the north of Cross Street with the creation of Russell Street.

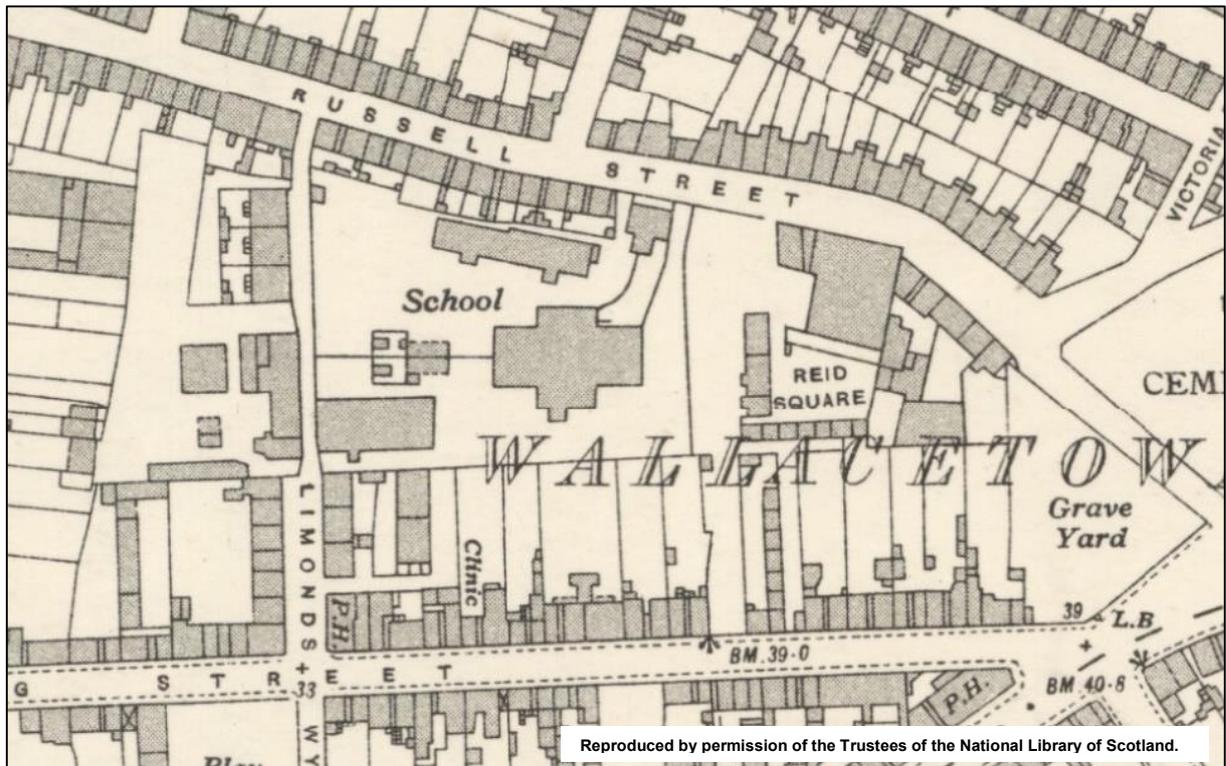
Figure 2b: Extract from the 4th edition Ordnance Survey map of 1935

15. By the time the 4th edition Ordnance Survey map was published in 1935, the southern half of the site was largely built over, with most of the two southern-most plots now mainly infilled. The area to the north which contained the school, however, still remains mostly devoid of structures. Two fairly substantial structures have, however, been built within the grounds, one in each of the two segregated areas of the school. These may reflect additional school buildings, perhaps built to accommodate infants or primary school attendees.

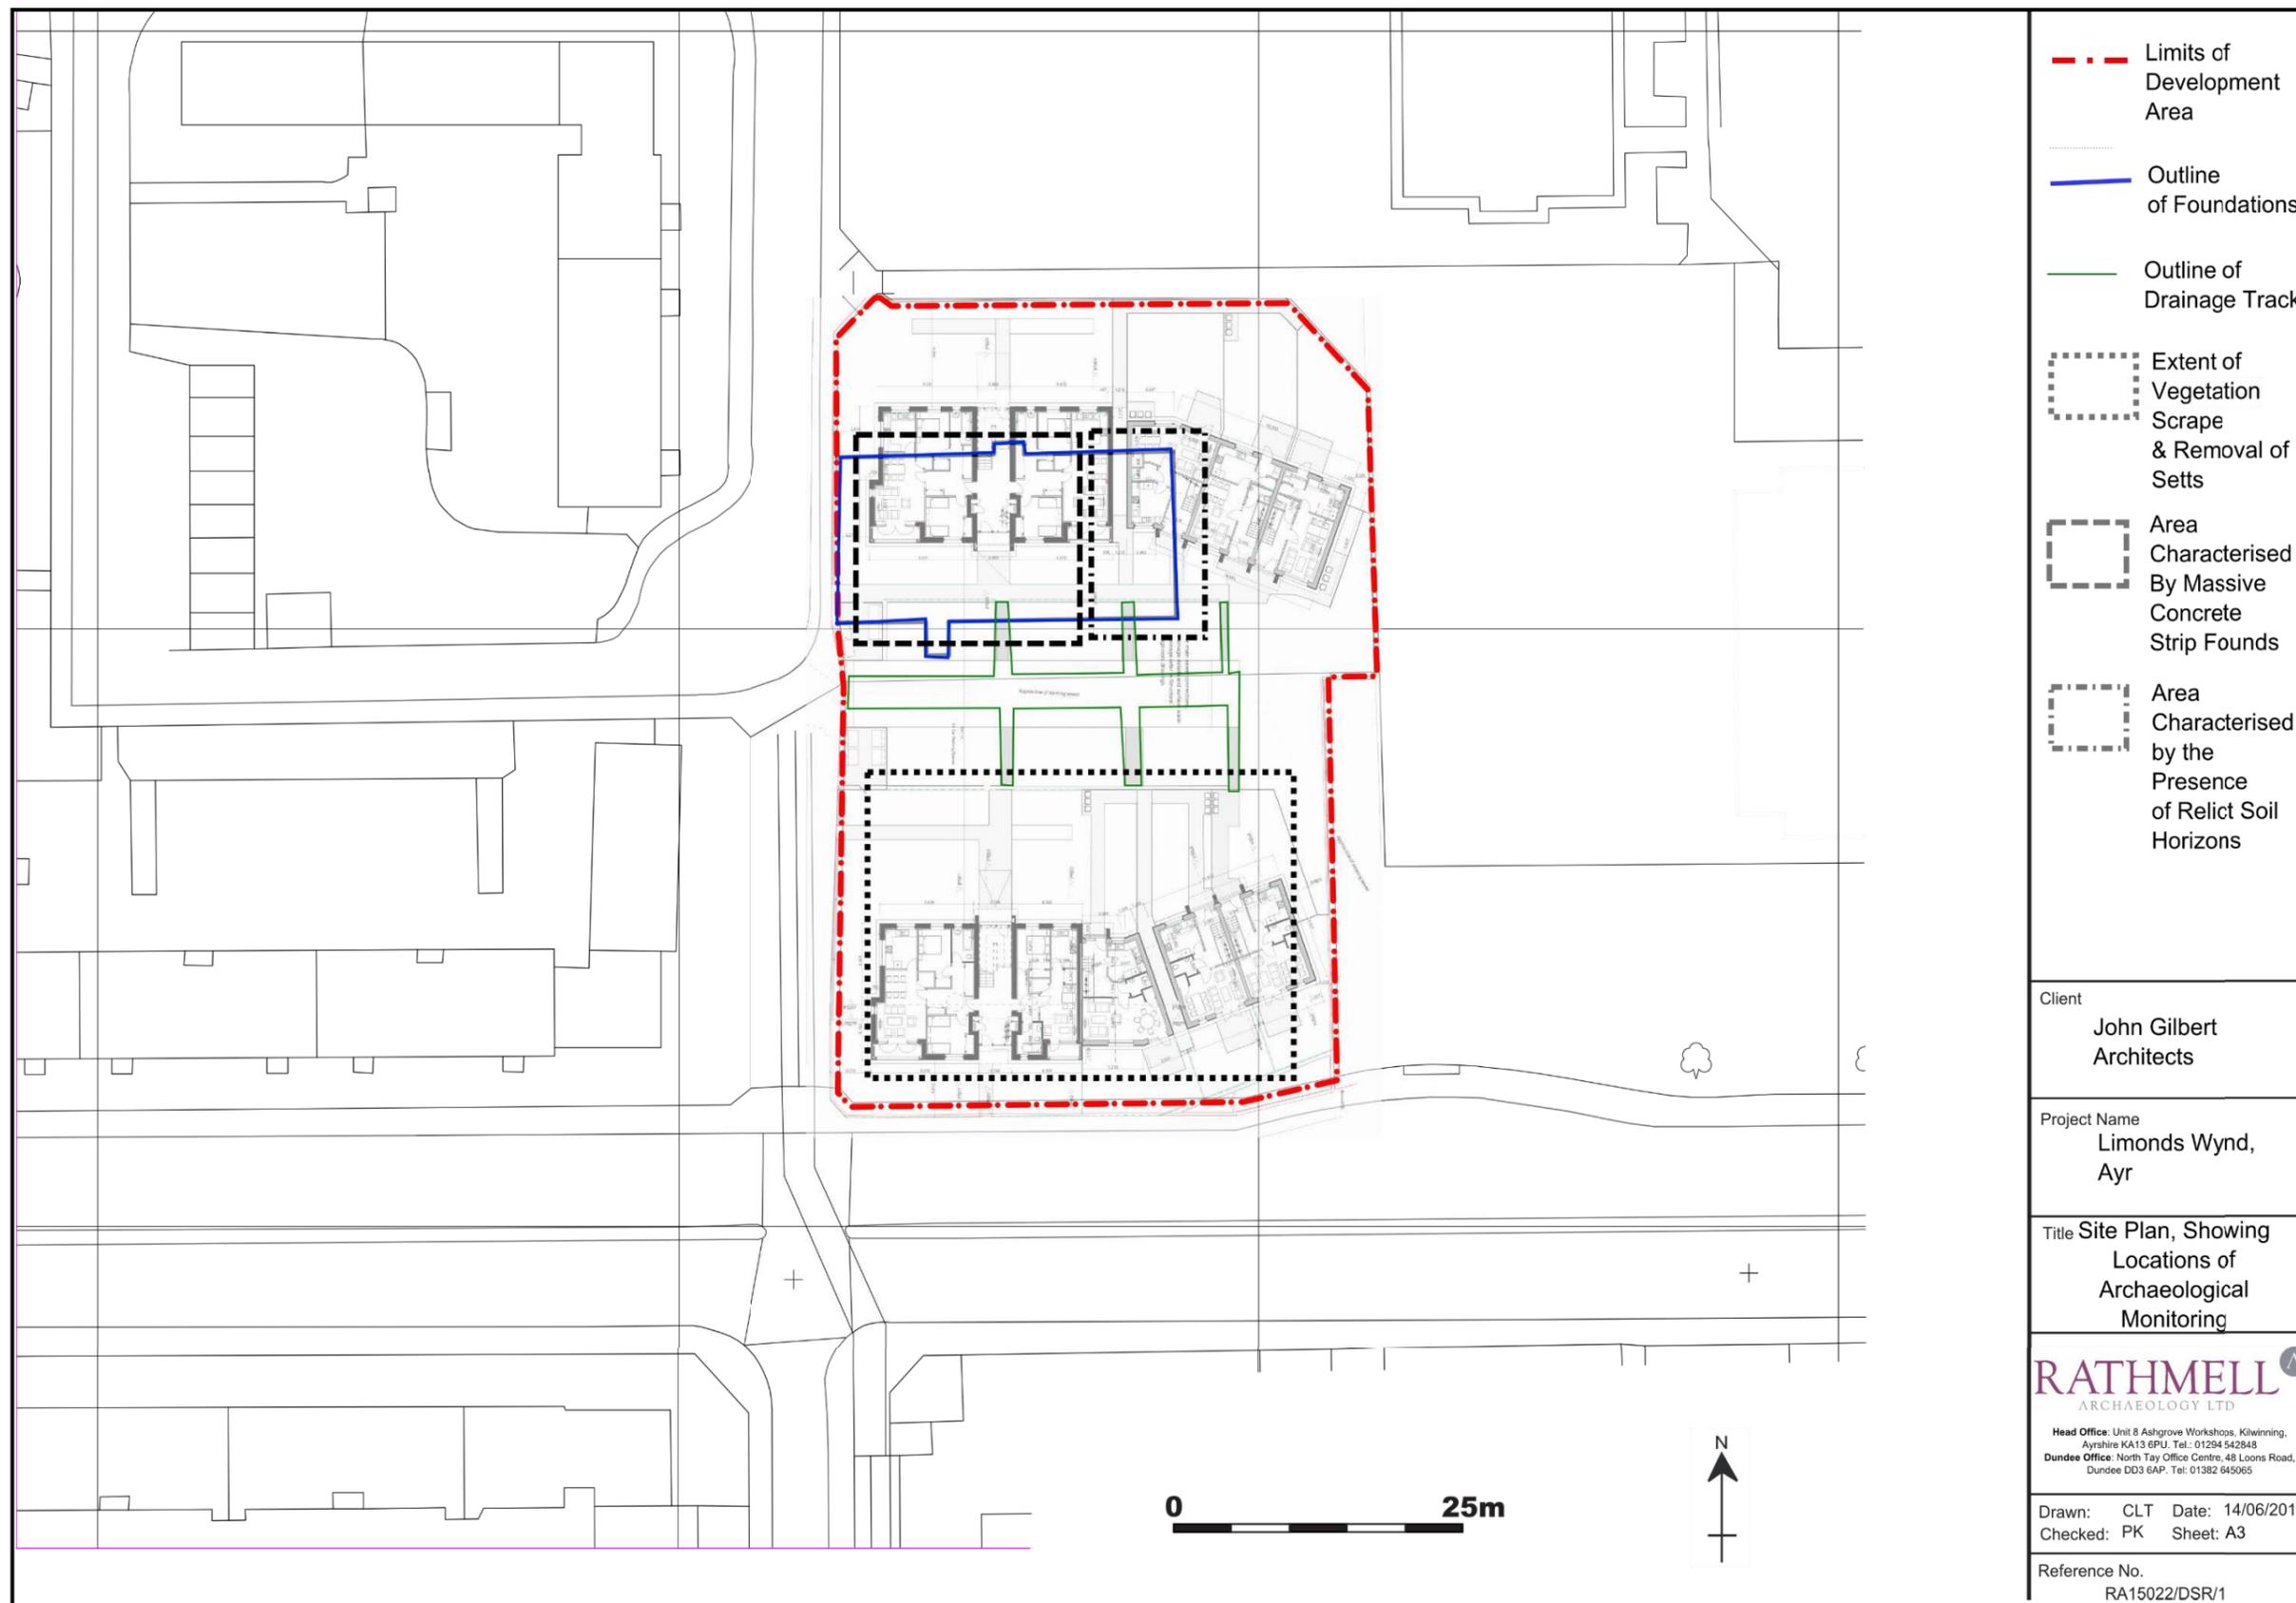
Figure 3: Site Plan

28. Sufficient observations were made, however, to establish a sound understanding of the underlying sediments, and also to map those areas where levels of preservation were better and where, by contrast, they were poor and subject to previous disturbance. The method of excavation was by necessity rough and brutal, but it was clear that the initial foundations would, in the first place, have resulted in the destruction of any archaeological features directly underlying the line of the building. Any observations relating to old ground surfaces, etcetera, had instead to be made through observations in section of those portions of fresh ground cut on either side of the earlier founds.

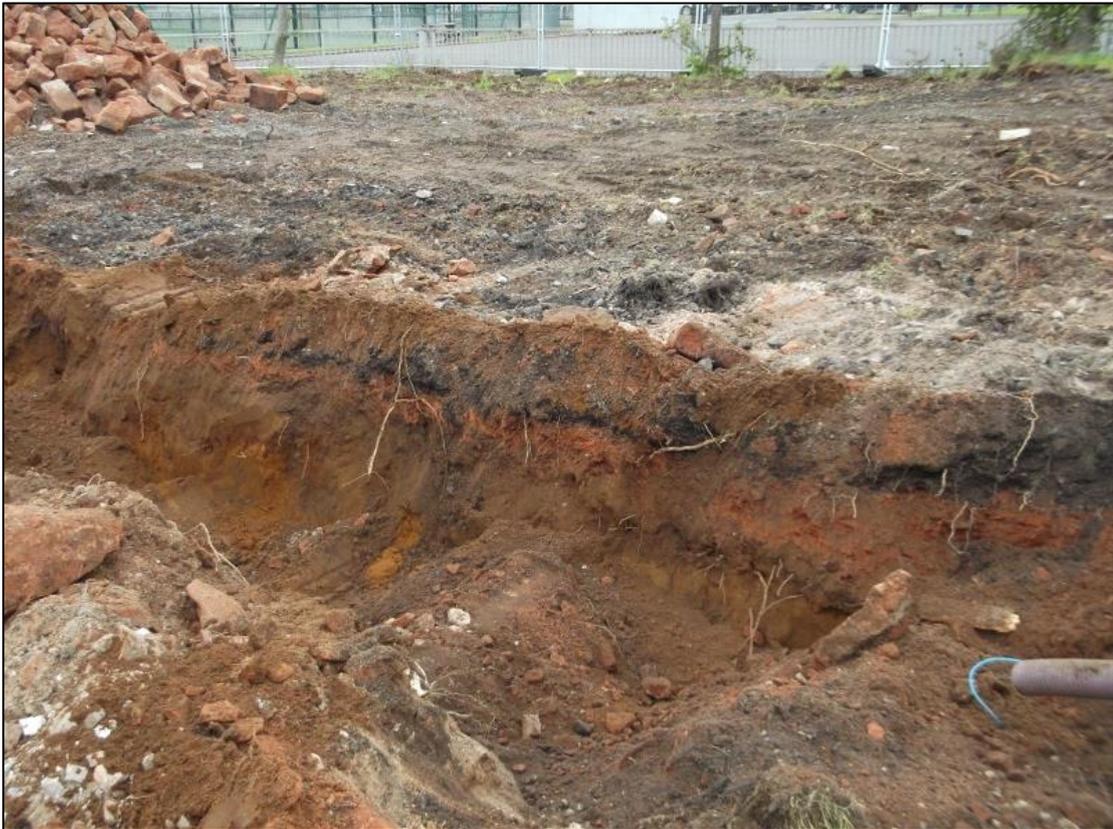
31. Across the full extent of this area, a similar profile was revealed. Made ground of recent date formed the uppermost half metre depth of deposits. Typically, this comprised a humic layer of topsoil (001) 0.2m deep, overlying a layer of crushed pink sandstone (006) 0.3m deep, which comprised the demolished remnants of the school building. Deposit (006) in turn overlay a dark brown sand (007) which varied in depth between 0.3 and 0.5m, and which was quite rooty and humic in character (Figures 3a and b). This in turn overlay a sterile yellow-brown sand (002) which was interpreted as the natural subsoil. It was uniform in colour throughout its depth, suggesting that it was not composed of accumulated layers of windblown sand typical of the aeolian sands which proved so troublesome to the burgh of Ayr during its early history.

Figure 4a: Soil Profile, E side of Site (W-Facing)

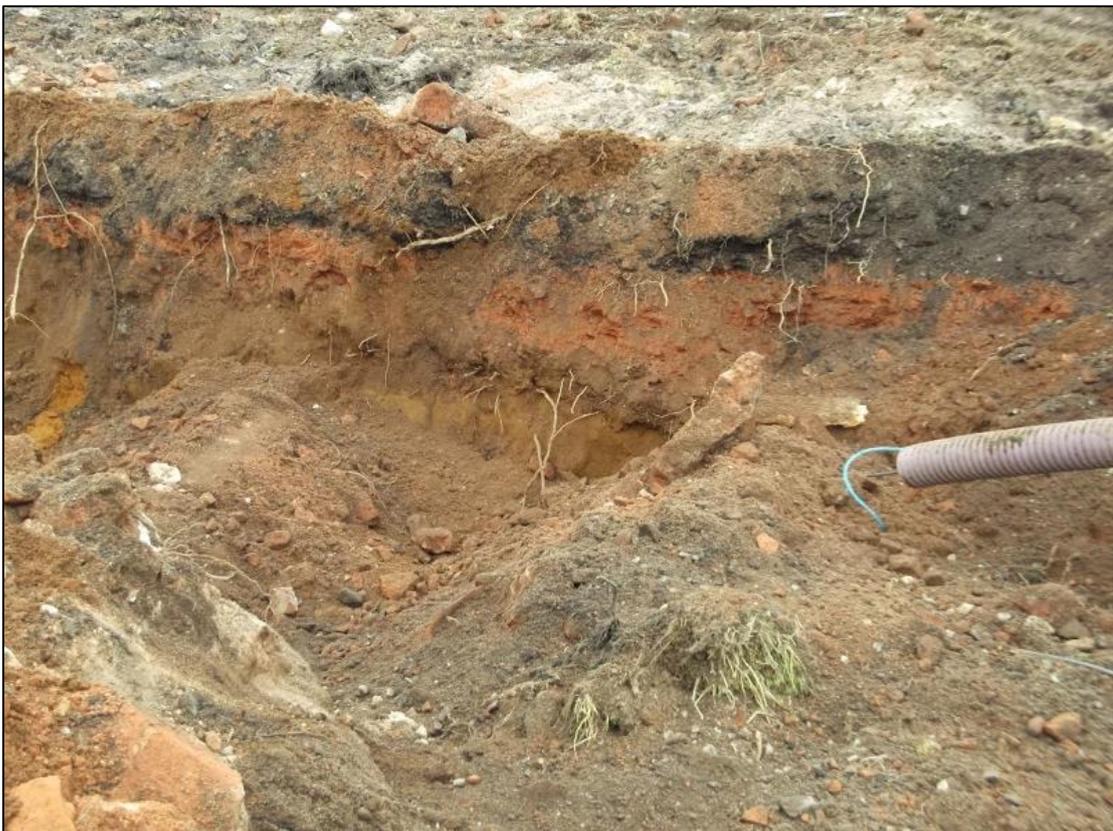
32. The interface between (007) and (002) was ragged and uneven, with small deposits of (007) extending to a depth of 0.1m into (002) on a regular basis. These deposits could have been interpreted as stakeholes, but their random and yet consistent presence, their shallow depth, and their relatively broad profile at the upper levels, combined with a complete lack of any other evidence for anthropic activity, suggested that these features owed their presence to natural agencies, in particular mixing and sorting at an interface between soil horizons caused in part by root disturbance and exaggerated by worm activity. This in turn suggested that (007) had once functioned as a topsoil, now buried following later activity on the site.

Figure 4b: Soil Profile, E side of Site (W-Facing) – detailed view of sediments

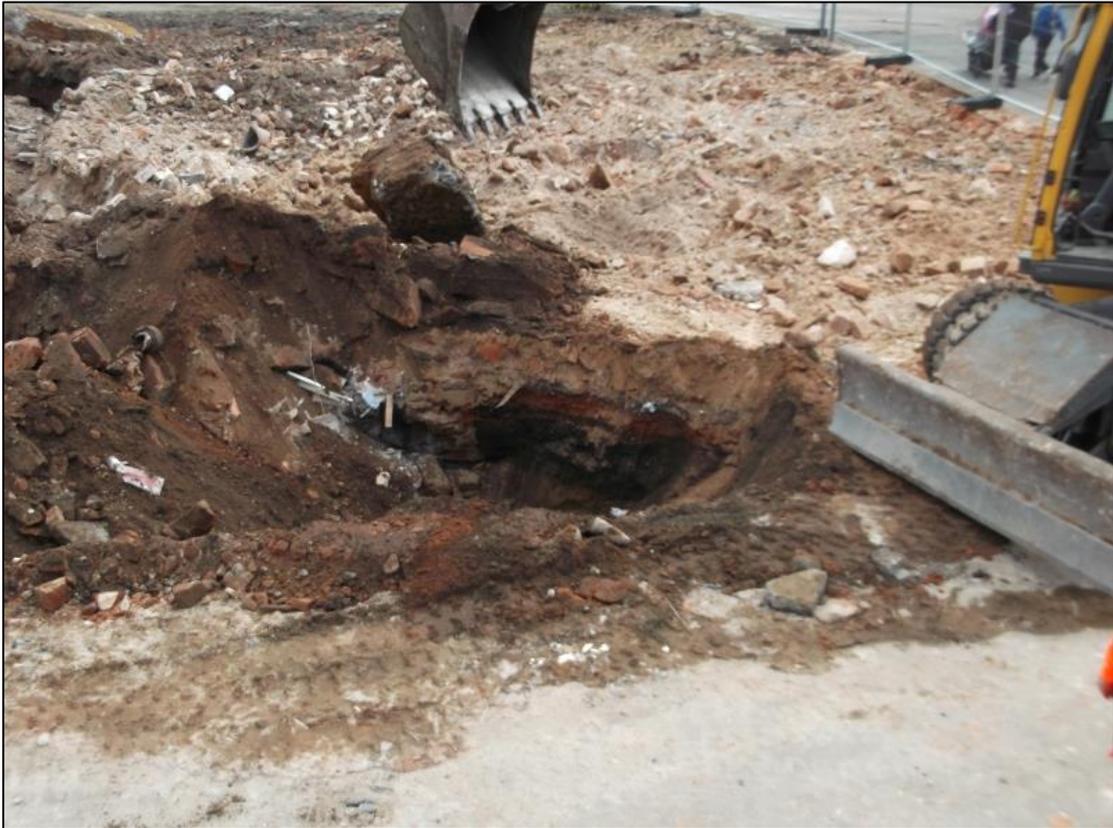
33. Along the western edge of the site, removal of the foundations proved to be a challenging task which caused significant disruption to the buried sediments. The foundations comprised a raft of poured concrete measuring up to 1.6m wide in places (though averaging 1.2m wide), encountered at a depth of roughly 1.2m below the modern ground surface. These lay within a deposit (008) which was mixed in character and clearly redeposited, producing finds of brick and masonry. Averaging around 1m in depth, it was unclear whether this layer comprised a levelling layer or an infill of an earlier subterranean feature such as a basement, or whether it merely formed the fill of a much broader foundation cut, the edges of which were not breached during the excavations.

Figure 5a: Soil Profile, W side of Site (S-Facing) – detailed view of sediments

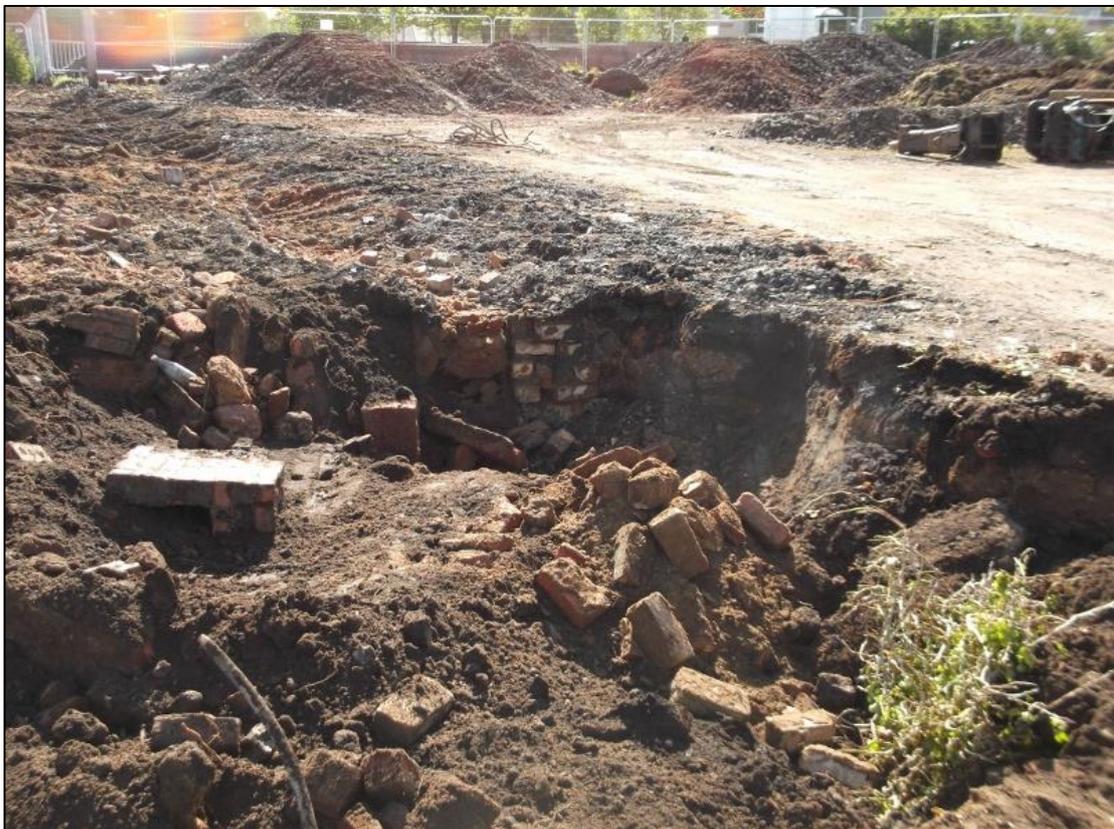
34. Traces of an upstanding wall built of sandstone ([009] – see Figure 5b) were identified as comprising part of the now-demolished school. Elsewhere, a white brick wall [010] was identified along the southern edge of the former school. This appears to have abutted another length of sandstone wall [009] and it is likely that this structure represented the remains of an ancillary lean-to structure (such as a coal bunker) which formerly abutted the school building. While it appeared to be located below the modern ground surface, the absence of the tell-tale crushed sandstone layer (006) supports a date late in the sequence, i.e. contemporary with the occupation of the school.

Figure 5b: Brick Wall [010], western edge of development area
