Dolphin Cottage, Blackwaterfoot, Arran: Archaeological Monitoring

Data Structure Report

issued 6th May 2015

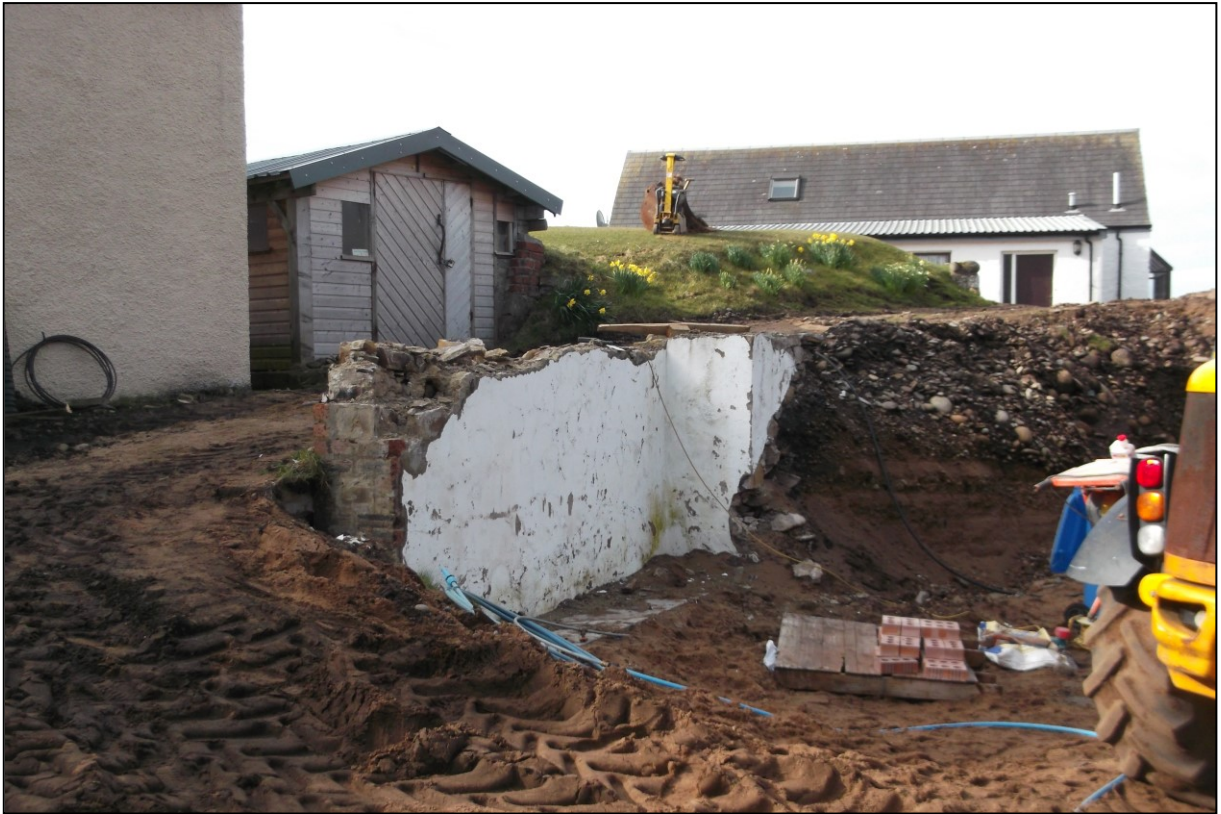
12. Rathmell Archaeology Ltd arrived on site after demolition and excavation work had already progressed. Dolphin Cottage, which had previously existed on site, had latterly existed as a single story structure with a pre-fabricated structure on top. This building had been constructed on a roughly north-north-west by south-south-east alignment and recessed into the natural slope. Ground level on the west side of the building sat much higher than on the east. The construction of this building has caused substantial disturbance to the sediments on the slope. Prior to Rathmell Archaeology Ltd being on site most of this original building had been removed including the foundation levels. Only the lower portion of the southern gable wall remained (Figure 3a).

Figure 3a: Southern gable of demolished Dolphin Cottage

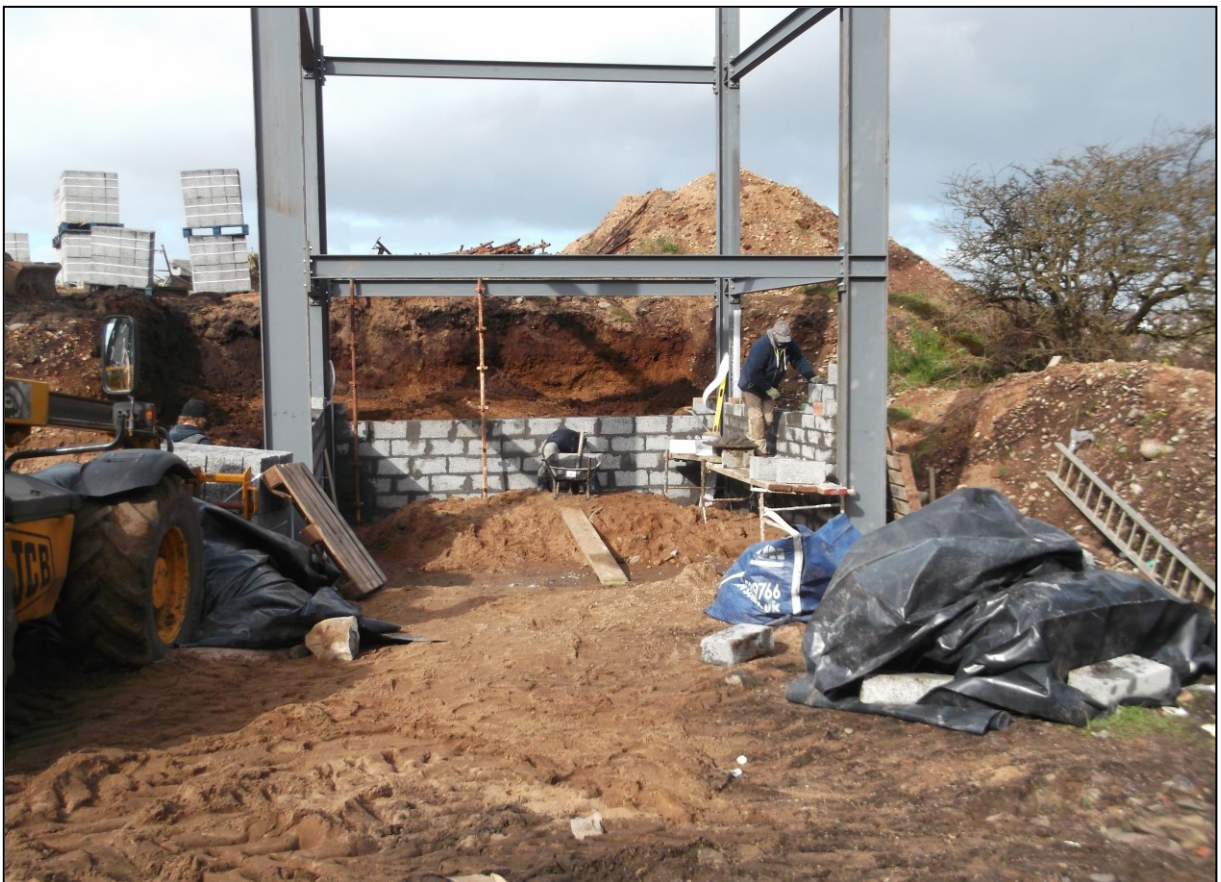
Figure 3b: Steel frame structure in the north-west corner

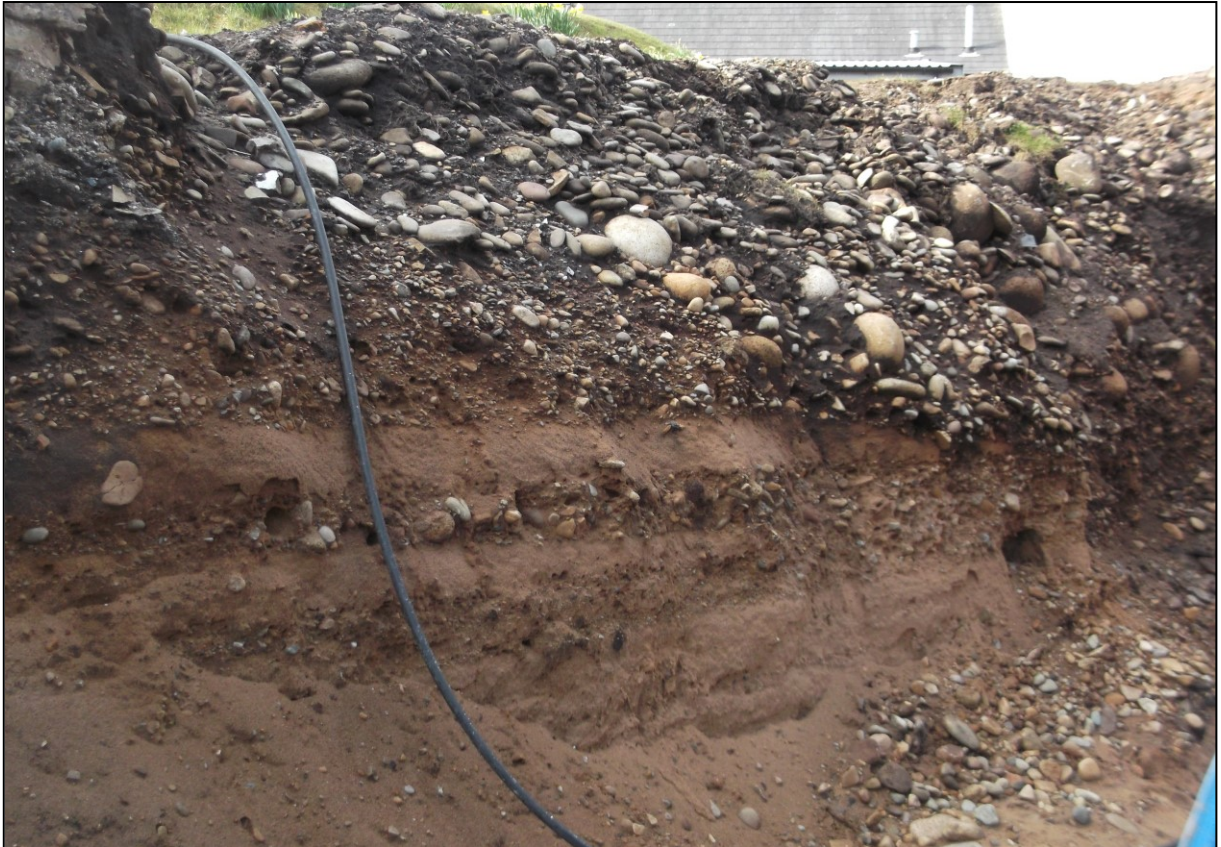
14. The exposed section on the western part of the site (Figure 4a) was composed of an upper layer of loose gravel and large rounded pebbles in a matrix of dark brown clayey sand (004). This deposit was observed to cover the ground to the west and south of the site and may represent a raised beach deposit. Immediately beyond the southern part of the excavated area, (004) formed the surface of the access road. In other parts of the site topsoil and turf, (001) to the west and (005) to the east, formed the ground surface.

15. Beneath (004) was a layer of compact yellow orange sand with lenses of small rounded pebbles (003). This was identified as archaeologically sterile natural subsoil. (003) was exposed across the rest of the excavated area which had already been opened by the 15th of April 2015. After examination of the exposed sediments upon arrival, no significant archaeological features were observed and no anthropic material was recovered other than that which would relate to the modern (later 19th to 21st century) use of the site.

Figure 4a: Section exposed in western part of site

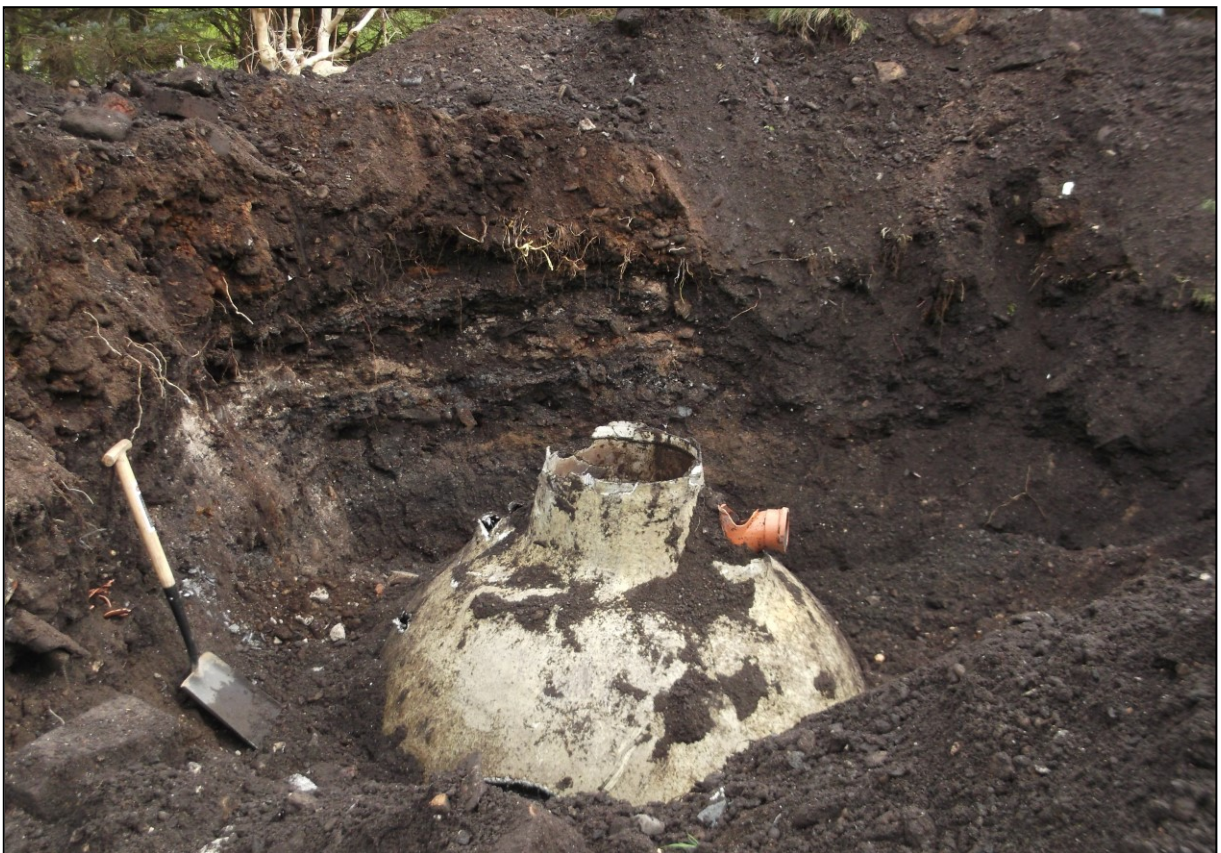
Figure 4b: Excavation for the removal of the existing septic tank

17. Excavation and partial removal of the existing septic tank (Figure 4b) was carried out on the afternoon of the 15th of April 2015 under archaeological supervision. An area approximately 3m by 3m was excavated to a depth of 1.6m. The only sediments exposed were modern backfill (006) containing modern brick, plastic, wood and building debris. At the depth of 1.6m, excavation was halted with the intention to concrete over it although the existing tank continued deeper. No significant archaeological material was exposed during this excavation work.

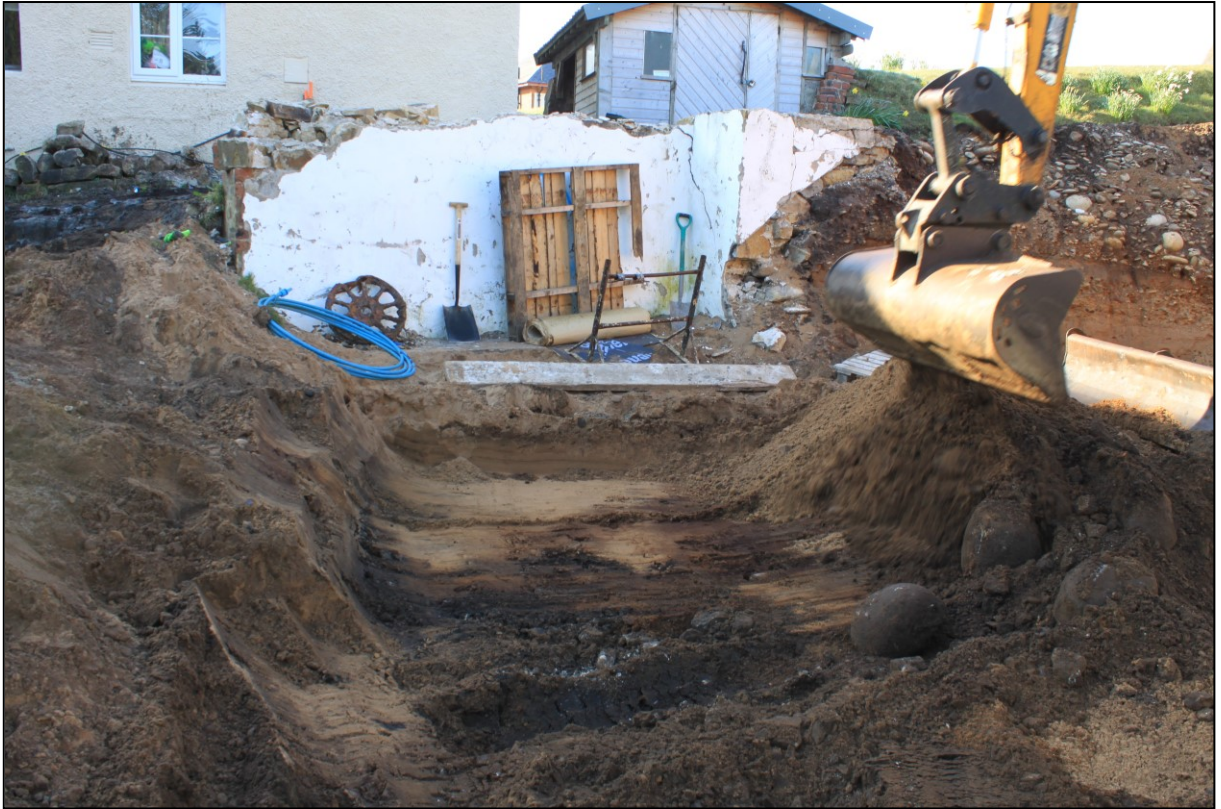
18. The excavation for the foundation trenches for the new building was carried out on the 22nd of April 2015 under archaeological supervision. A portion of this excavation was carried out in the already exposed natural subsoil in the footprint of the demolished Dolphin Cottage (Figure 5a) and the north-eastern portion was in the undisturbed area which was still mostly under turf (005). Natural subsoil (003) (Figure 5b) was exposed at the base of these trenches. The only feature exposed was identified as the base of the foundation of the demolished Dolphin Cottage (007). No archaeologically significant features were uncovered during this work and no anthropic material was recovered other than would suggest the modern (later 19th to 21st century) use of the site.

Figure 5a: Excavation in the footprint of the demolished Dolphin Cottage

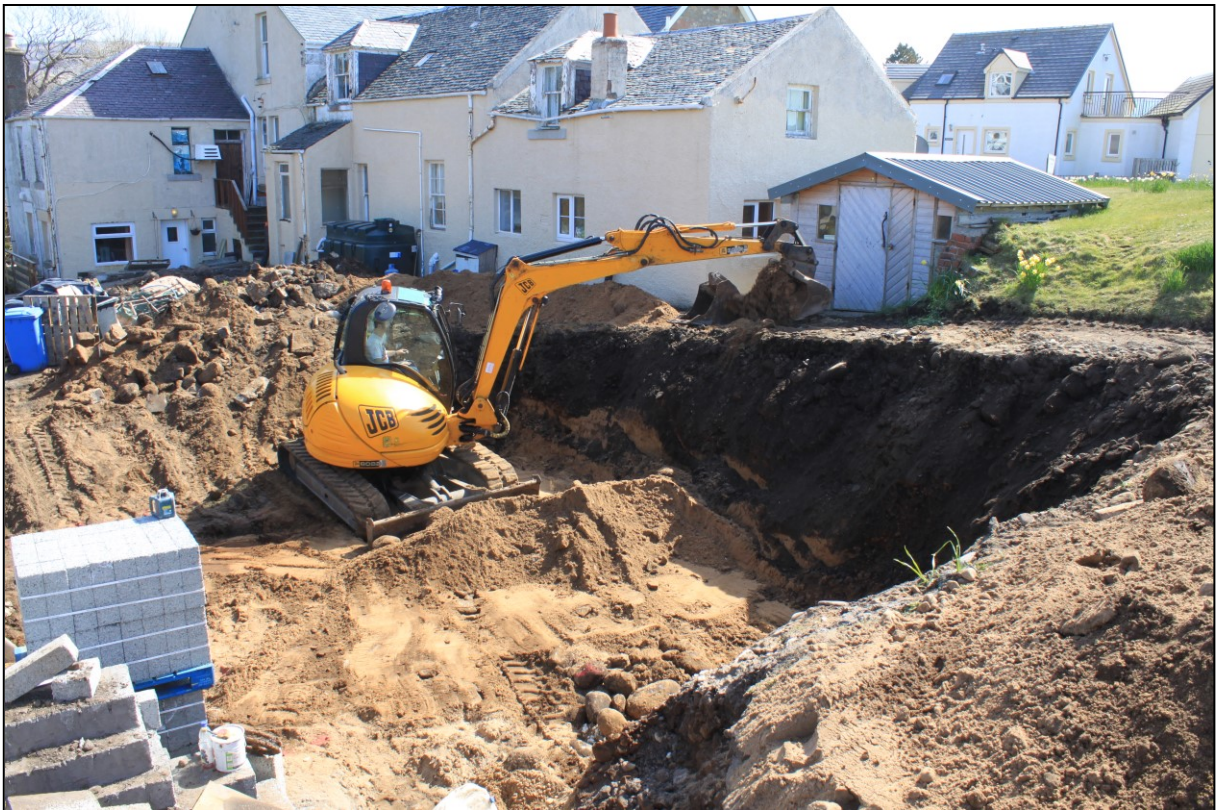
Figure 5b: Exposed subsoil (003)
