Newton Mearns Faith Schools' Joint Campus: Archaeological Monitoring

Data Structure Report

issued 21st April 2015

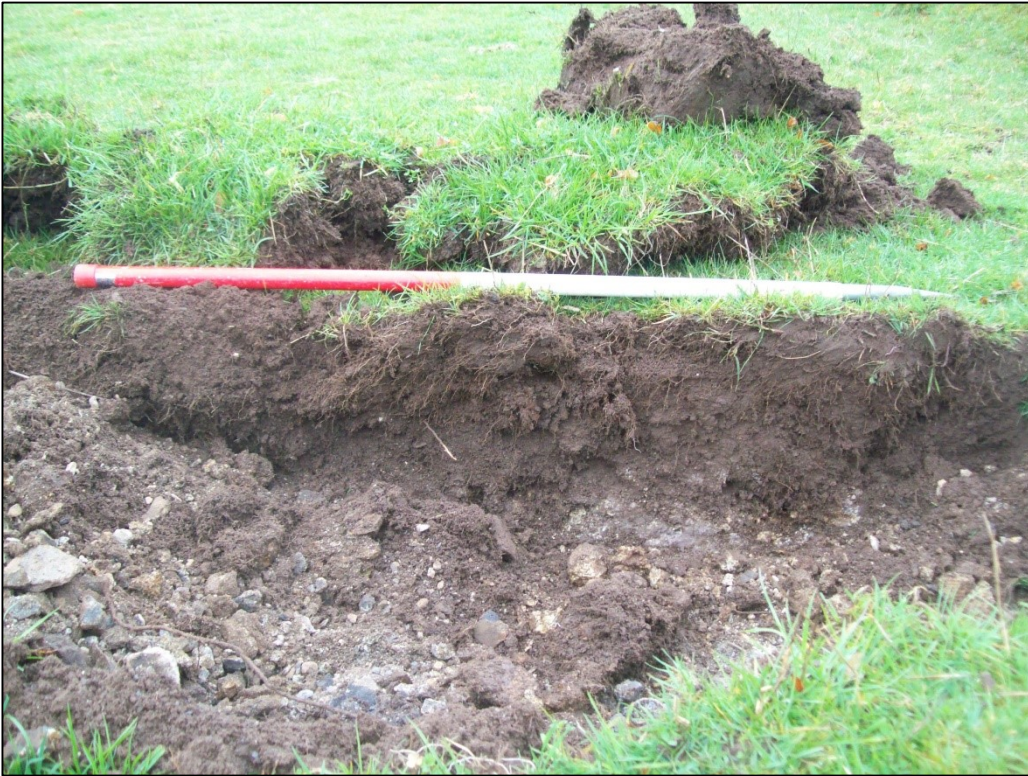
14. The test pits and trenches were excavated through turf and topsoil: typically, the latter comprised a loose, dark-brown clay silt with a high humic content and generally stone-free. Depth varied markedly across the site. The topsoil was extremely shallow in the west corner of the site – where it appeared in TP 1 (101), it measured 0.25m in thickness (Figure 2a). It was similarly thin in the north corner, with the topsoil deposits recorded in TP 26 (2601) measuring 0.3m in thickness, and similarly across the southwest portion of the site, with TPs 19, 20, 22, 23 and 24 (Context Nos. 2001, 2201, 2301 and 2401 respectively) again measuring between 0.2m and 0.3m in depth.

Figure 2a – Test Pit 1 ('TP1'), NE-Facing Section – Topsoil (101) overlying bedrock (102)

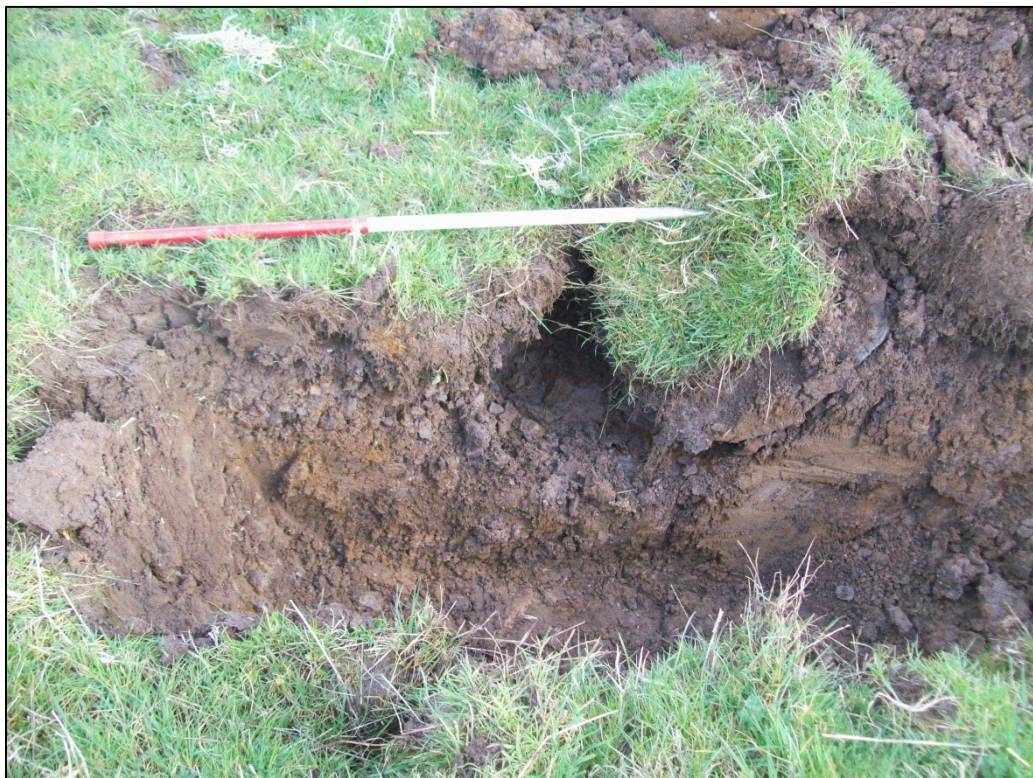
15. Although the topsoil was largely uniform in character over the full extent of the site, some local anomalies were noted. In TP 17, a number of sub-angular stones and cobbles and the occasional boulder were noted, both within the topsoil and partly lying within the subsoil. The junction between topsoil (1701) and the underlying subsoil (1702) was also very diffuse and the soil waterlogged. This characteristic appeared to result from the fact that the area had earlier been used as a gateway, with a gap in the hedgerow and a disused gatepost apparent, causing a localised hollow which had since become waterlogged (Figure 2b).

Figure 2b – Test Pit 17 ('TP17'), SW-Facing Section – High stone content in topsoil (1701)

29. Across the entire site, the topsoil was remarkably free of stones, but a marked concentration was evident near a disused gateway at the north corner of the main, southwestern field (TP17, topsoil (1701)), suggesting that a programme of field clearance had been undertaken across this field, with a similar dearth of stones within the topsoil across the full extent of the site suggesting similar practices elsewhere.

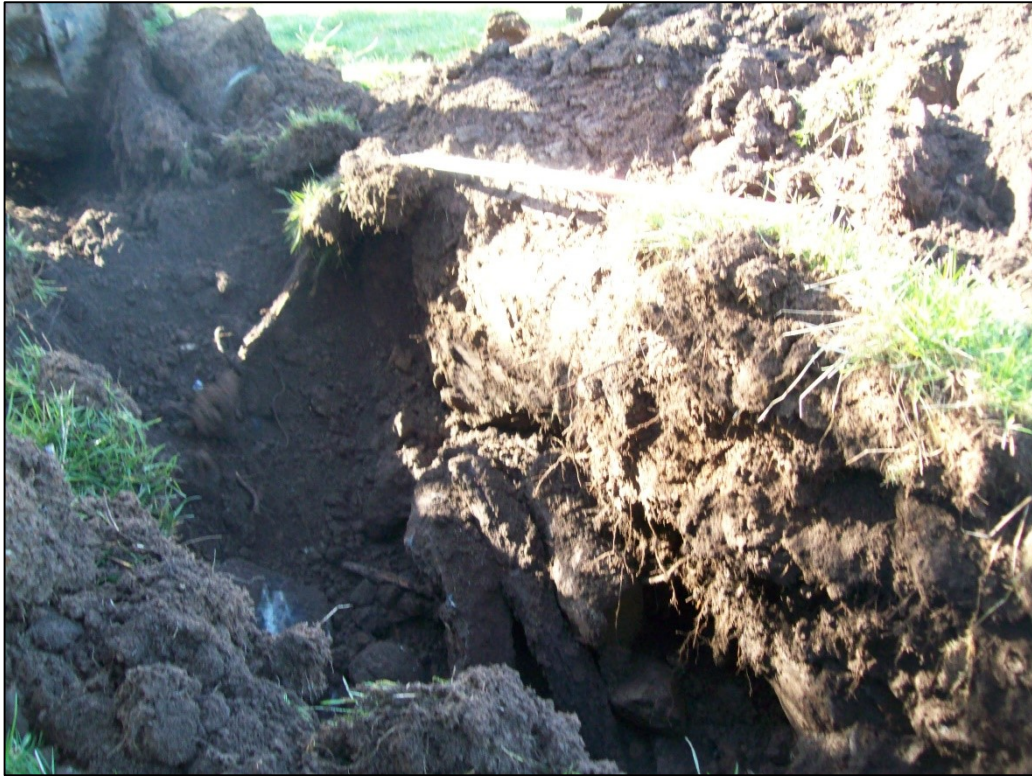
22. TP 25 took the form of a slot trench measuring 6m by 0.5 in extent which was placed to establish the location and current condition of the well shown on historic mapping at the northeast boundary of the steading.
23. No clear evidence of a surviving well structure was found. However, a number of worked stone blocks (2505) with a pronounced curved to their long surfaces were recovered within a topsoil-like fill (2504) of a pit [2503] measuring around 1.2m in width. This pit had been cut into the bedrock. A stout circular-sectioned timber was also recovered from the pit – this may have functioned as the central axle of the windlass used to lower and raise a bucket down into the well's interior.

Figure 3a – Test Pit 25 – Dismantled well superstructure (2505) within well infill (2504)

27. Slightly to the southeast of Structure d (the northeast-southwest running wall which formed the southeast edge of the sunken enclosure described above), historic mapping showed a well located immediately adjacent to the northwest-southeast running field boundary. Only a faint depression was visible in the field, but excavation revealed a rock-cut shaft within the bedrock [2503] which was now infilled, partly with an upper fill of soil (2504) but also with what appeared to be the dismantled remains of the well superstructure (2505) (Figure 3a). Though the well infill was stony in character (Figure 3b), the well shaft itself did not appear to be lined: it was unclear whether lining had been required with the shaft having cut through bedrock, or whether the lining was robbed at the point of the well's abandonment and demolition.

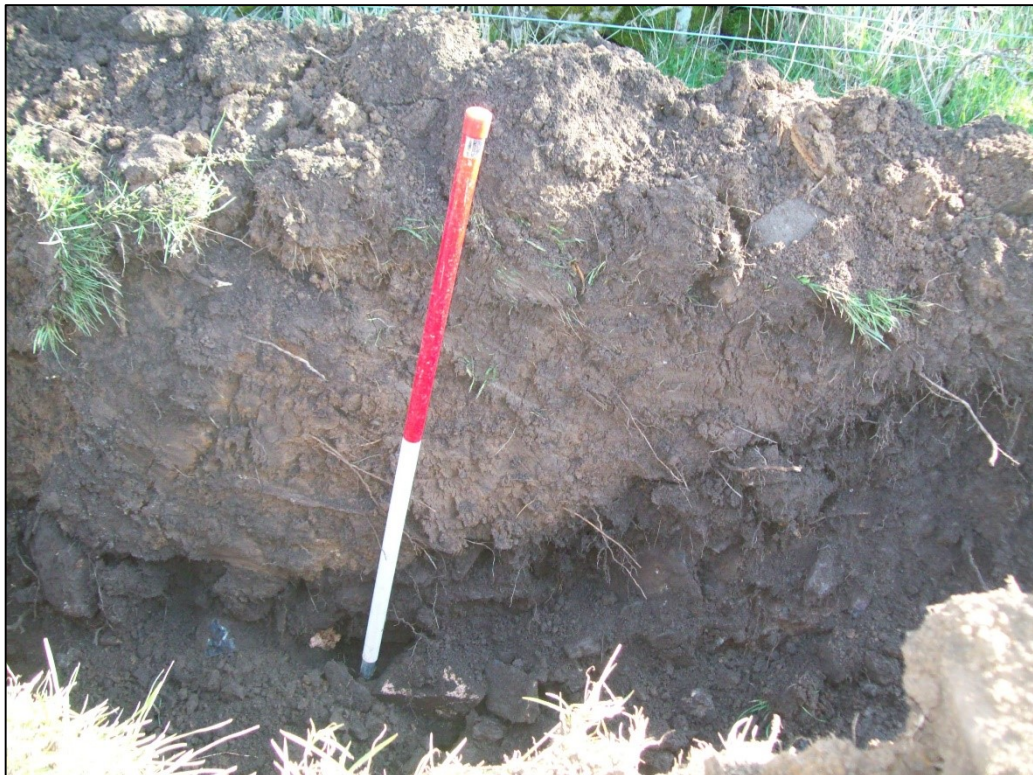
Figure 3b – Test Pit 25 – Topsoil (2501) slumping into infilled shaft of well with well infill (2504) below
